132 MURRAY ST FACADE INVESTIGATION

PERTH, WA

TECHNICAL CONDITION SURVEY

132 Murray Street Facade Investigation

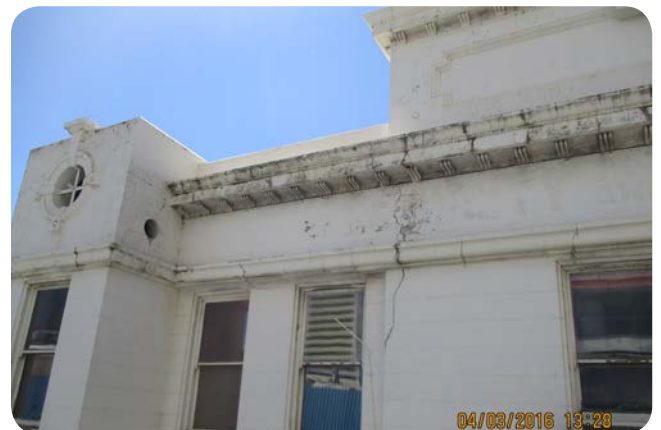
- Overview of 132 Murray Street.
- Concrete cracking on signage band.
- Concrete deterioration on balustrade.
