CURTIN UNI CEILING & ROOF WORKS

CURTIN UNIVERSITY BENTLEY
CAMPUS, PERTH, WA

MAINTENANCE - WATERPROOFING

Curtin University Level 7 Ceiling and Roof Works

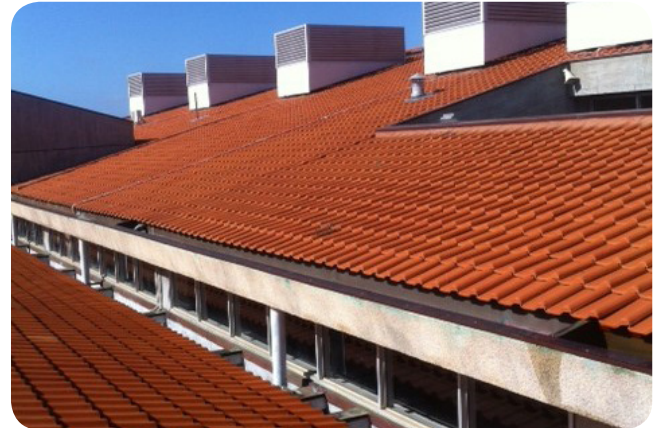
The roof had deteriorated significantly over time as a consequence of poor construction and ambient factors. Historical roof leaks were occurring on regular basis due to cracked/damaged roof tiles, improper sarking installation, failed sarking joint and cracks in the copper gutters. The scope included:

- ▶ Overview of the roof.
- ▶ Vermiculite application in progress.
- ▶ Completed ceiling.

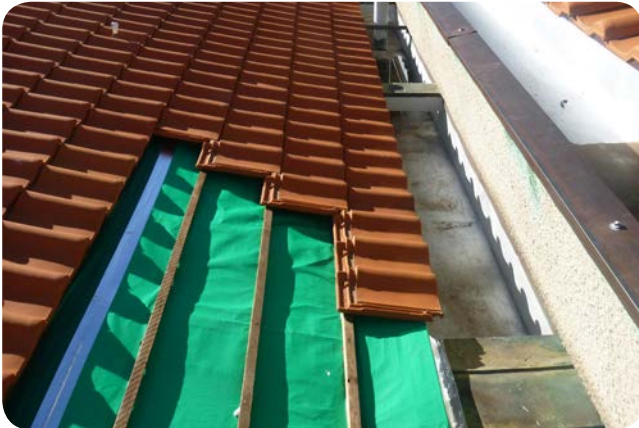
- ▶ Anti-ponding boards installed.
- ▶ Repair areas in sarking membrane sealed tight using tape.
- ▶ Cold water services installed along the existing access walkway.

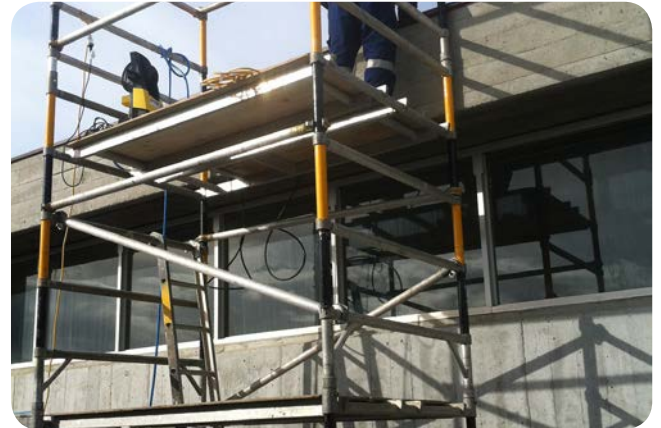
- ▶ Scaffold access installed for gutter works.
 - ▶ Cracked/damaged tiles replaced.
- ▶ New evaporative coolers installed using a crane.
