**Title:** 5th Field Company, Australian  
Engineers

March 1918

REPORT ON CONDITION OF TRENCH SYSTEM TAKEN OVER FROM THE  
11th FIELD COMPANY AUSTRALIAN ENGINEERS.

## - REPORT ON BRIDGES

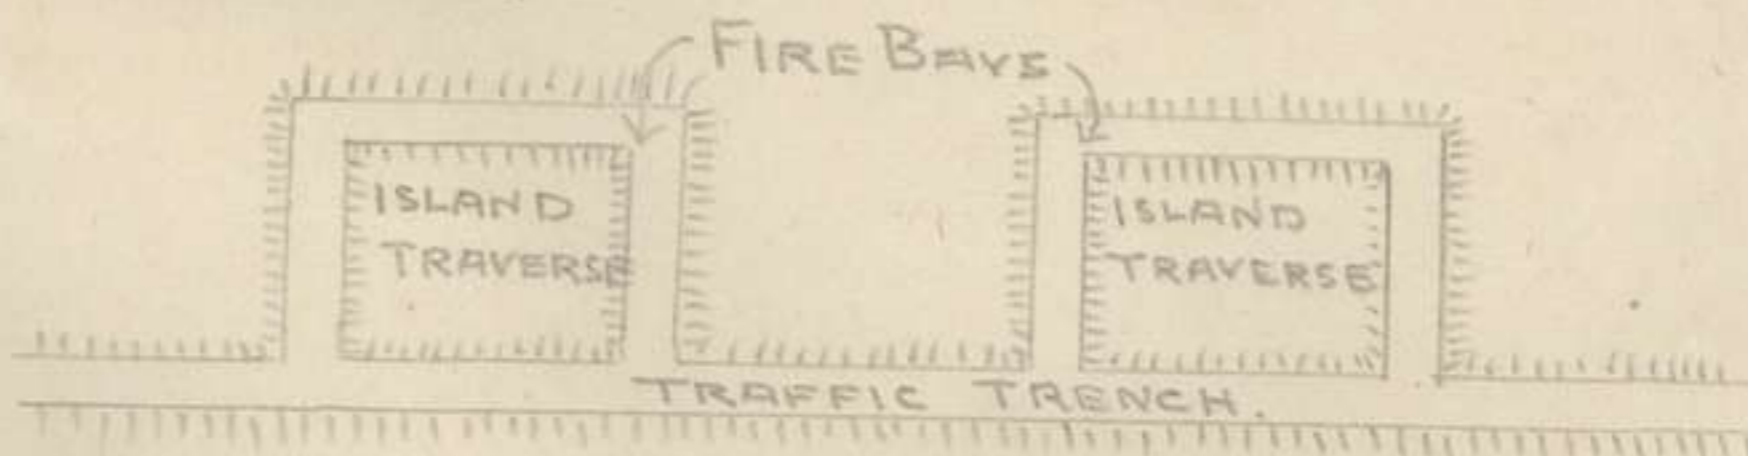
This trench was in good condition. A series of 7 firebays on the island traverse system ( see sketch ) had been newly constructed.

and revetted. The firestepping remained to be completed and the anchoring of the revetment was also incomplete. The drainage in the trench had been somewhat neglected. It was necessary to clean out a large amount of earth from underneath the duckboards before the drainage was good again.
