**Port Macquarie-Hastings Council**

Broadwater Canal  
Canal Maintenance Plan

May 2016

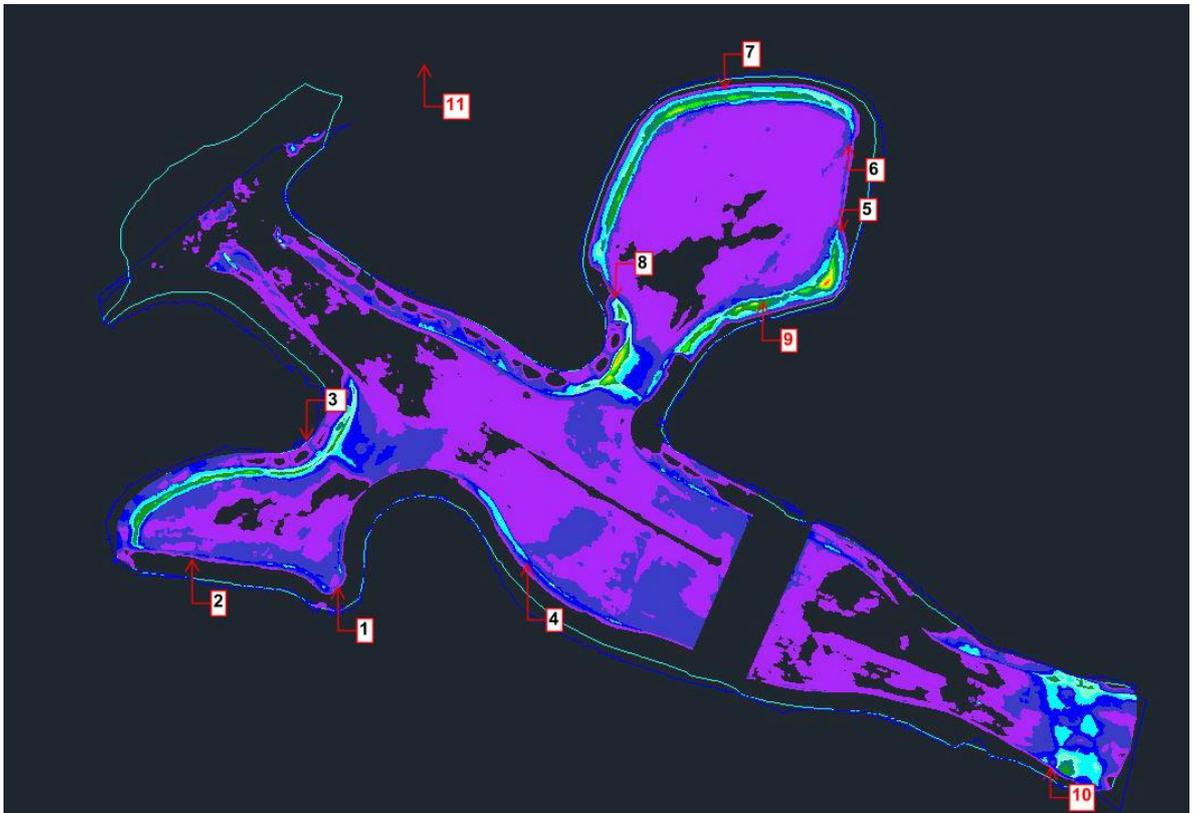
**Figure 3 Approximate locations of stormwater outlets relative to amount of sedimentation**

Raised bed levels as a result of sediment accretion have the potential to restrict or even block the flow of stormwater outlets. Each outlet has a pipe diameter in accordance with its design flow. The diameter of the pipe has an effect on the depth at which the bottom of the pipe joins the canal, as evident in Table 3. It should be noted that all information provided below has been derived from the original design drawings. Also, only the outlets identified on the site visit were included in Table 3, and have been numbered in accordance with Figure 3.

As specified above in Section 3.3.1, the absolute minimum depth for vessels to navigate safely throughout the waterway is 2 m. If water depths were to reduce to this level, vessel navigation would be inhibited however all of the stormwater outlets identified would remain unrestricted by sediment build up. This is because the deepest outlet is only 1.82 m below AHD. This statement is based upon uniform accretion across the canal which is clearly not evident upon inspection of the information provided in Section 3.3.2 and Appendix B. The current canal condition displays elevated levels on foreshore areas, and as such, there is the potential for stormwater culverts to be blocked.

located in regions where levels of sedimentation appear to be greater than the surrounding bed of the canal. However the validity of these levels is ambiguous due to the reasons outlined in Section 3.3.2.

In light of the above considerations, dredging is not required at this point in time.

It is recommended that dredging of the sediments surrounding any stormwater outlets be deferred until dredging of the lagoons (and potentially Main Canal) is required. In the event that localised sediment build up impacts the functioning of the stormwater outlets or navigation
