Woodsreef Asbestos Mine report for New South Wales

WOODSREEF ASBESTOS MINE REPORT

**Re: Woodsreef Mine Report: Relative to the Mill House
and Adjacent Area Remediation.**

Report: Woodsreef Mine: Mill House Site Remediation
for
New South Wales Department of Mineral Resources, Environment

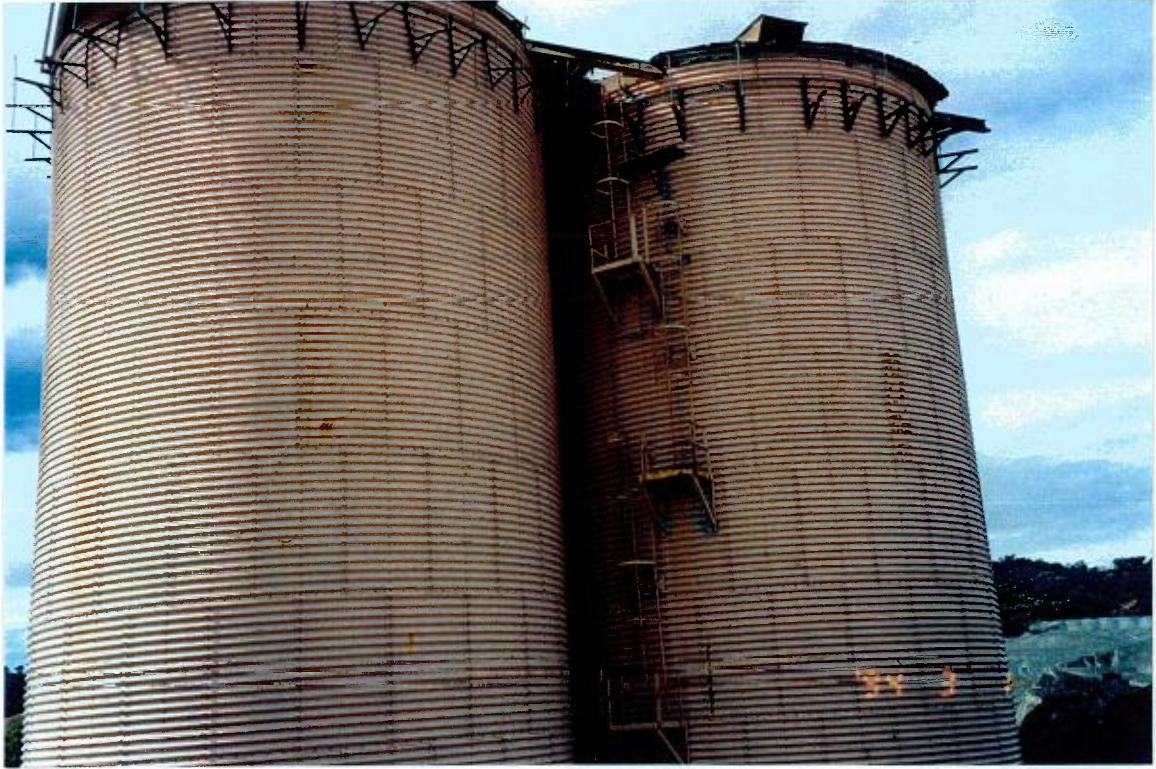
Corrugated steel storage tanks. Conveyors to Mill House have been removed.

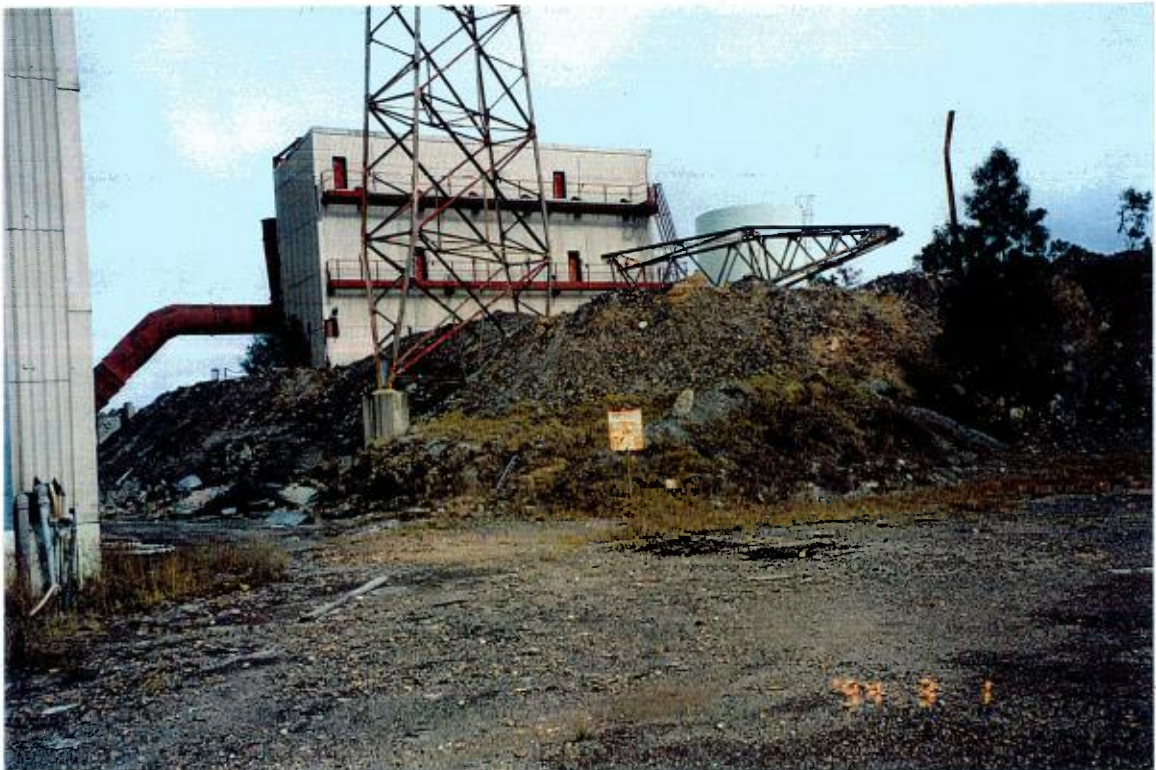
Drying House, of three levels, containing filter bags and highly contaminated.

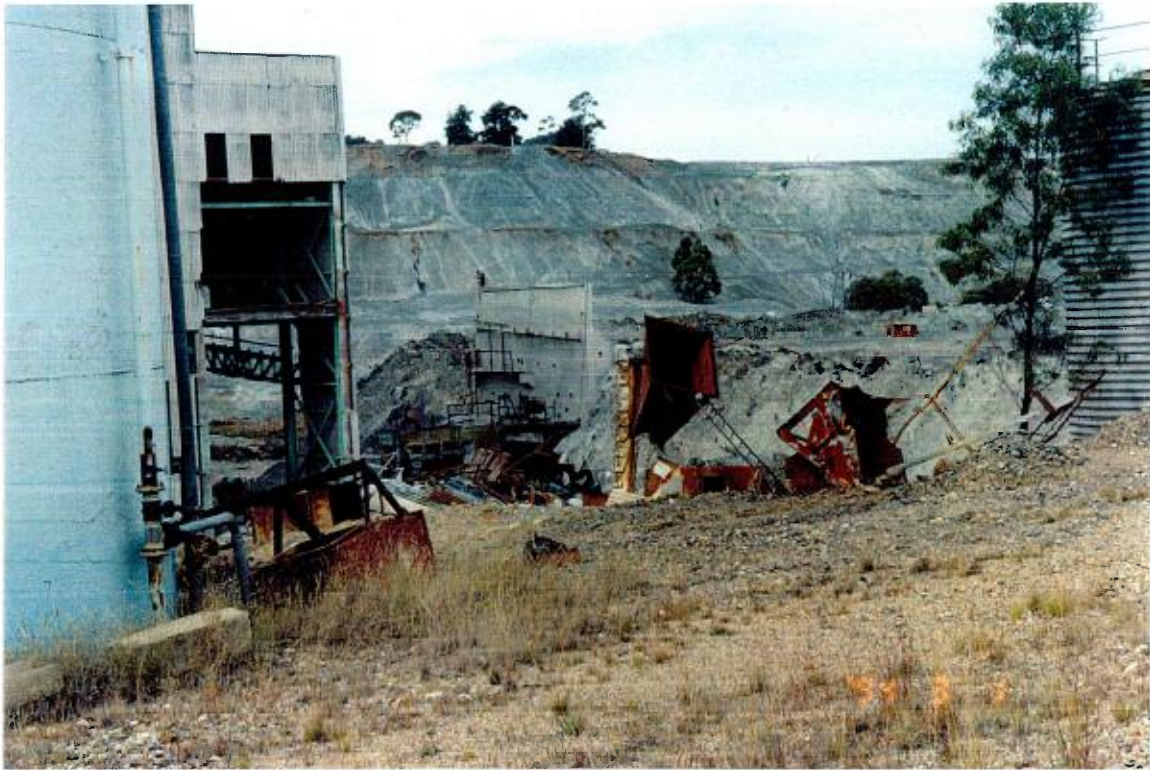
View from the west of the remains of the Crushing Plant.

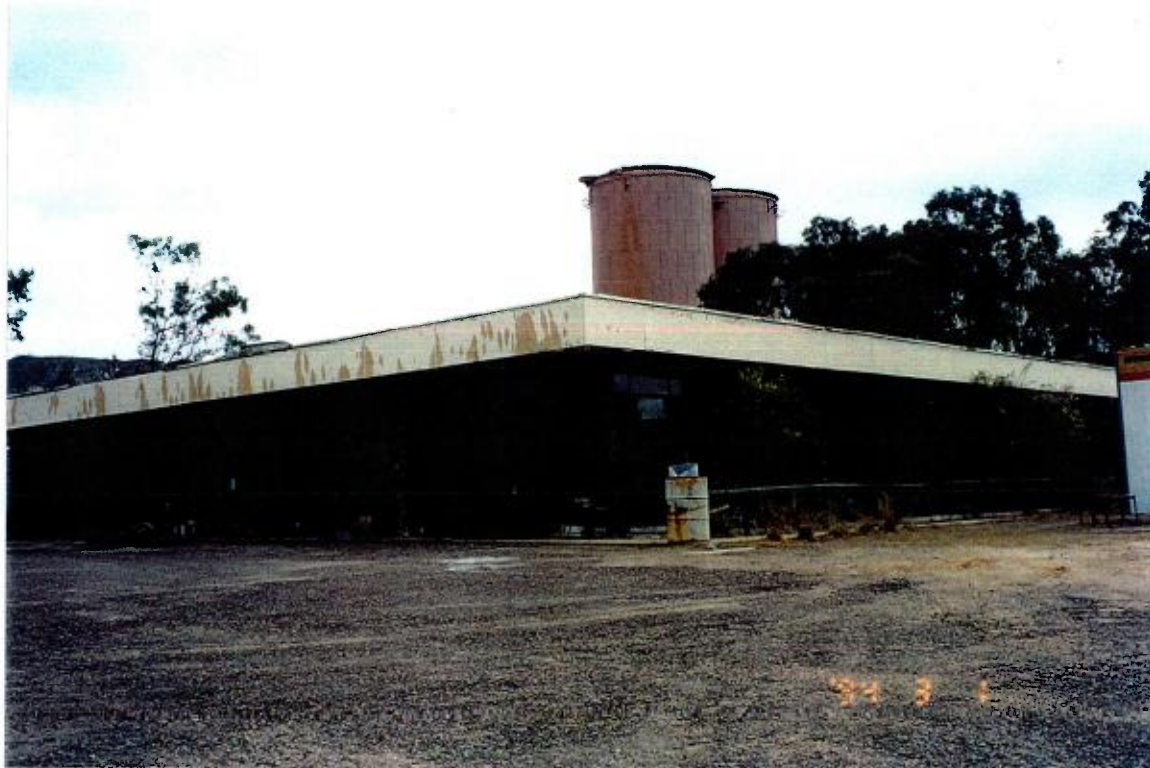
Office building with corrugated storage tanks at back.

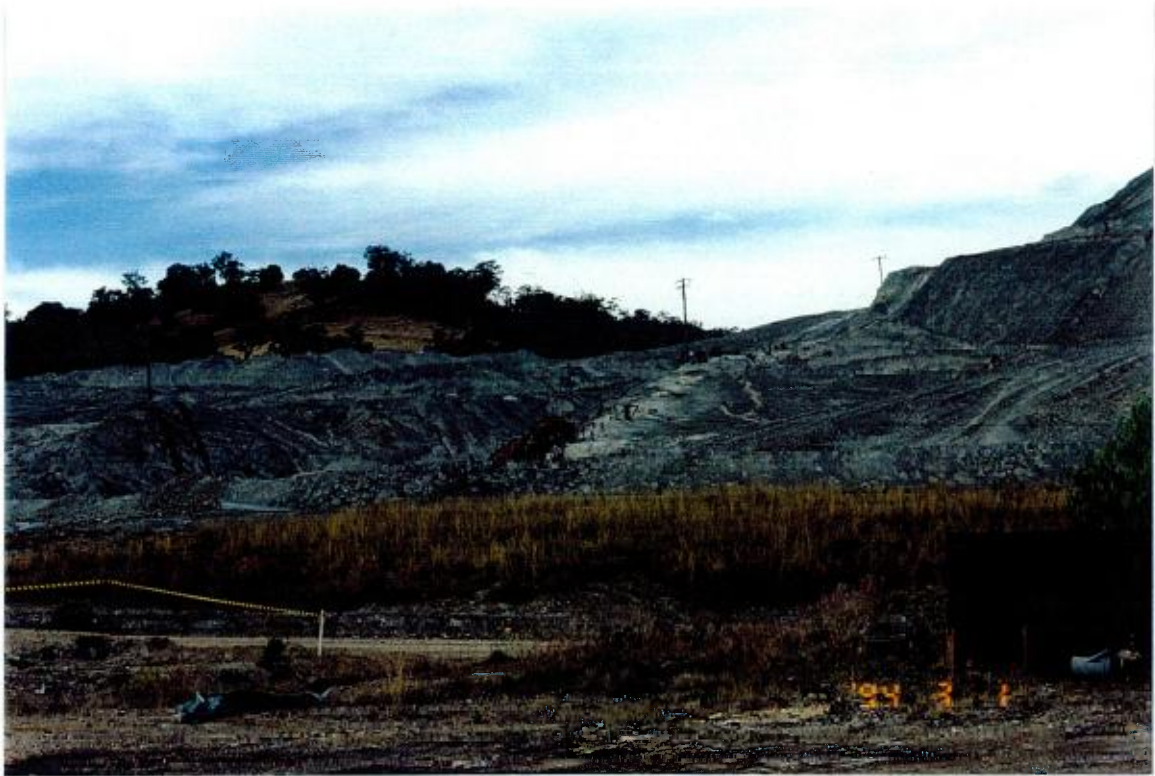
Remains of the conveyor footing on the tailings dump.

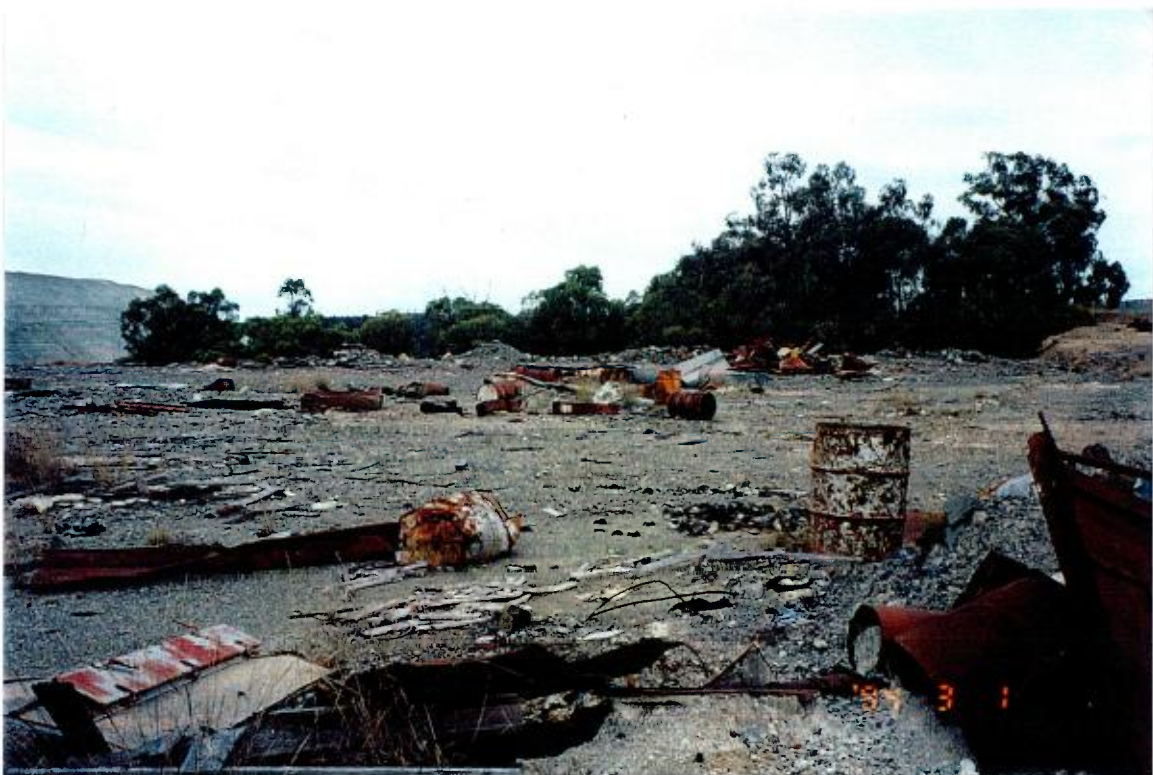
- Adjacent to the Mill House:
 - i) Disassembled scrap metal located within the adjacent area of the Mill House was quite varied and consisted of large sections of hoppers and ducting, piping, tower frames, angle, steel plate, ladders, empty drums and an assortment of minor steel and iron. All material noted was asbestos contaminated and represented little or no commercial value. The decontamination of the material in situ would pose problems as most is scattered over a large area and partially buried in asbestos contaminated fill. The larger sections of ducting at the crusher end could be processed and salvaged, but would be of minor value. Our recommendation would be to decontaminate where possible, load into plastic lined bins or trucks, and dispose into the nominated burial sites.

Typical scrap metal and debris scattered on asbestos residue.

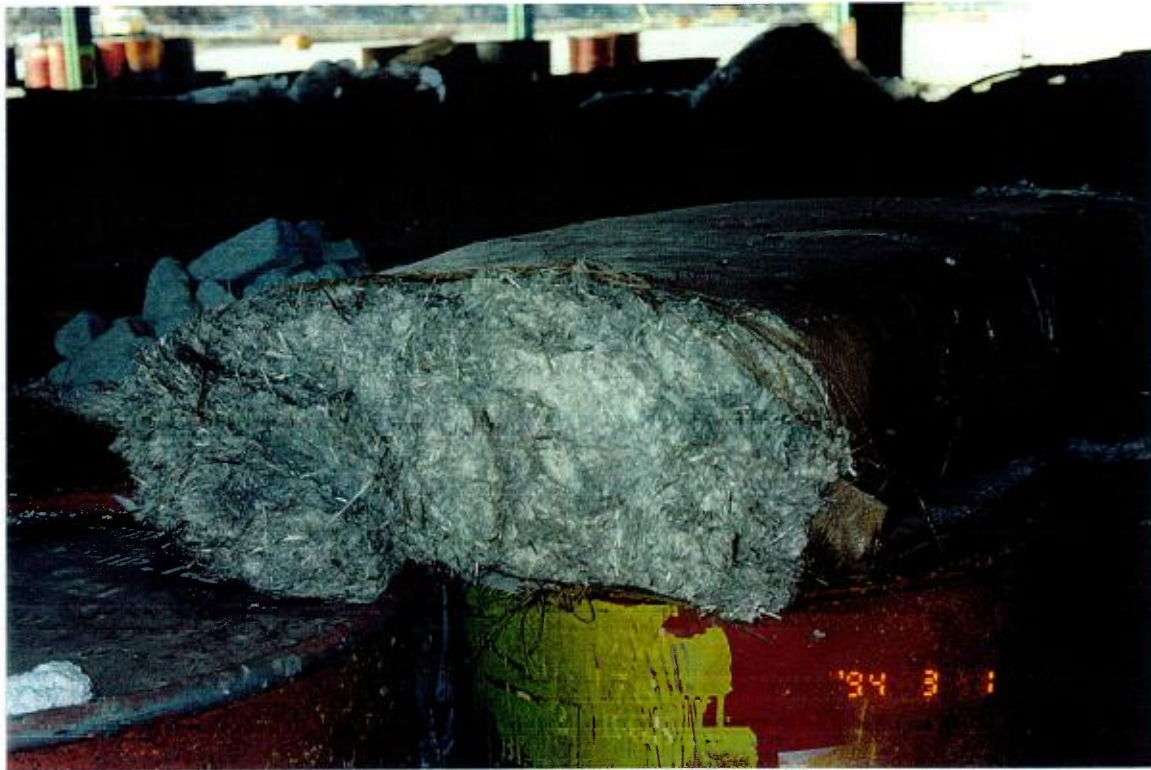
- Processed pure 100% asbestos fibre has been stored on the ground floor areas in steel drums and plastic wrappings. Some containers are in good condition but others are in a dilapidated state. A conservative estimate of the packaged materials would be 25 tonne.

Pure asbestos fibre in dilapidated wrapping.
Sealed drums contain finished product ready for shipment.

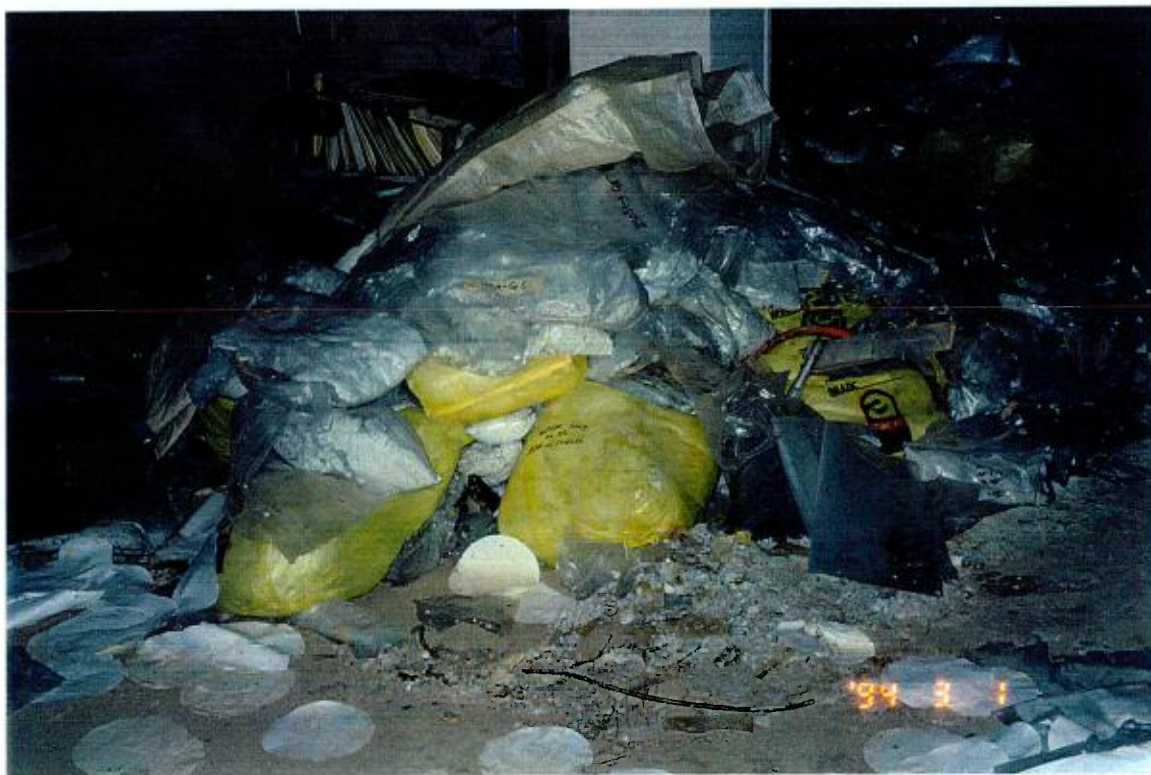
Processed asbestos fibre in broken plastic packaging.

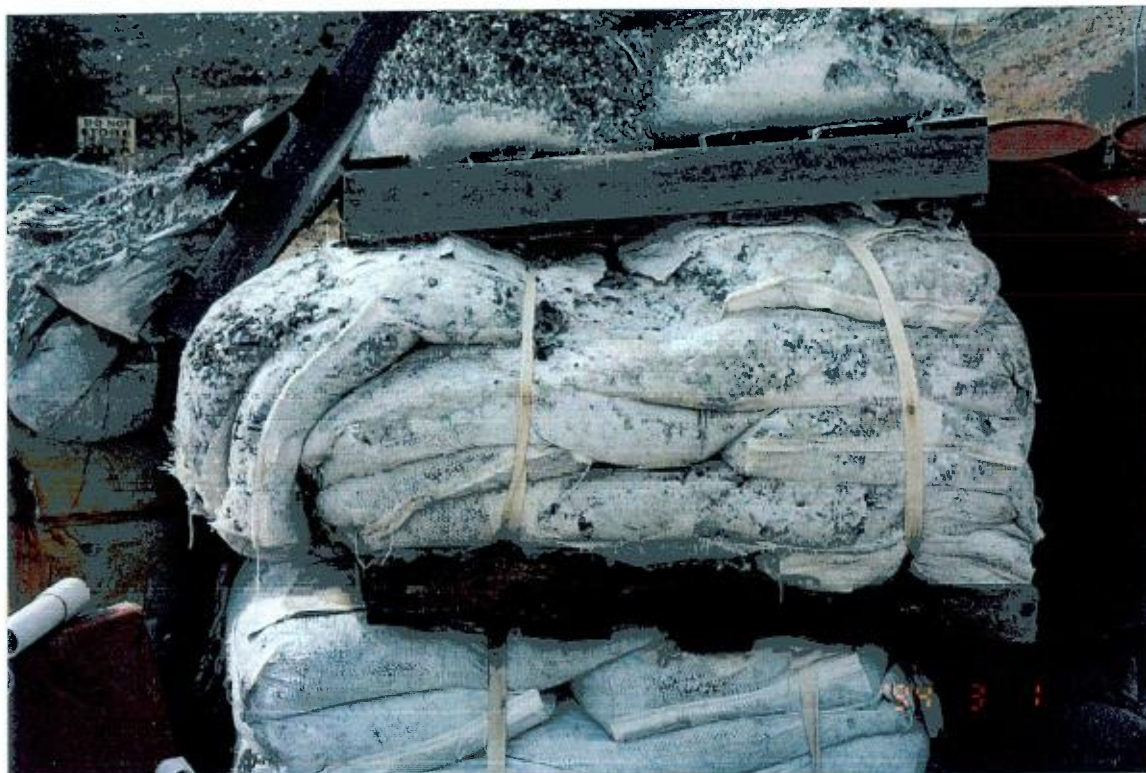
Processed asbestos fibre ready for shipment.

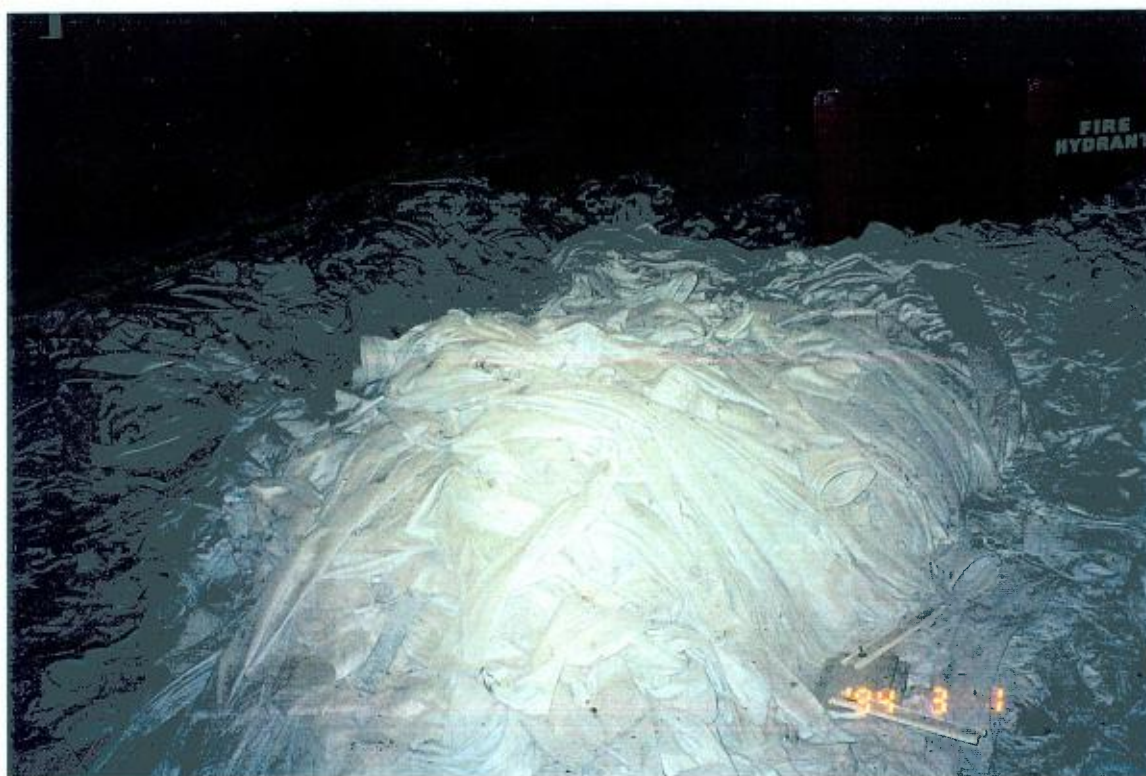
Typical precipitator filter bags containing pure fibre.

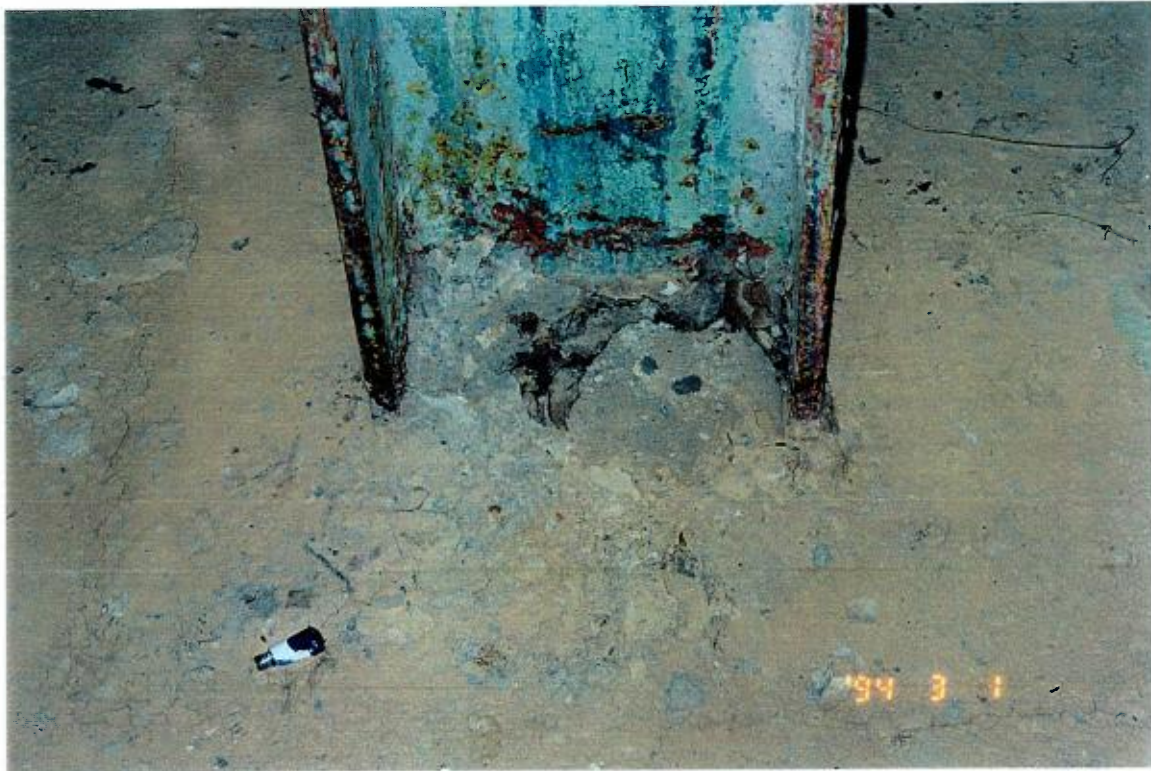
Asbestos fibre on the floor around structural columns.

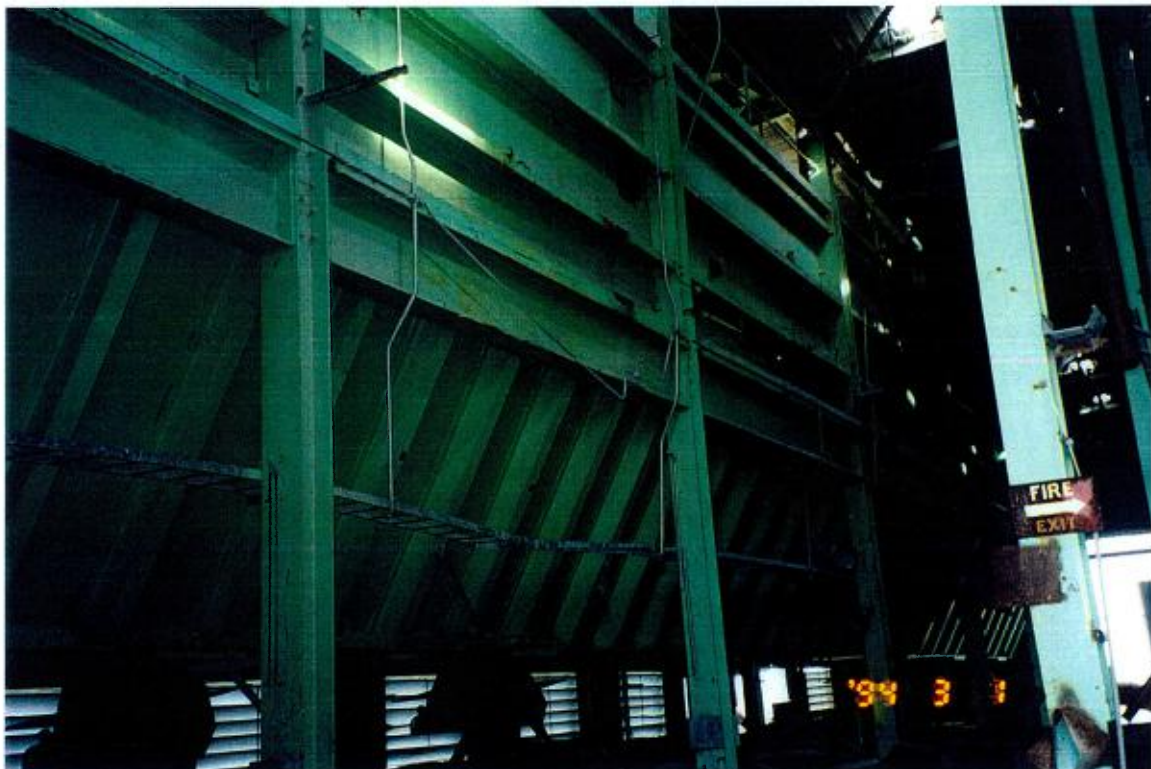
One of three large hoppers on the 7th and 8th floors, containing asbestos material.

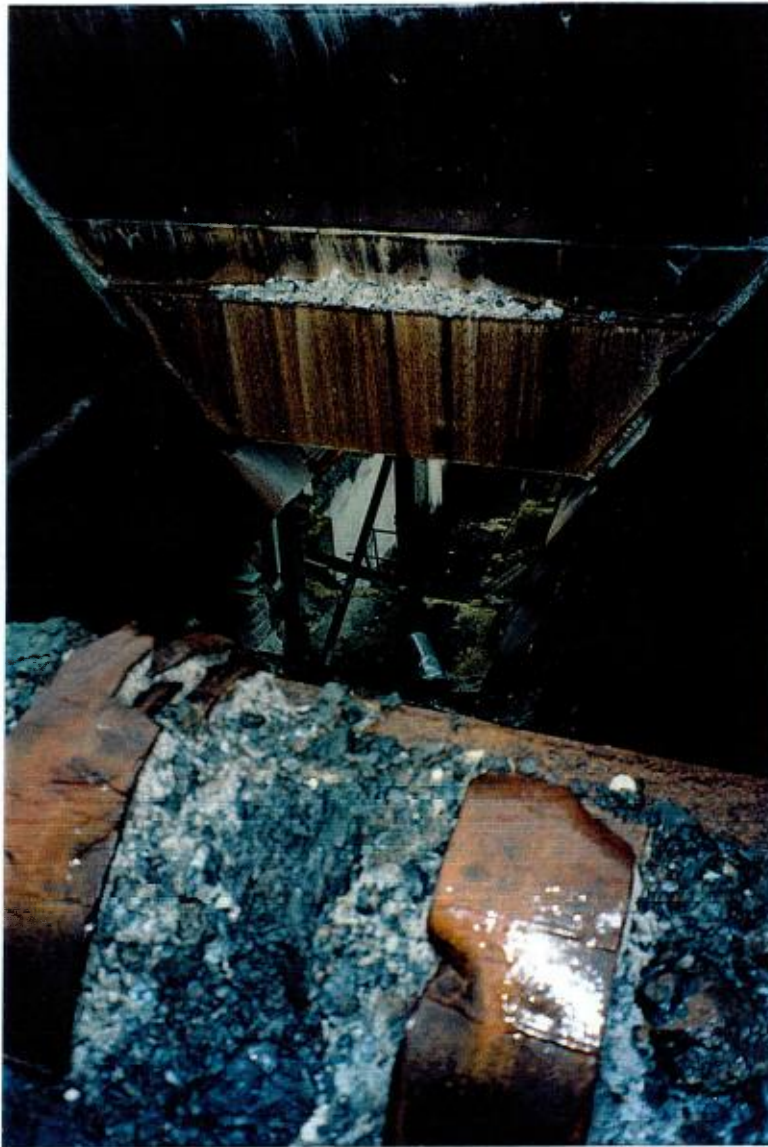
← Crushing
Plant inlet
hopper, not
protected.

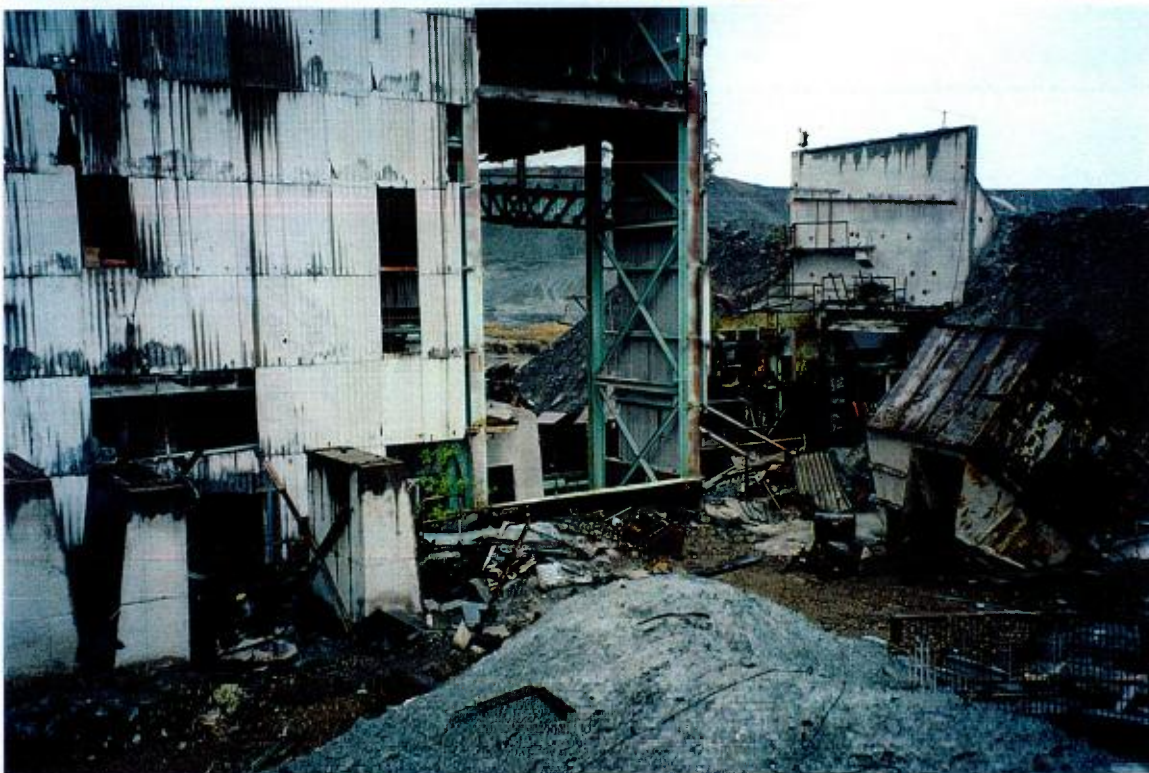
↓ Southern
end of the
Mill House
and
partially
demolished
Crushing
Plant.

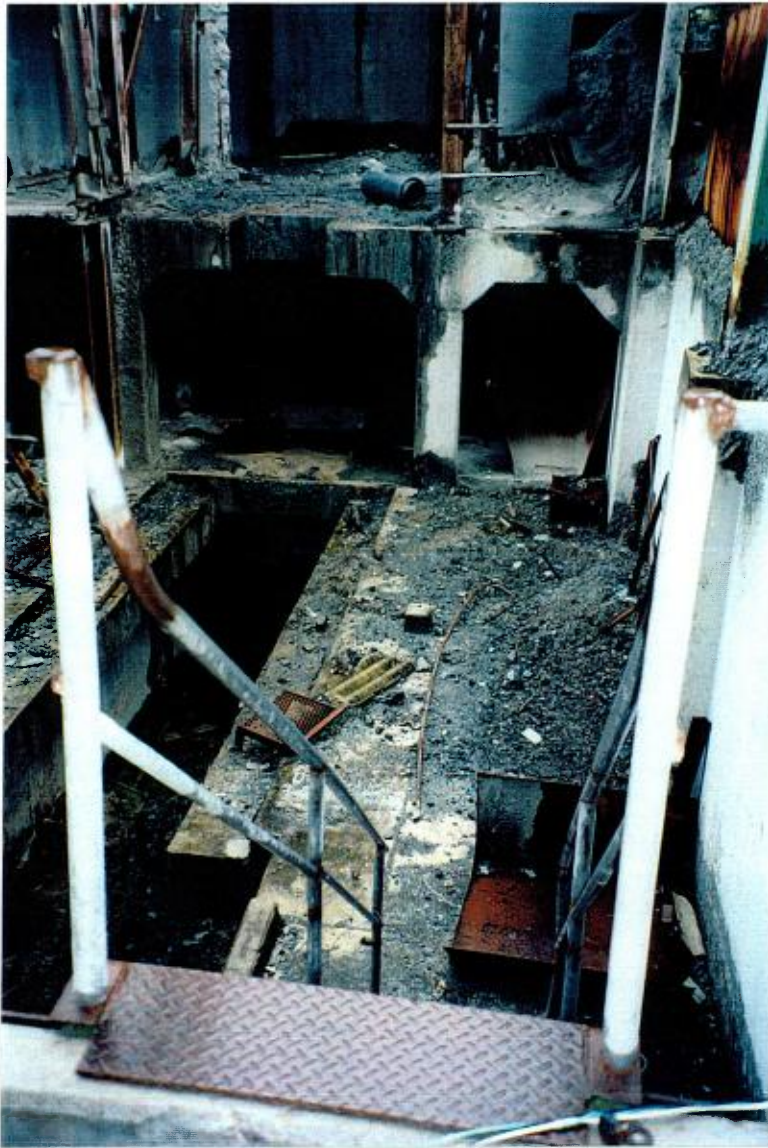
← Remnants of the Crushing Plant depicting unprotected pit and asbestos fibre.

It is recommended that weld mesh be fitted to the various openings accessing this area. The area poses a serious hazard, particularly for any juvenile intruders, with unprotected sump areas filled with water and conveyor tunnels left open. Reference should be made to the various photos accompanying this report. Please note: The date on some of these photographs is incorrect due to a faulty battery.

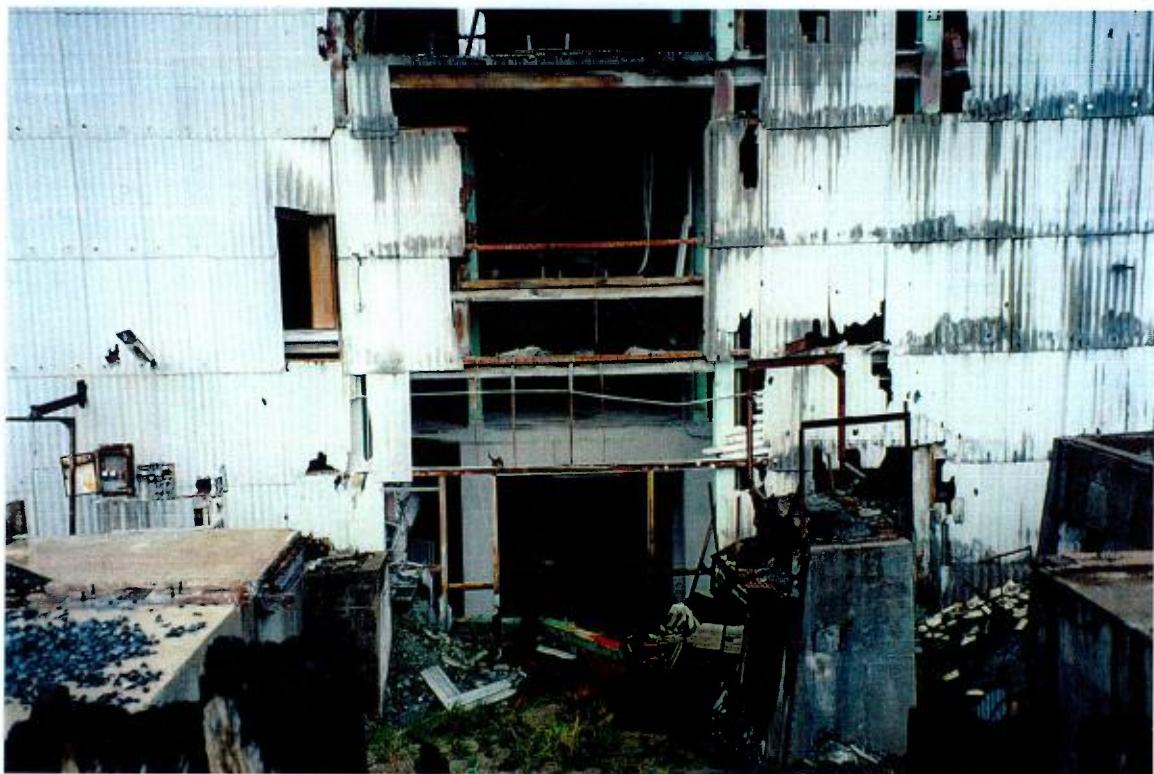
External cladding of the building is corrugated asbestos cement sheeting. Significant damage has been inflicted on this sheeting with probably up to 35% either being damaged or missing. Our estimate of asbestos cement sheeting is 130 tonne.

↓ Southern wall of the Mill House showing broken asbestos cement cladding.

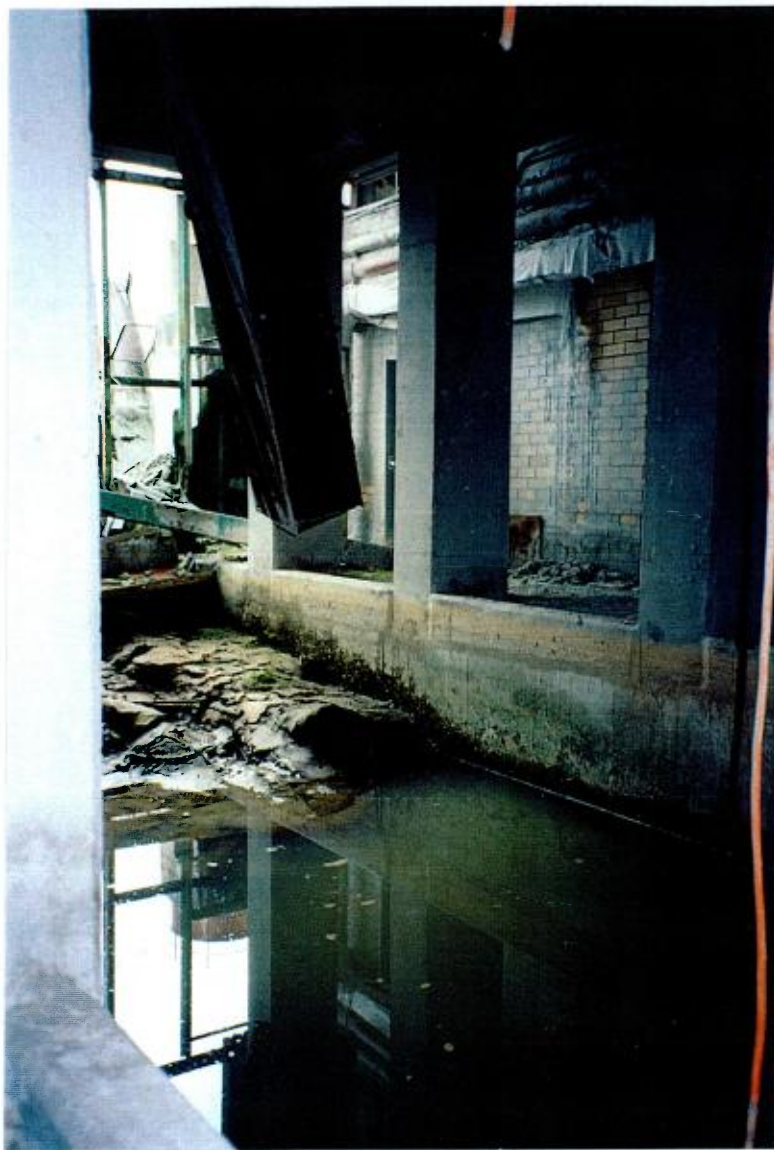
← Internal conveyor pit with broken pipe lagging on the wall in the background.

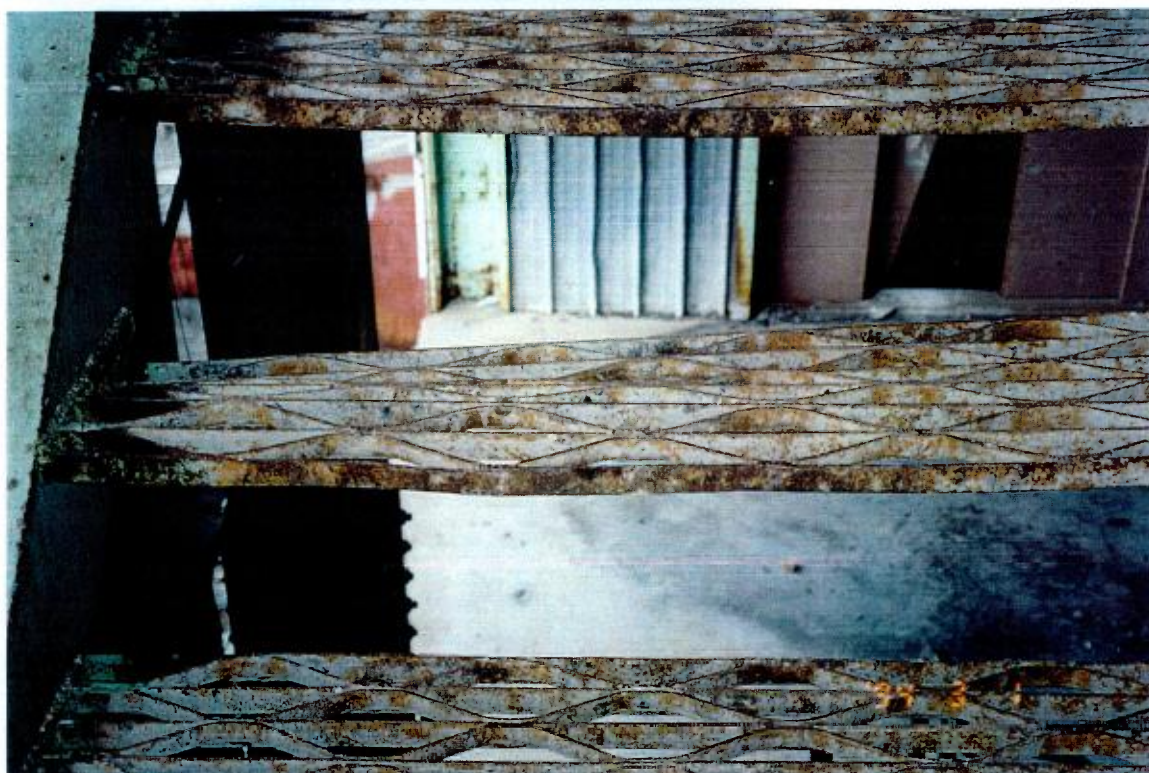
A goods lift is located at the centre of the main building and serviced all floors to the 8th level. Several doors are not secured and are a hazard. It is unlikely that this lift could be brought back into service and no consideration has been given to this possibility.

↓ Example of damaged stairs and open lift door on the top right corner.

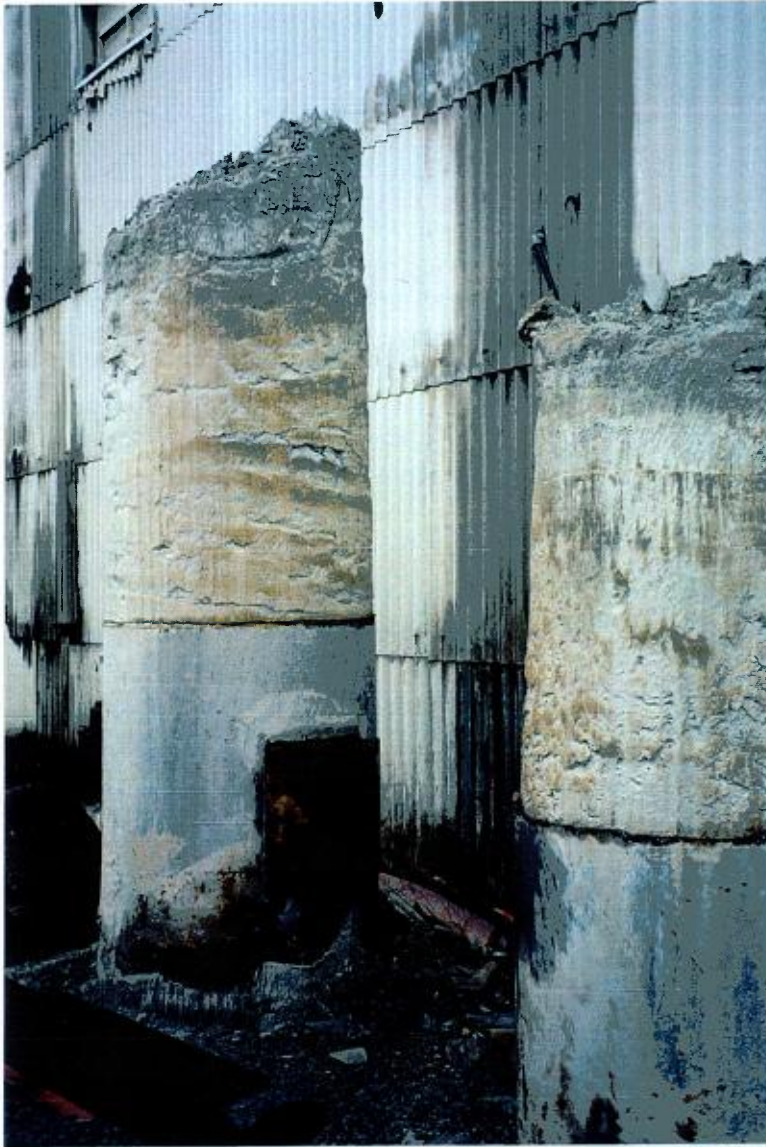
← Solid
asbestos
fibre in
remnants
of supply
pipes.

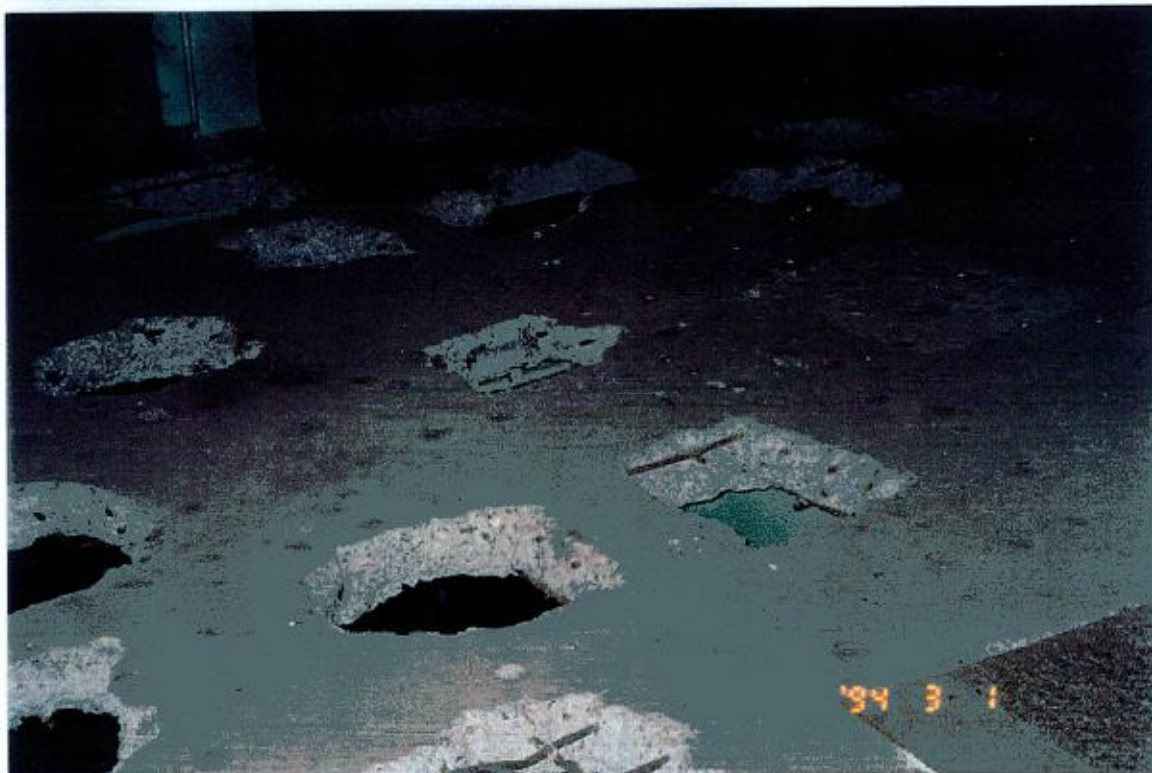
↓ Typical
floor
penetra-
tions.
