Report : Woodsreef Mine Mill waste disposal for NSW

**WOODSREEF MINE
MILL WASTE DISPOSAL**

Report prepared for
NSW Department of Mineral Resources
June 2000

DAMES & MOORE
Ref: 29139-009-371\REPORT\WOODSREEF REV-1.DOC
27 June 2000

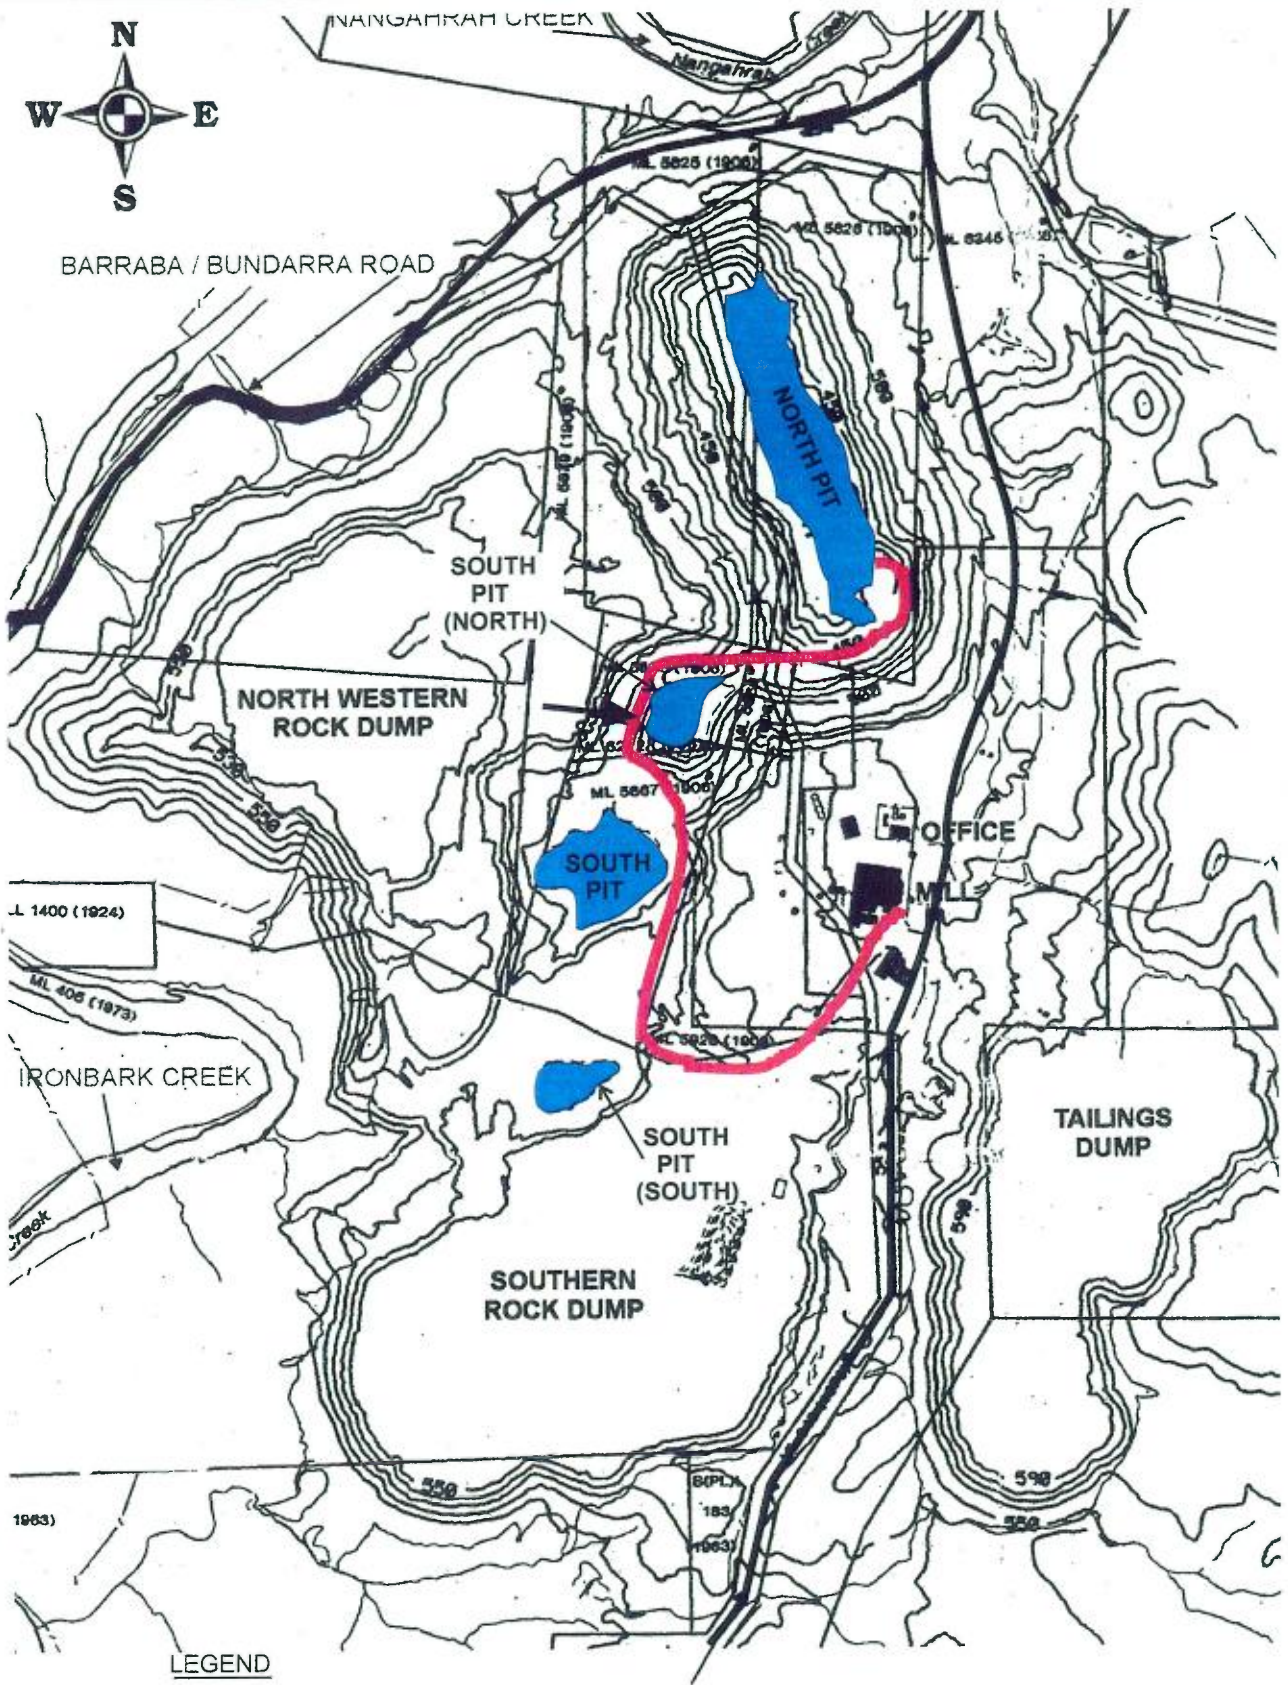
FIGURE 1

The site layout is shown on **Figure 1**.

Access is available to the water level in all of the pits only via a cutting on the south side of the pits (**Figure 1**). Access from the top of the North Pit is not feasible without major earthworks because of a major failure and erosion of the benches. Further failure is expected in the future as there are large tensions cracks along the eastern wall.

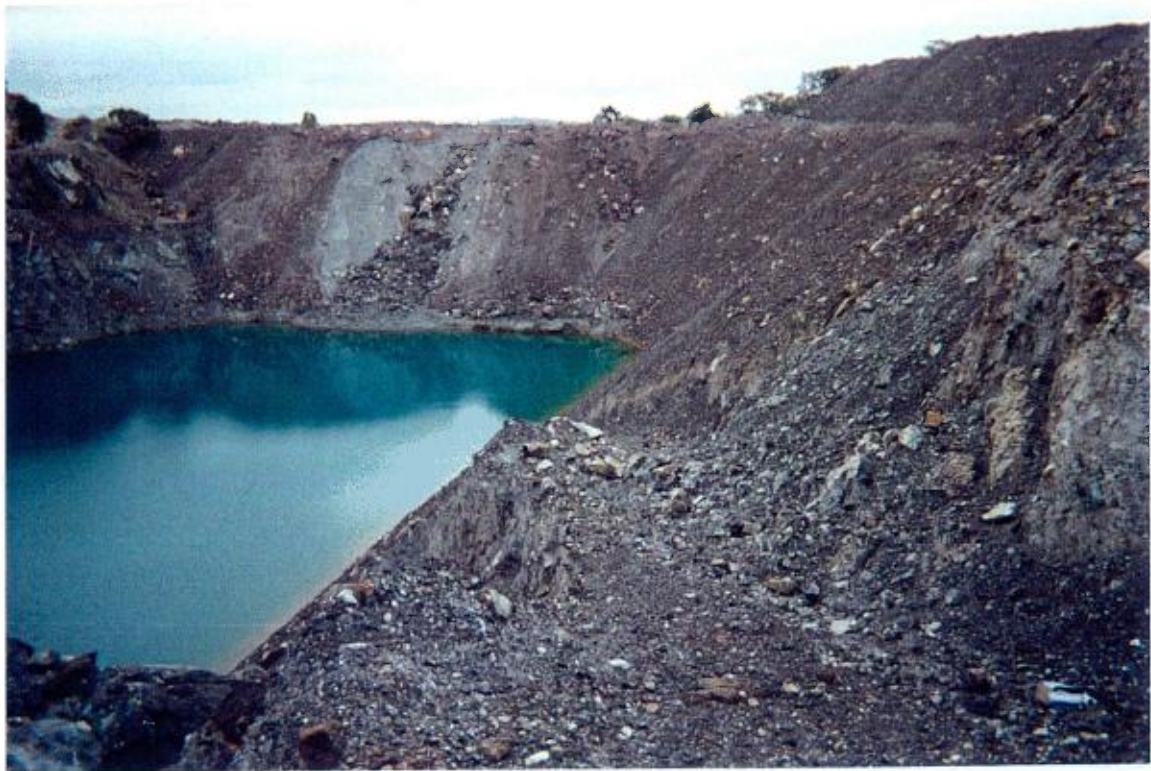
Vehicle access to the water level in South Pit (South) was previously by a steeply inclined ramp on the north eastern side of the pit. While access by foot is possible, the ramp is narrow and has been deeply eroded (**Plate 1**). Restoration of this access is not feasible without major earthworks.

PLATE 1.
ACCESS RAMP AND SOUTH PIT (SOUTH)

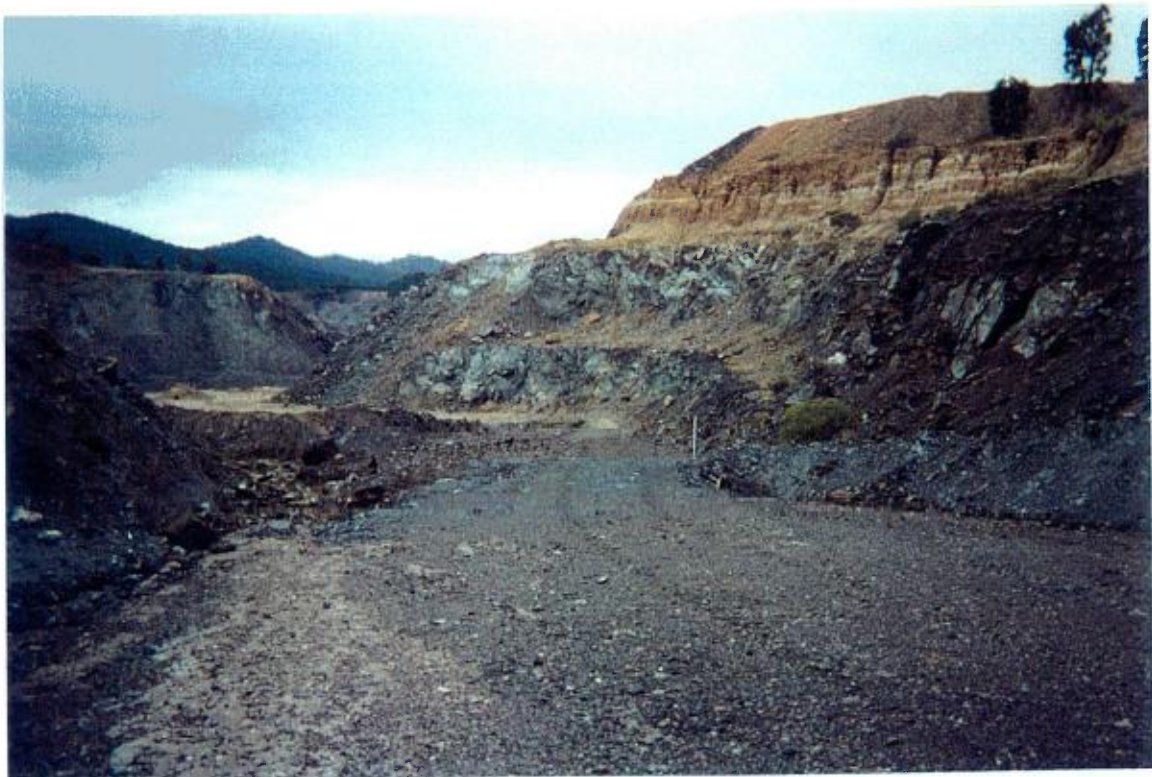
Vehicle access to the northern side of South Pit is relatively easy via an access road (ramp) on the eastern side of the pit (**Plate 2**). Erosion in this road is relatively easily repairable. The road occupies a relatively wide down ramp between the pit and the outer pit wall, and it is not likely to be affected by instability. Access is to a small "beach" area from where water has previously been extracted, as this is the easiest point of access to any of the water bodies. Near this beach there is a moderately strong serpentinite rock ledge about 4m, above the water level (**Plate 3**).

PLATE 2.
ROADWAY DOWN TO SOUTH PIT

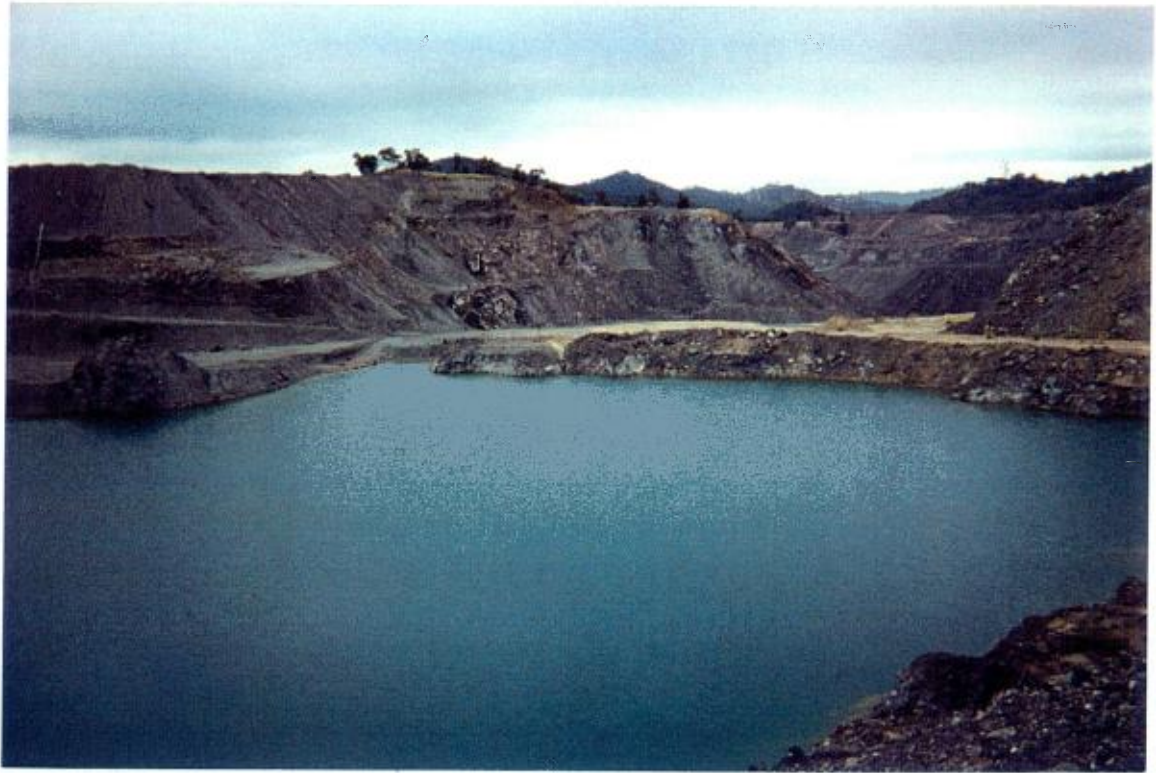
PLATE 3.
SOUTH PIT ENTRY POINT

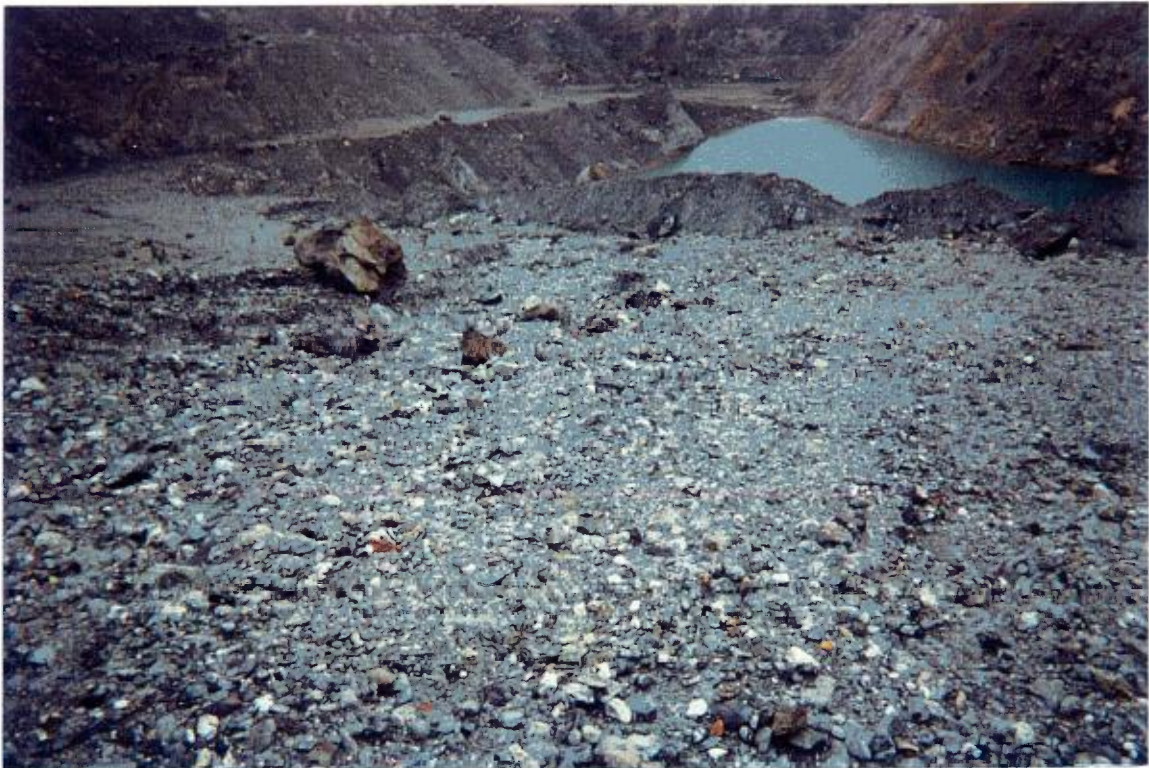
The access road to both the South Pit (North) and the North Pit passes to the western side of the South Pit, and is currently blocked by debris (**Plate 4**) from a rockslide and by erosion due to water

diversion by the slide. The slide has occurred by a bench failure towards the top of the pit wall, and the debris includes rock derived from the edge of the overlying North Western Rock Dump which has been undermined. The ramp is relatively wide in this location (**Plate 5**), and the access road could be repaired without major earthworks. Access is to a small beach area in the north eastern corner of South Pit (North).

PLATE 4.
**SLIDE DEBRIS ON ROAD DOWN TO SOUTH PIT (NORTH),
SHOWING ENTRY POINT**

- Minor upgrading of the road to the South Pit by repairing washouts;
- For disposal in the North Pit, removal of slide debris, repair of washouts, and covering of rock over a further approximately 600 m of access road;
- Haulage of asbestos filled bags from the Mill to the disposal site; and
- Mobilisation of placement equipment, eg. crane or barge.

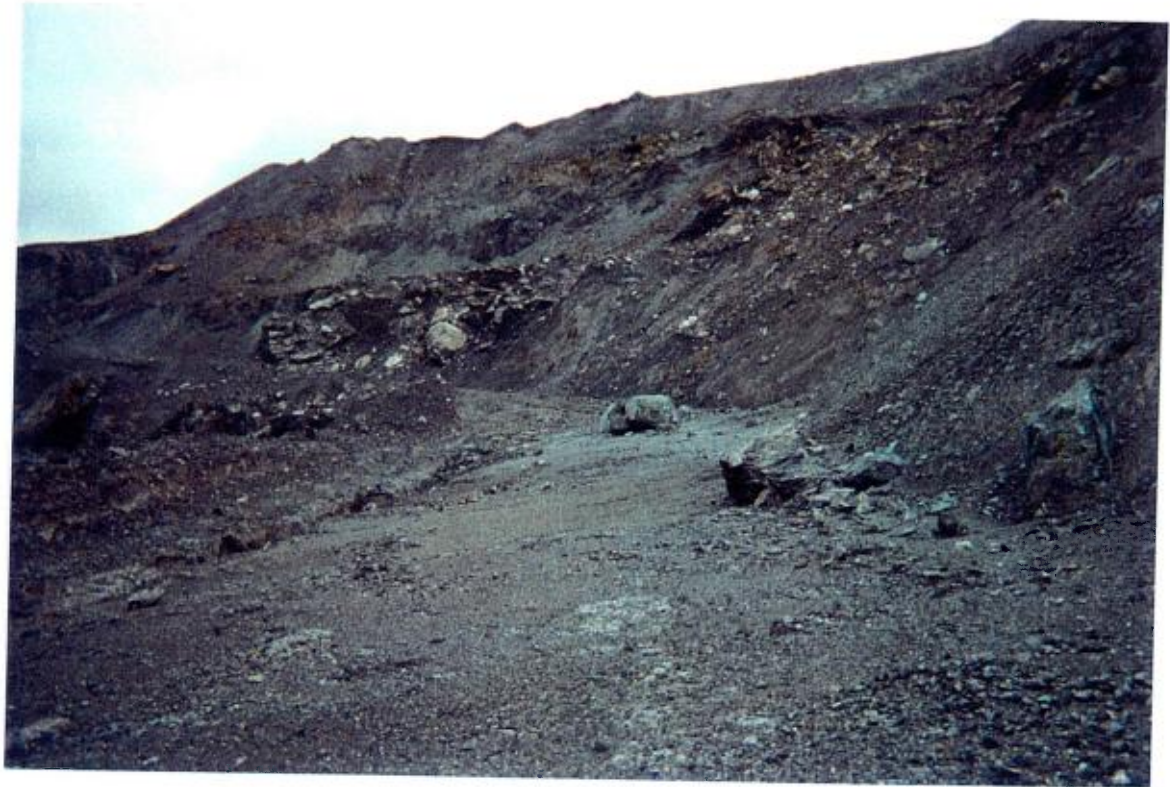
PLATE 5.
ROAD DOWN TO SOUTH PIT (NORTH)

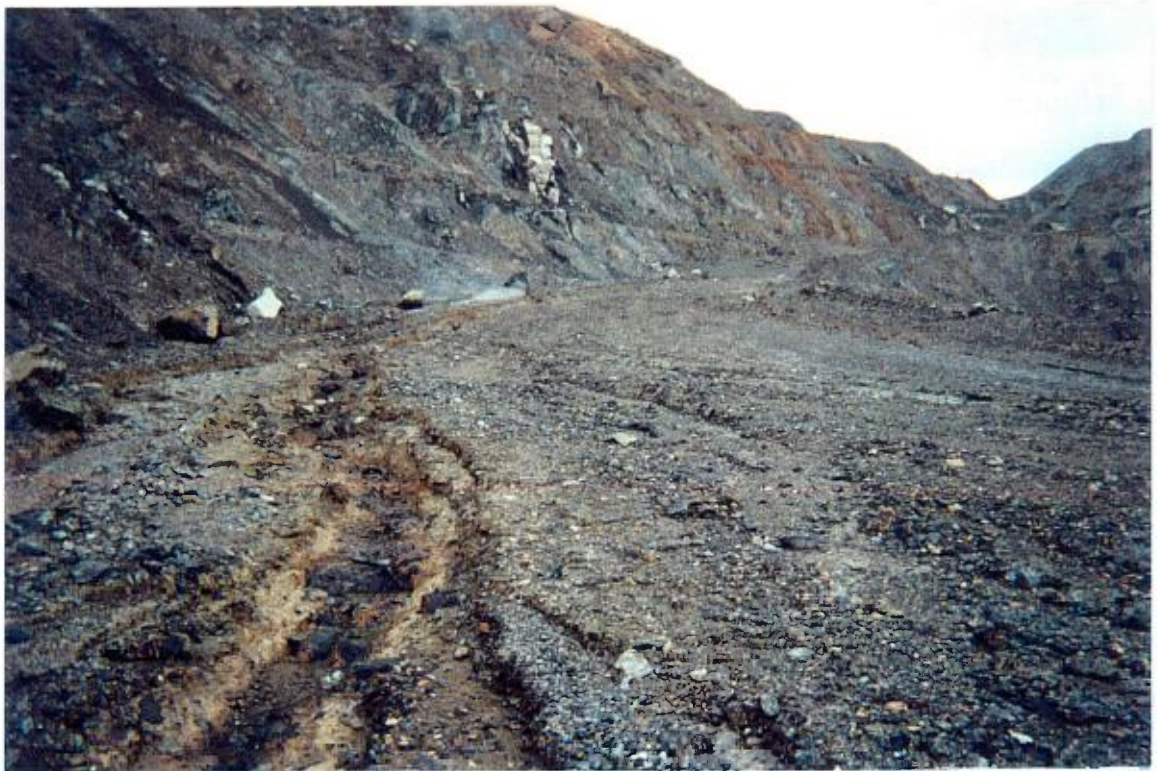
The access ramp continues down to the south end of North Pit. While the ramp has a rough rocky surface and some 0.5m deep erosion gullies along the side of the road (**Plate 6**), it is relatively wide and could be relatively easily repaired. Access is to a wide rocky ramp, (**Plate 7**) which probably continues as a bench underwater, probably with a steep drop on its western side. **Plate 8** shows the water level in North Pit.

PLATE 6.
ROAD FROM SOUTH PIT (NORTH) TO NORTH PIT

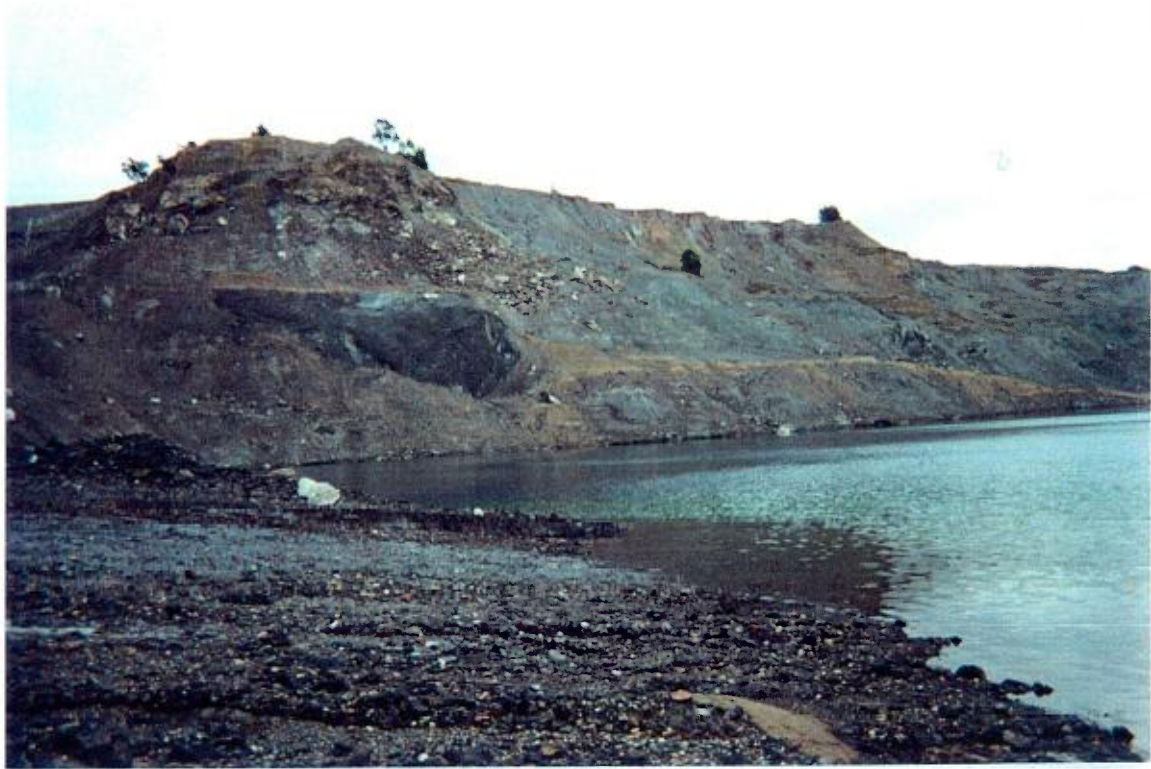
PLATE 7.
NORTH PIT ENTRY POINT

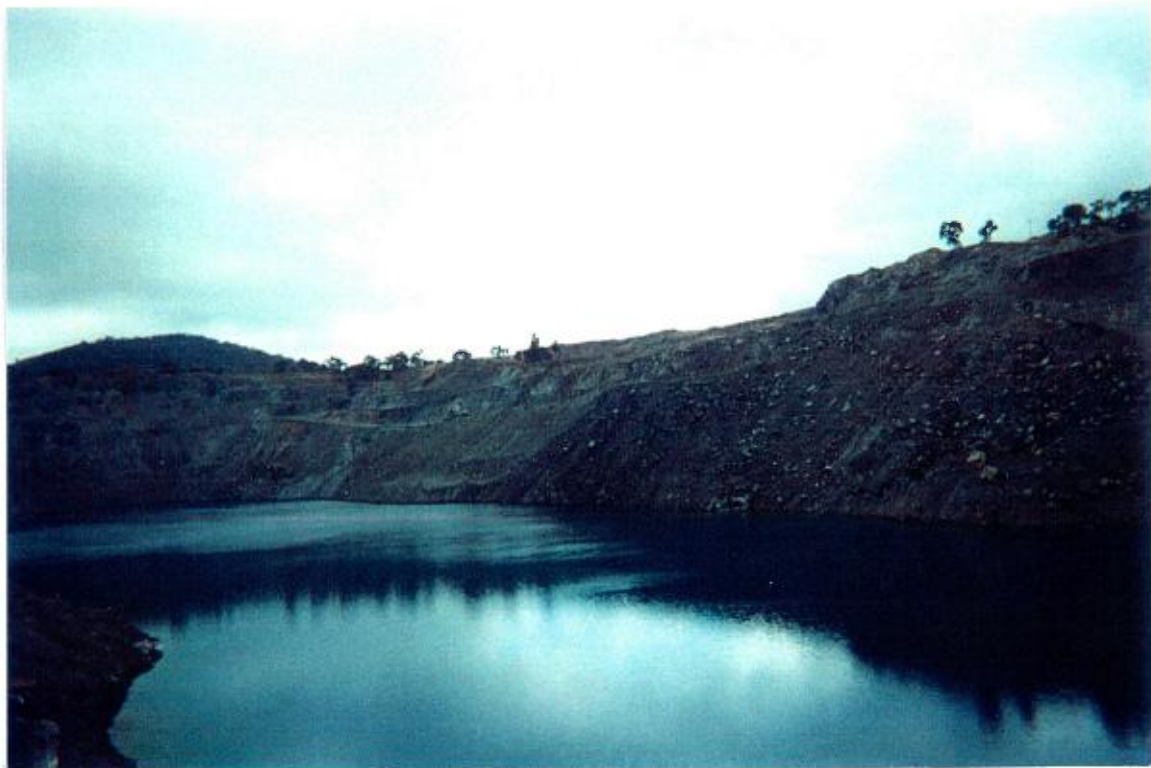
PLATE 8.
NORTH PIT
