Woodsreef Asbestos Mine, Barraba : synopsis for risk
assessment

Woodsreef Asbestos Mine, Barraba.

Synopsis for Risk Assessment

September, 1996

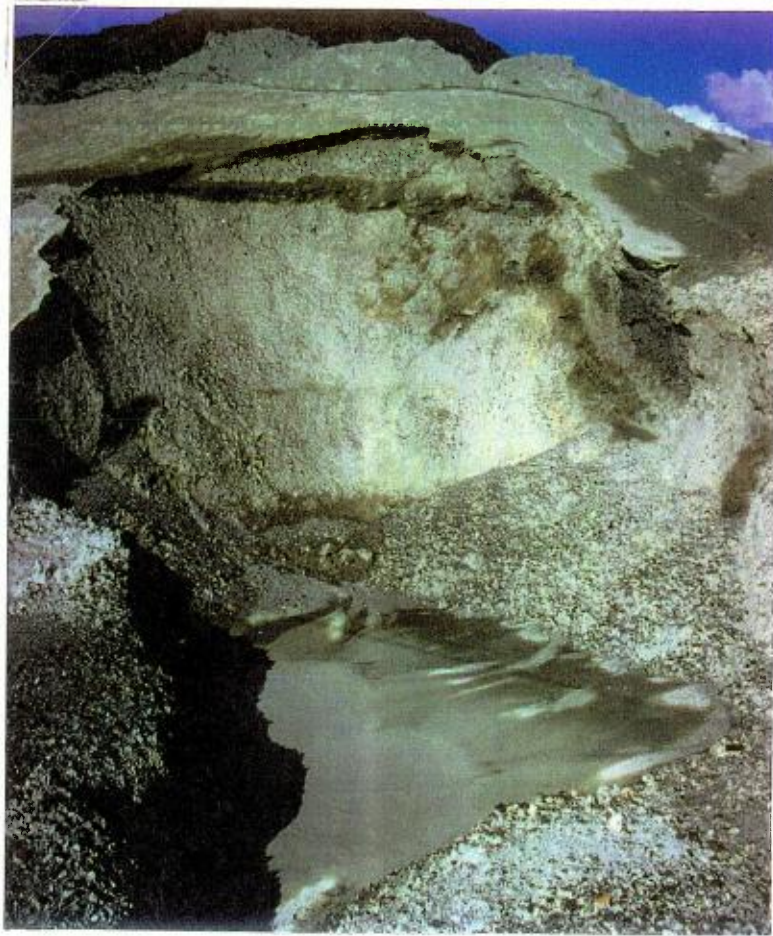
The protective crust of both the tailings and waste rock dumps has reduce the potential of waste material becoming mobilised, particularly by wind. This crusting of the surface material, however, may reduce infiltration into the dumps, thus increasing runoff. Runoff does not present a major hazard on the relatively flat top of the dumps. However, movement of this water over the dump batters and sloping areas has led to the extensive rill and sheet erosion (Figures 4.4 and 4.5). This erosion has caused sedimentation of Ironbark and Nangahrah Creeks, as well as settling dams and other drainage lines (Figure 4.6).

Figure 4.2: *Surface crusting on the tailings dump.*

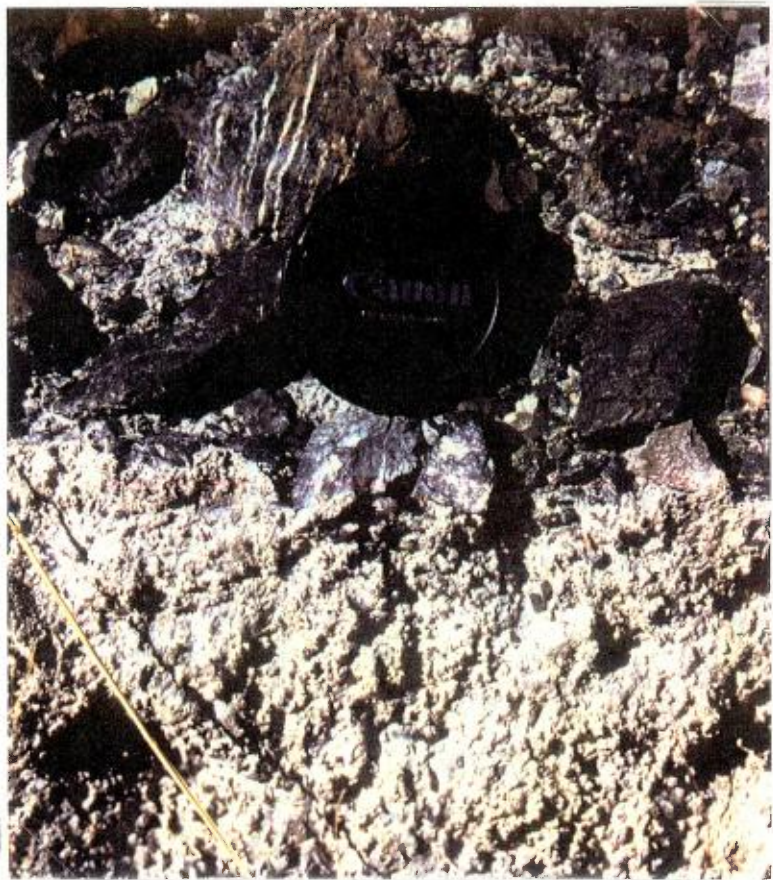
Figure 4.3: *Eluviation of fines deeper into the profile of the southern waste rock dump, leading to a stable surface.*

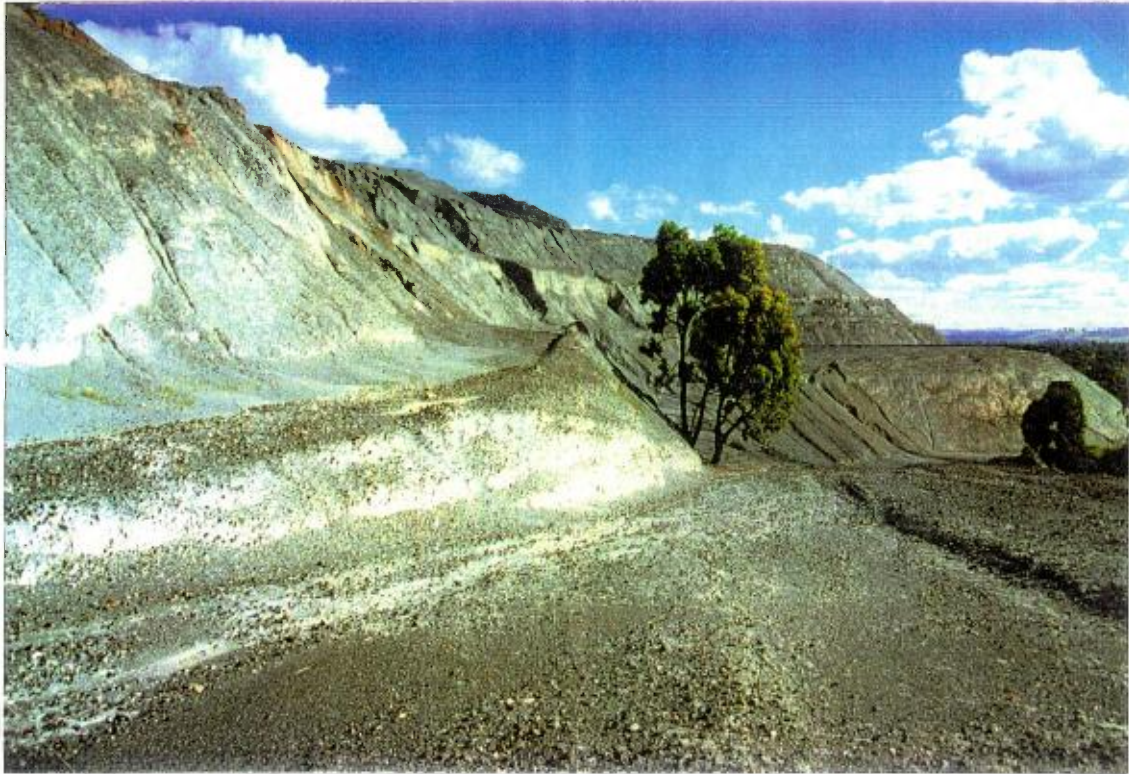
Figure 4.4: *Rill erosion along the western batters of the tailings dump.*

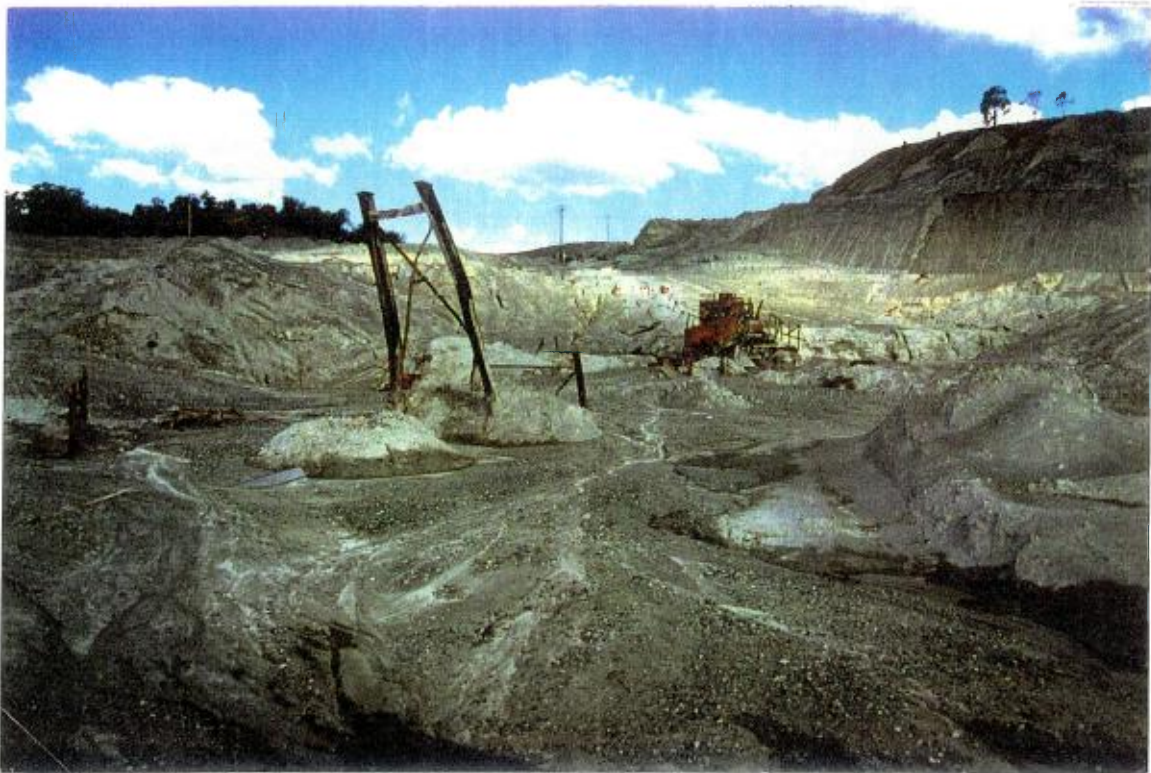
Figure 4.5: *Erosion of the access track and conveyer belt run, at the north west end of the tailings dump.*

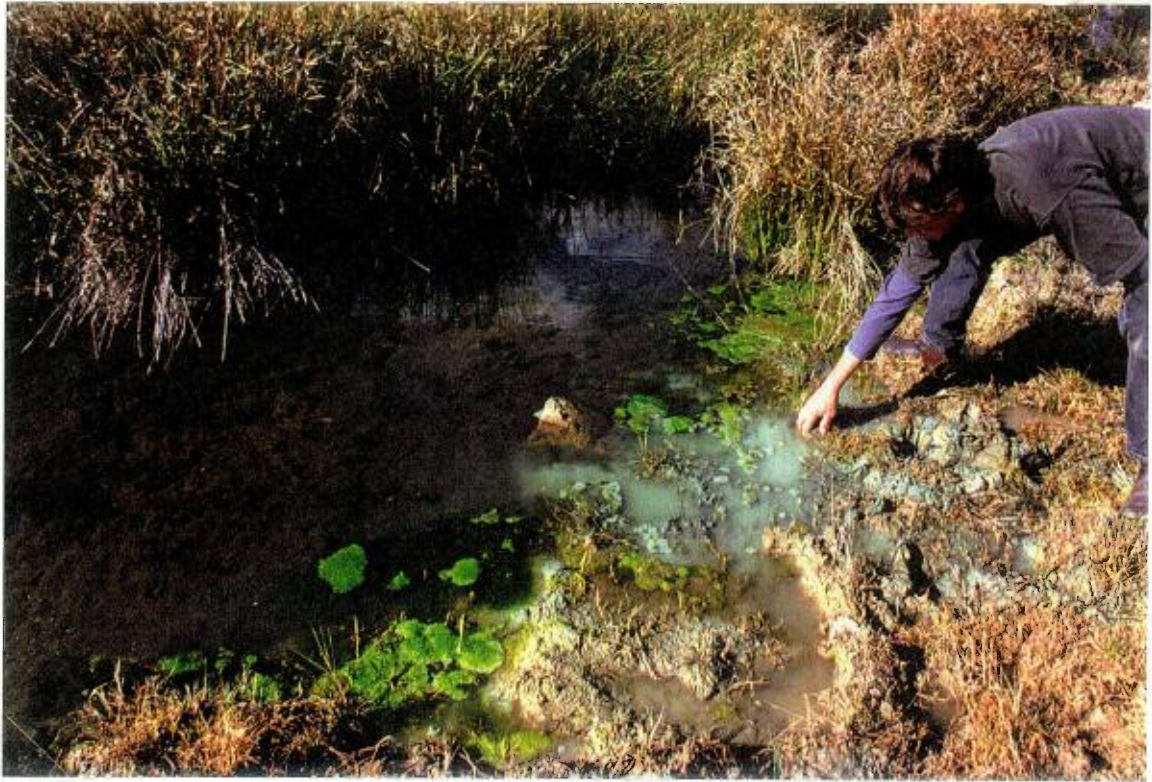
Figure 4.6: *Accumulation of mine derived sediment in the southern drainage channel. The grey sediment has formed a boggy substrate up to one meter deep.*

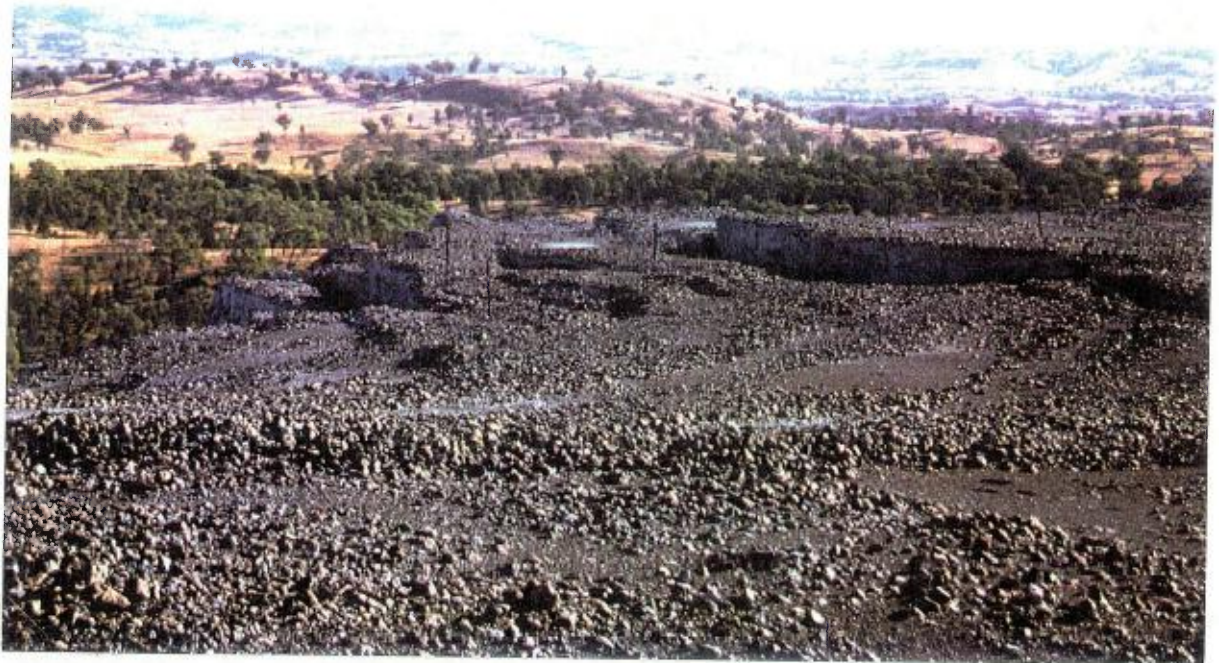
The southern batter of the tailings dump is at risk of collapse, as indicated by slumping along the batter head. Steel gauge posts were used to monitored batter movement between 1989 and 1990, (Figure 4.7). This investigation indicated that batter movement was strongly correlated with moisture

Figure 4.7: *Steel gauge posts on the southern batters of the tailings dump.*

content within the tailings dump. Compounded by its 30° to 40° slope, the batter requires re-grading to a suitable angle, otherwise collapse is inevitable. Batter collapse may only result at the toe of the dump and is likely to be contained by the settling ponds. As collapse is more likely to occur during a high intensity rainfall event, settling ponds would quickly exceed capacity and tailings would be transported into Ironbark Creek. Such a sedimentation event would significantly affect water quality, hydrology and aquatic environments down stream of the mine (Quinn et al, 1992 a & b).

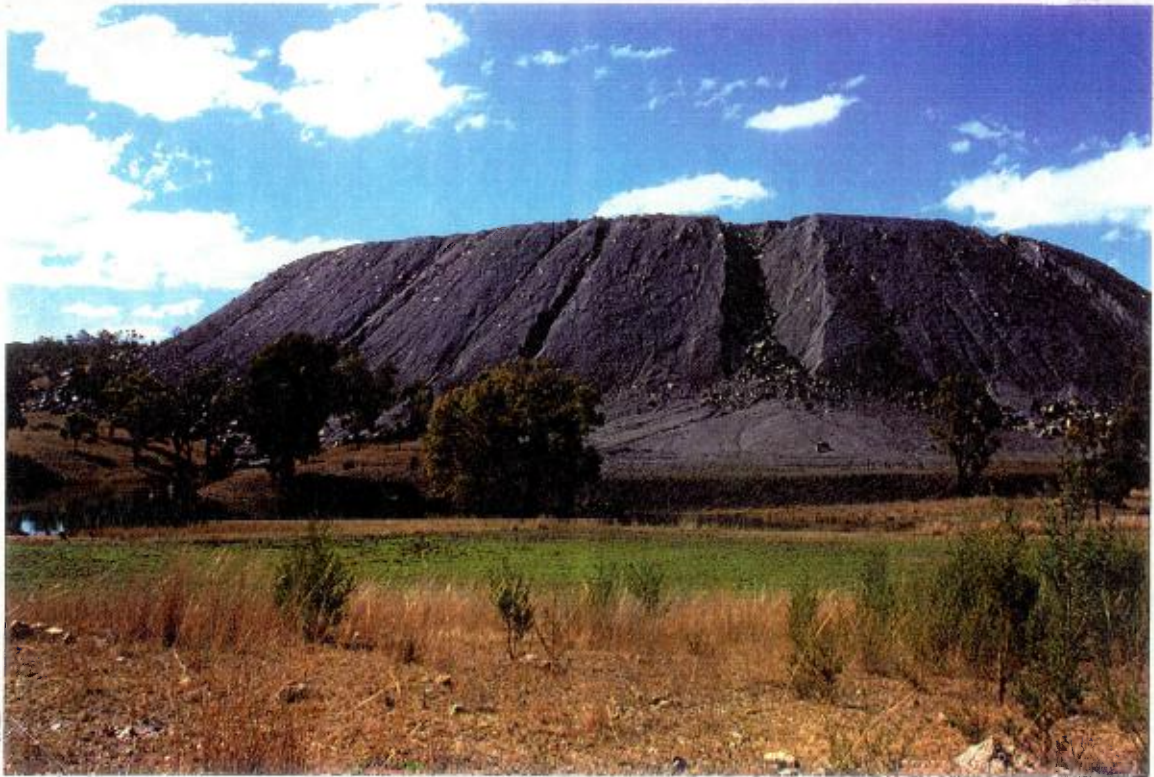
The southern waste rock dump batter was also monitored using steel gauge posts. No significant movement recorded between 1989 and 1990. These batters are not stable as a number of breaches in the head bunds are evident, as well as severe rill erosion down the slope. These breaches probably occurred as a result of water ponding behind the coarse grained head bunds, with the resulting pressure causing failure. The two largest breaches occur on the southern side of the southern waste rock dump batter. The eastern most breach formed in January 1989 while the other is much older (Figure 4.8). Material scoured from current and future breaches poses a significant sedimentation hazard to Ironbark Creek and the settling dams below the waste rock dump, (Figure 4.9).

Figure 4.8: *A large breach in the south western batter of the southern waste rock dump.*

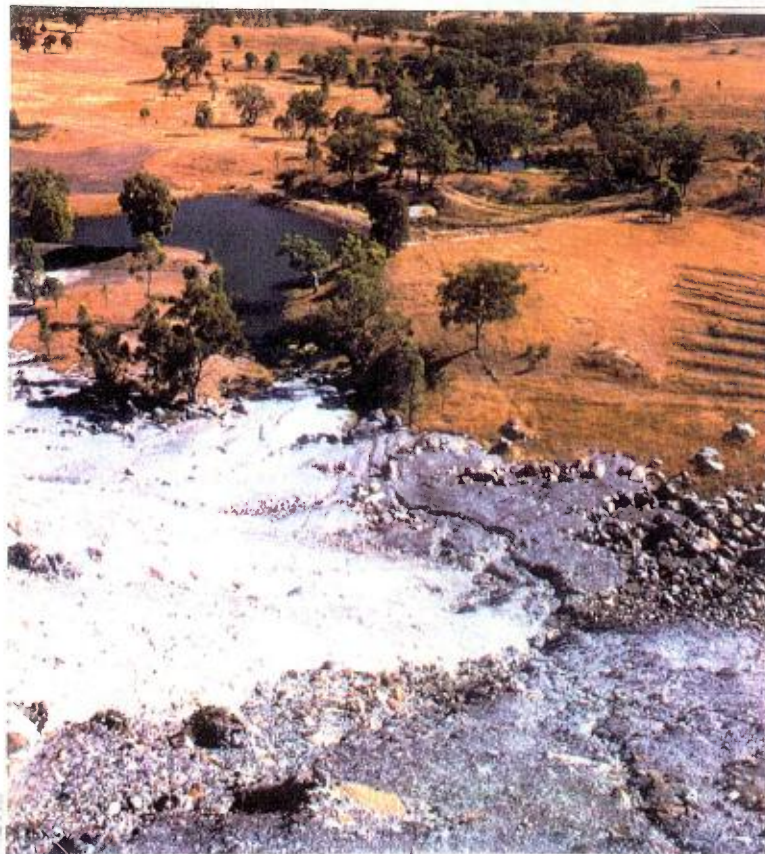
Figure 4.9: *Sedimentation of dam by material derived from the southern waste rock dump. (View from head of southern waste rock dump looking south)*

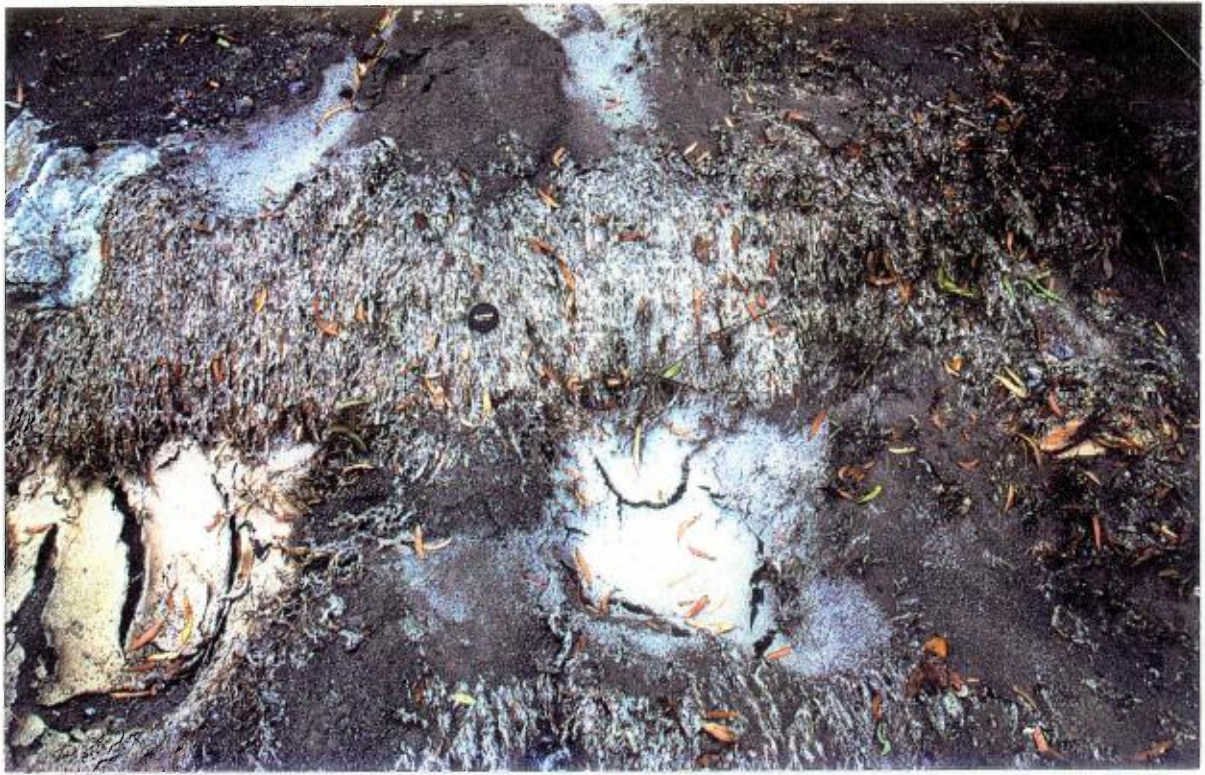
Environmental hazards arising from waterborne chrysotile relate to its flocculating nature that may have implications for the substrate, filter feeding organisms and watercourse vegetation as shown in Figure 5.3. These hazards have not been investigated at Woodsreef nor are they reported in the literature or. It should be noted that background fibre levels naturally exist, the hazard lies with increased fibre levels due to the existence of the derelict mine.

Figure 5.3: *Chrysotile forming mats on couch grass along drainage lines.*

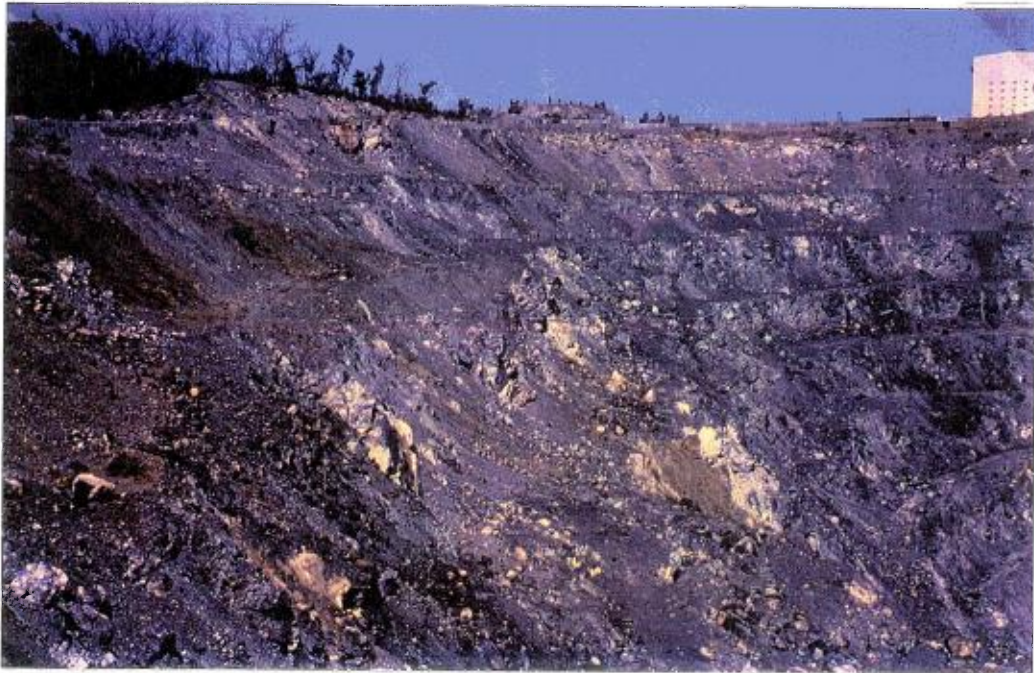
The South and north pits are highly unstable, with the old benches susceptible to erosion and mass movement. Coffey & Partners Pty Ltd (1982a) investigated the stability of the north pit and determined that the benches were unstable particularly along the eastern wall, where tension cracks and scarps had developed. The western wall of the north pit also is unstable as indicated by bench deterioration and a large failure along the western rim of the pit. Three major factors contribute to the unstable nature of the pits:

Figure 5.4: *Mass movement within the North Pit*

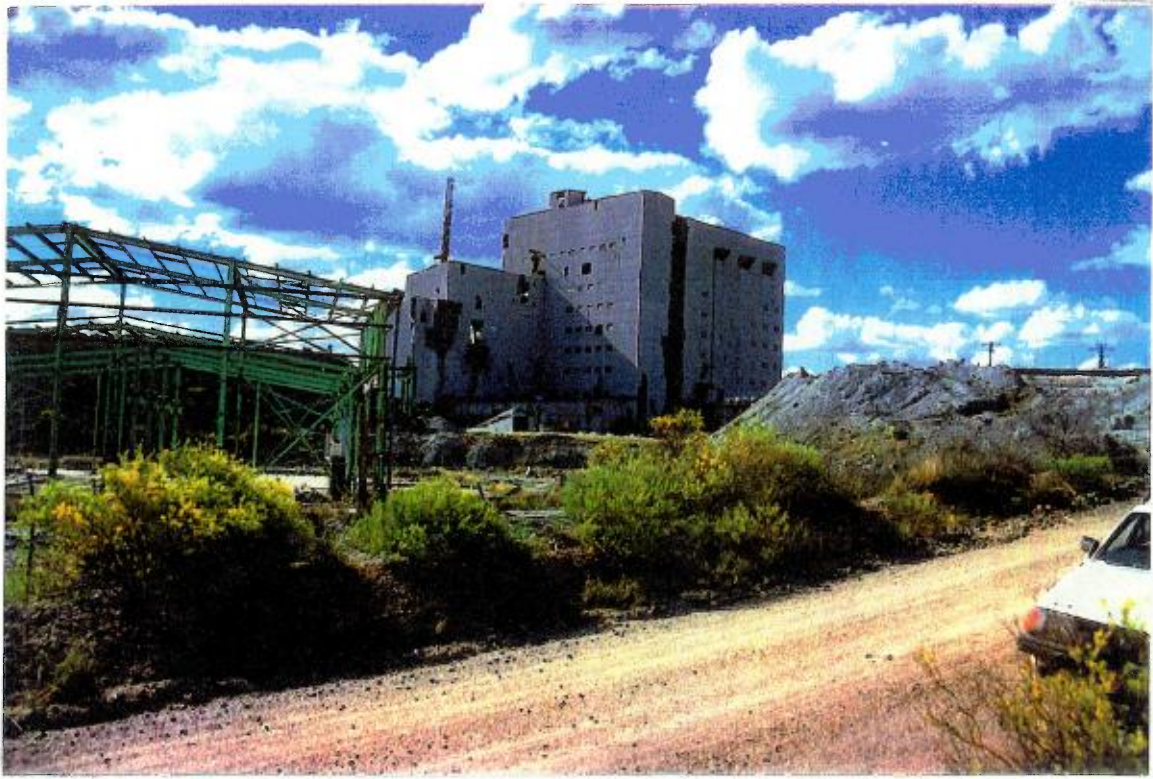
Figure 7.1: *Refuse within the mine site (view from Crow Mountain Rd)*

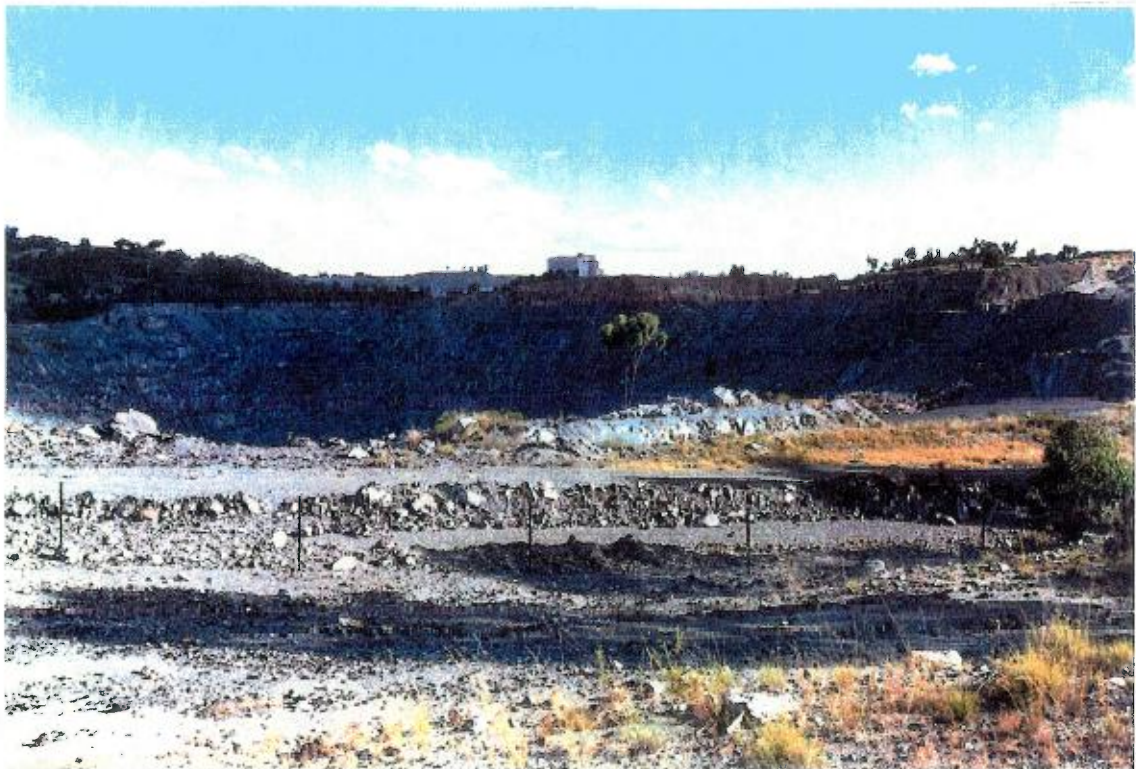
A standard star post and plain wire perimeter fence extends around the mining area, with an additional section of man-proof chain mesh fence around the mill. Several warning signs have also been posted on the perimeter fence indicating the hazards of the mine. In many instances these exclusionary precautions are inadequate to prevent trespass. For example, sections of the fence around the tailings dump have being completely buried by tailings sediment, through the processes of runoff and deposition. In respect to the pit, the perimeter fence is an inadequate deterrent as shown in Figure 7.2. This area is the most common site of trespass.

Figure 7.2: *Plain wire perimeter fencing above the North Pit*

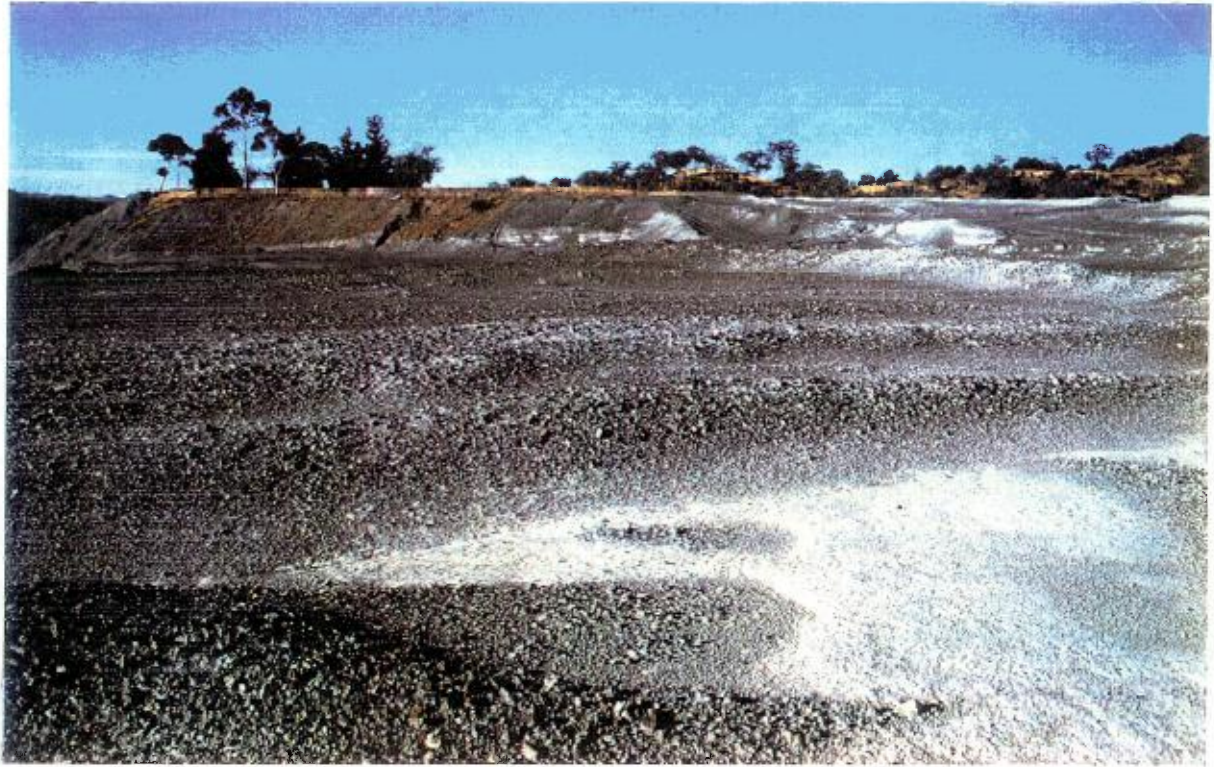
Figure 8.2: *Successful trial revegetation plot on the tailings dump, using a soil substrate (plot 1).*

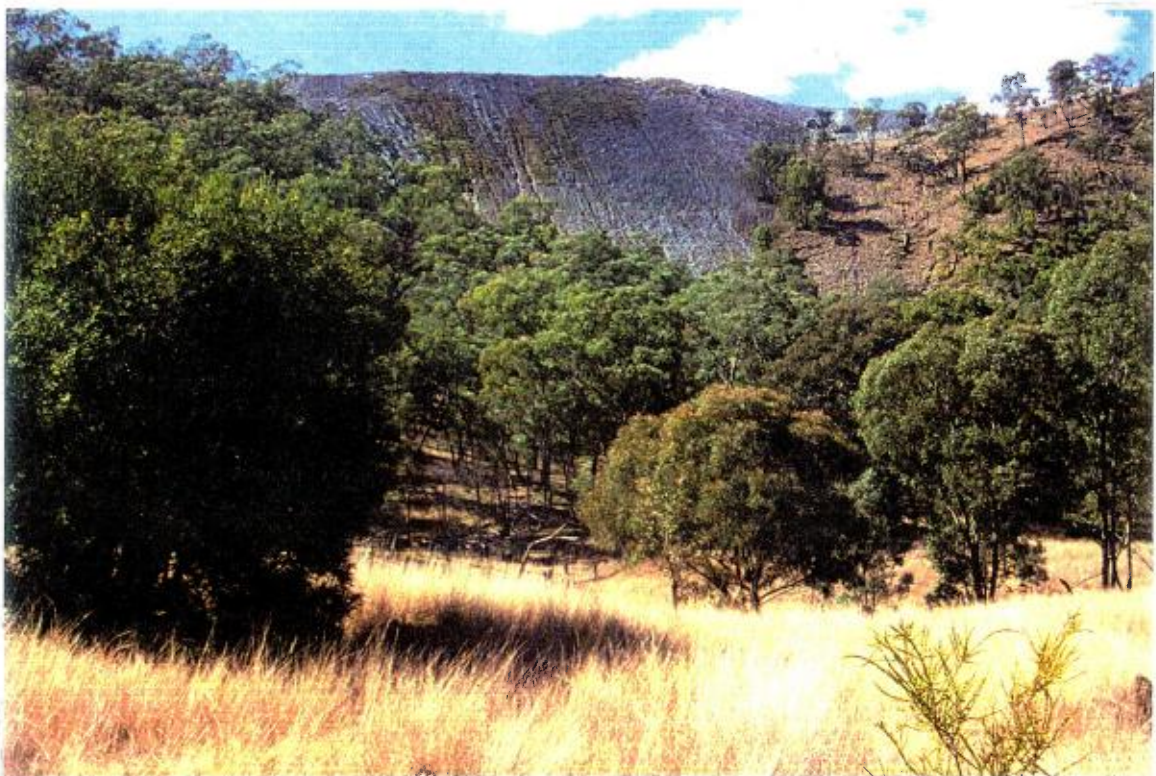
Figure 8.3: *Dumped soil supporting natural herbaceous growth, on the south western batter of the western waste rock dump (plot 6).*

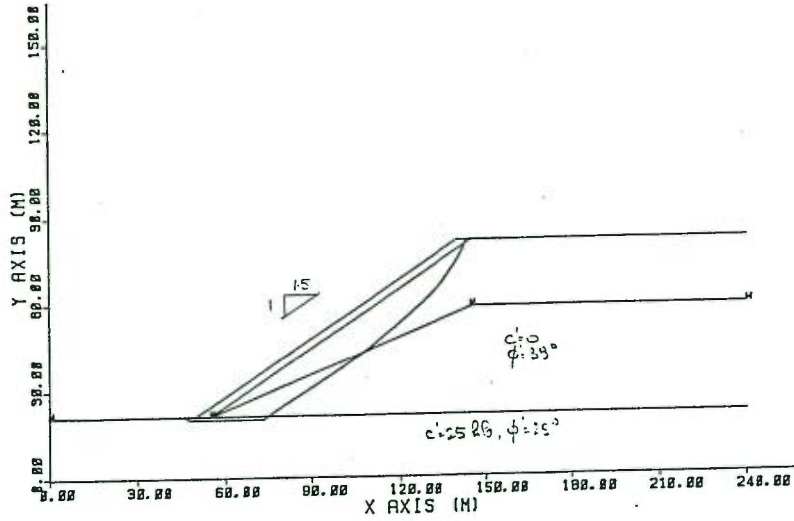
WOODSREEF MINE -- TAILINGS DUMP
(NGT0269)

FACTOR OF SAFETY FOR SPECIFIED SURFACE = 1.11

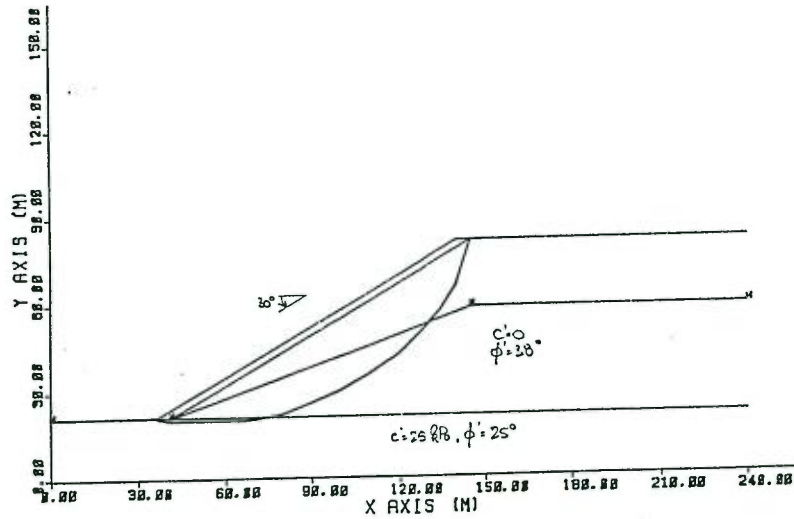
WOODSREEF MINE -- TAILINGS DUMP
(NGT0269)

FACTOR OF SAFETY FOR SPECIFIED SURFACE = 1.20

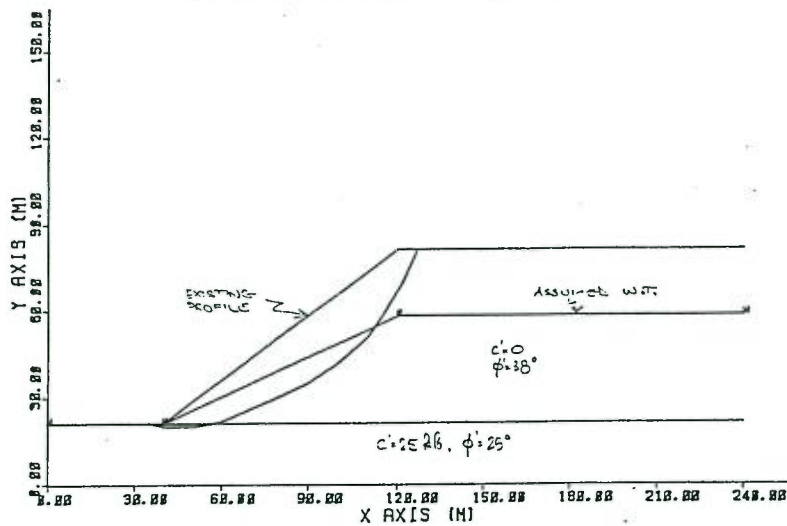
WOODSREEF MINE -- TAILINGS DUMP
(WGT0269)

FACTOR OF SAFETY FOR SPECIFIED SURFACE = 0.95
