Gravel pits & derelict mines within the Upper Shoalhaven
Catchment : their impacts, management and rehabilitation

Peter Dougan

November, 1995

A report prepared for the Upper Shoalhaven Catchment
Management Committee

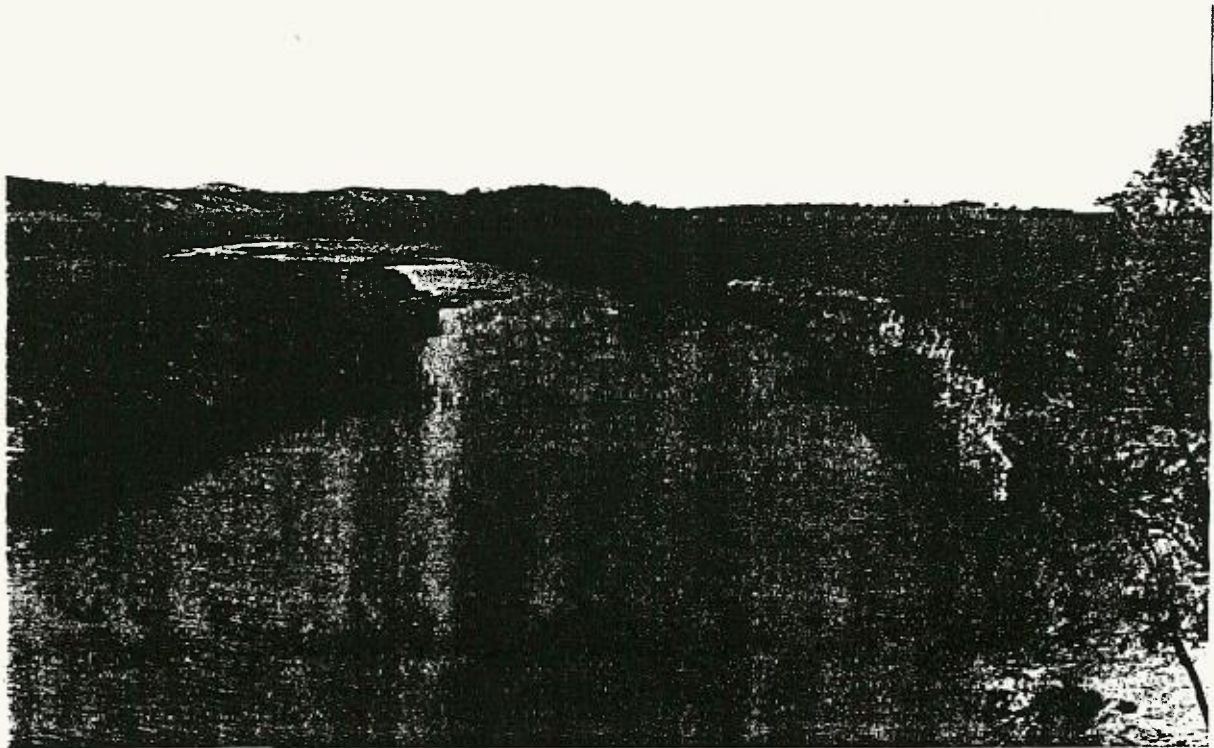
Photo 1 Mulloon Creek Derelict Sand/ Gravel Extraction Site

The Mulloon Creek derelict sand /gravel extraction site (grid reference 385970) covers an area adjacent to the Mulloon Creek stretching approximately 1 km. The operation together with other influences has caused substantial alteration of the character of the creek with large areas of unvegetated bank and undercutting evident. The stockpiling and excavation of materials has altered some areas of the adjacent land leaving them unstable to further erosion.

(undercutting of the creek has occurred as a result of its changed character as a result of poor extraction techniques and lack of site rehabilitation)

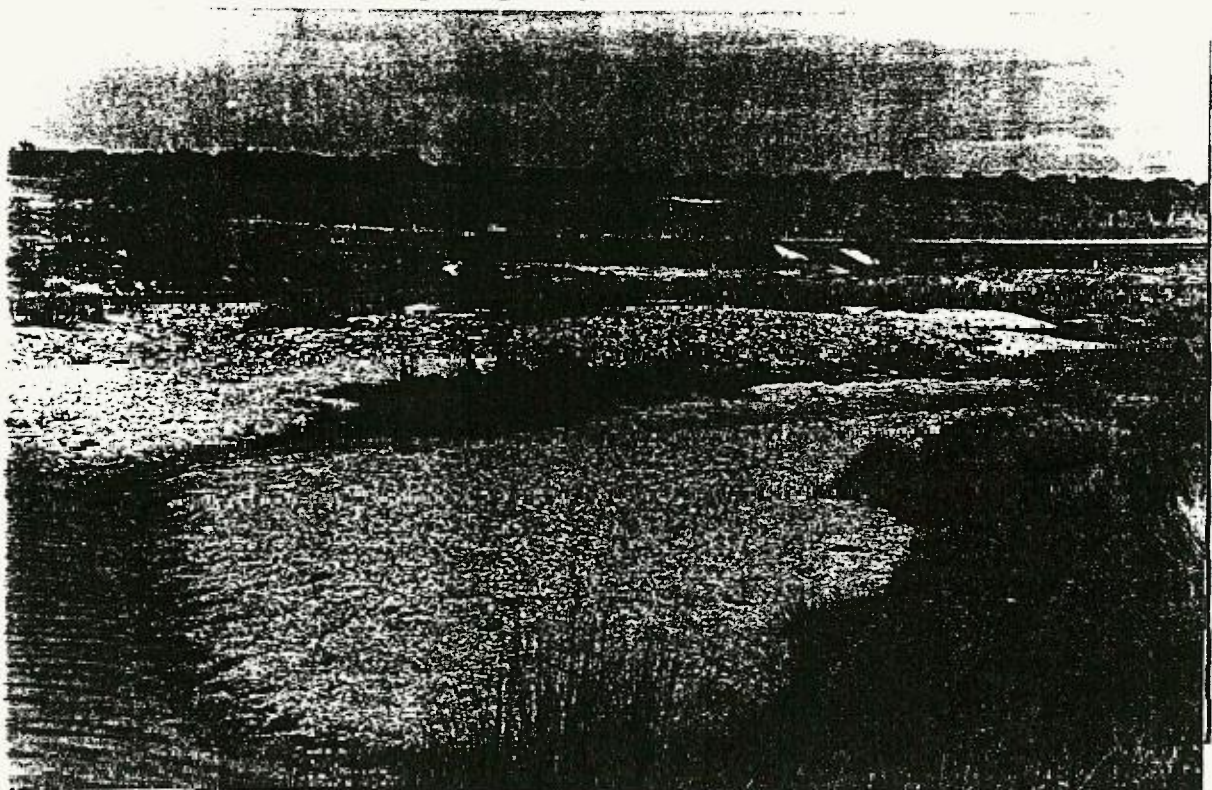
Photo 2 Mulloon Creek Derelict Sand/Gravel extraction site

(view South towards Kings Highway)

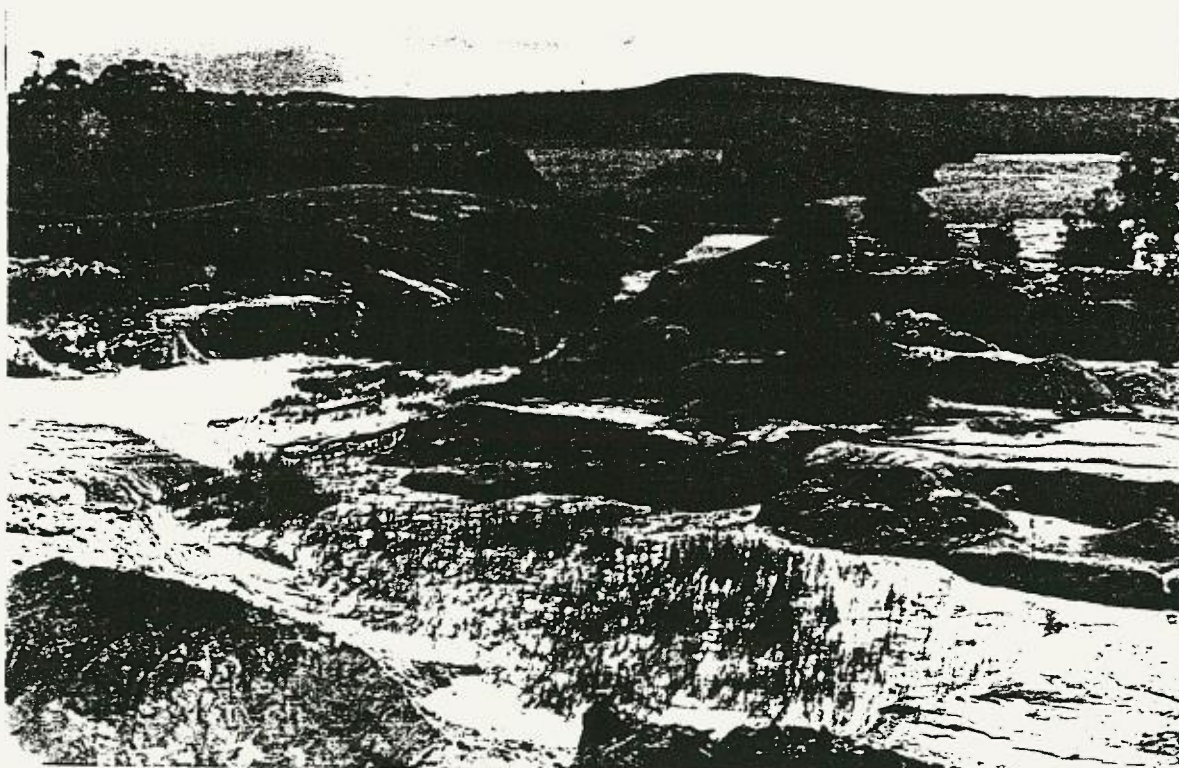
The Mayfield Rd Clay pit (grid Reference 545045) is a commercial operation covering an approximate area of 800 x 700 metres. The sites has minimal water control features creating a high susceptibility to erosion. However, because the pit is extracted to some considerable depth and the construction of a sediment control dam at the sites lowest point means that impacts to date appear minimal.

However, the limited depth of the sedimentation dam which appears to be collecting some quantity of such sediment together with the low infiltration characteristics of the site means that in a large rainfall event considerable quantities of sediment would be washed off site into the nearby Boro Creek. Furthermore, the design and operation of the site appears haphazard with no effort to minimise the total area of extraction at any one time. Staged rehabilitation of the site in conjunction with tits ongoing operation would seem appropriate.

Photo 3 Mayfield Road Clay Pit
(note the sediment control dam located on the upper right of the photo)

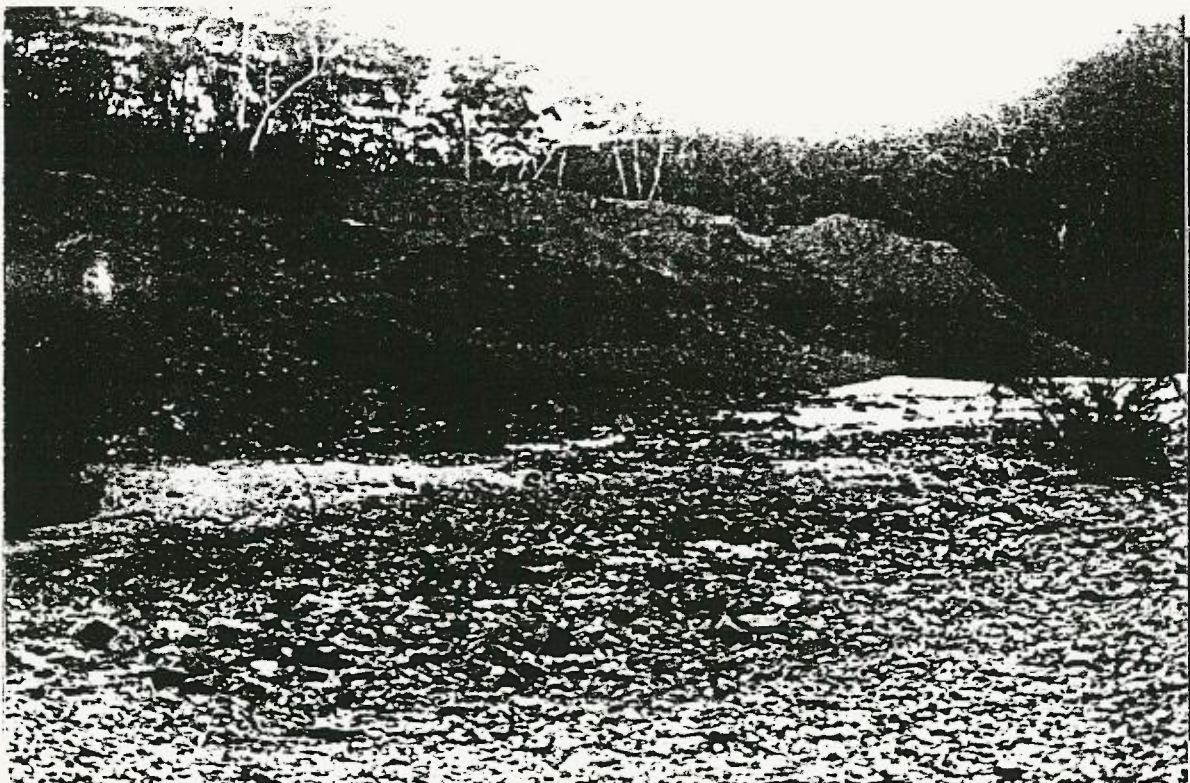
Photo 4 Mulloon Tailings Dumps, Site A
(approximately 20 metres from Mulloon Creek)

Site A is located in close proximity to the Mulloon Creek and includes the before mentioned smelter site and a number of remnant hut sites. The area of concern consists of a large tailings dump within which are located a number of shafts, most of which are filled with woody debris and some of which contain ponded water. The tailing dumps are of a red oxidised nature of broken rock fragments commonly of coarse nature supported at intervals by stone retaining walls. The dumps extend over a largely unvegetated area of approximately 60 metres by 20 metres and at their closest point are approximately 20 metres distant from Mulloon Creek. However, during periods of high rainfall it is evident that the Creek would rise to cover the lower portion of the tailings dump.

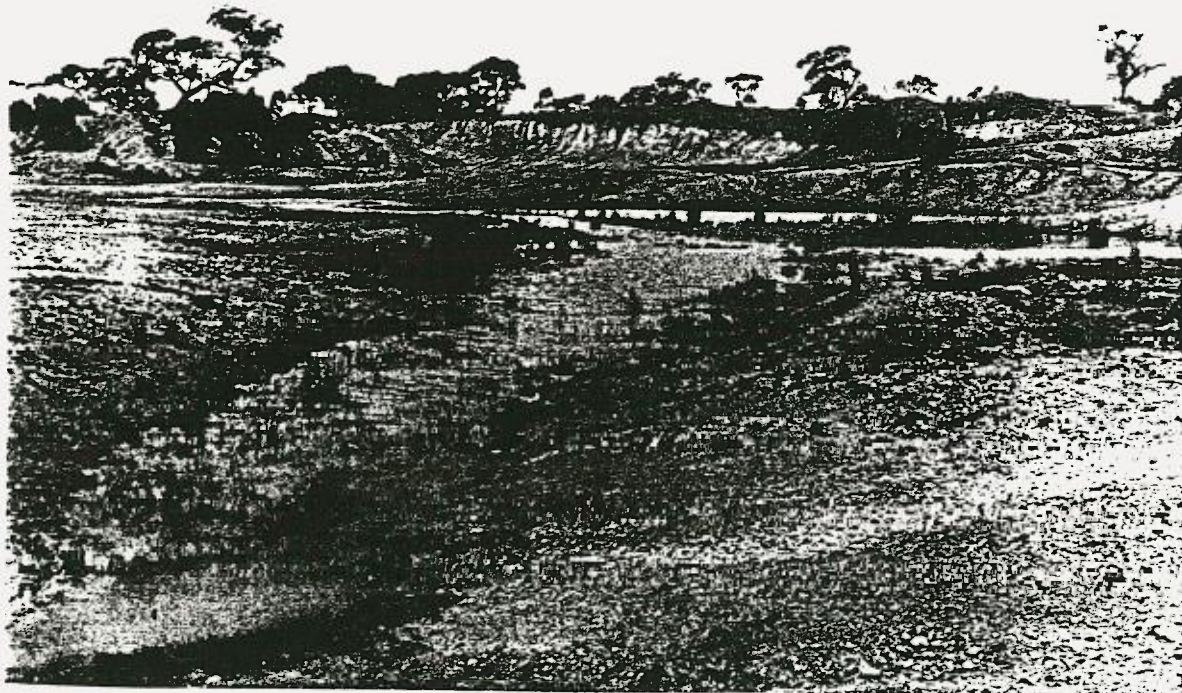
Photo 5 - Back Creek Gravel Pit after 2 inches of rain; September 1995.

The primary impacts of extraction sites are on sedimentation and turbidity of streams and watercourses. This is especially evident at sites such as Back Creek pit where an inspection of air photos shows sediment plumes coming out from the gravel pit area. Such impacts are normally not apparent, as discussed in the introduction, until a major rainfall event is experienced - perhaps as infrequent as 5-10 years. However, extraction sites are especially vulnerable to these events as they have little or no cover and because their often compacted nature generates large amounts of runoff which carries sediment in to our rivers and streams. As such a precautionary approach is needed in respect of their operation and rehabilitation.

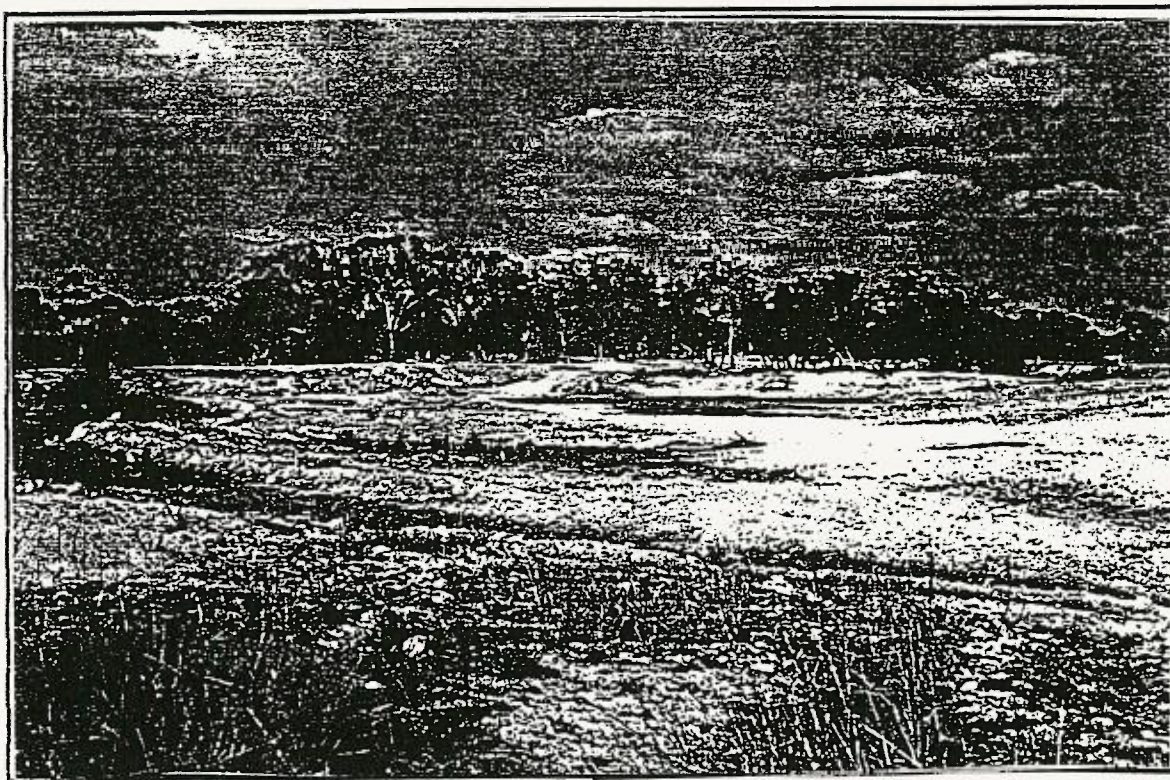
Their second most significant impact is in my opinion an aesthetic one - ie their impact on the appearance on the landscape. Derelict sites such as the Doughboy pit on the Kings Highway are as much as scar on the landscape as areas of severe dryland salinity. This relates to how we view the catchments environment in regard to whether we see it as a infinite product to be exploited or a resource to be managed.

Photo 6 Doughboy TSR Derelict gravel pit
This site is directly adjacent to the Kings Highway

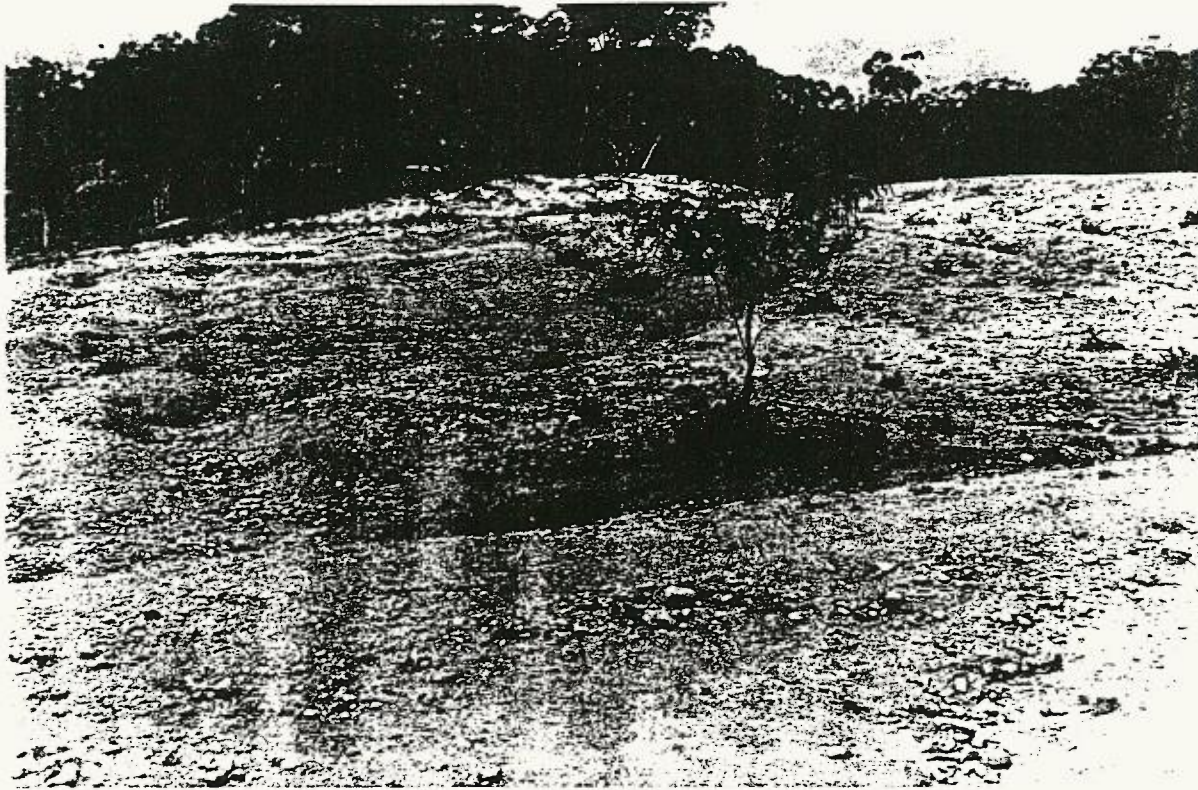
5. Crokers (GR 535932) priority : high
location : Off Mayfield Road near Sandy Creek
size : 70x70 + adjacent areas
present impacts : Tunnelling on South side of pit
access road badly eroding
runoff and recharge may contribute to a waterlogging/
salinity problem down slope
potential impacts : will further deteriorate to a significant degree

Site is located approximately 400 metres on RHS of road. Evident and escalating degradation of site and surrounds is occurring, particularly associated with the access road. Design of pit is inappropriate with resulting erosion depositing sandy particulate matter over adjoining pasture. Some remedial work apparent but inadequate. Impacts, while considerable are likely to be restricted to those of a land based nature.

Photo 8 Crokers Gravel pit: The poor design and maintenance of the access road and the pit itself has caused substantial rill erosion.
