Elura Mine subsidence, 16 & 17 March 1996 : report

**ELURA MINE SUBSIDENCE
16 & 17 MARCH 1996**

REPORT

**Graham TERREY
Chief Inspector of Mines
Department of Mineral Resources, NSW**

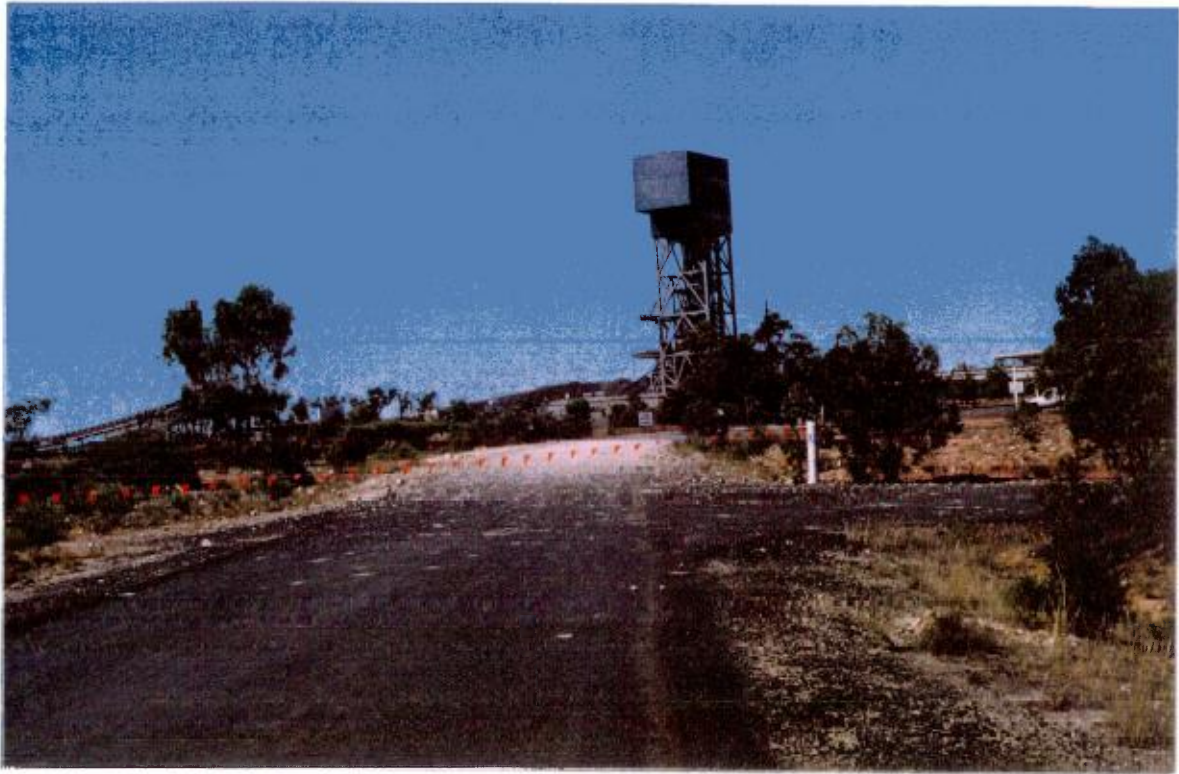
Road near Elura gate
Showing flyrock from rock fall

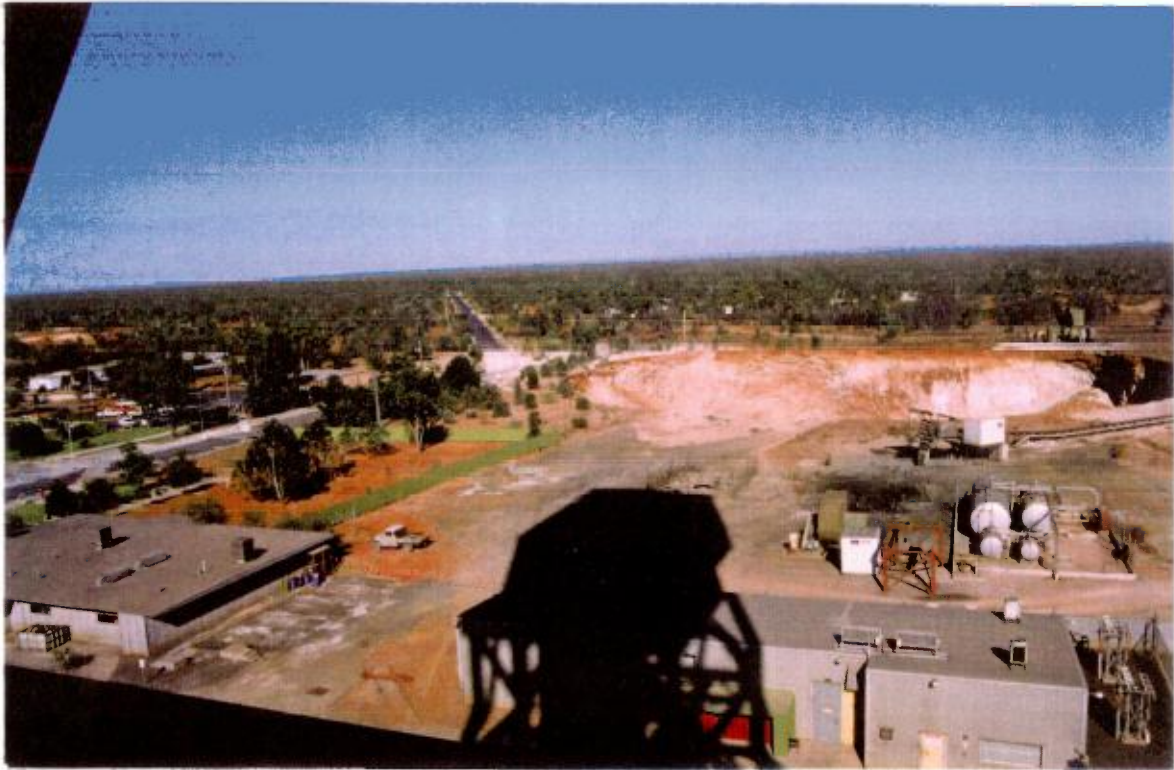
Subsidence looking West from Headframe

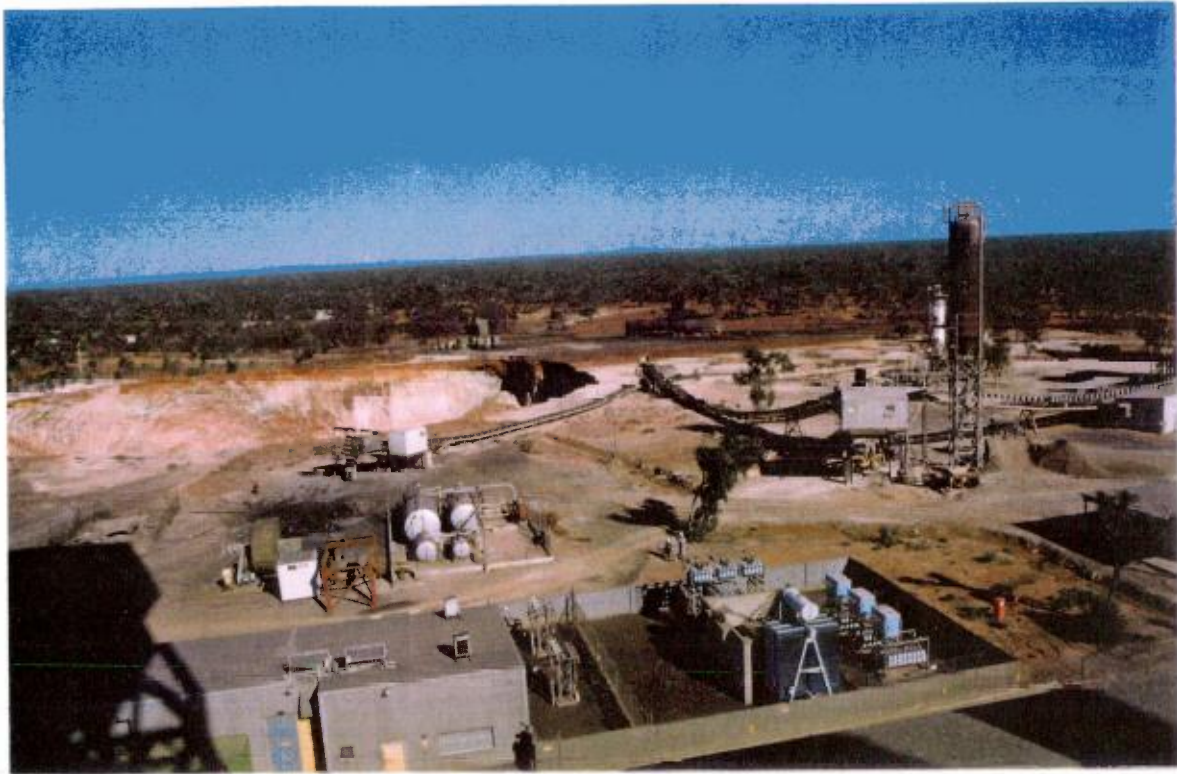
18 March 1996 Subsidence looking West from Headframe

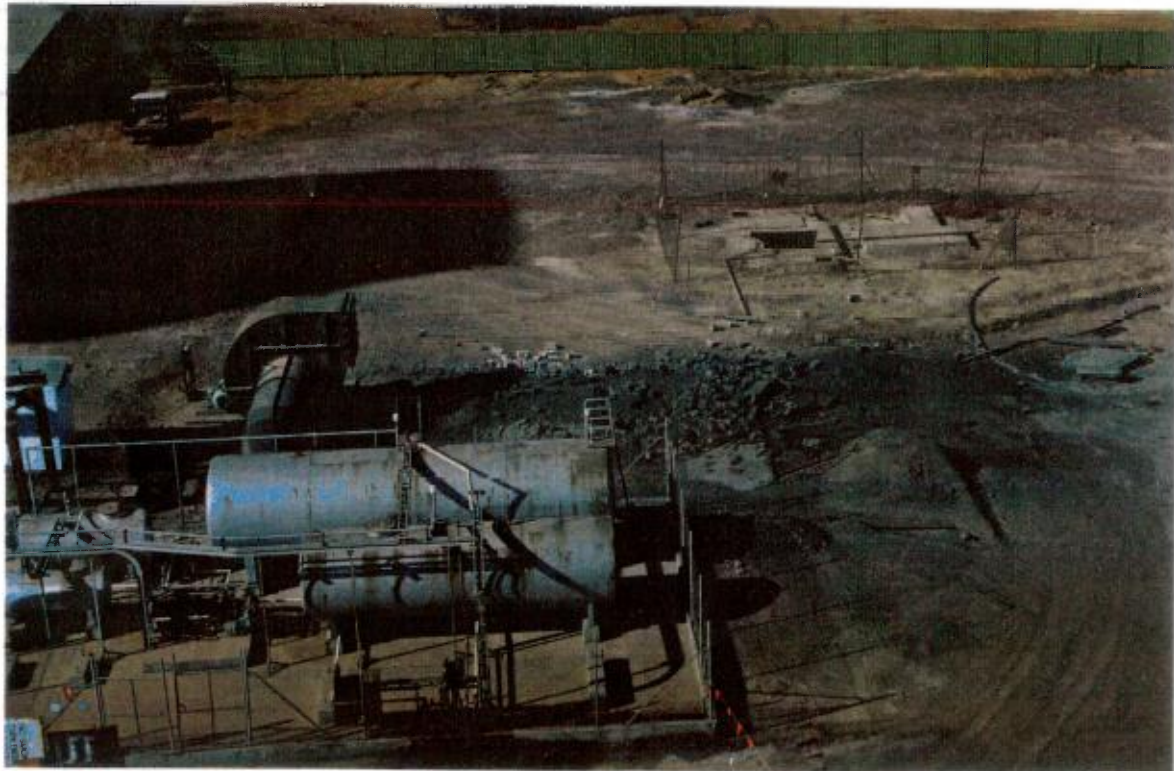
18 March 1996 Damage to Wall Infront of Allied Vent Fan

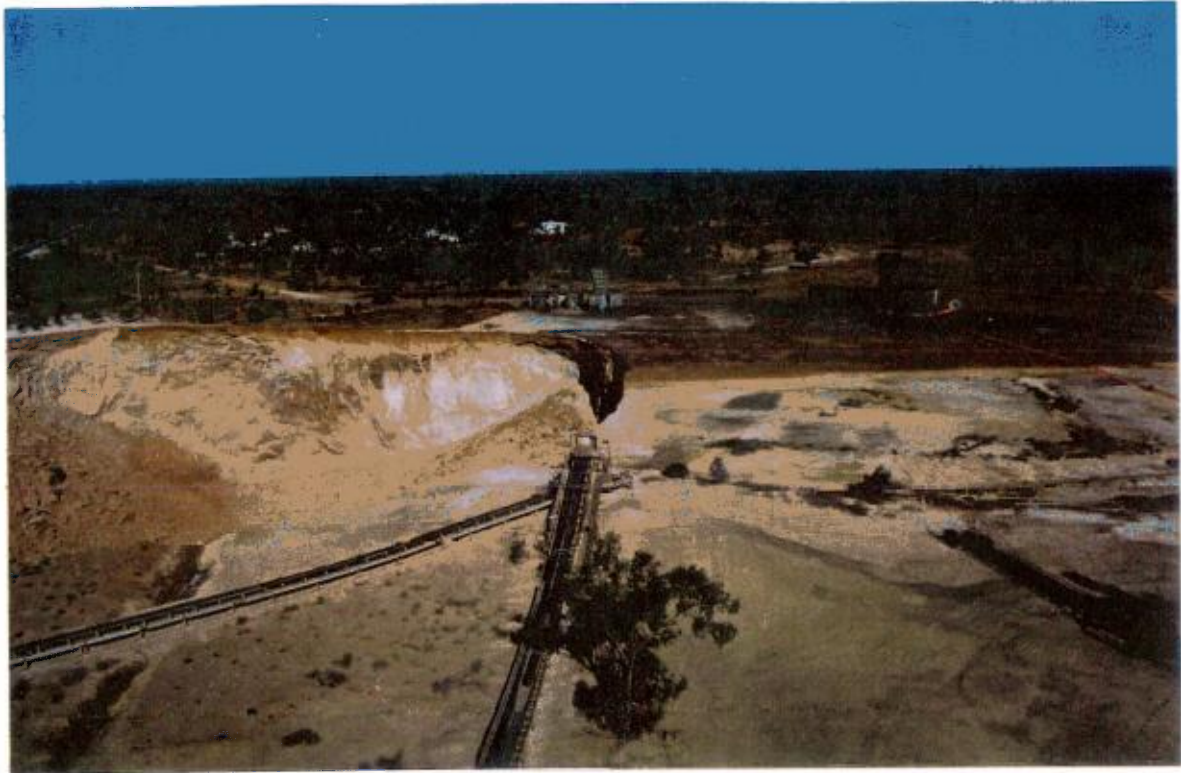
18 March 1996 Subsidence from Cement Silo looking West

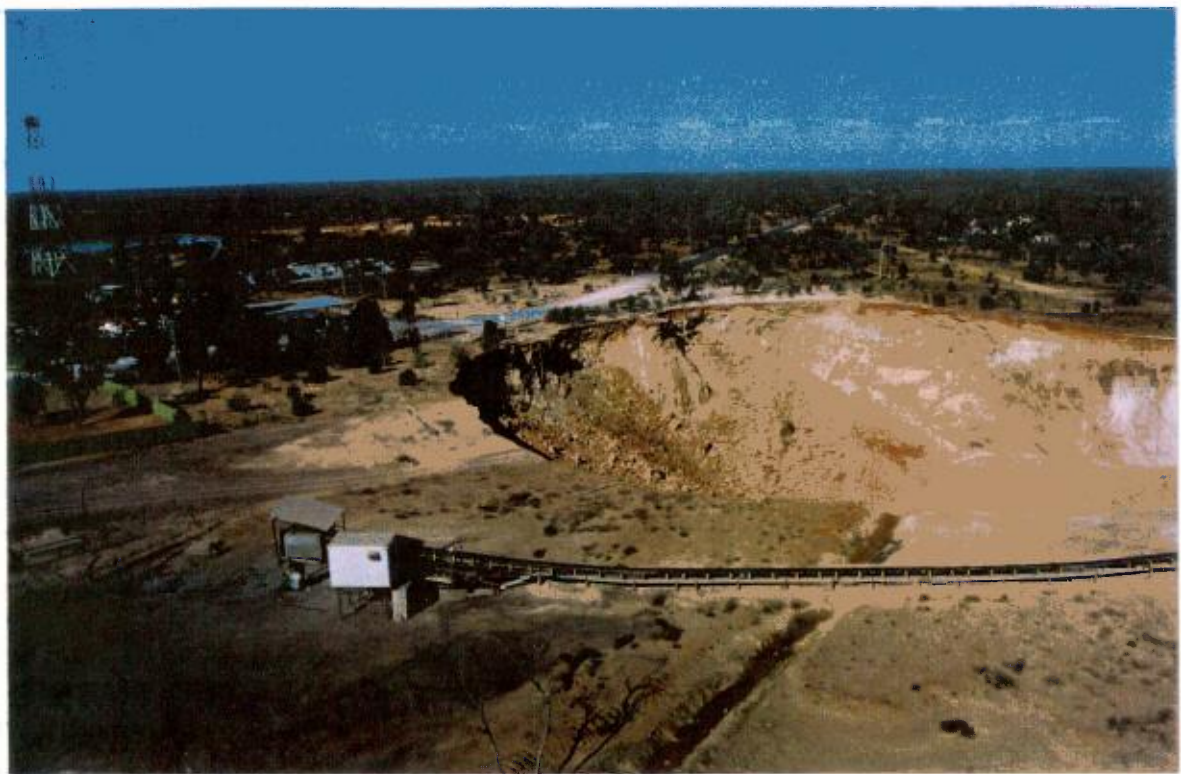
18 March 1996 Subsidence looking West from Cement Silo

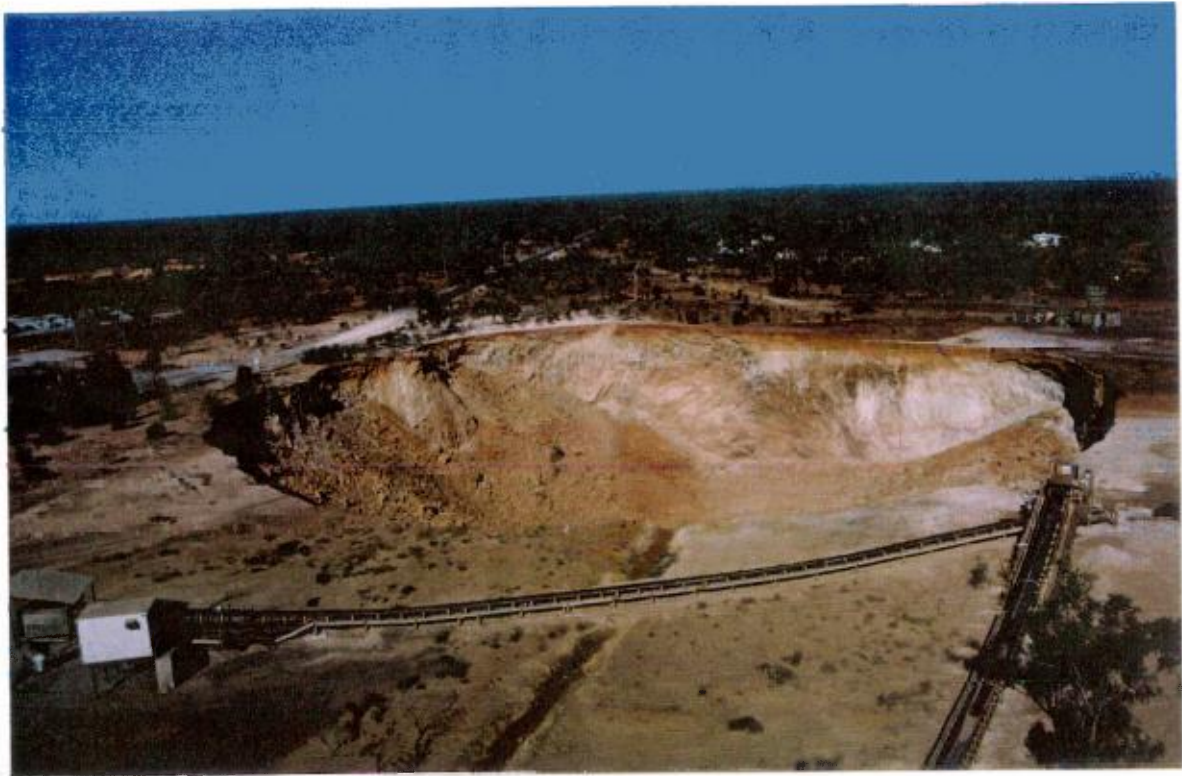
Subsidence looking West from Headframe

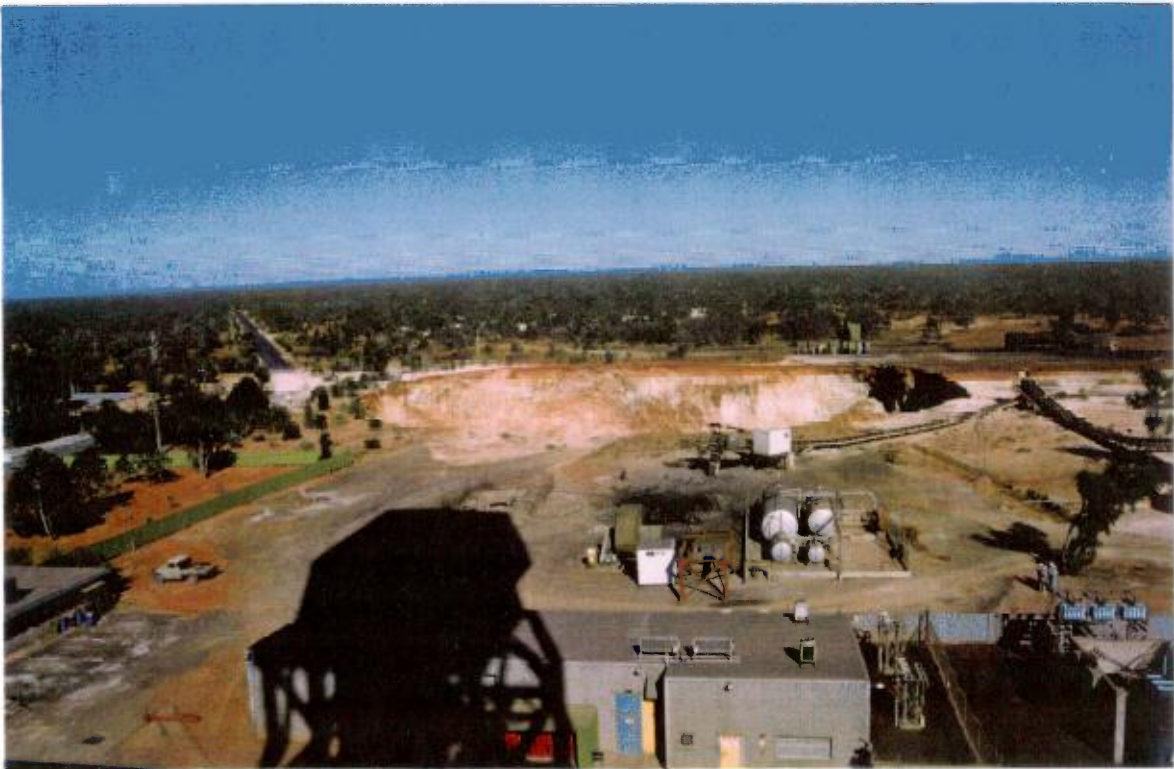
Subsidence looking West from Headframe

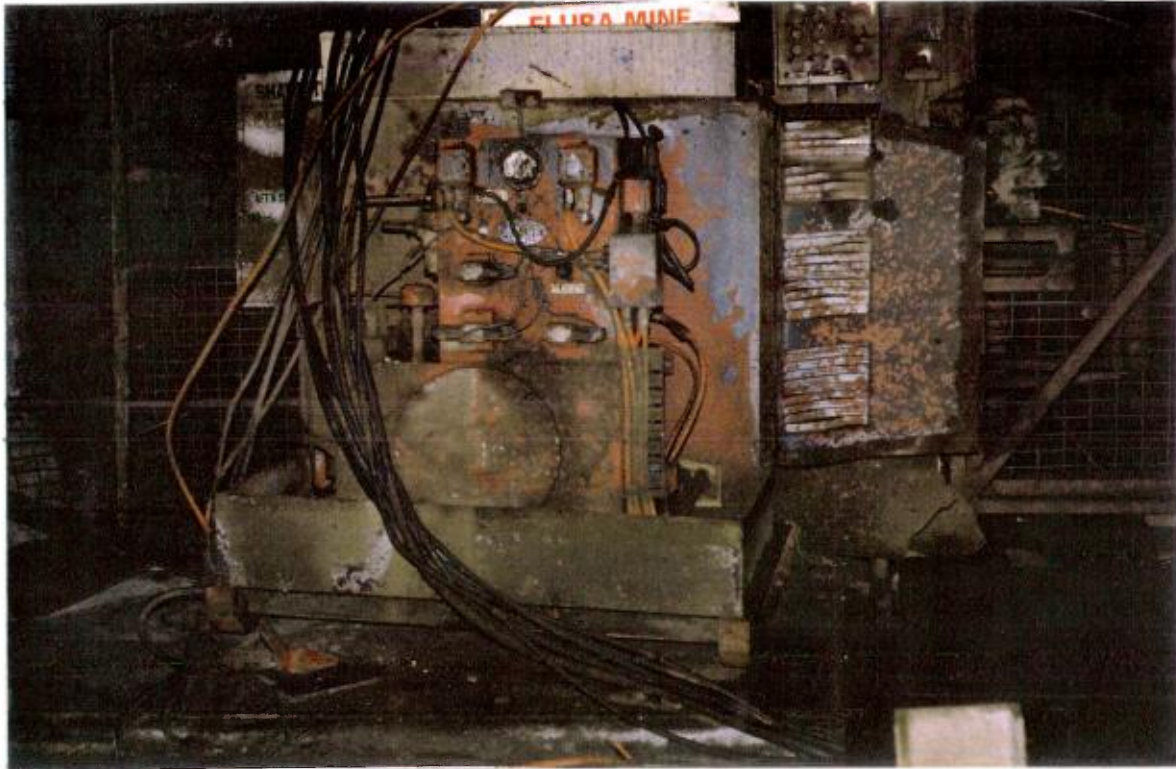
18 March 1996 **Power Pack for Plat**
1 Haulage level, showing displacement due to air blast

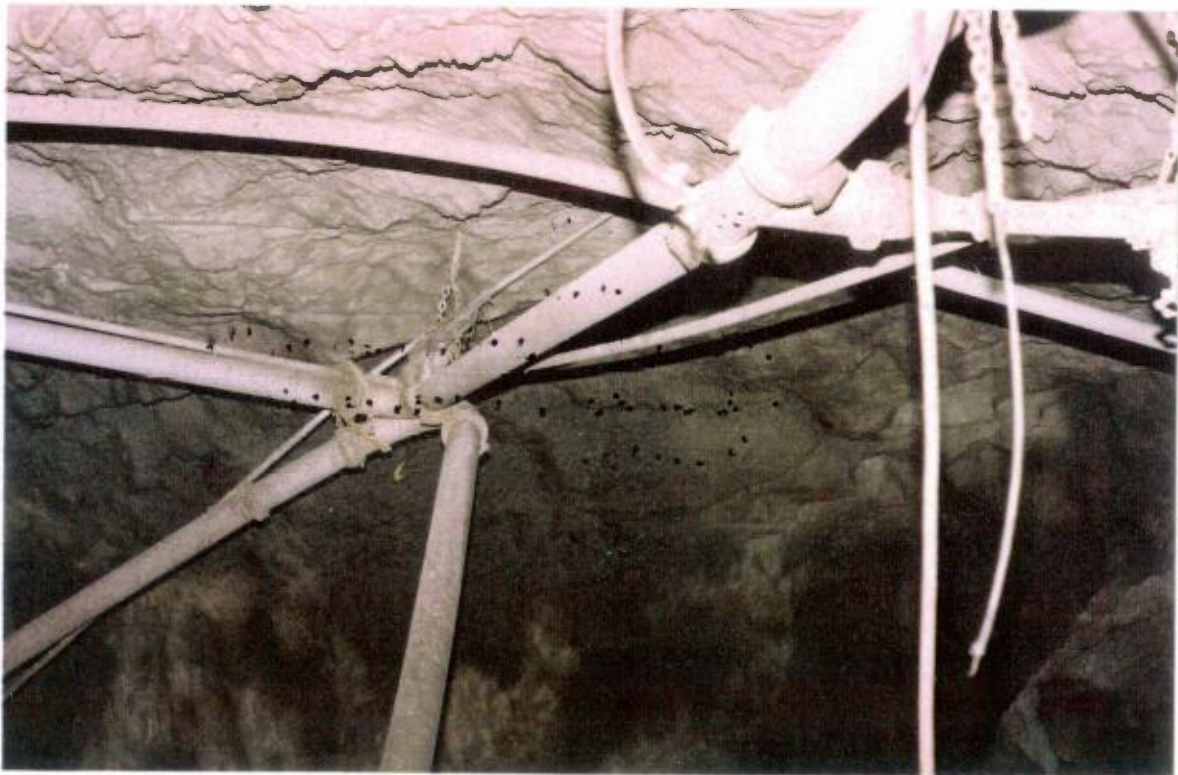
18 March 1996 **2 Drill Access**
Decline Intersection
Large diameter pipes (150mNB)
Largely undamaged

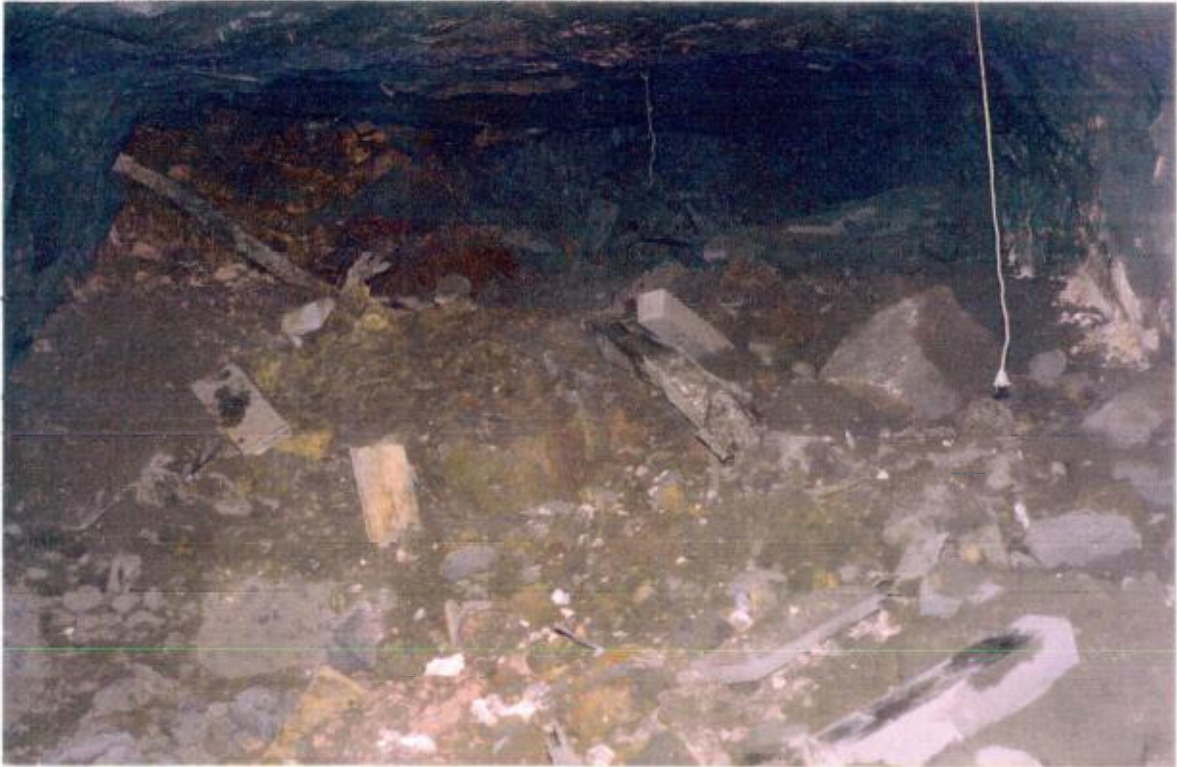
2 Drill

Debris from supergene workings in fallen ground

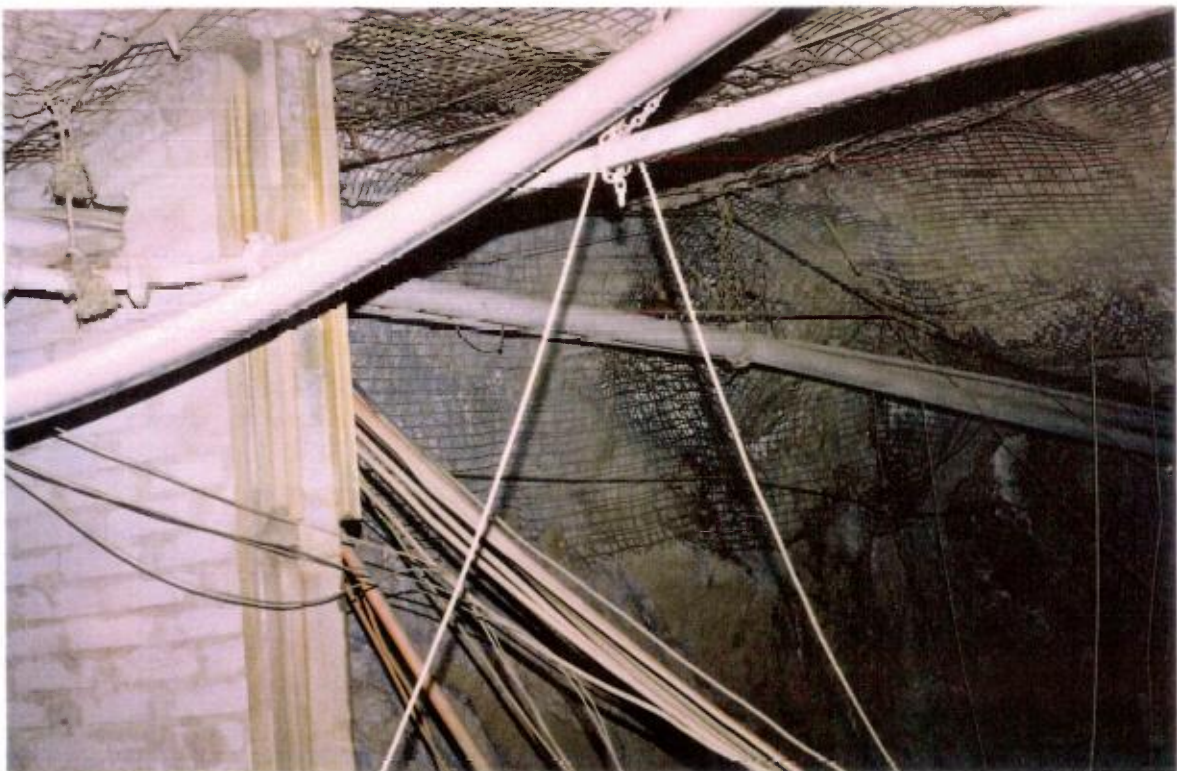
2 Drill Access

Damage to cables

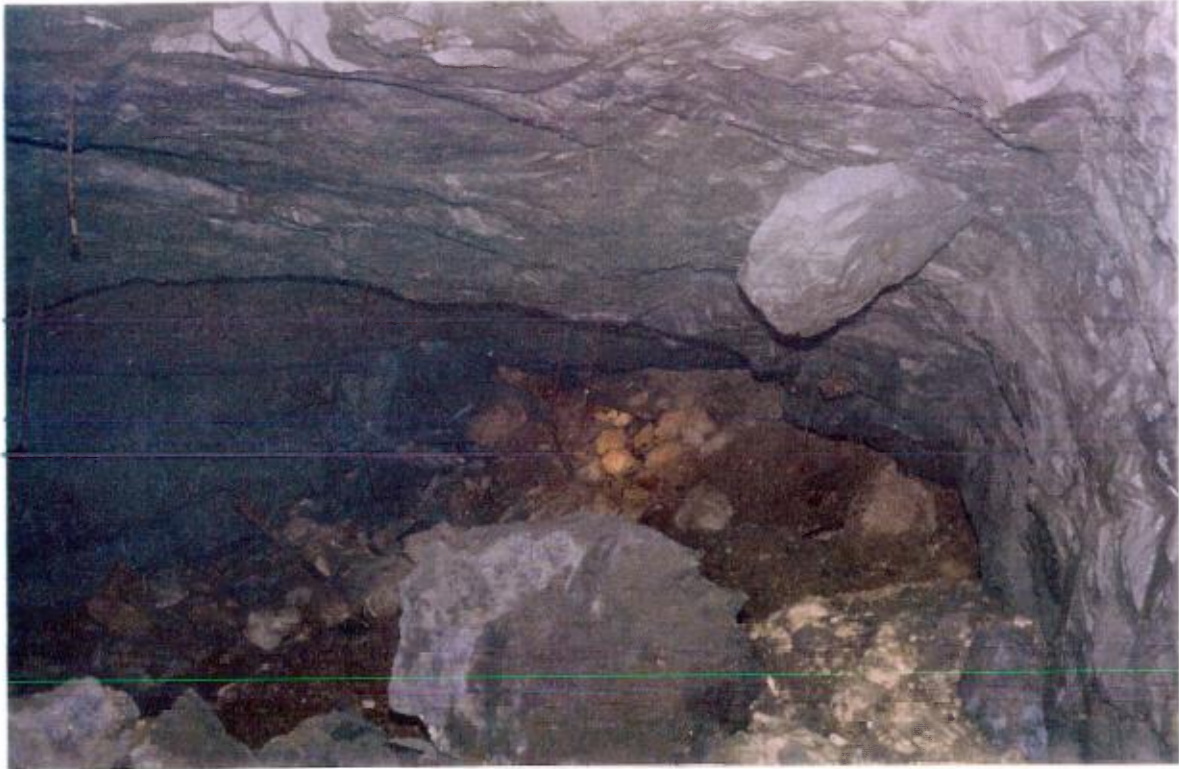
2 Drill

Fallen ground showing debris from supergene workings

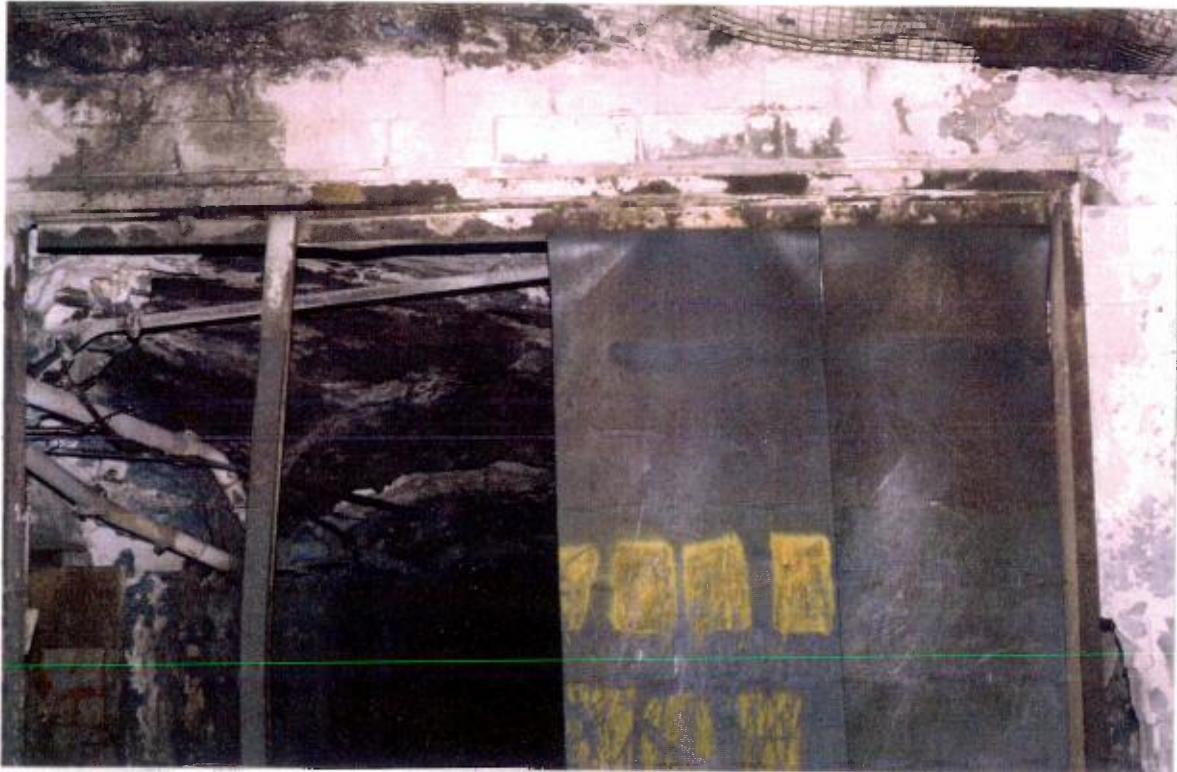
18 March 1996 2H Plat Area
Undamaged vent curtain

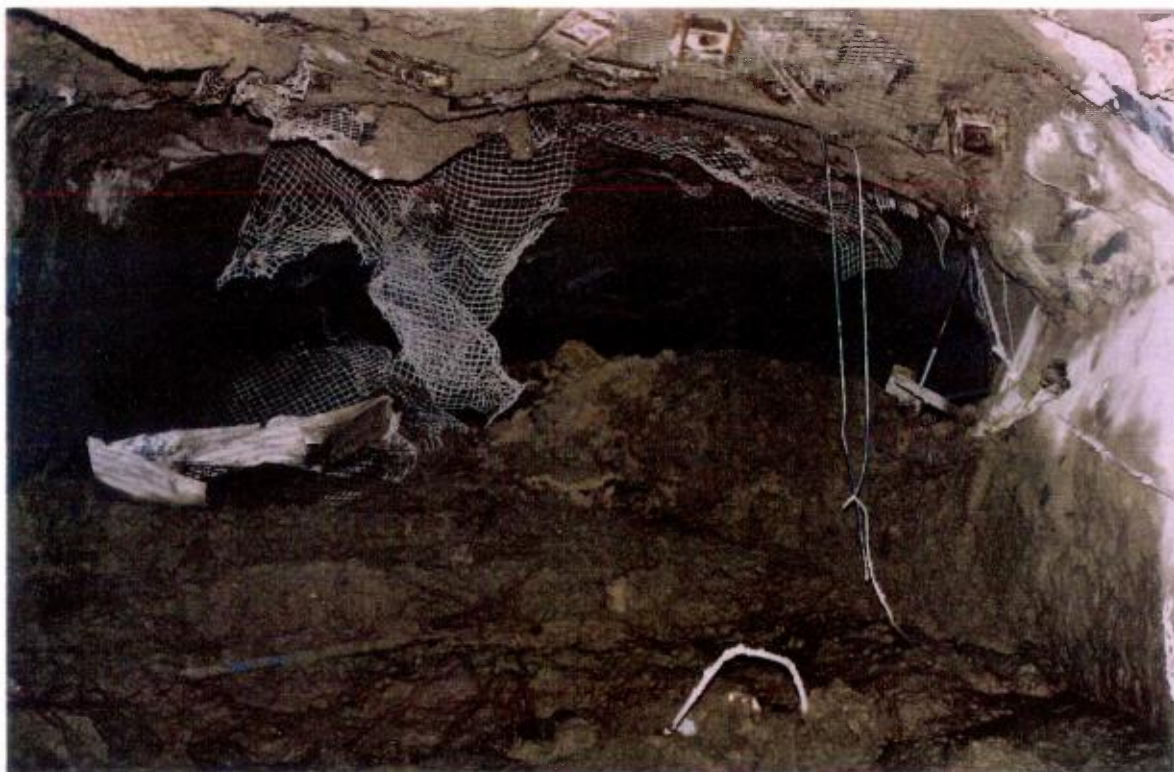
18 March 1996 3 Haulage EPD North of Fuel Store (looking north)
Showing fill flow
Consistency of fill
* Foreground - Sloppy
* Rear - Firm and putty like

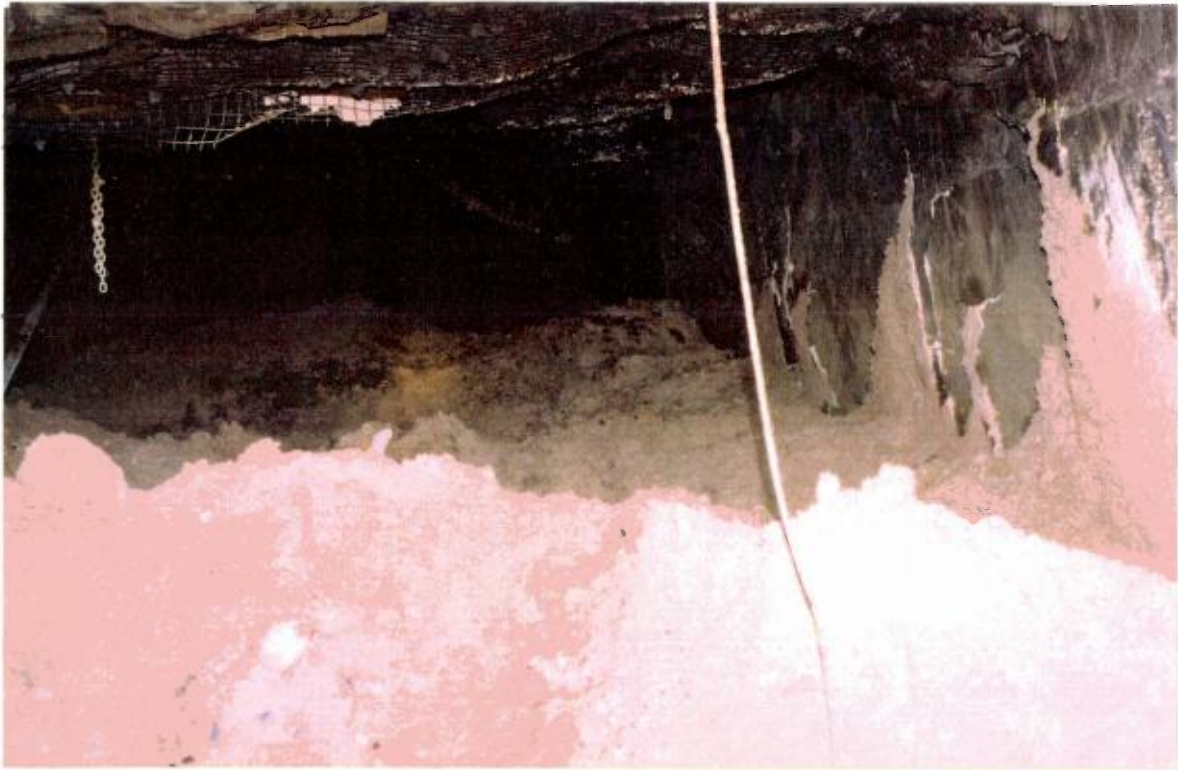
3 Haulage Fuel Bay Drive (looking West)
Showing fill "flow"
Fill consistency - Dry and powdery

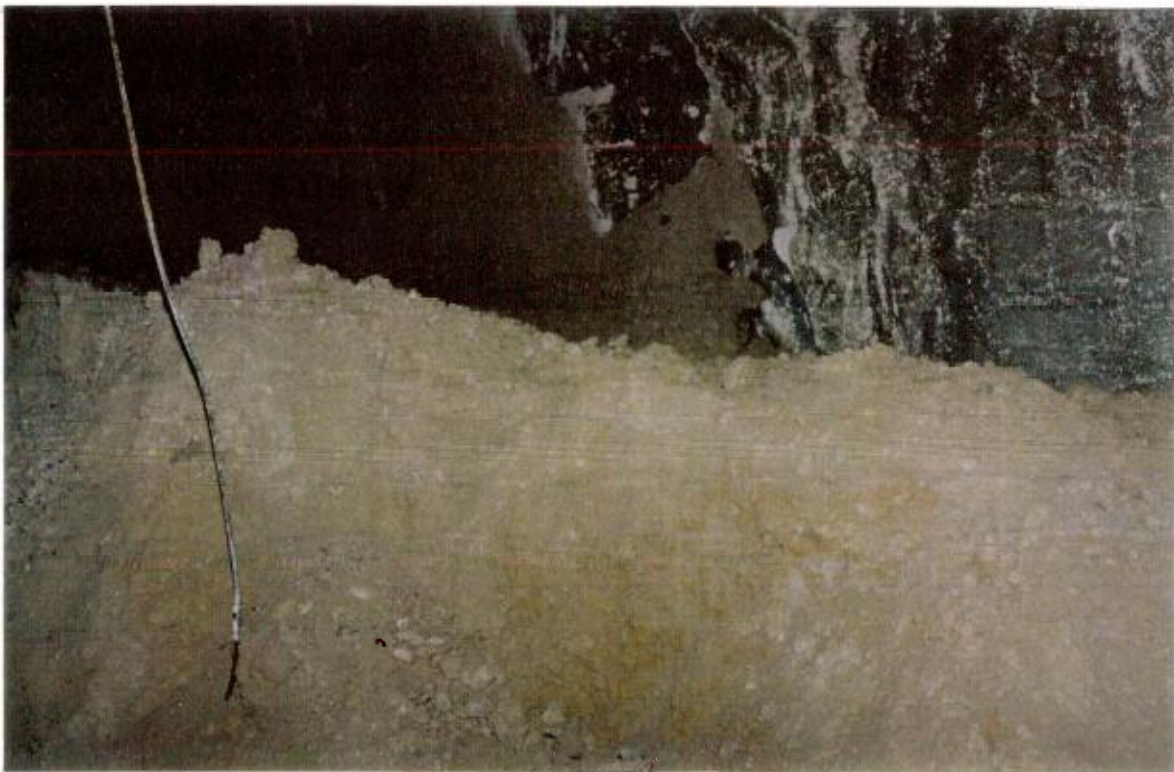
3 Haulage Fuel Bay Drive (looking West)
Showing fill flow
Fill consistency - Dry and powdery

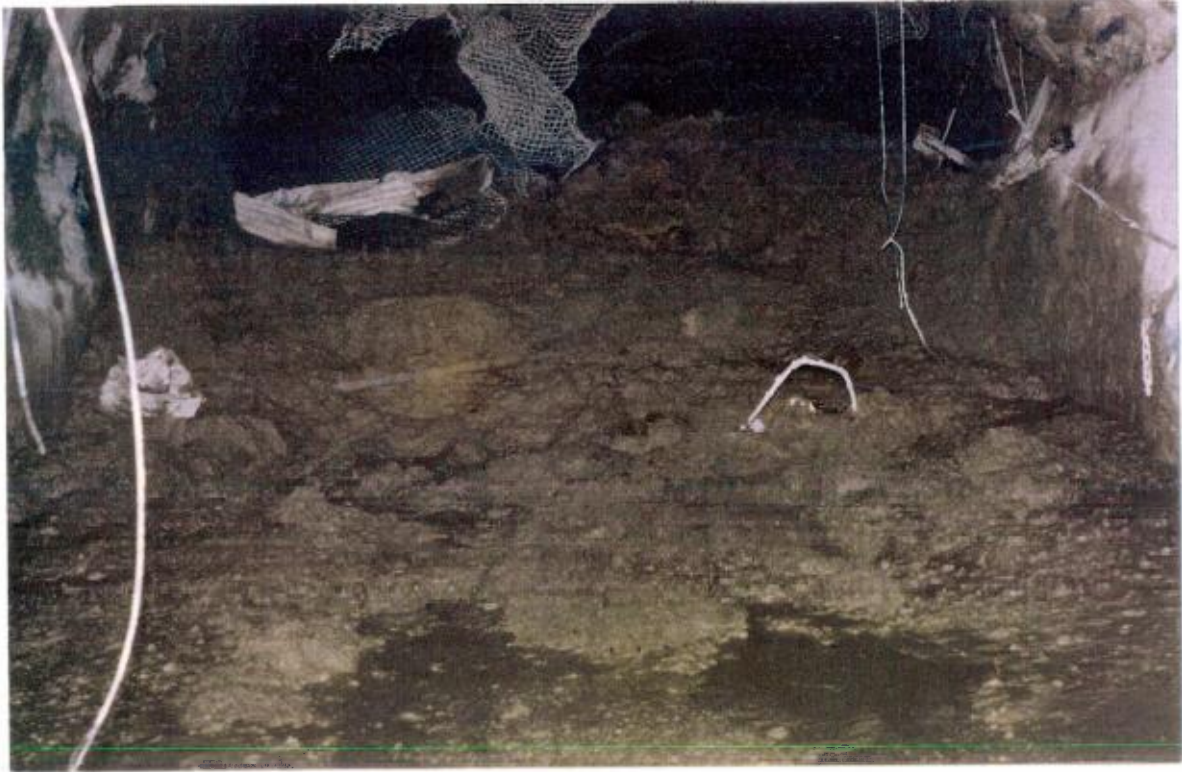
18 March 1996 3 Haulage EPD North of Fuel Store
Showing fill flow
Consistency of fill
- Foreground - Sloppy
- Rear - Firm and putty like

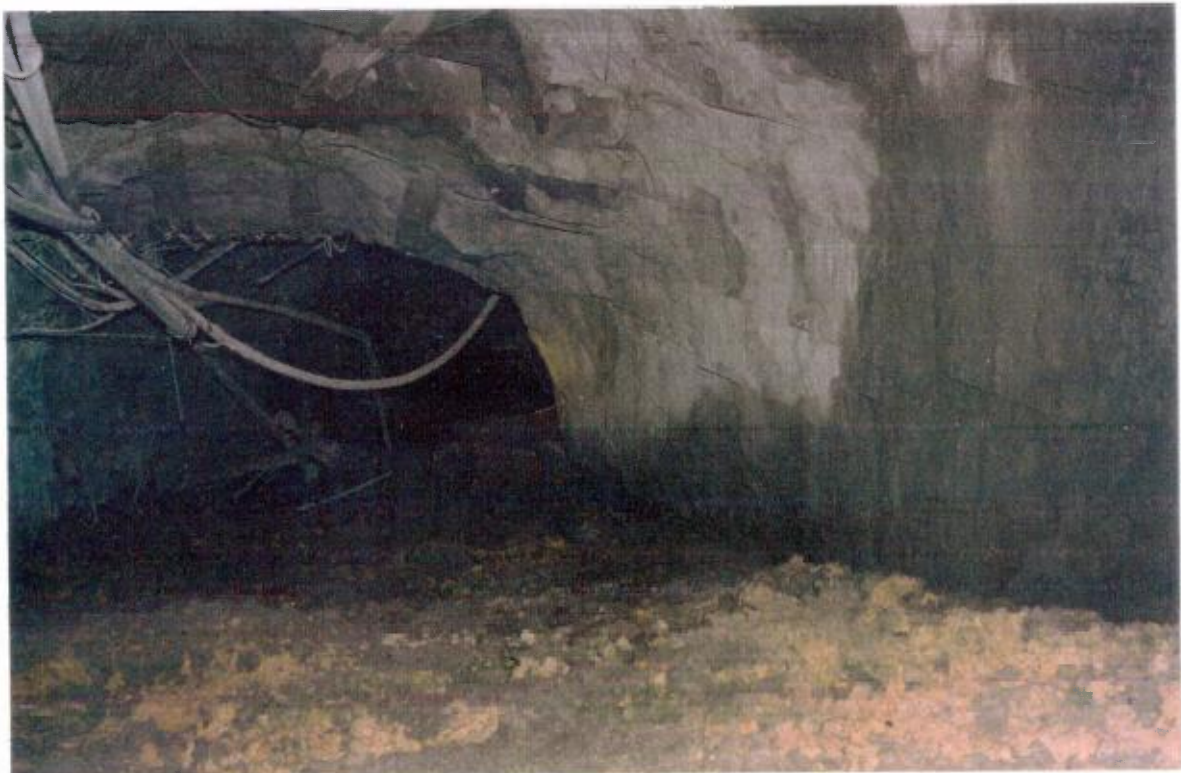
18 March 1996 4 Drill Access just West of substation showing fill flow
Consistency of fill "sloppy"

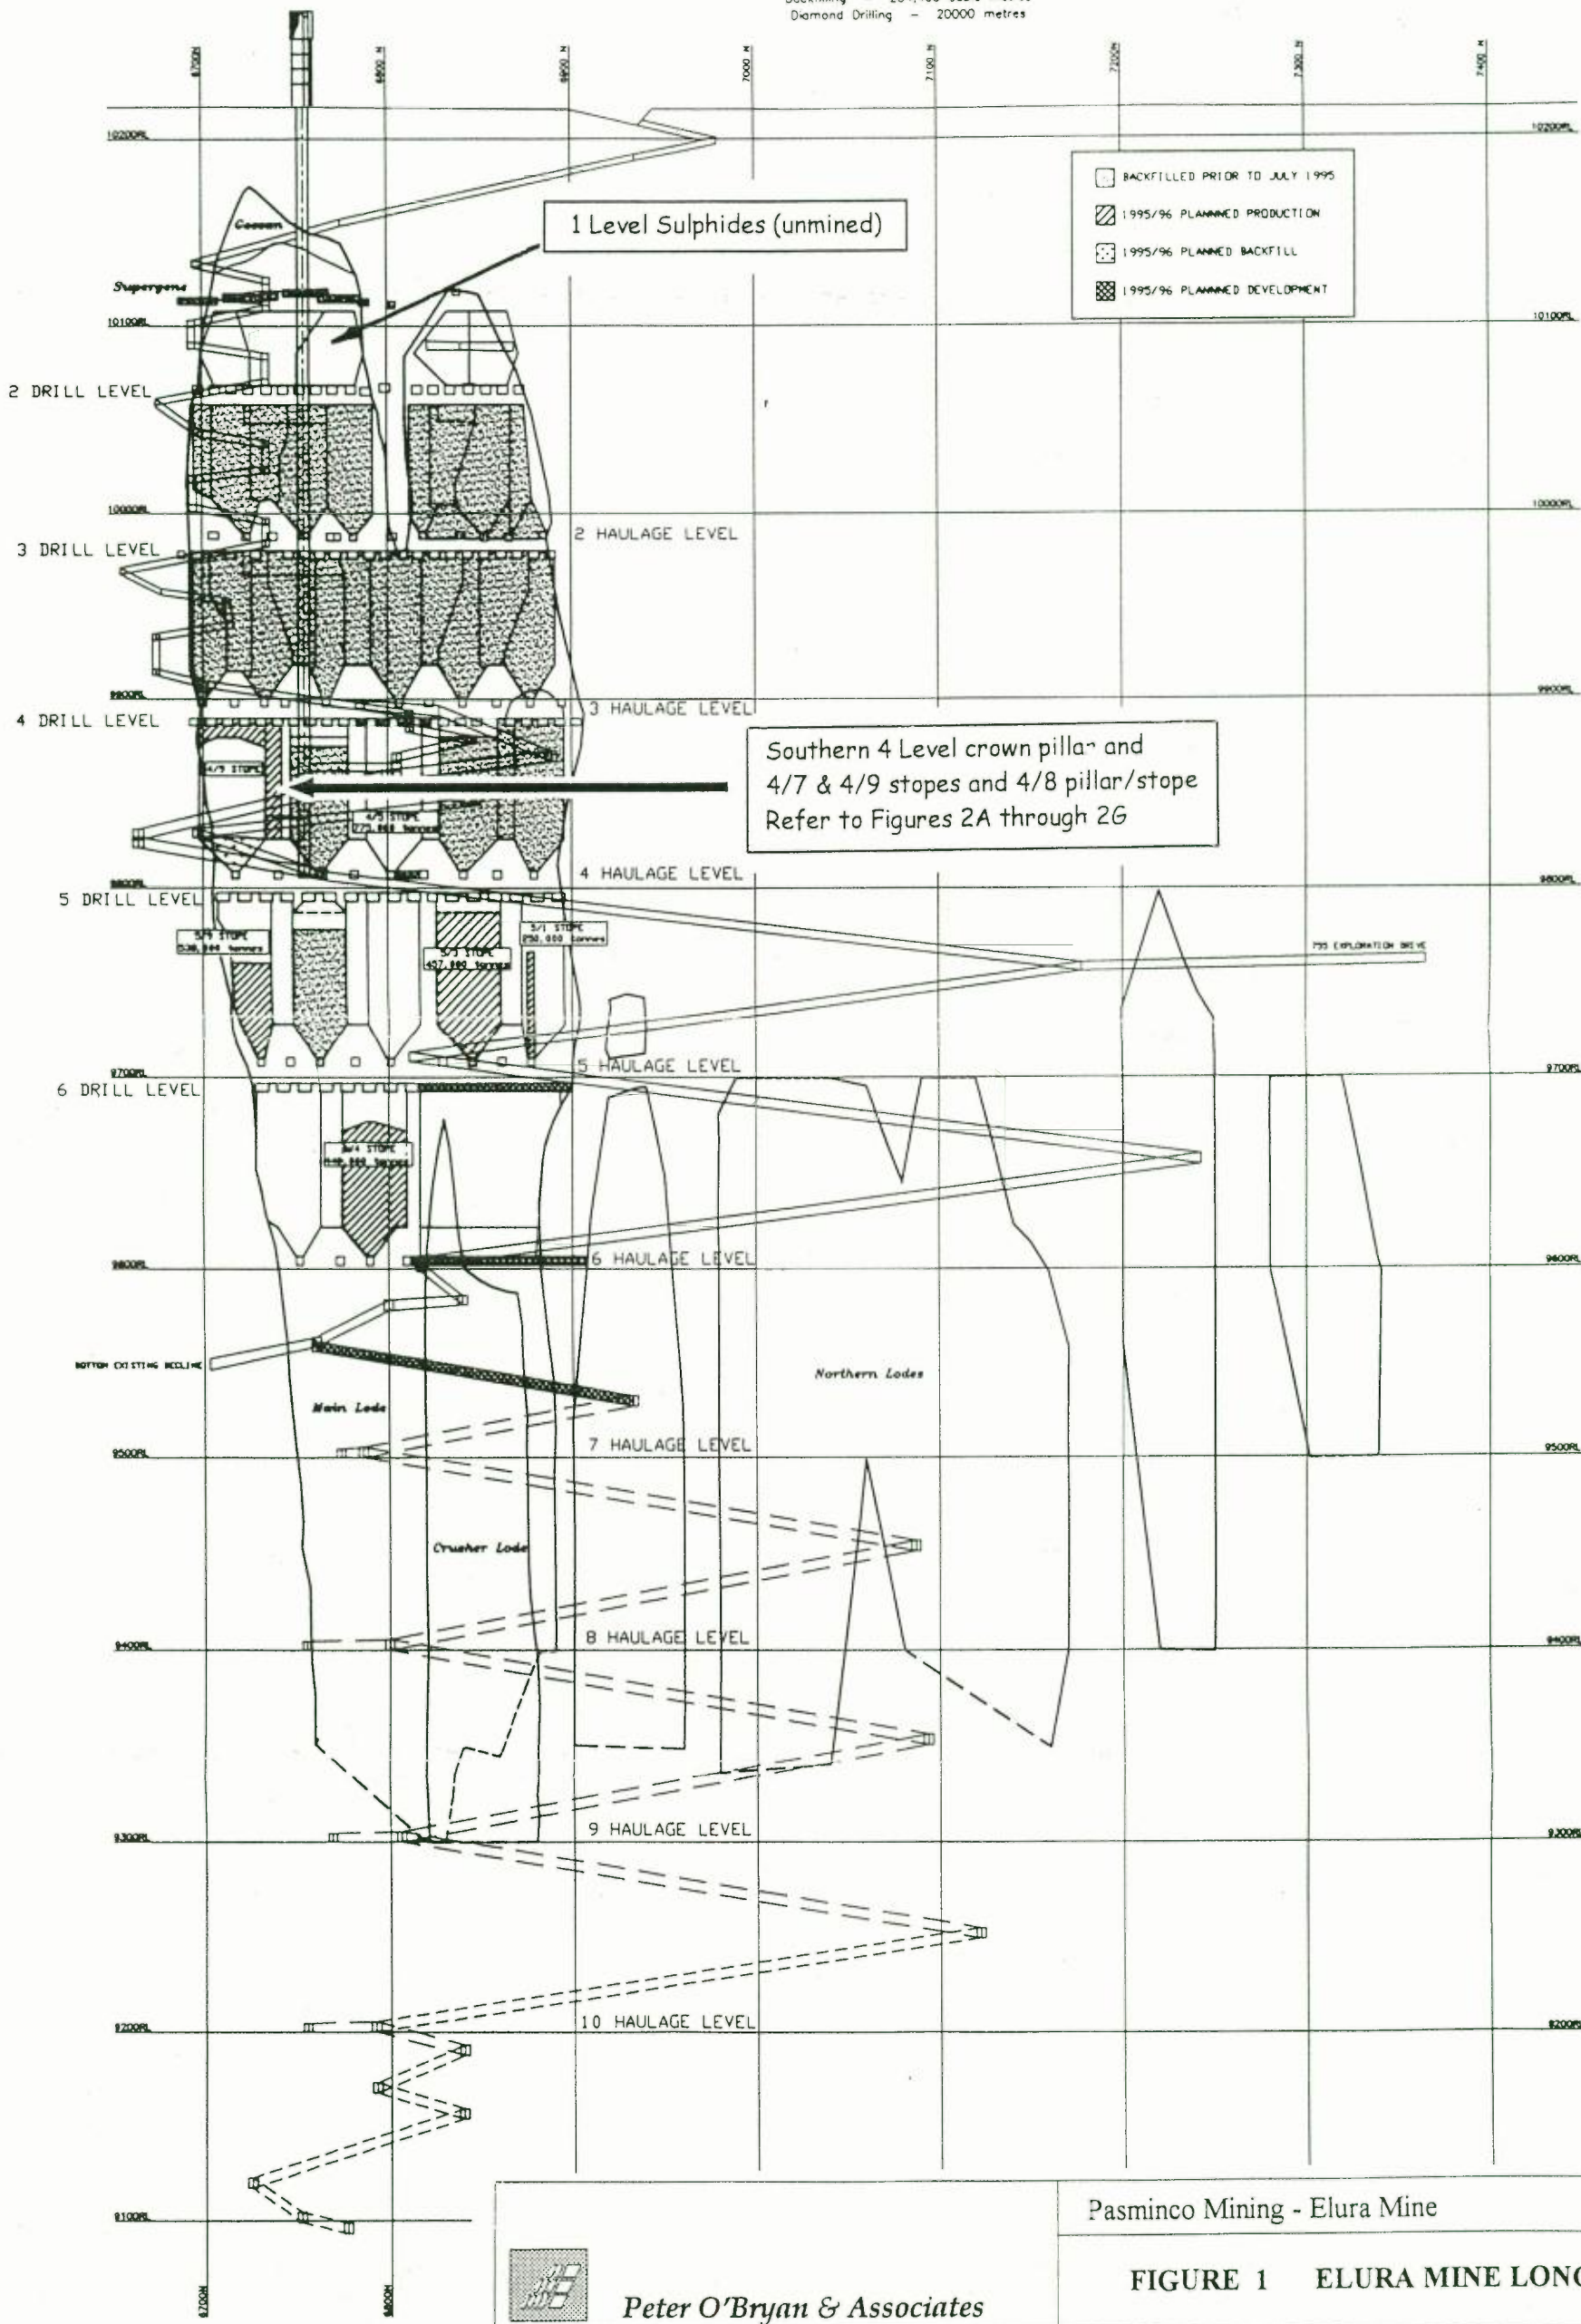
FIGURE 1 ELURA MINE LONG SECTION

The arrest of the collapse just below 2 Drill Level was temporary. At approximately 15:00 hours on 17 March 1996, the 2 Drill Level and the southern 1 Level sulphide block, Figure 1, failed removing support from the overlying gossans and highly weathered country rock. Sudden failure of this material resulted in the formation of a pipe to the natural ground surface, Figure 3.

The failure was temporarily arrested just below the 2 Drill Level, presumably strongly influenced by the presence of the unmined 1 Level sulphide block, Figure 1. The exposed span, plus the disturbance to abutment support and the presence of the western shear zone, were sufficient to cause failure of this block of transitional material (moderately weathered to slightly weathered to fresh rock). At least some of the "dull rock noise" heard following the initial collapse is attributed to have been from progressive failure along/within the western shear zone. Failure of this block occurred ~38 hours after the first event.
