Elura Mine subsidence, 16 & 17 March 1996 : report

**ELURA MINE SUBSIDENCE
16 & 17 MARCH 1996**

REPORT

**Graham TERREY
Chief Inspector of Mines
Department of Mineral Resources, NSW**

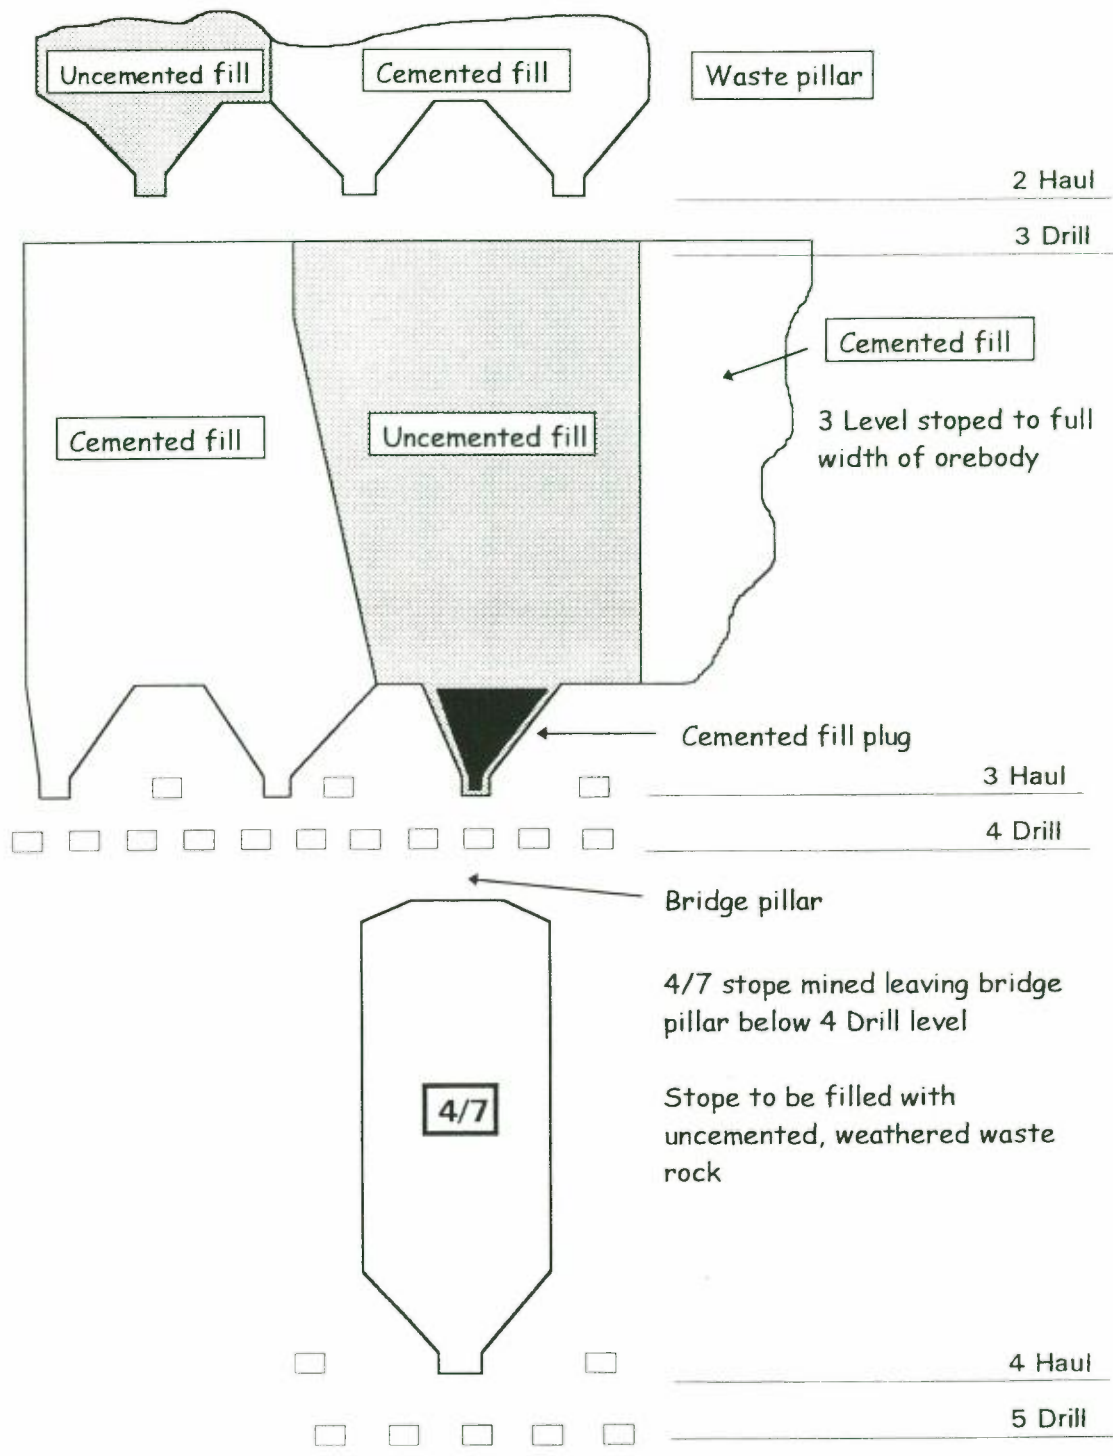
FIGURE 2A ELURA STATUS - PRE 1994

The 3/6, 3/7 and 3/9 stopes immediately above the 4/7 crown were filled with uncemented material, Figure 2A, which would fail/run as soon as exposed. Given the size of the void (~220,000m³) within the 4/7 - 4/9 stope at the time, there was no chance of choking-off the initial run of fill. The fill would have fallen into 4/7, and fallen and/or flowed into 4/9.

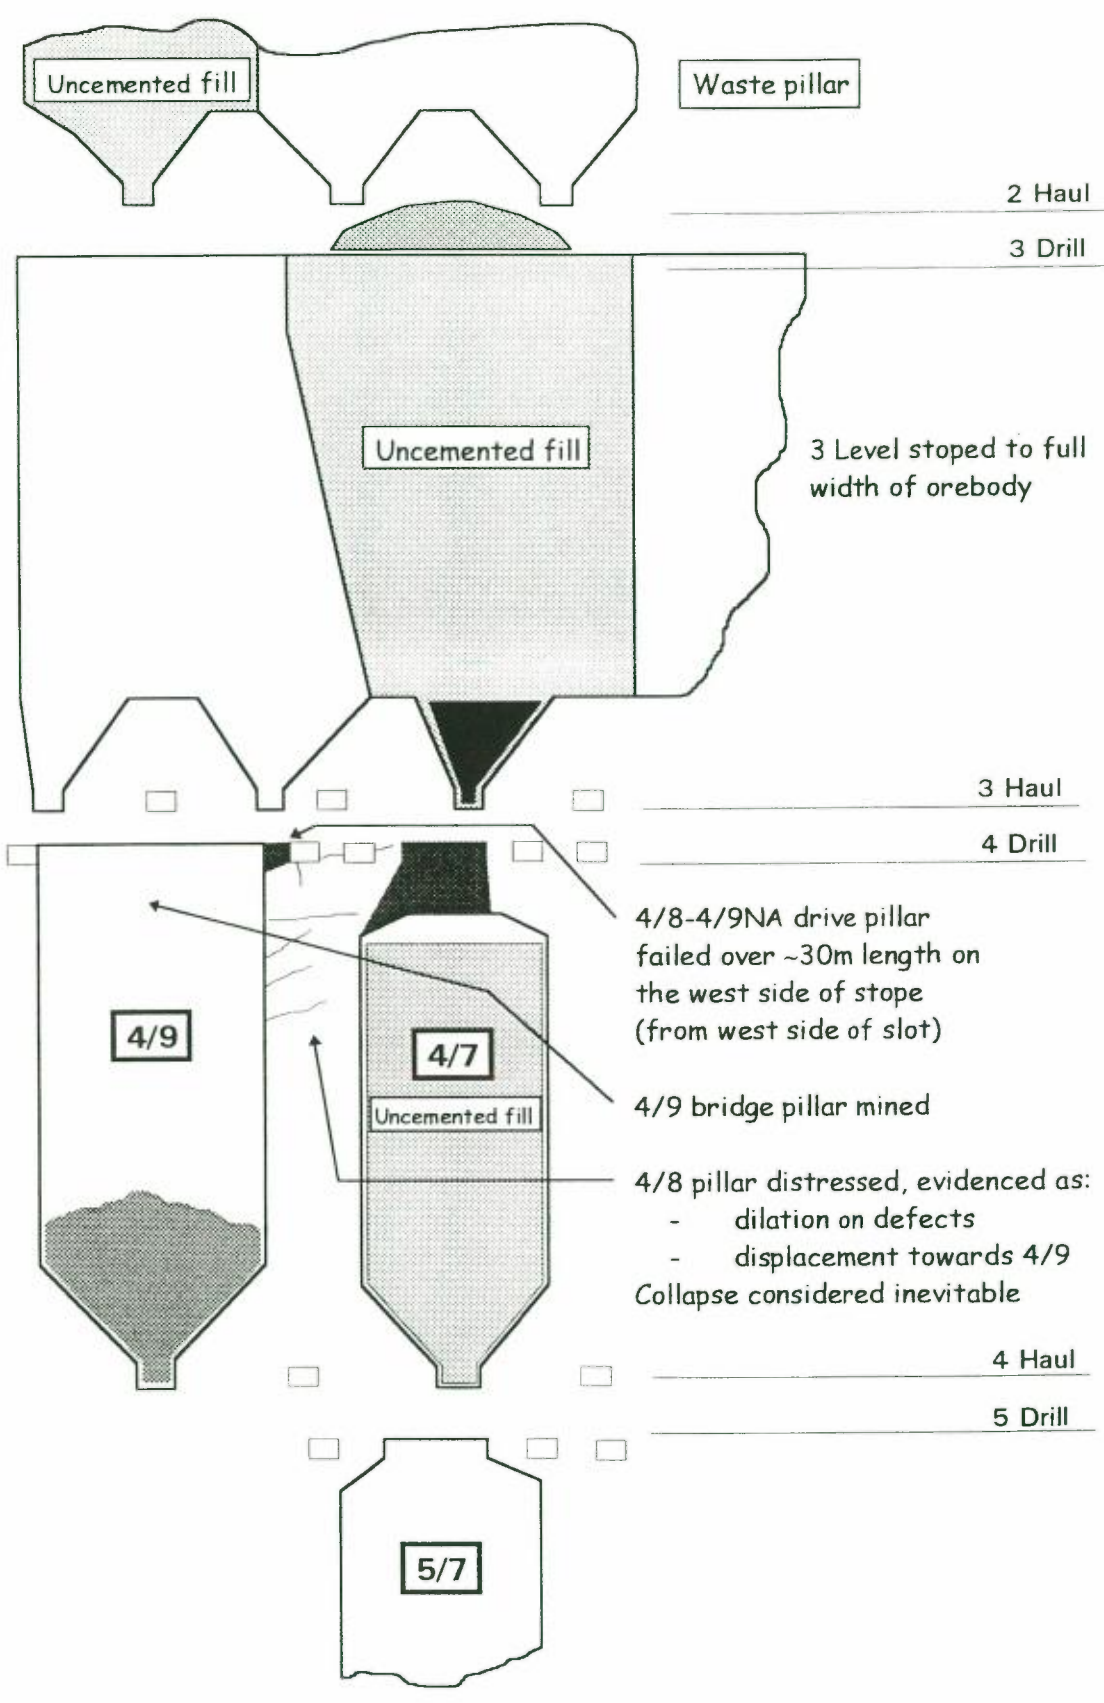
FIGURE 2D ELURA STATUS - JUNE 1995

Significant dilation was observed within the 4/8 pillar following the removal of the 4/9 bridge pillar, Figure 2D. Sub-vertical tension cracking was observed in the 4/8, 4/7SB and 4/7SA drill drives, as was dilation across sub-horizontal joints in the pillars between these drives. Similar dilation across sub-horizontal joints, although of a significantly lesser magnitude, can be observed within the remaining portions of the 5/3 drill drives. In this case the dilation has occurred following the (partial) mining of the 5/3 bridge pillar.

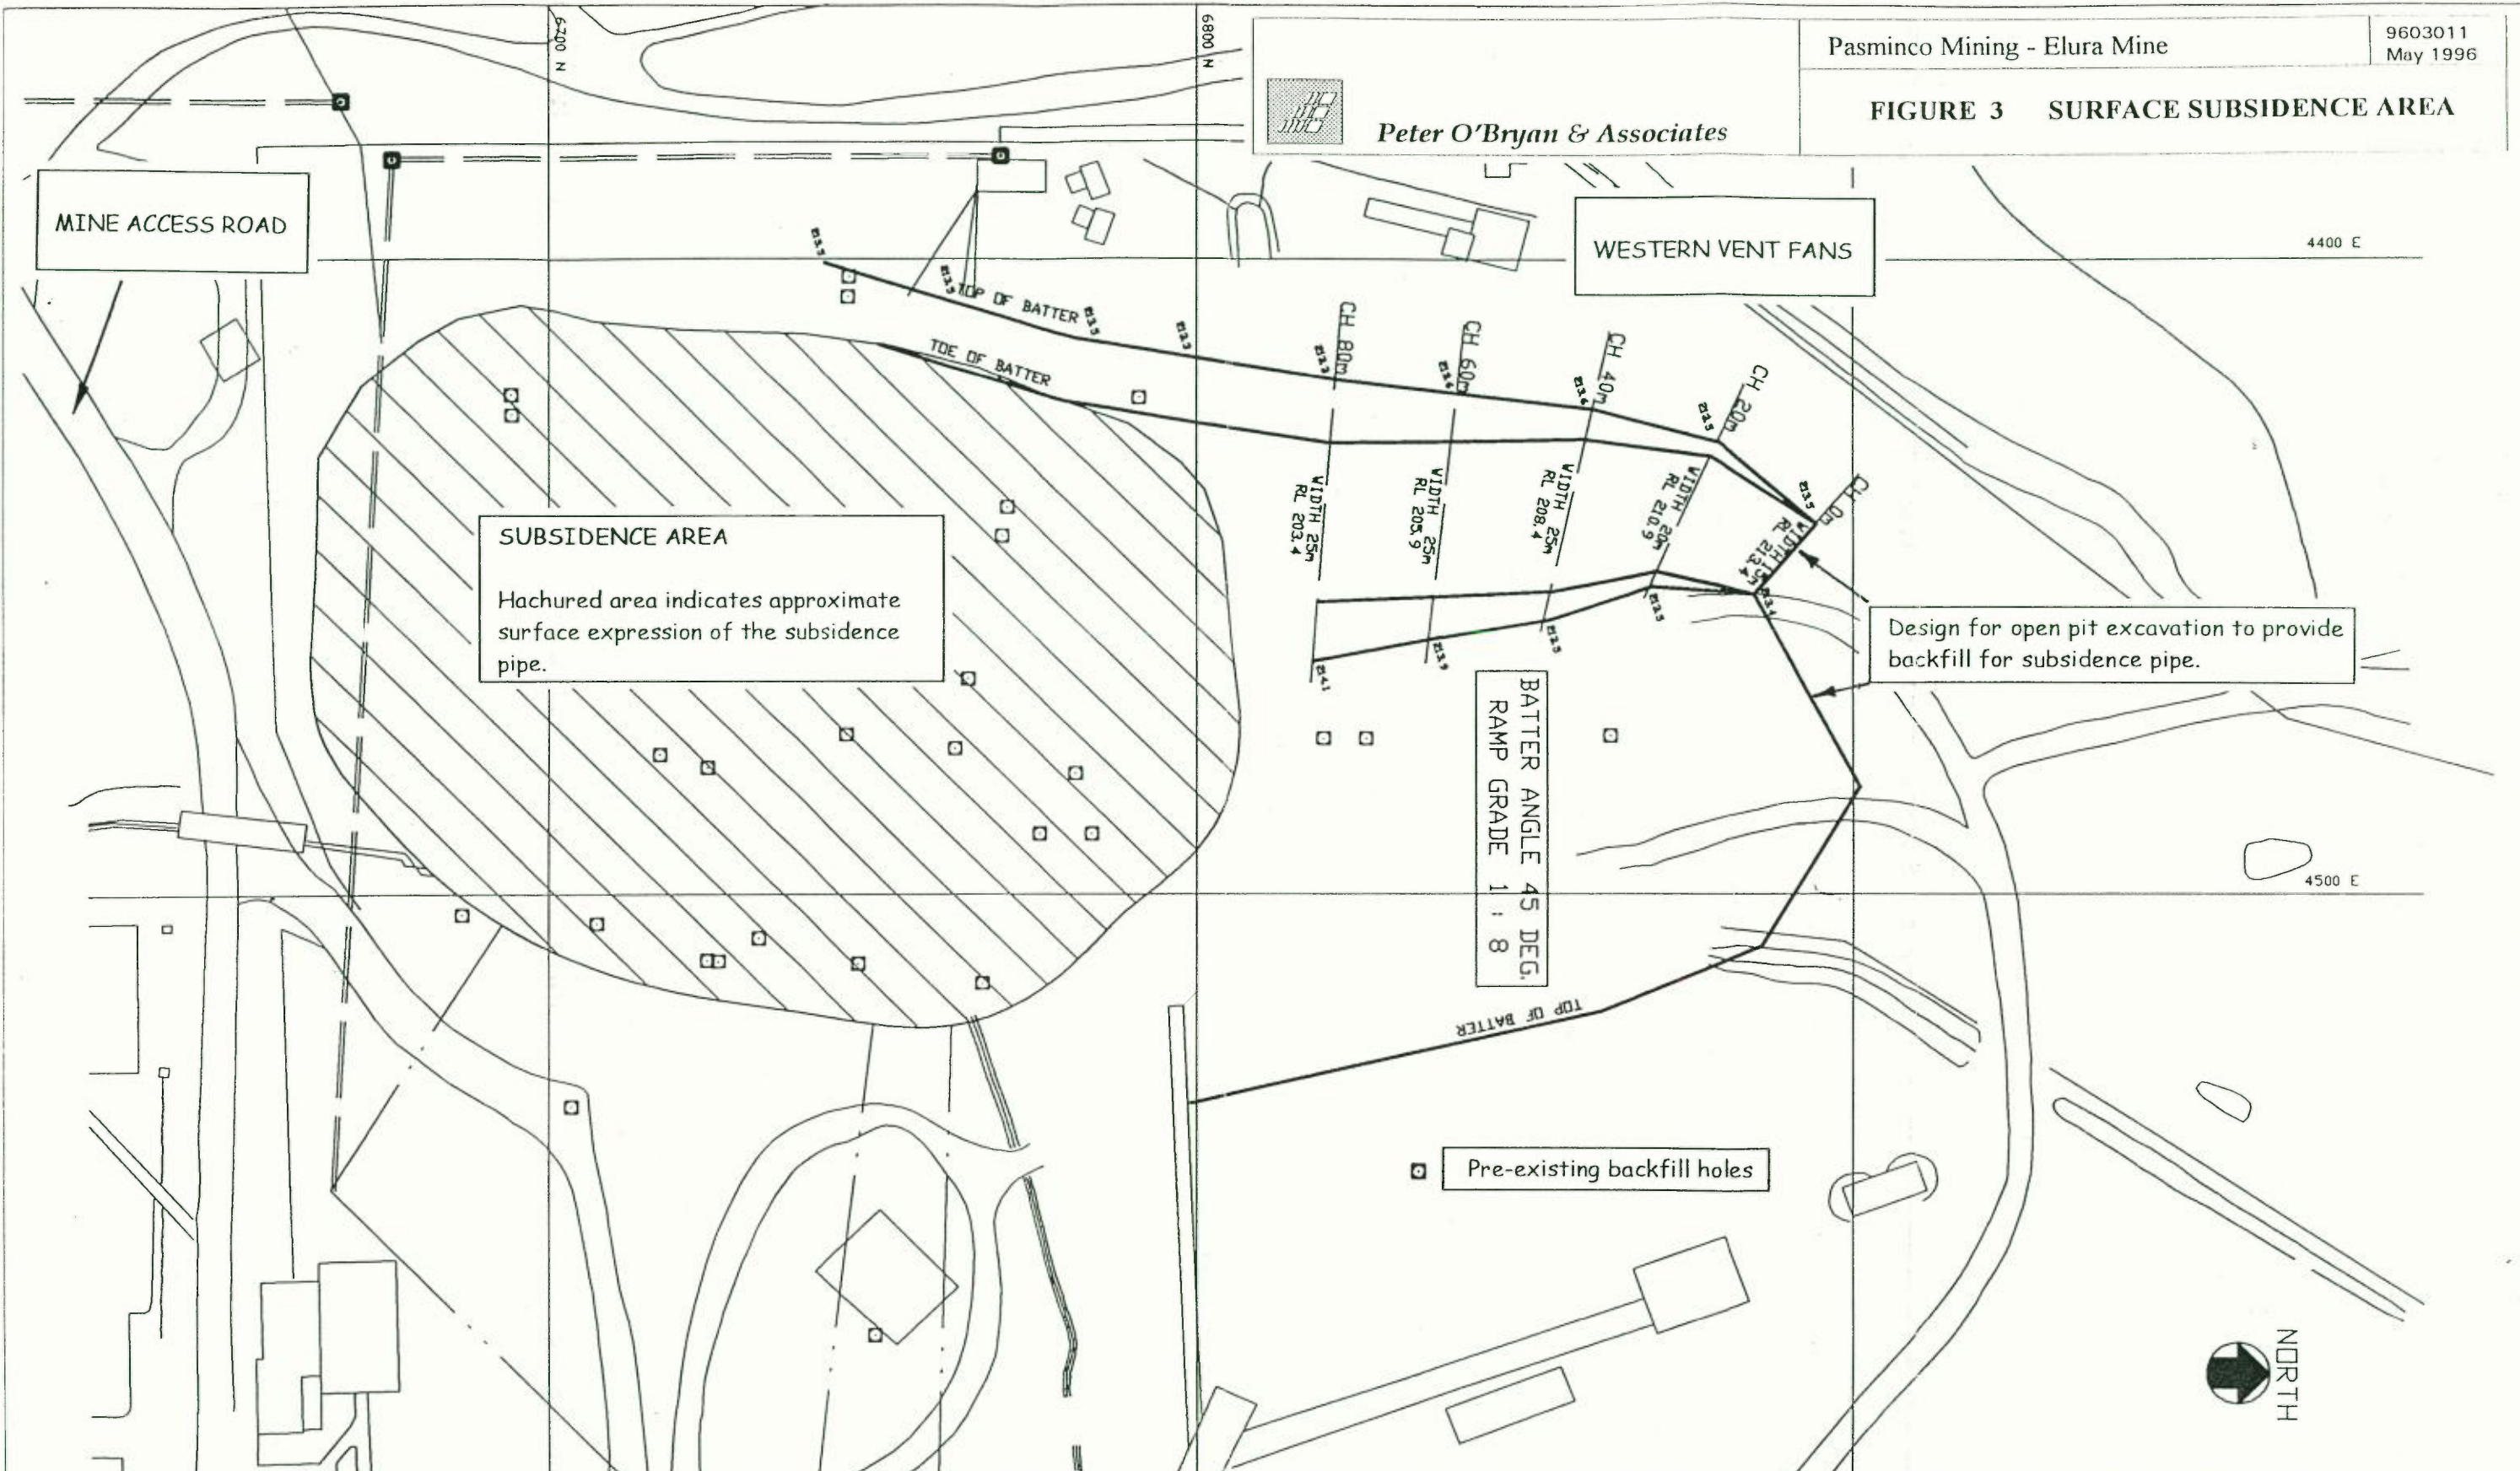
FIGURE 3 SURFACE SUBSIDENCE AREA

The surface cavity caused by this subsidence is roughly "elliptical" in plan, ~110m by ~140m, and up to ~40m deep. The walls of the pipe at surface are sub-vertical, and cracking, approximately "concentric" to the crest of the pipe, is currently evident up to ~40m outside the crest.

The area immediately influenced by surface subsidence is estimated to be ~110m by up to ~140m. Figure 3. The deepest point of subsidence is estimated to be ~40m (at the mid point of the area). The photogrammetrically surveyed volume of the surface expression of the pipe is 230,000m³. Cracking is currently evident up to 40m behind the pipe crest.

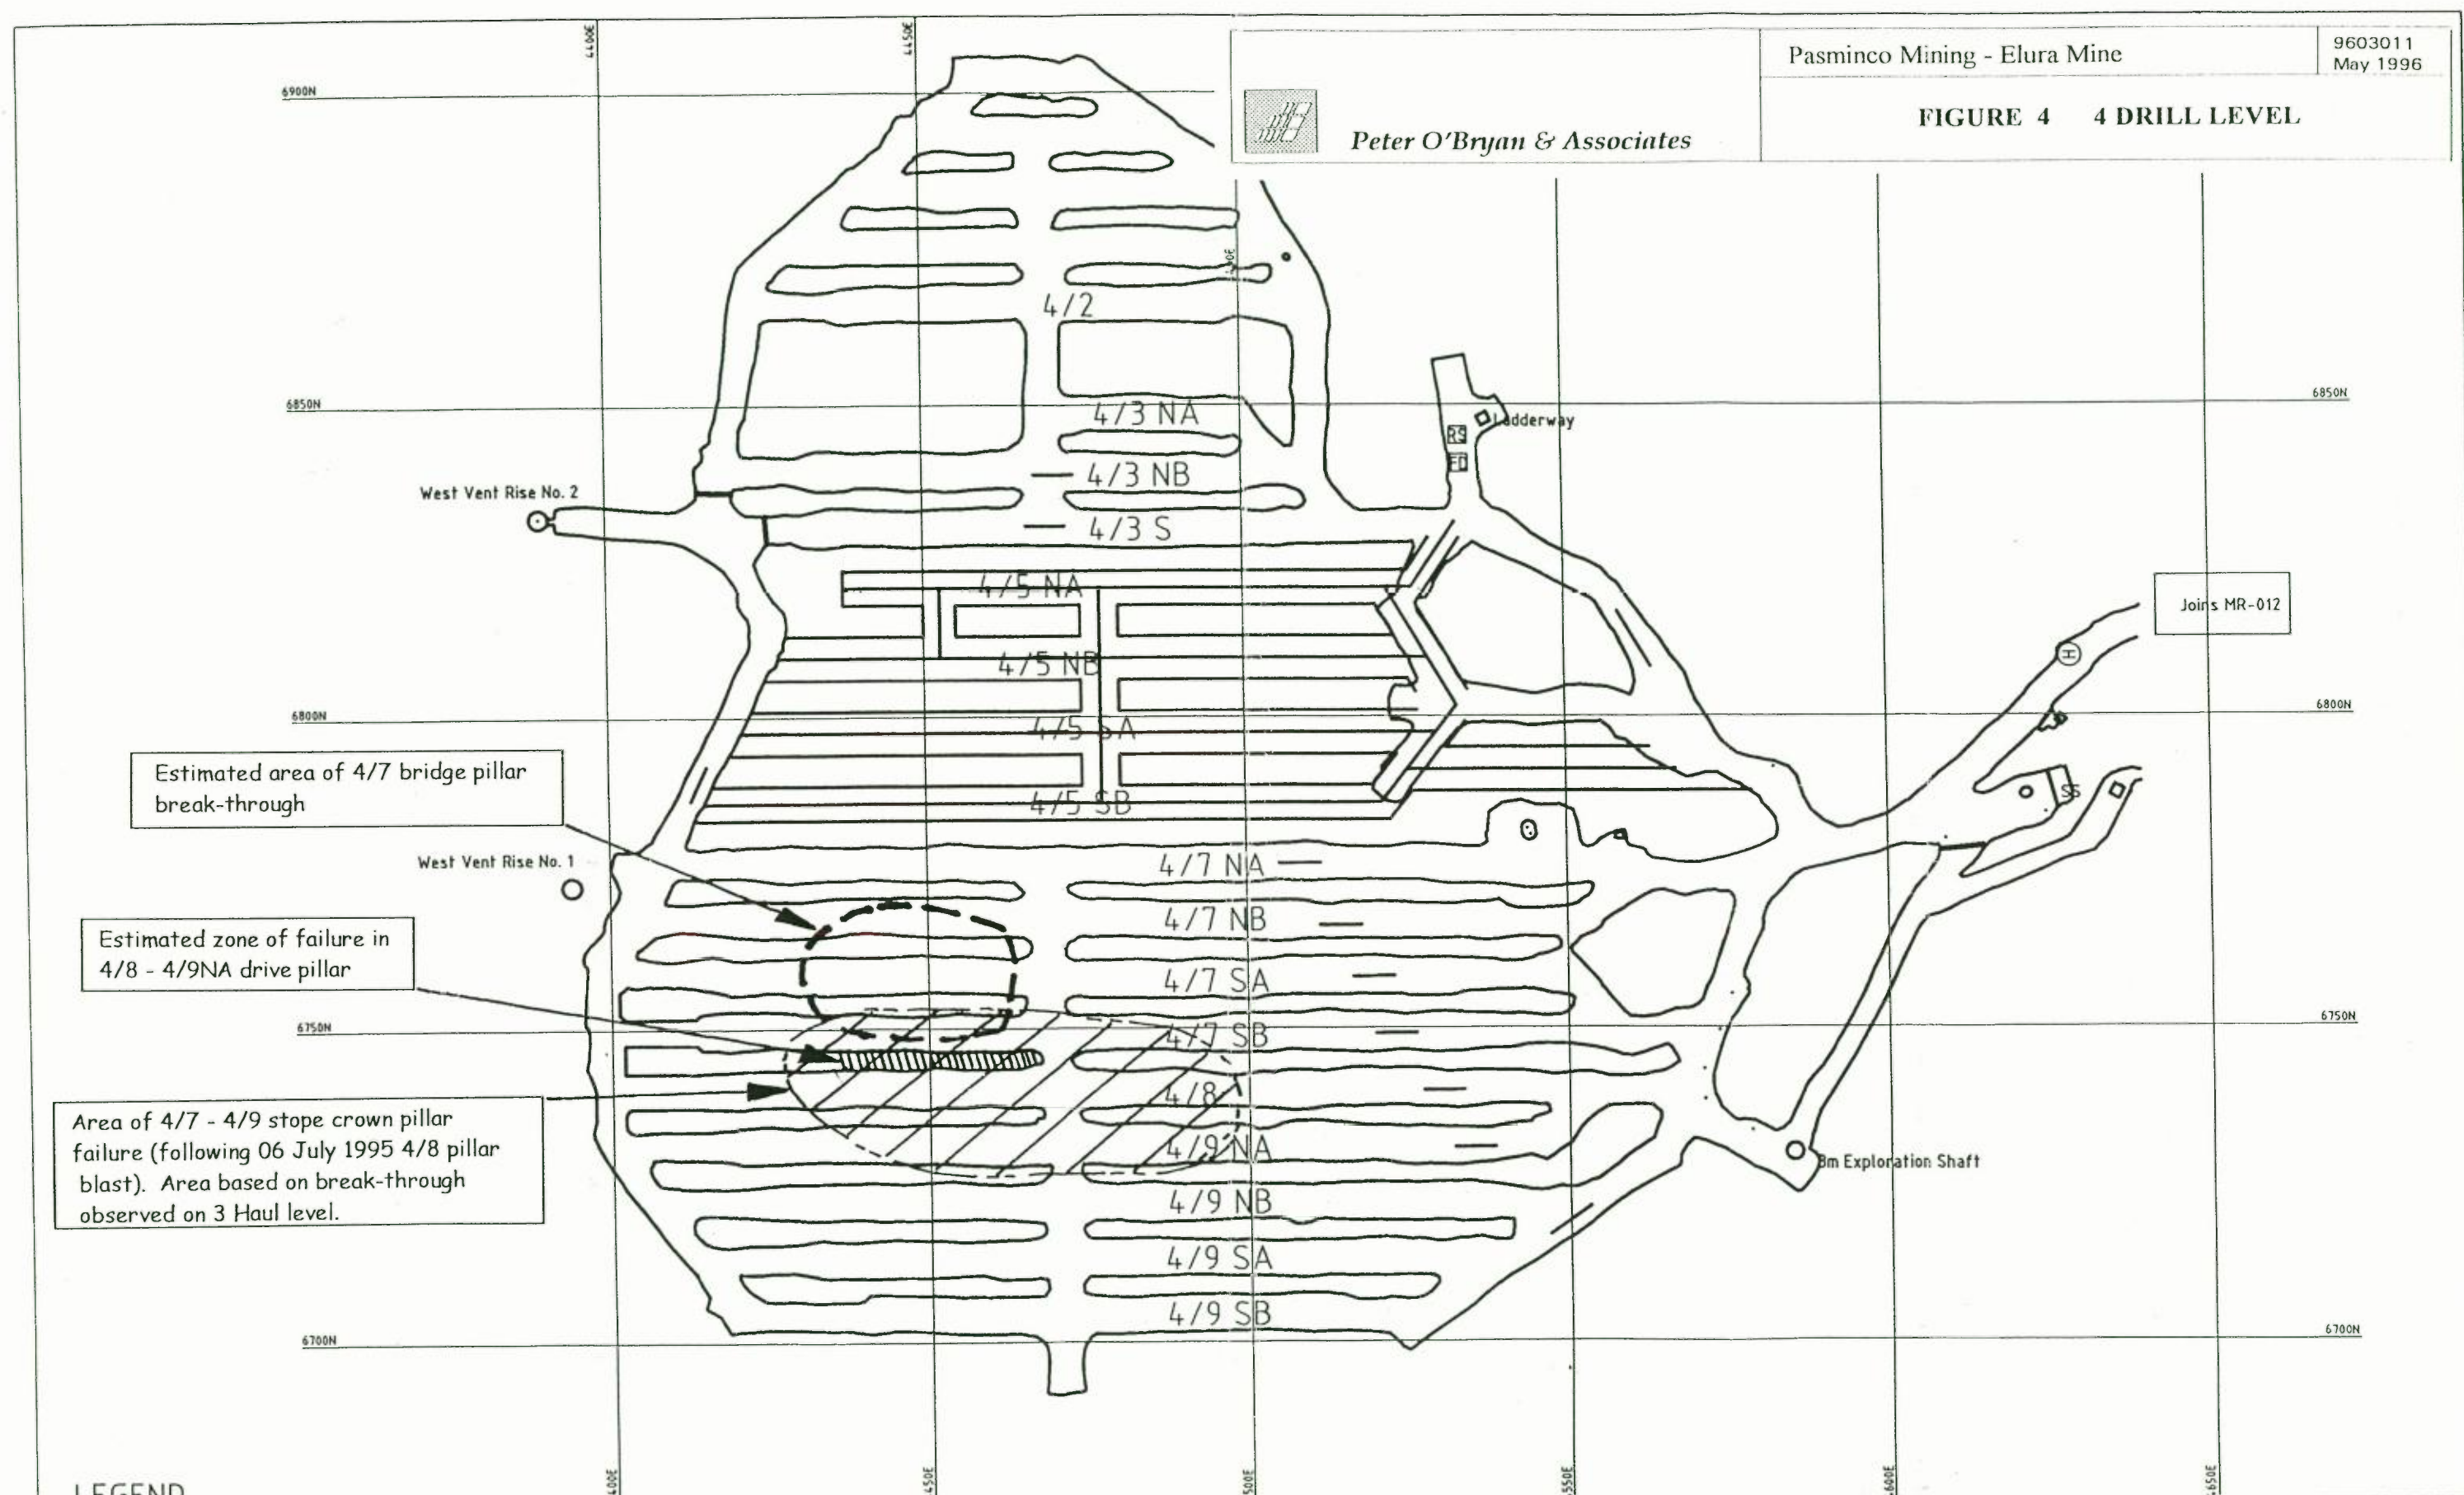
Estimated area of 4/7 bridge pillar break-through

Estimated zone of failure in 4/8 - 4/9NA drive pillar
