The Newcastle earthquake '89 : background, causes, effects,
implications

A publication of the Munich Re
Service Division

The Newcastle earthquake, December 28, 1989 – causes, effects, implications

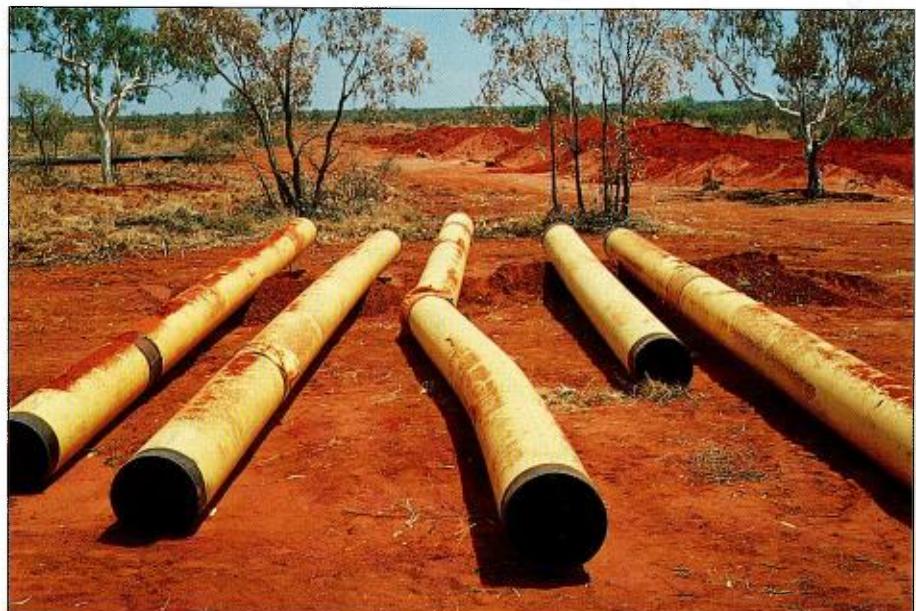
10. Damaged portions of the natural gas pipeline which extends from production fields west of Alice Springs to Darwin. The pipeline was shortened by almost one metre where it crossed the faultline. (Photo by courtesy of K. McCue, Australian Seismological Centre, Bureau of Mineral Resources)

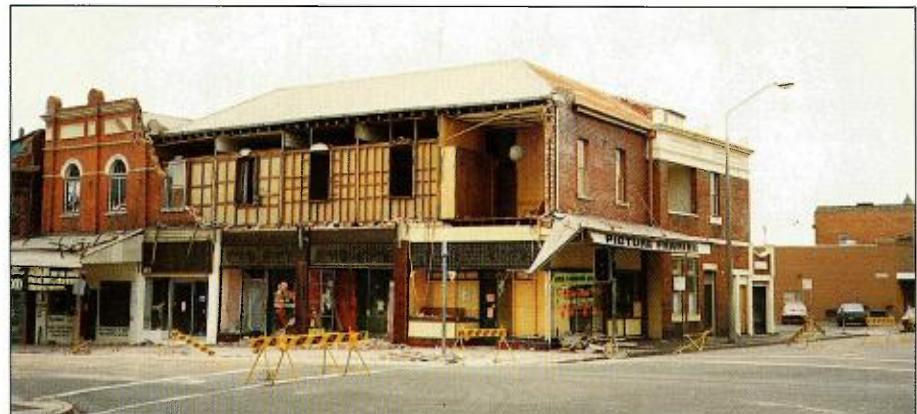
17. Wall failure in an older unreinforced masonry building in Cooks Hill. Failures of this type occurred particularly in walls oriented at right angles to the direction of propagation of seismic waves. (Photograph by courtesy of C. Featherstone)

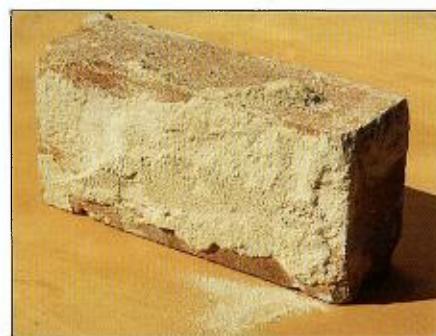
18. In earlier days lime mortar was used extensively in construction in Newcastle and other Australian cities and towns. The low strength of this mortar contributed to many losses. Similar problems with lime mortar were identified after the Adelaide, 1954 and Picton, 1973 earthquakes. (Photograph by courtesy of the GIO (NSW))

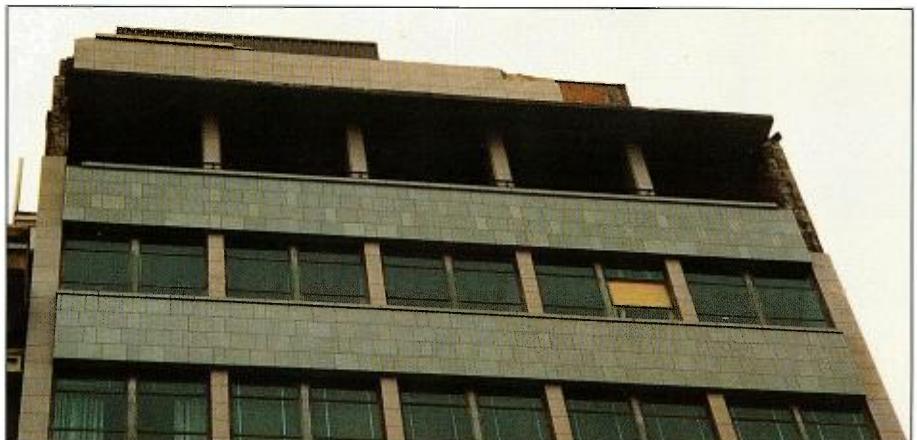
19. The QBE Insurance building. This modern high rise reinforced structure suffered damage to the top floor and part of the parapet, emphasising that damage is concentrated at the top of the building. (Photograph by courtesy of C. Featherstone)

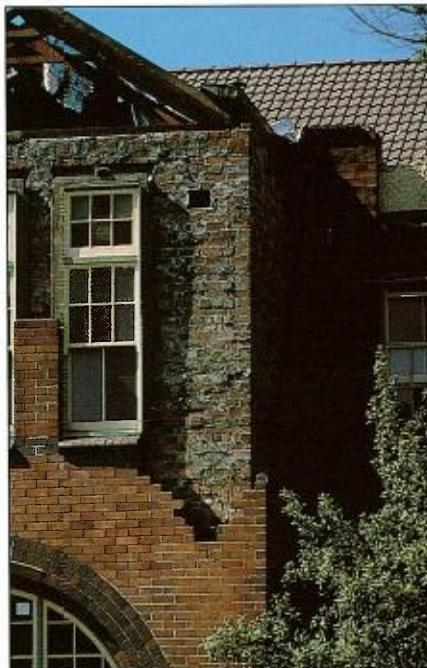
21. Failure of the outer skin of an unreinforced masonry wall at Junction Public School. Such failures were typical of those observed in older masonry buildings (Photograph by courtesy of the GIO (NSW))

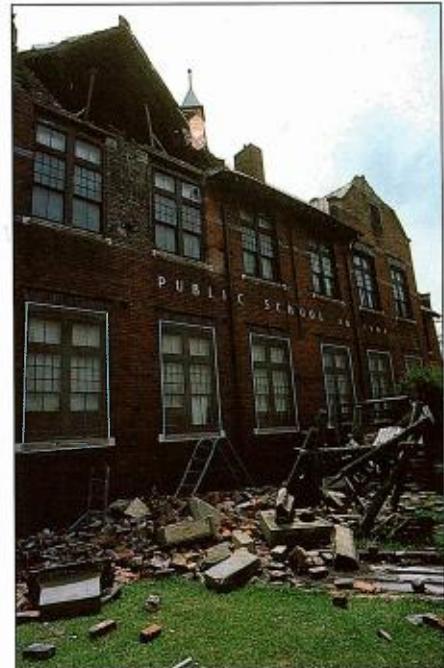
22, 23. The top of this wall at Wickham Public School leans outwards by 7-10 cm. The gable on the front of the building has also been damaged producing large amounts of debris in the school playground. If the earthquake had occurred on a normal school day many children may have been injured. (Photographs by courtesy of the GIO (NSW))

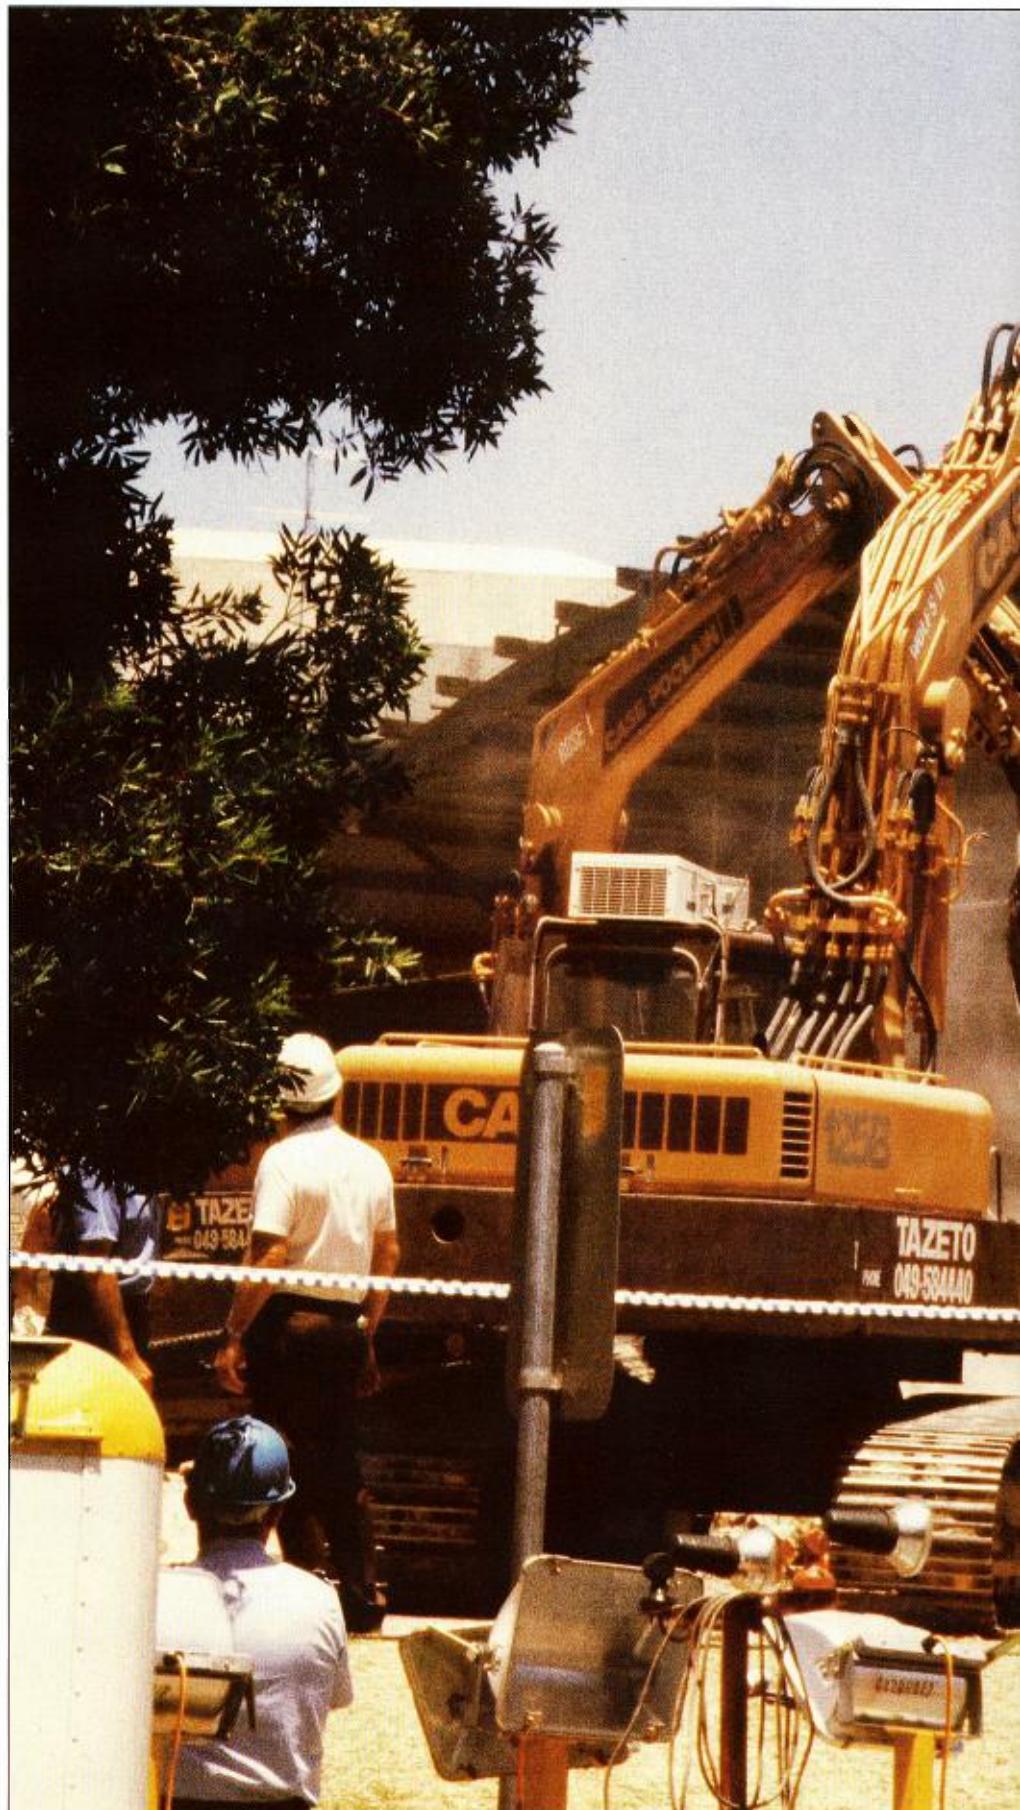
The most dramatic example was the collapse of the Newcastle Workers' Club in which 9 people were killed. The Workers' Club was really two separate buildings, modified several times between 1937 and 1972; an older unreinforced masonry part and a more recent (1972) concrete-framed building which was four storeys tall. The newer section was constructed of concrete slabs supported by concrete columns. The collapse of part of this building is, at the time of publication, the subject of a coronial inquiry.

25. A large section of the Newcastle Workers Club collapsed leading to the deaths of nine people. In the photograph workers tear down a damaged wall that was hampering efforts to get heavy machinery into the Workers Club. (Photograph by courtesy of the Newcastle Morning Herald)

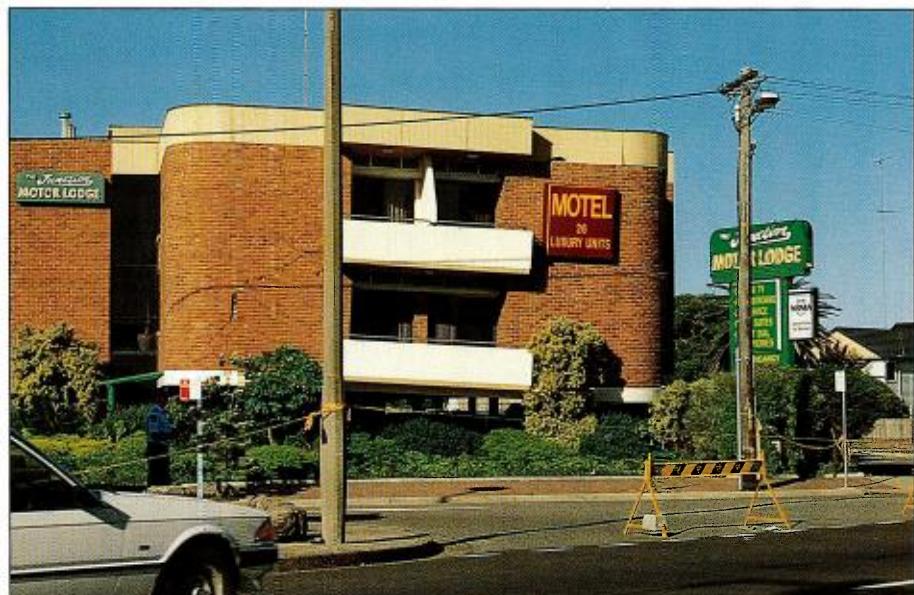
Severe structural damage also occurred to the Junction Motor Lodge, built in about 1980, with a reinforced concrete frame, concrete slab floors and brick infill wall panels above the ground floor level. The building was open at the ground floor level for parking access. The damage to the Junction Motor Lodge was due to local failure of the concrete columns just below the concrete first floor slab at the eastern end resulting in disintegration of the concrete and subsequent buckling of the reinforcement. Structural failures of this type in reinforced concrete frame buildings with limited lateral stiffness at the ground floor level have been quite common in earthquakes elsewhere. Though the Junction Motor Lodge did not collapse it was demolished. Had the upper stories not been unreinforced masonry it is quite possible the building could have been jacked up and restored. It appears that other major structural collapses were confined to older buildings where failure of unreinforced masonry walls occurred. Examples include:

26. Severe cracking of the front wall of the Junction Motor Lodge resulted when local column failure occurred at the right hand (eastern) end of the ground floor carpark. This building was subsequently demolished. (Photograph by courtesy of G. Johnson)

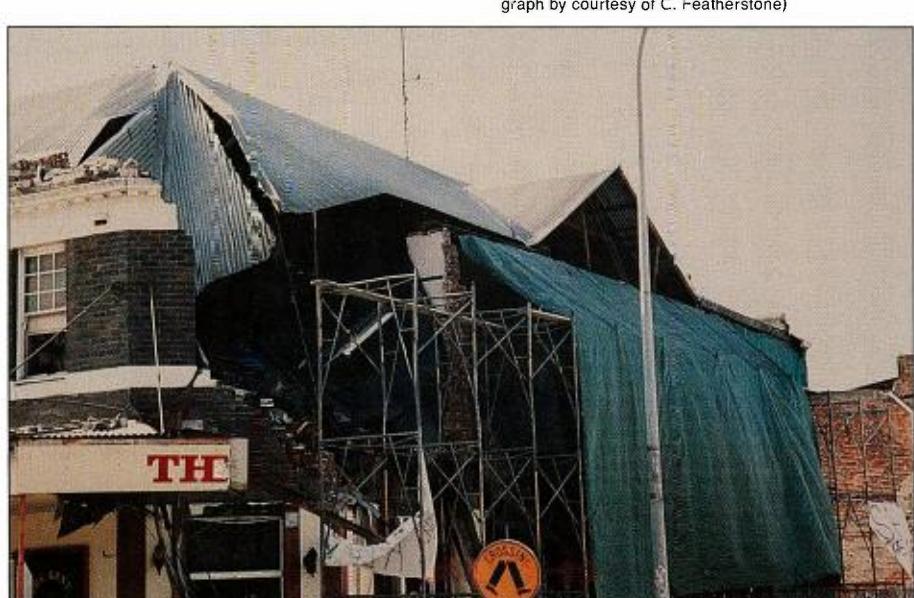
- Kent Hotel, Beaumont Street, Hamilton – an old brick unreinforced masonry building which had undergone substantial architectural renovations in the previous 18 months. Although most of the front of the building fell into the street, evidently more than 20 people inside the hotel escaped unharmed. However, the collapse of the front wall and the awning into Beaumont street killed two people.
- Broadmeadow Hotel – this hotel had also recently undergone substantial non-structural renovations. The building was declared a total loss and demolished.

27. The gable end, parapet and front wall of the Kent Hotel in Beaumont Street, Hamilton fell into the street, demolishing the awning and killing two people. (Photograph by courtesy of C. Featherstone)

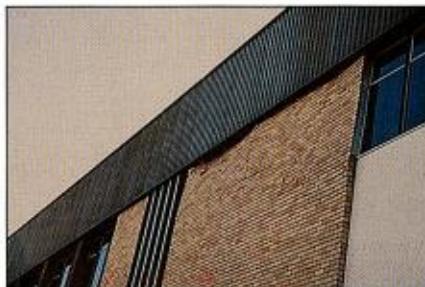
28. Wall failure at the Hamilton R.S.L. Club, a steel-framed building with brick in-fill panels. After the earthquake it was possible to push bricks out from the inside by hand. (Photograph by courtesy of C. Featherstone)

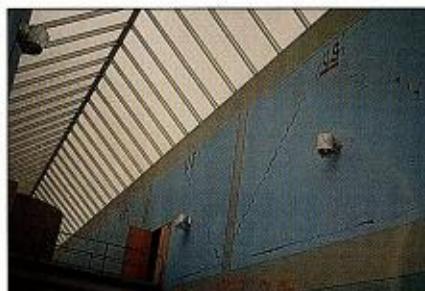
29. Brick in-fill panels at Rankin Park exhibit severe cracking typical of transverse wall failures. The reinforced concrete frame structure of the building was undamaged. "US" written on the walls means "unsafe". (Photograph by courtesy of C. Featherstone)

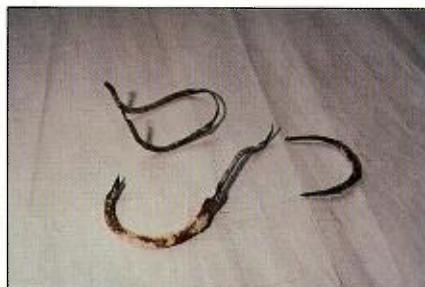
30. The failure of wall ties was a common cause of damage in older buildings in Newcastle. Most wall ties are made of 3.5 mm soft galvanised wire which corrodes readily in coastal environments. (Photograph by courtesy of the GIO (NSW))

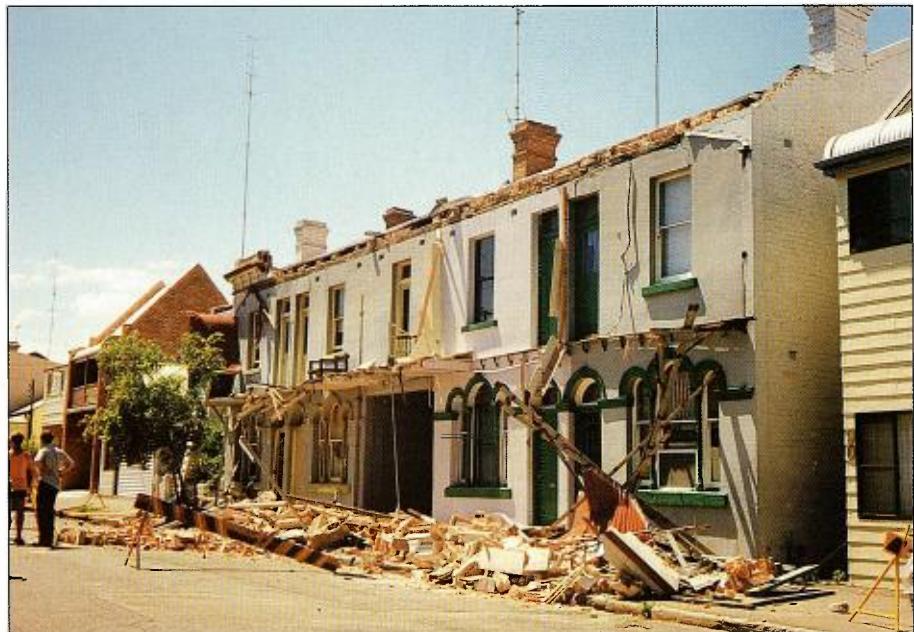
32. Ground motions are greatest at the tops of buildings. Parapets commonly fail because they are poorly supported, producing large amounts of debris in the streets. (Photograph by courtesy of K. Schreiber)

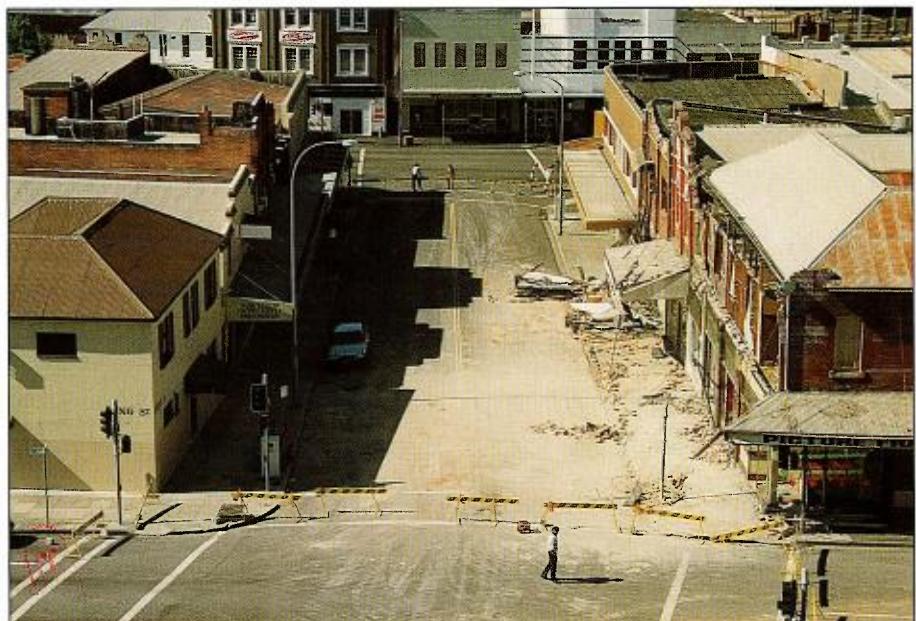
34. Road closures occurred in the Central Business District and in Beaumont Street, Hamilton because facades, awnings and parapets had fallen in some areas and because the structural safety of some buildings was suspect. Street closures, which lasted up to twelve days caused large losses on business interruption policies. (Photograph by courtesy of K. Schreiber)

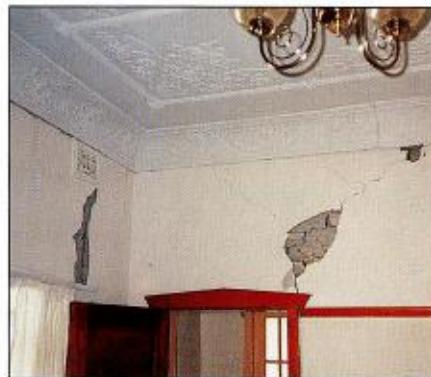
36. Cracking of brick and plasterwork in a typical older unreinforced masonry residence in the suburb of Merewether. While often not serious, such damage can be expensive to repair. (Photograph by courtesy of C. Featherstone)

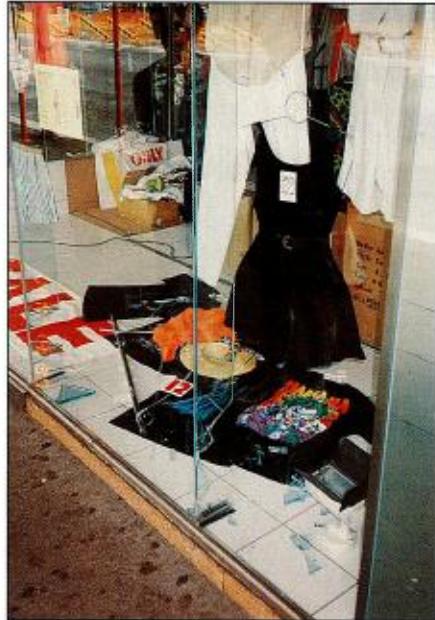
35. Window glass broke in several shop fronts in Hunter Street during the earthquake. In other cases, rubber seals holding windows in place worked loose, necessitating removal of the glass in order to make repairs. (Photograph by courtesy of C. Featherstone)

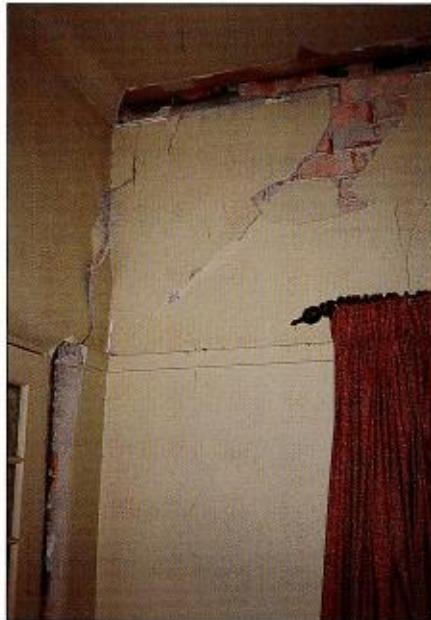
37. Numerous homes suffered minor damage. Typically unreinforced masonry walls moved, cracking plaster. Fallen cornices were a common form of damage. (Photograph by courtesy of C. Featherstone)

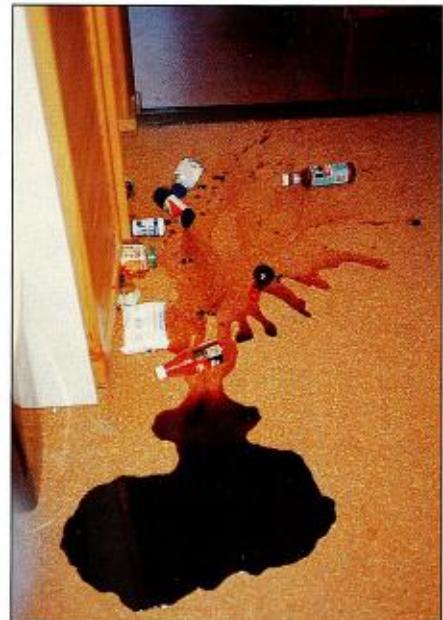
38. In many cases, damage to contents in homes was limited to that caused by bottles and books falling from shelves. Insurance claims for such damage were generally very limited with typical household contents claims being only a few hundred dollars. (Photograph by courtesy of K. Schreiber)

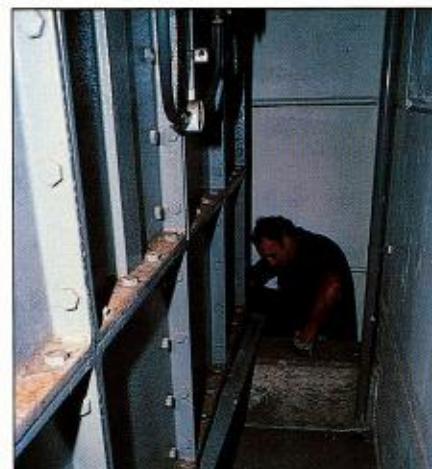
41, 42. The water tank at the Police Centre which was displaced during the earthquake. The tank had to be emptied before it could be moved back into position. The water tank moved only a few mm but relocation was expensive for the insurer. Simple measures could have prevented movement. (Photograph by courtesy of the GIO (NSW))

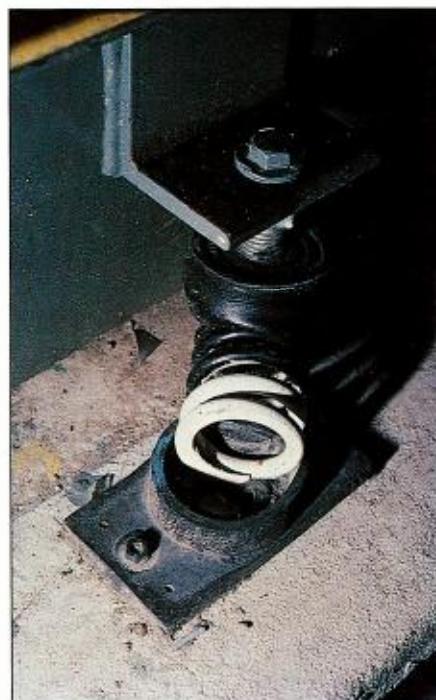
43. A typical displaced mounting. (Photograph by courtesy of the GIO (NSW))

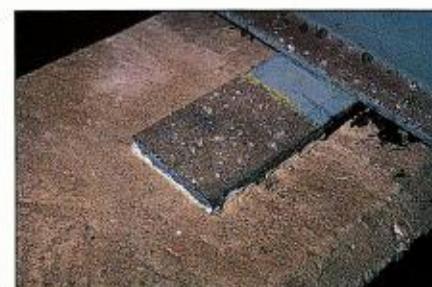
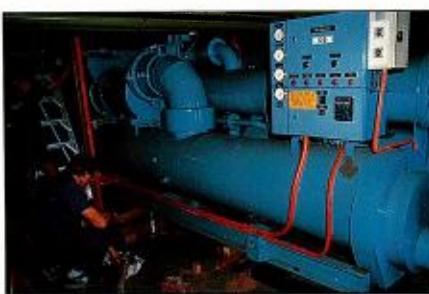
40. This airconditioning unit, on the top floor of a modern building moved off its mounting during the earthquake. The workmen are using hydraulic jacks to move the unit back into position. (Photograph by courtesy of C. Featherstone)
