Inspection Report

111 Newport Rd, Dora Creek, NSW, 2264

Inspection Date: 13 Jan 2025

Pest And Building Inspection

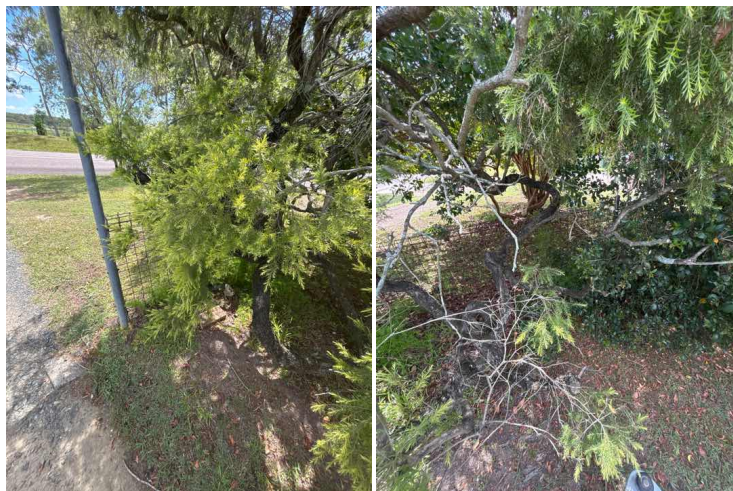
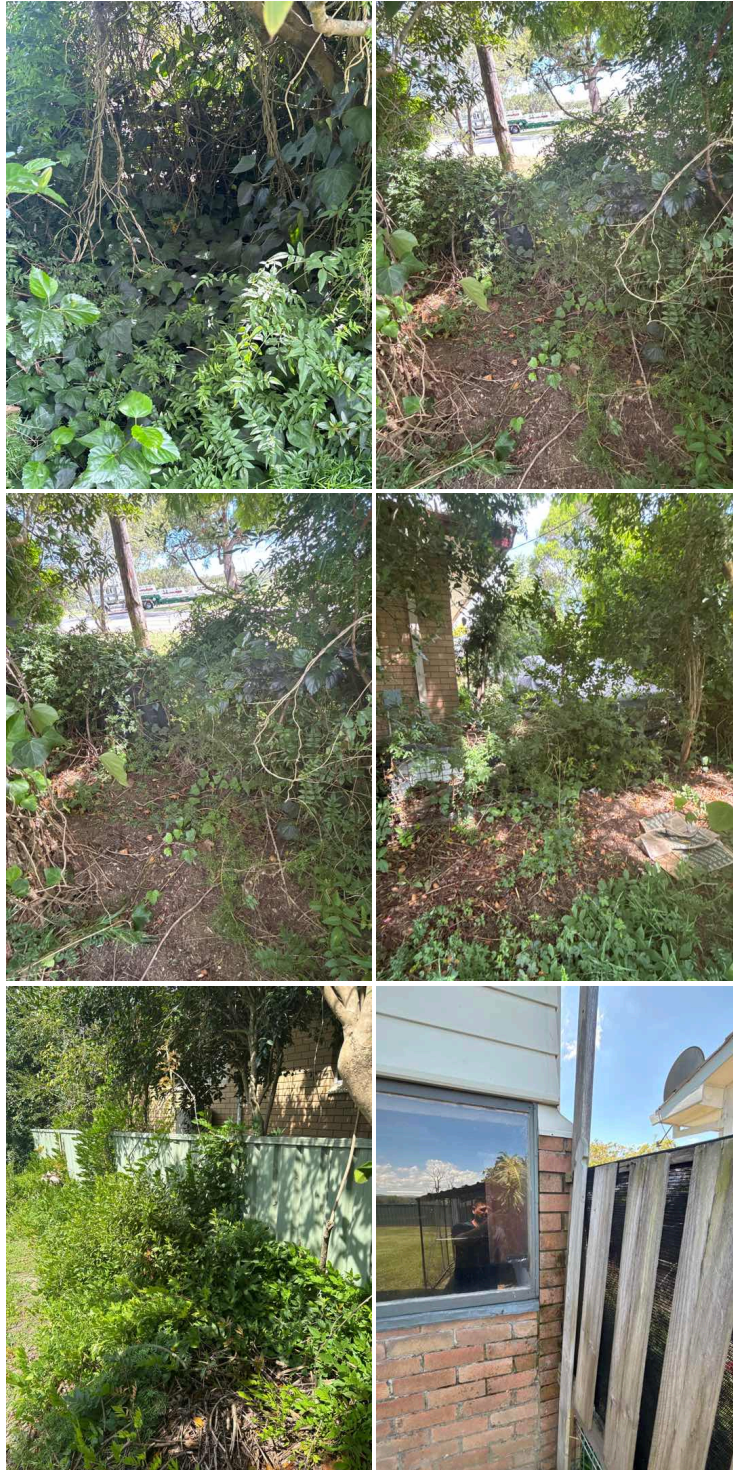
Overall Condition

The visible sections of fencing and components had some general age deterioration (e.g. corrosion, leaning). There was also decay in timber screening. Recommend general maintenance and repair as necessary by a suitably qualified tradesperson.

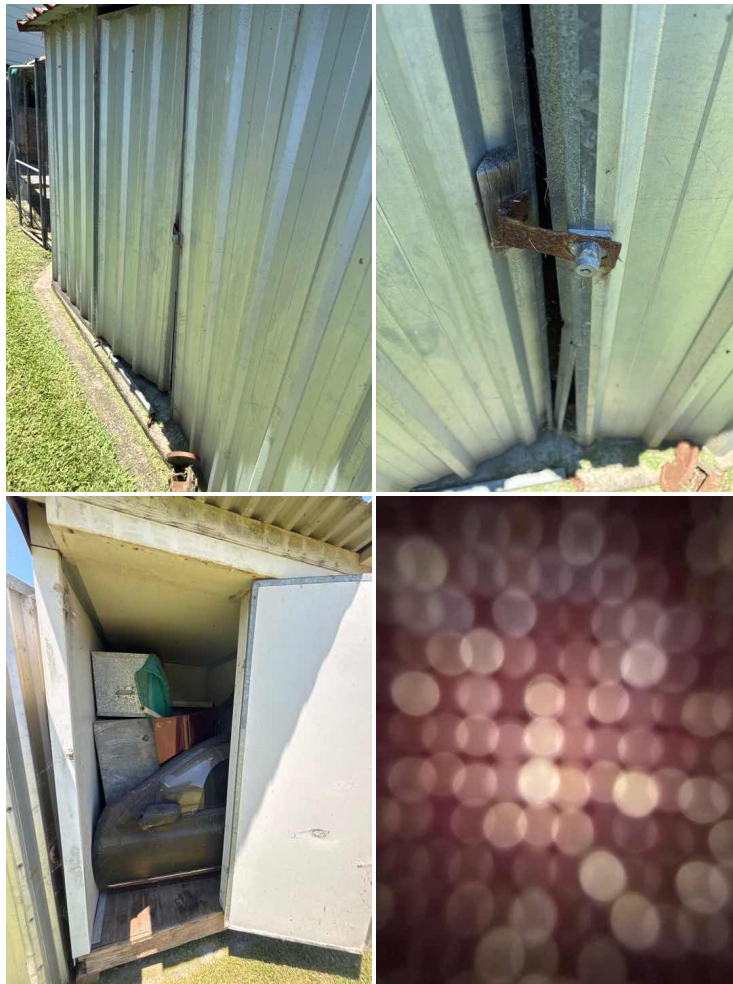
Shed Condition

The sheds had some deterioration and damage and require repair. These include but are not limited to: deterioration in floors / supporting substructure, wall damage, doors and frames; deterioration to the roof frame and cladding.

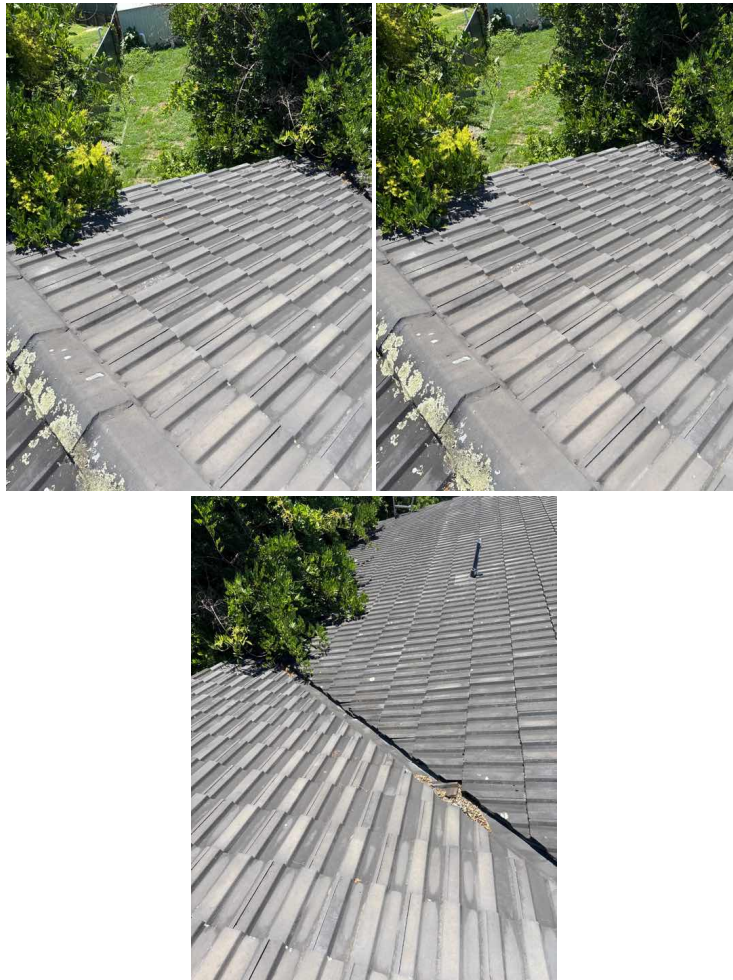
Roof Clad Condition

Visible section of The roof cladding appeared to have been painted or restored previously. However, there were still a relatively small number of cracked (particularly to overlocks) and dislodged (particularly near valleys) tiles. Recommend repair as necessary by a suitably qualified tradesperson.

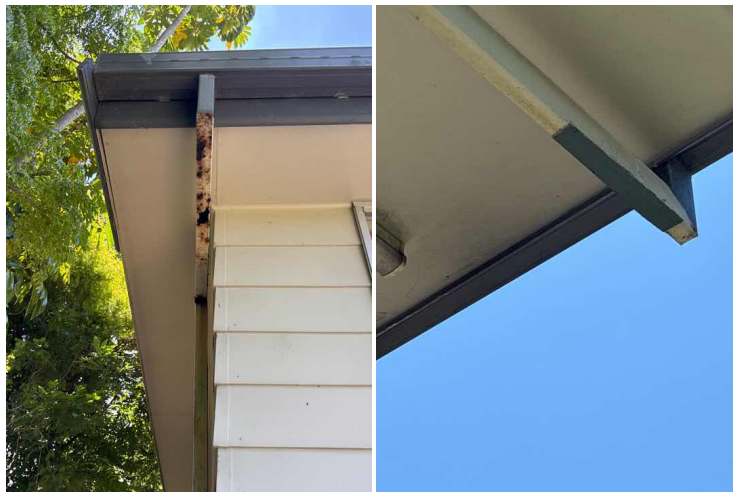
Rust penetrations observed within down pipe/s. Over time this has potential to cause differential settlement to the footings, rising damp, and is also conducive to termite infestation. A licensed plumber should be engaged for advice and recommendations.

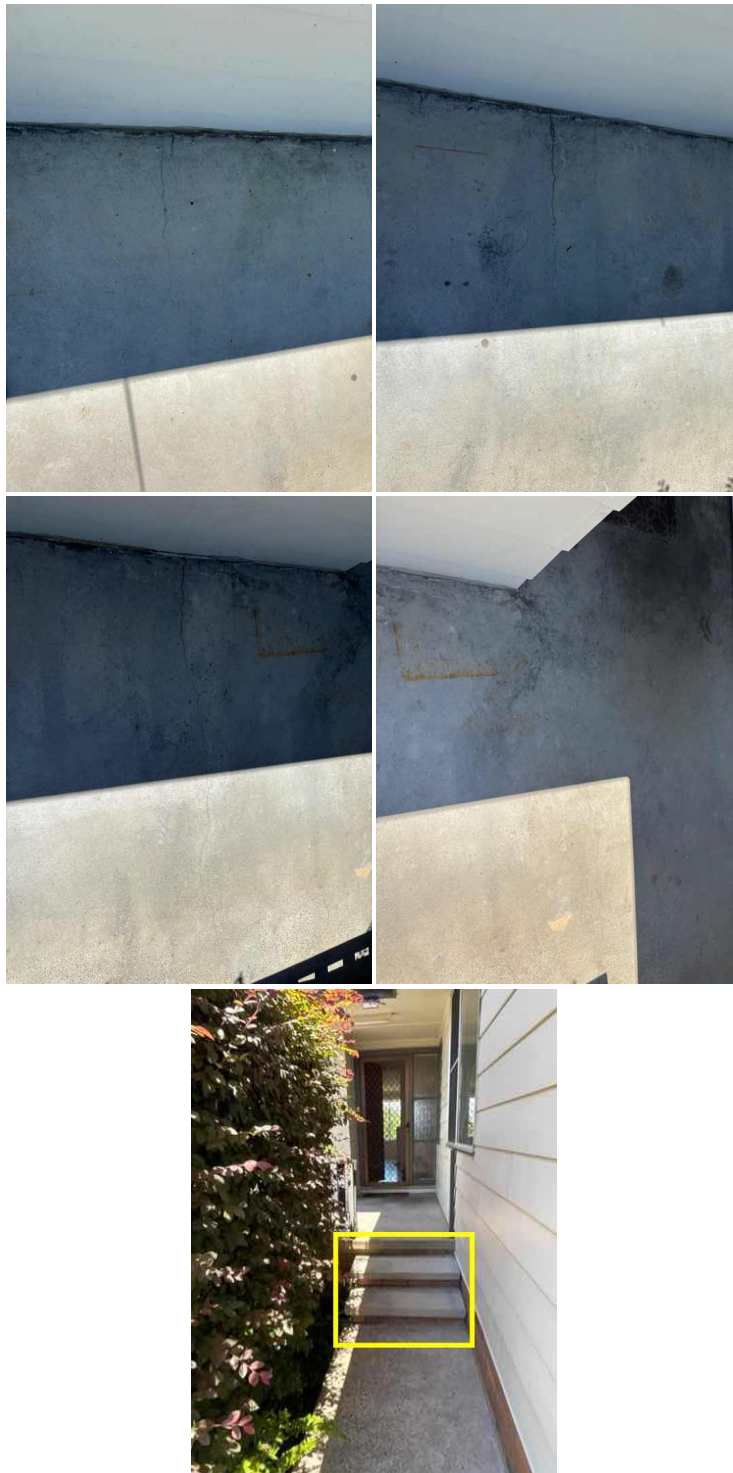
Base or Flooring Condition

Typical concrete cracks evident. These are typical for the age.

Some treads to the entry porch were poorly fixed / loose. Recommend repair as necessary by a suitably qualified tradesperson.

Please note: Whilst these cracks appeared to be minor and typical at the time of inspection, we recommend you monitor these cracks and if worsening occurs contact a qualified concreter for repairs.

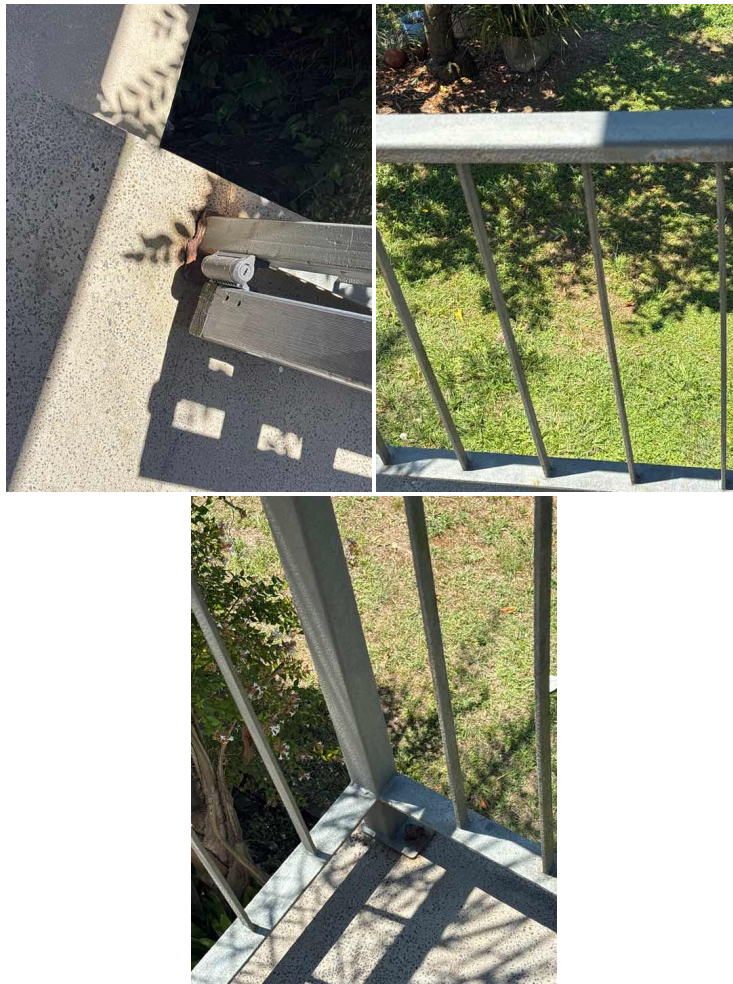
Walls / Screening Condition

There was deterioration / rust in the balustrades. There was also evidence of repair, however the works did not appear to be done in a tradesperson like manner. Recommend repair as necessary by a suitably qualified tradesperson.

Baluster rail height should be 1 m in height from deck/balcony/patio floor. In some circumstances this regulation was non-existent dependent on the age of the dwelling and technically there is no requirement to rectify. We strongly advise you rectify to comply for safety concerns.

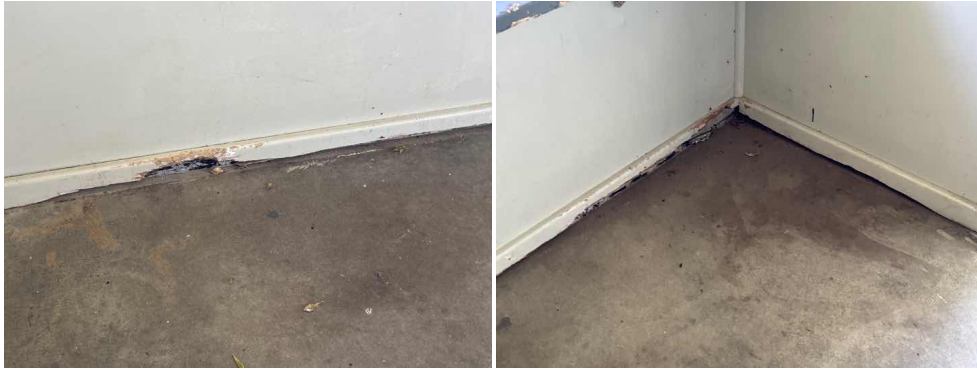
Walls / Screening Condition

Skirting boards were damaged / deteriorated in areas. Recommend repair as necessary by a suitably qualified tradesperson.

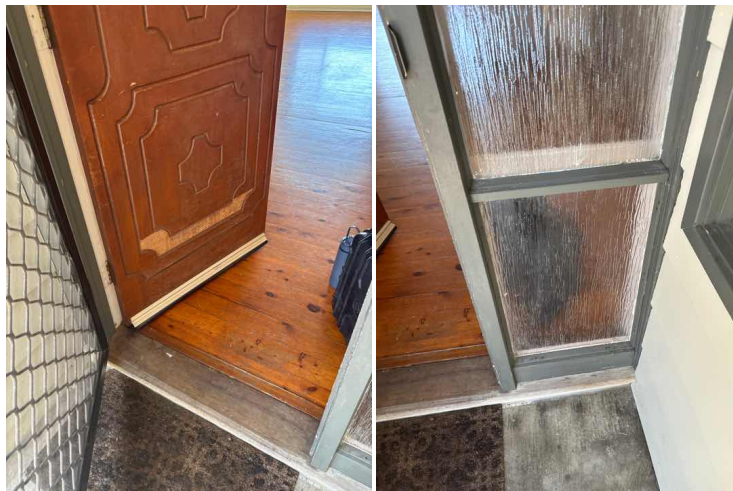
Door Findings - Front

The front entry door is weathered and deteriorated. Recommend repair or replacement as necessary by a suitably qualified tradesperson.

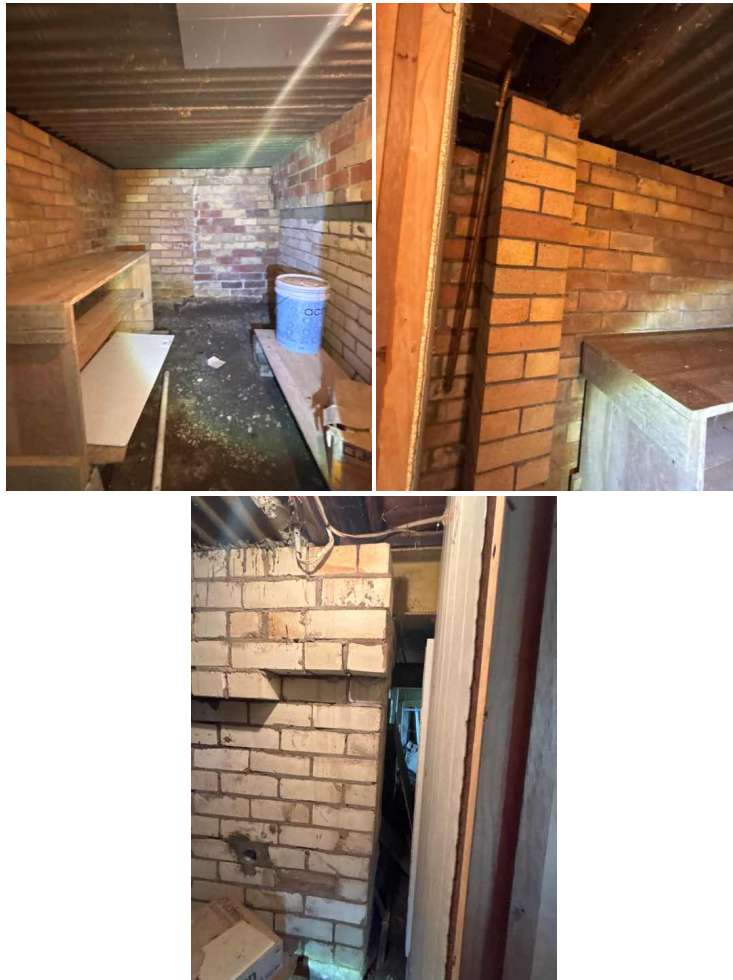
Door Findings

The personnel / rear access door requires repair or replacement (e.g. notable deterioration). Recommend repair or replacement as necessary by a suitably qualified tradesperson.

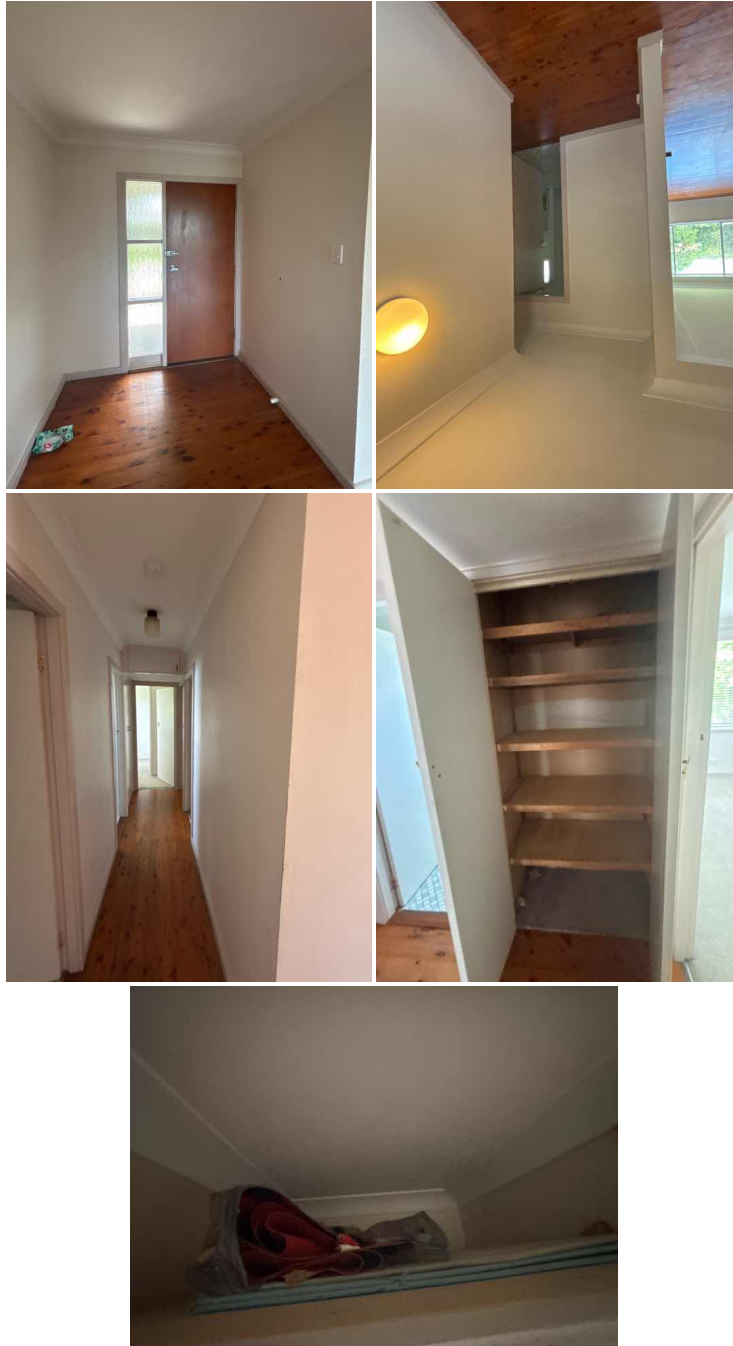
Ceiling

Settlement / movement cracks observed. These are typical and generally patch and paint will suffice, however monitoring these cracks is advised for 12 months and if they become worse, further investigation by a suitably qualified professional is advised.

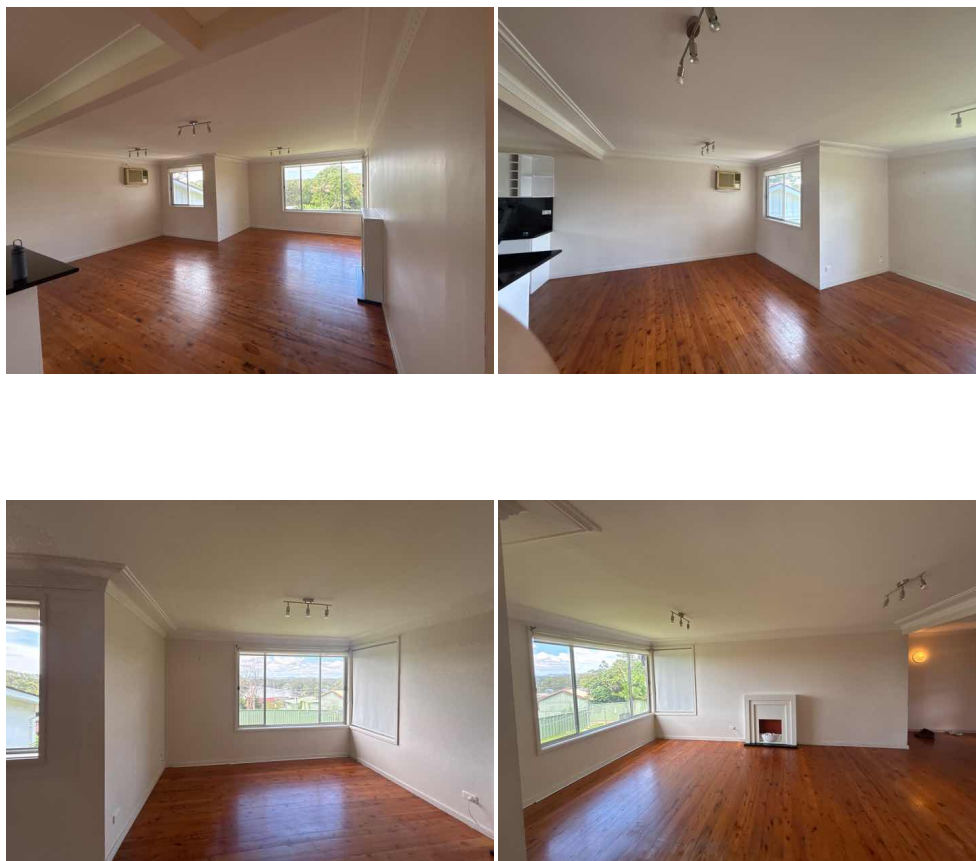
There was deviation and damage to the ceiling and cornices. Recommend repair as necessary by a suitably qualified tradesperson. Please refer to the roof void section of this report for further information regarding the roof frame and observations.

Ceiling stains observed, with elevated moisture readings obtained. In the absence of rain It's difficult to ascertain with certainty the location of the leak. A qualified roofer should be engaged to further evaluate the roof and all water damaged materials repaired or replaced as necessary by a suitably qualified tradesperson.

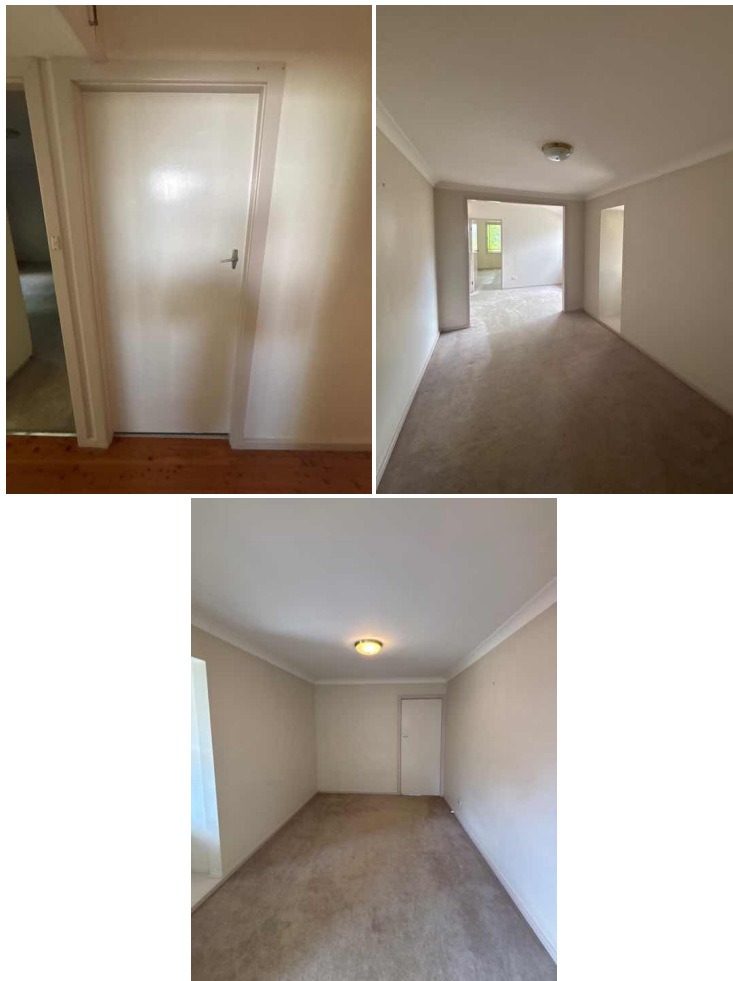
Ceiling

There was evidence of leaking from the roof. The areas were tested with electronic impedance moisture testing equipment and / or thermal imaging and found to be dry (consistent with other areas / linings) at the time of inspection. Recommend repair as necessary to deteriorated damaged materials by a suitably qualified tradesperson and monitoring for further issues.

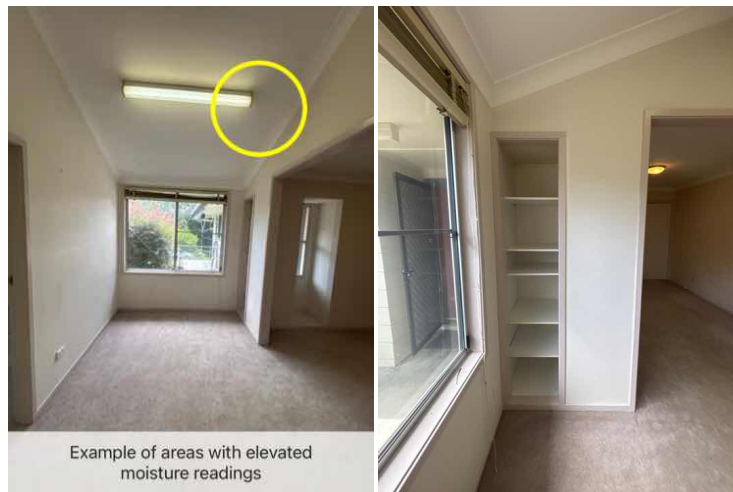
General age and wear deterioration (e.g. dings, marks, scuffs, and the like) in ceiling linings and cornices. Recommend a suitably qualified tradesperson be engaged for general maintenance and repair as necessary (e.g. patch and paint).

Ceiling stains observed, with elevated moisture readings obtained. In the absence of rain It's difficult to ascertain with certainty the location of the leak. A qualified roofer should be engaged to further evaluate the roof and all water damaged materials repaired or replaced as necessary by a suitably qualified tradesperson.

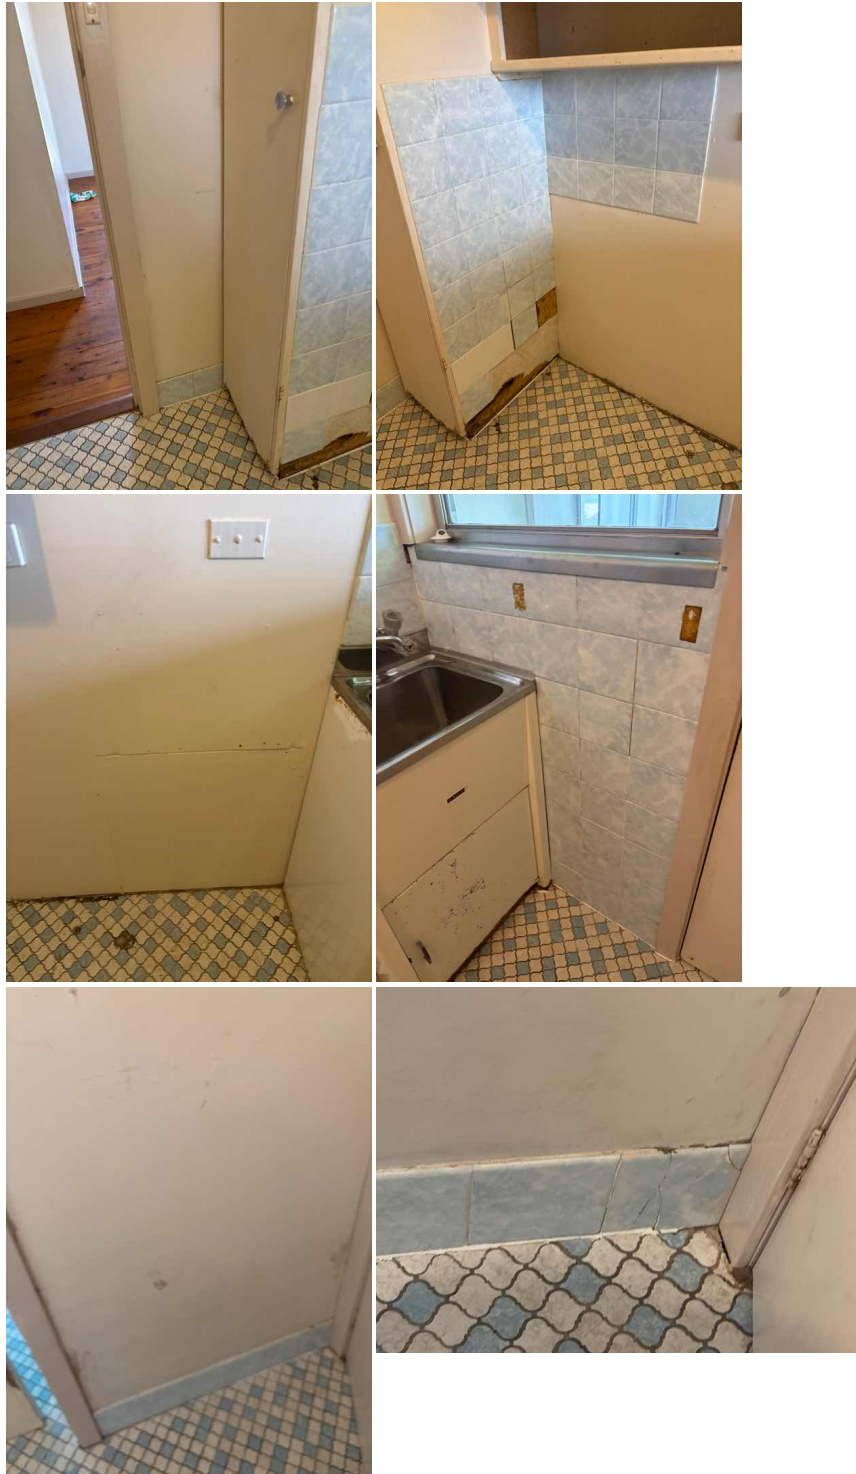
Taps and Sink

There was rust deterioration in the basin cabinet. Recommend repair or replacement as necessary by a suitable qualified tradesperson.

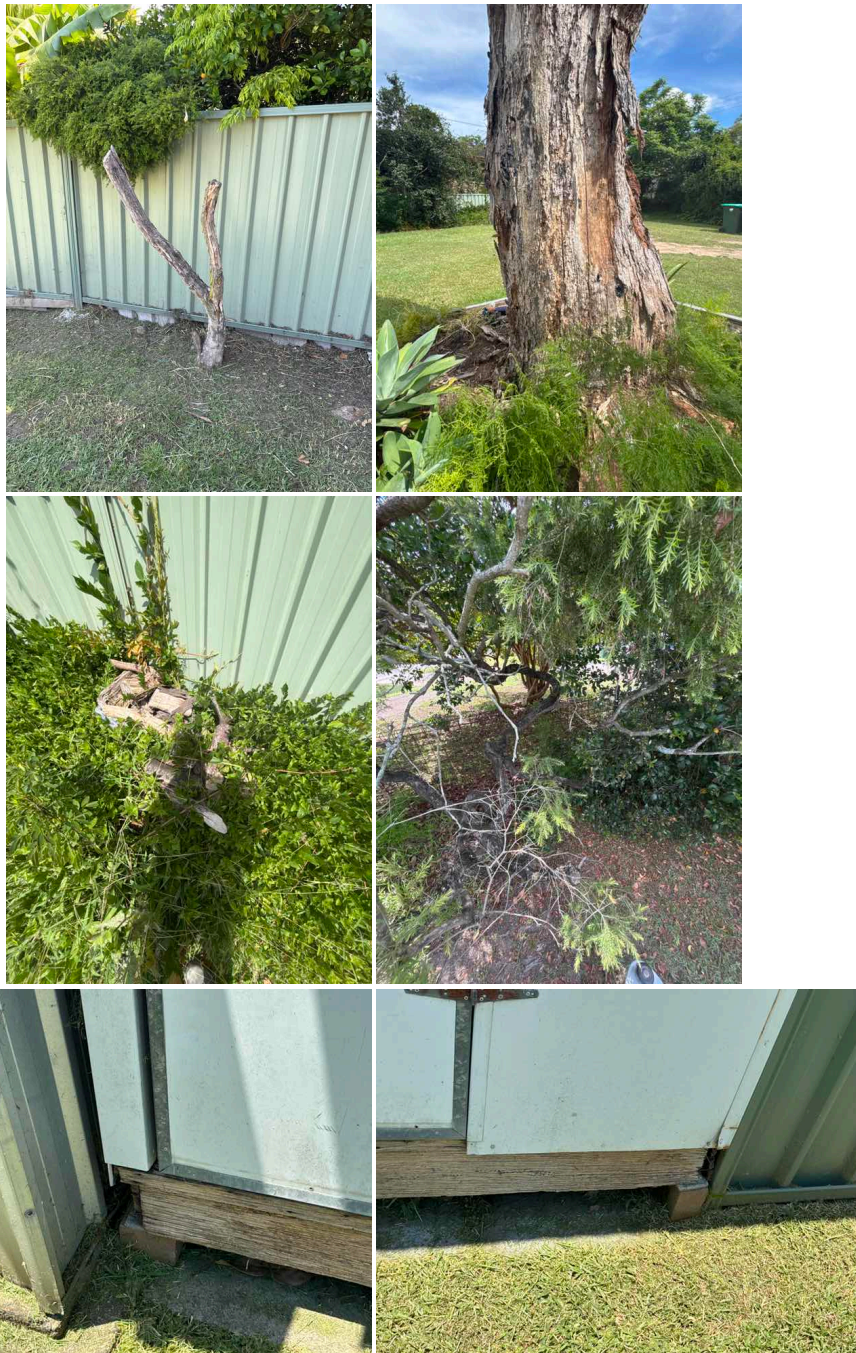
Timber fire wood, limbs, and off cuts in contact with ground. This provides conducive and concealed entry conditions and concealed entry for termite infestation. Remove and store above ground surface.
