# Inspection Report

**Inspectrite Australia Pty Ltd**

**4 Celestial Dr, Morisset Park, 2264**

### Pest And Building Inspection

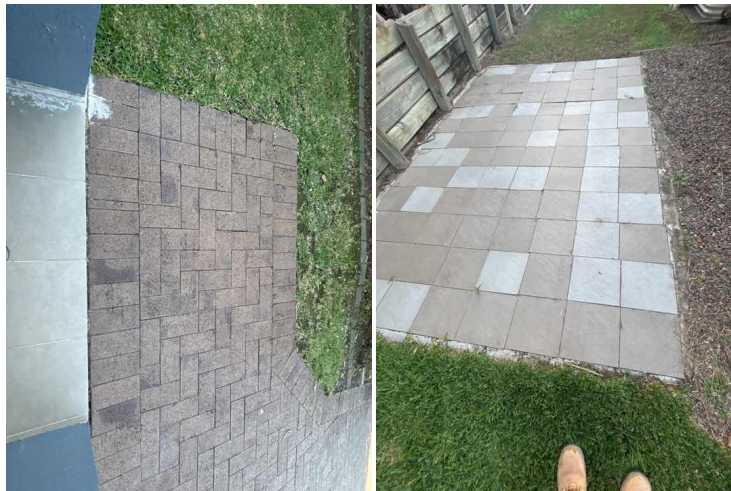
Surface raised and settled, loose laid in some areas (e.g. near the corners line). This can cause water ponding. Repair or relaying is recommended.

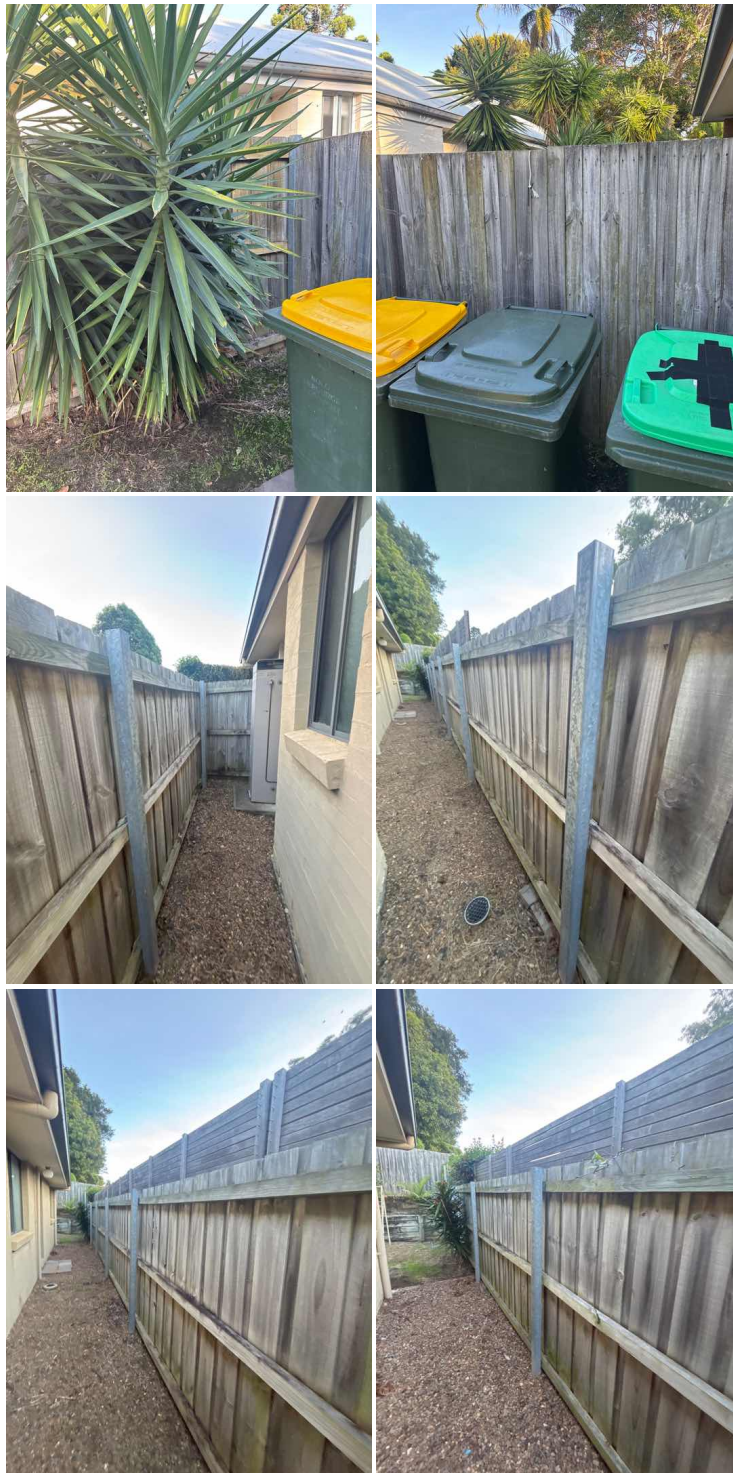
The fences and components had some general age deterioration / weathering and damage. Recommend general maintenance and repair as necessary by a suitably qualified tradesperson.

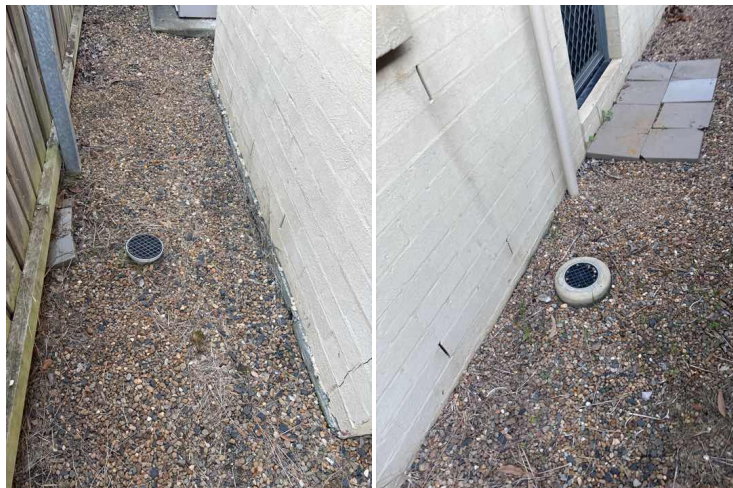
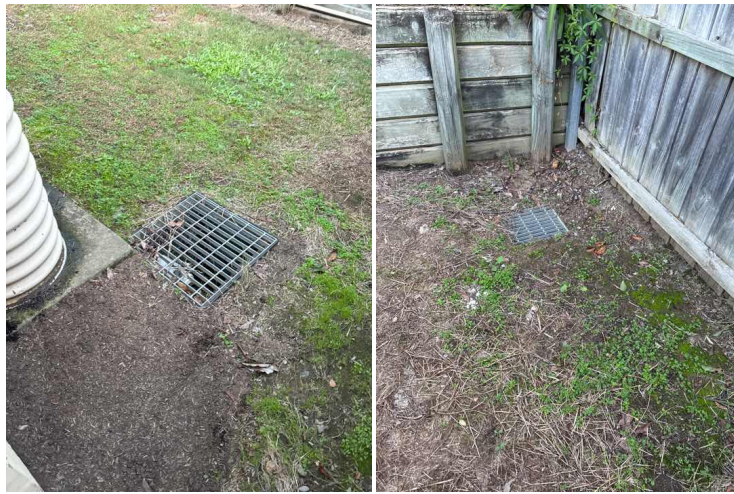
Some yard gullies / drains require repair for proper function (e.g. above finished ground level) by a licensed plumber.

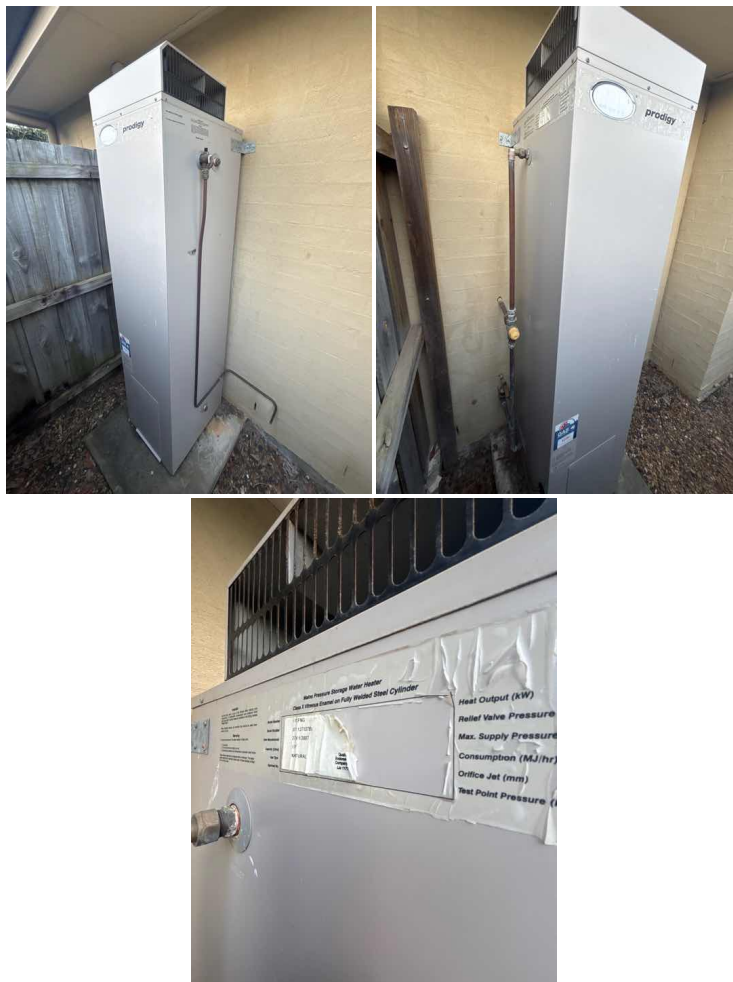
The hot water overflow requires diverting to a drain or further from the dwellings wall or footings. Excess water ponding alongside walls and into perimeter footings has the potential to cause rising damp, differential settlement and wall cracks over time. It is also conducive to termite infestation. Recommendations: Engage a plumber to rectify.

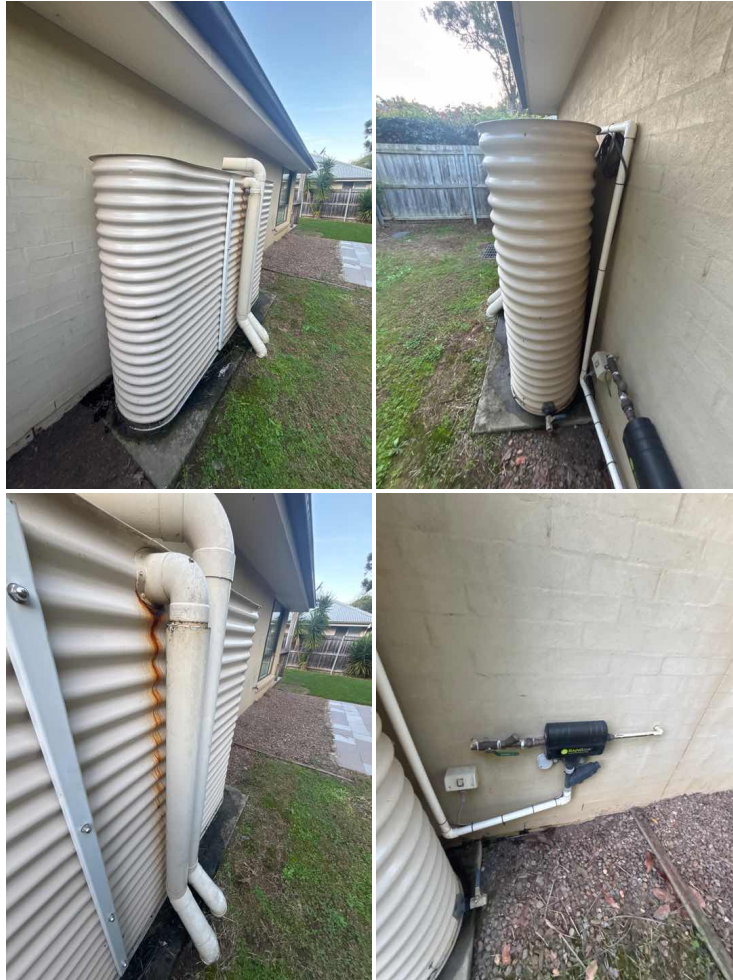
The overflow connection was leaking. Recommend repair as necessary by a licensed plumber.

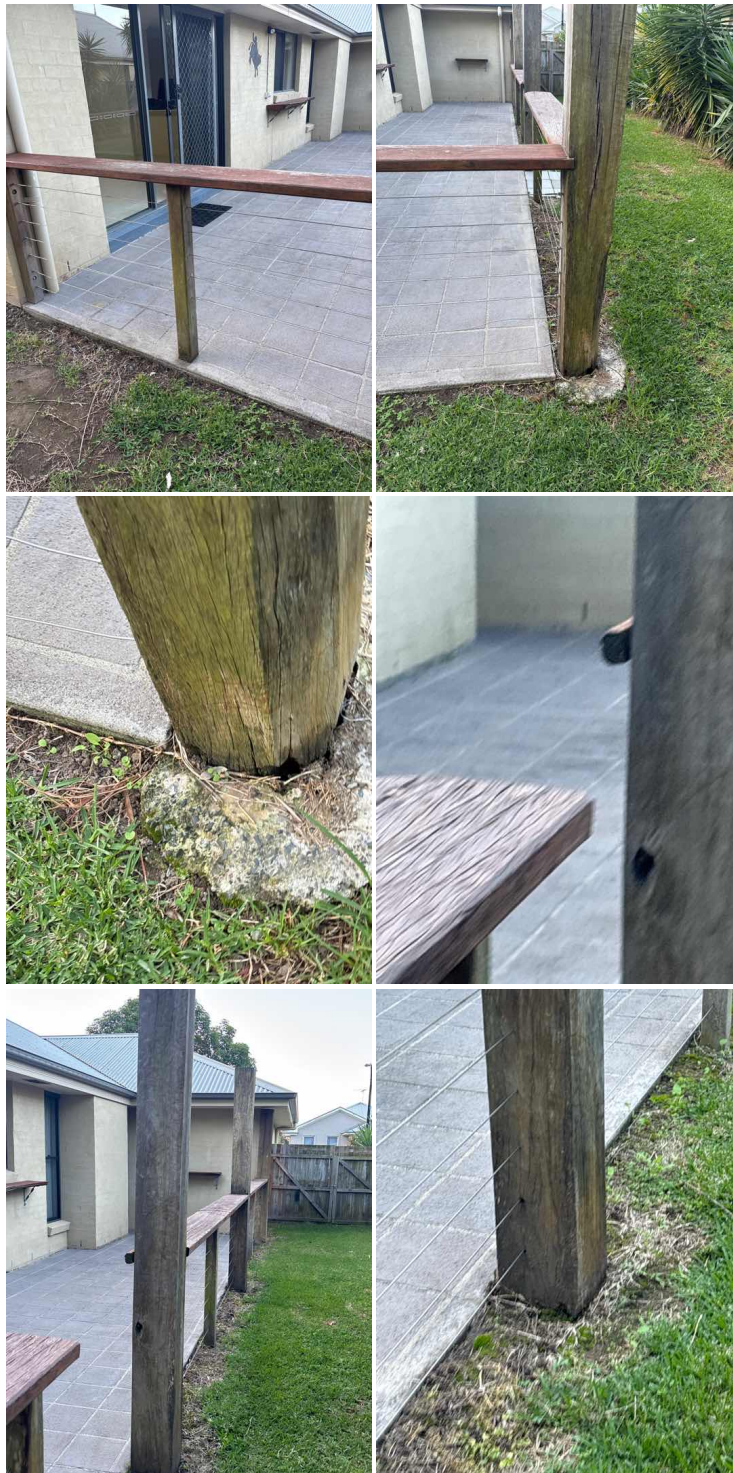
Post and balustrades had timber fungal decay. Recommend repair as necessary by a suitably qualified tradesperson. It is preferable to keep posts out of contact with ground soil due to decay and also being conducive to timber pest infestation.

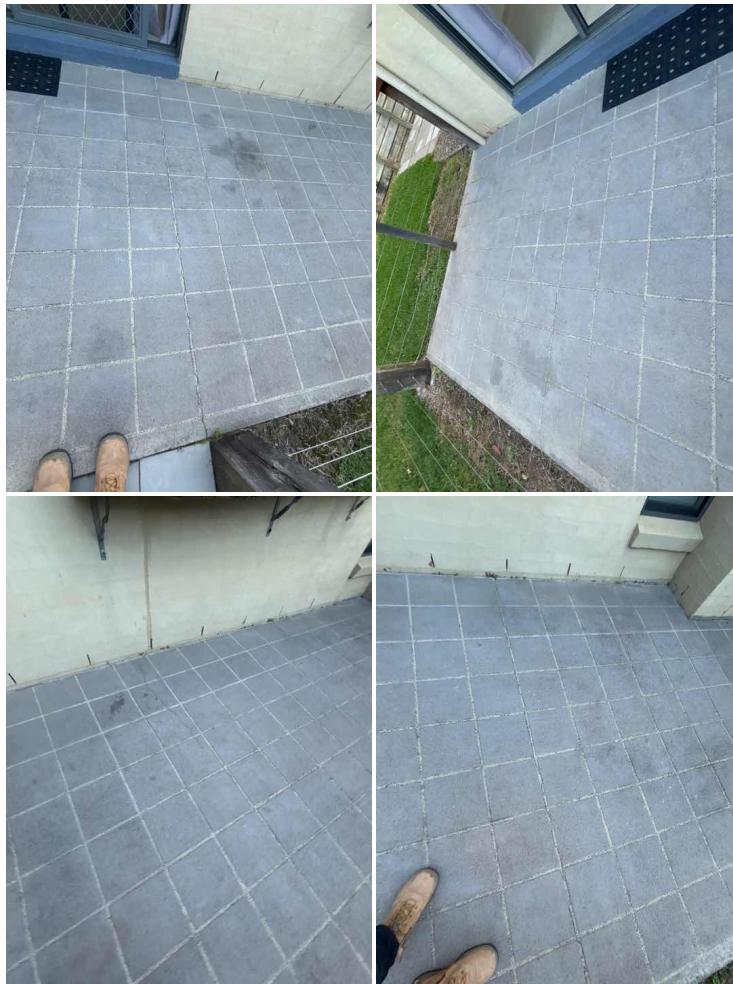
Typical concrete cracks evident. These are typical for the age.

Please note: Whilst these cracks appeared to be minor and typical at the time of inspection, we recommend you monitor these cracks and if worsening occurs contact a qualified concreter for repairs.

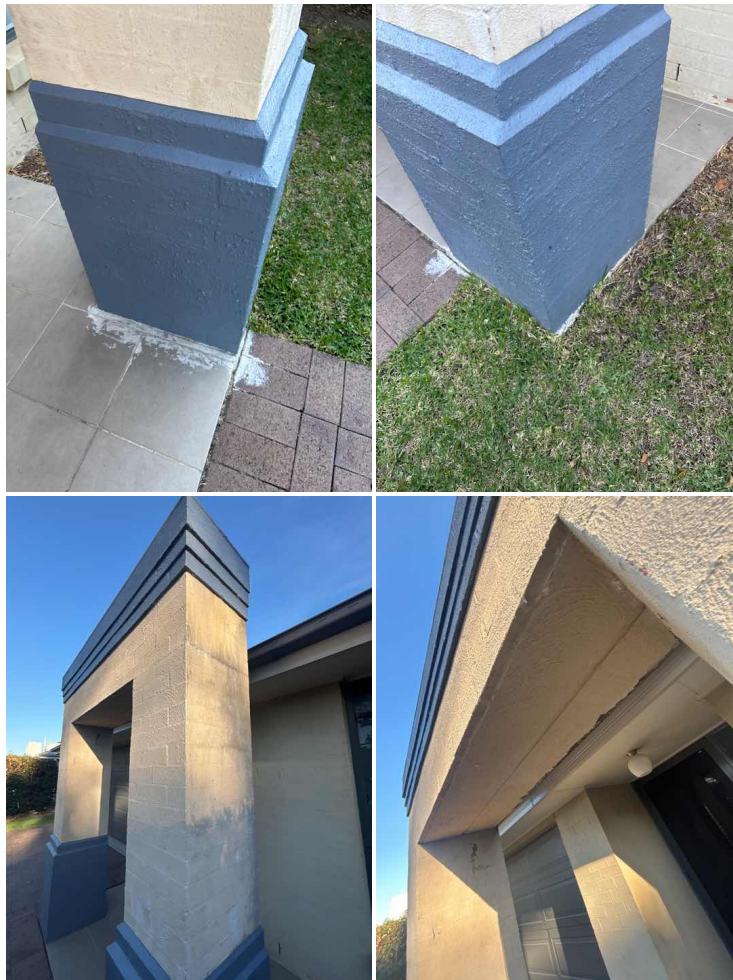
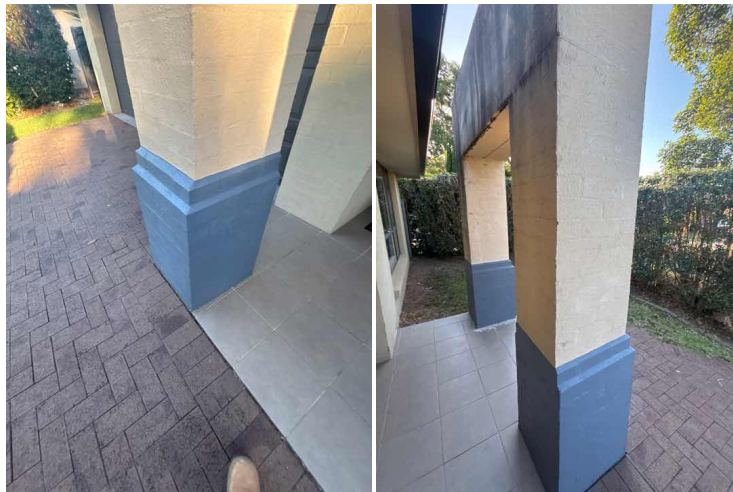
There was deterioration, staining, and bubbling in the render / bagged finish of the columns and facade. The issue appeared generally superficial, however monitoring is strongly encouraged and there may be some further issues to the masonry beneath the finish. Recommend repairs necessary by a suitably qualified tradesperson.

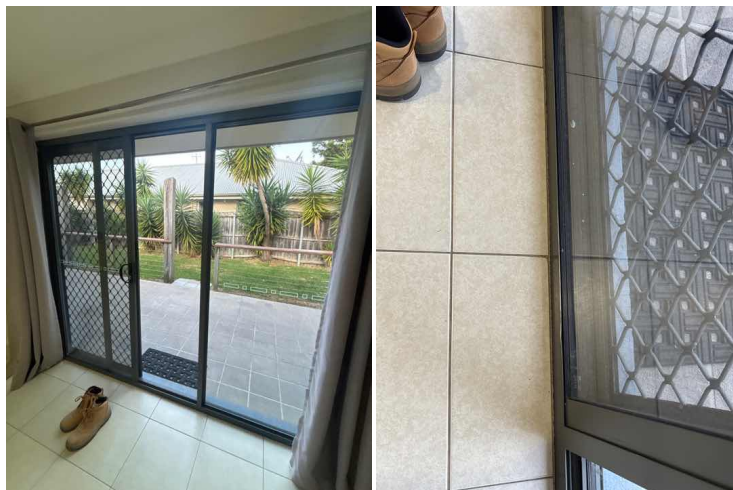
The sliding glass doors require general maintenance of repair by a licensed glazier (e.g. rollers, minor damage to the track).

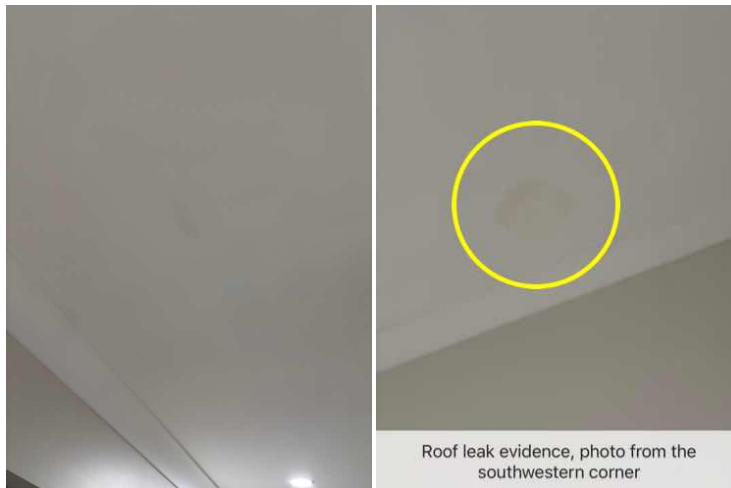
General age and wear deterioration (e.g. dings, marks, scuffs, and the like) in ceiling linings and cornices. Recommend a suitably qualified tradesperson be engaged for general maintenance and repair as necessary (e.g. patch and paint).

There was evidence of leaking from the roof. The areas were tested with electronic impedance moisture testing equipment and / or thermal imaging and found to be dry (consistent with other areas / linings) at the time of inspection. Recommend repair as necessary to deteriorated damaged materials by a suitably qualified tradesperson and monitoring for further issues.

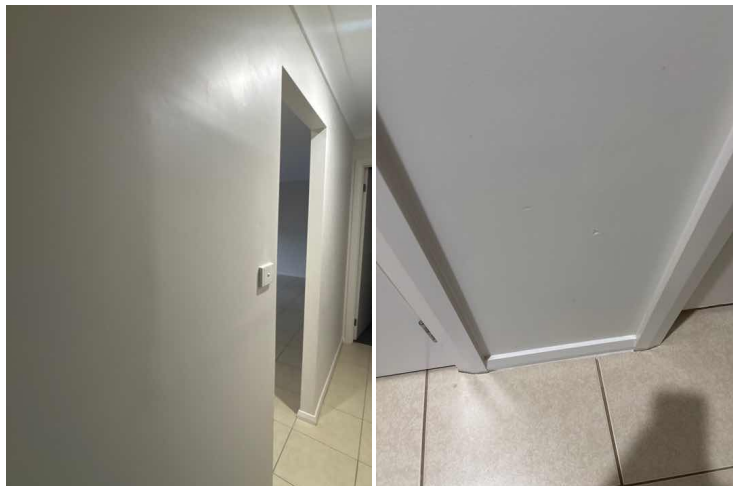
General age and wear deterioration, dings, or the like in wall linings and trims. Recommend a suitably qualified tradesperson be engaged for general maintenance and repair as necessary (e.g. patch and paint)

The wall linings had evidence of patches and minor repairs.

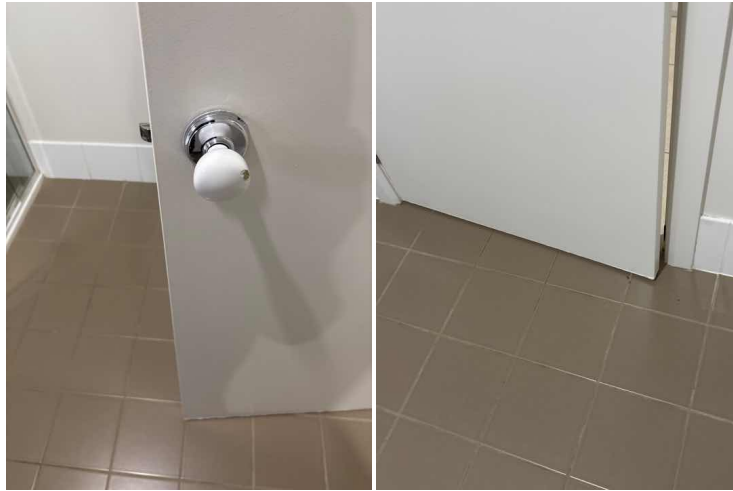
The bathroom door had some minor deterioration (e.g. base). Recommend repair or replacement as necessary by a suitable qualified tradesperson.

The door requires general maintenance or repair (e.g. hardware: door knob chipped) by a suitably qualified tradesperson.

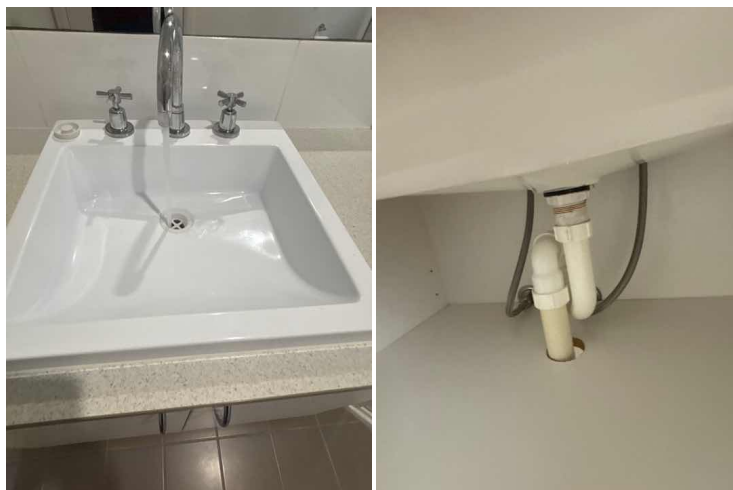
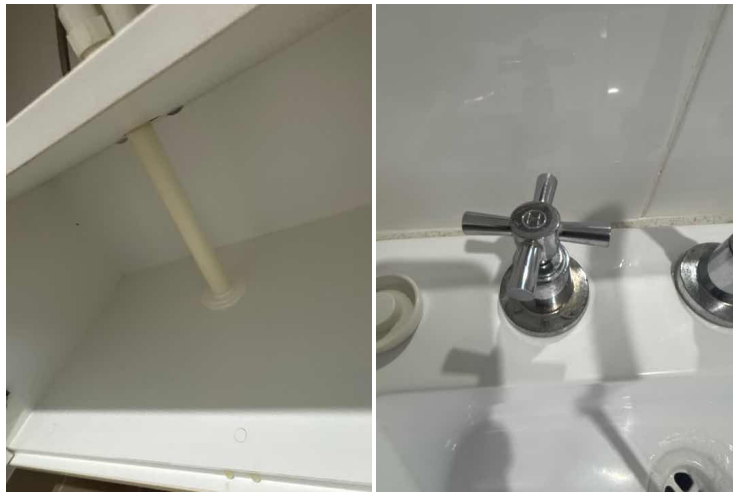
The hot water tap was stiff to open. A qualified plumber should be engaged for advice and recommendations. Normally replacing spindles will rectify.

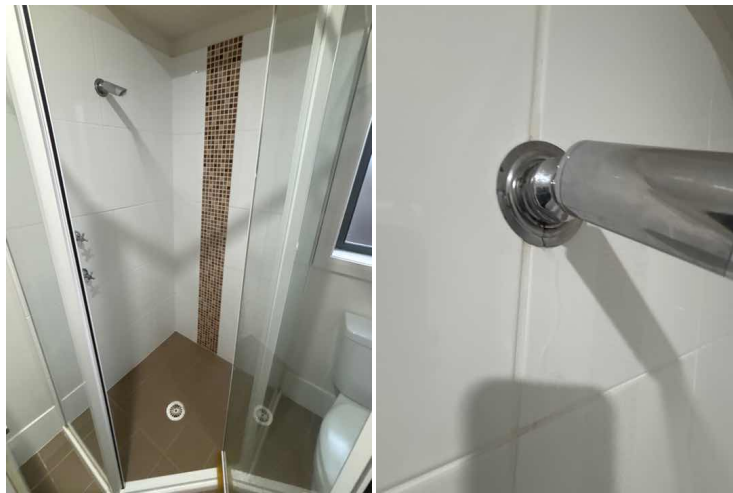
Shower head is leaking. Recommend repair or replacement as necessary by a licensed plumber.

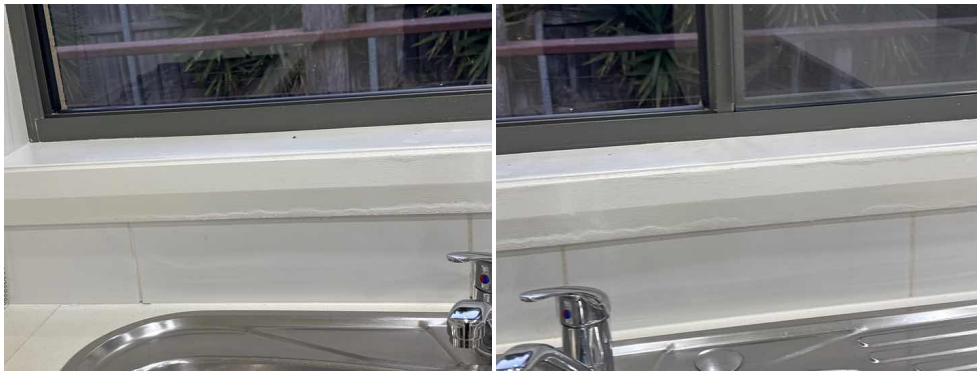
There was deterioration or damage in the window trims and reveals (e.g. moisture damage). Recommend repair as necessary by a suitably qualified tradesperson.

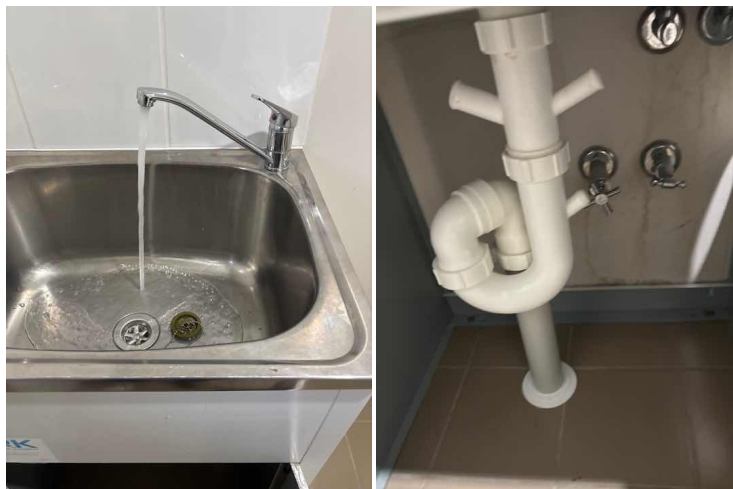
There tap was run and no leaks were observed. However, there was evidence of previous leaking, particularly near the washing machine taps. Recommend monitoring for further issues.

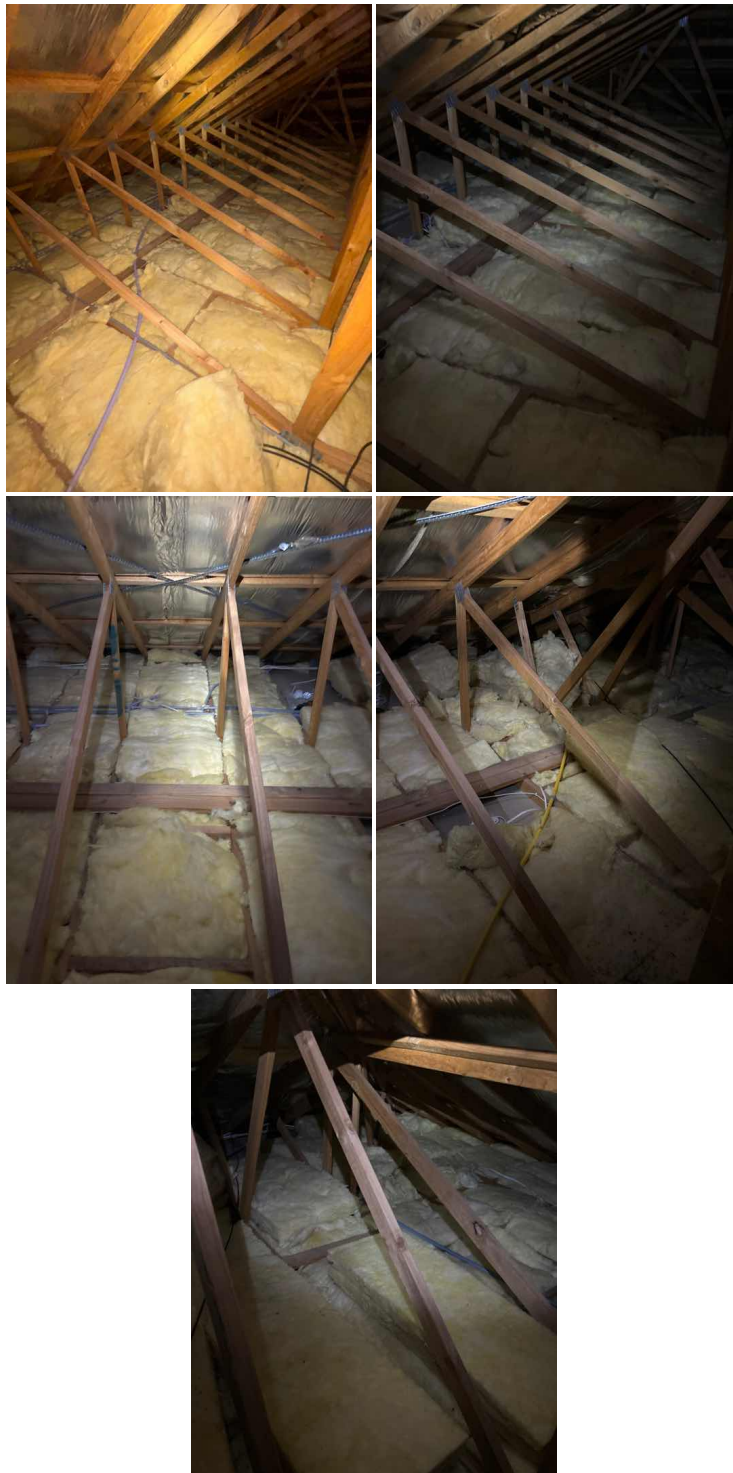
There is evidence to suggest that there is some leakage into the roof void (e.g. above the family / meals). In the absence of rain it is difficult to determine if this is an old leak or it's active. Monitoring during periods of rain should reveal and leaks, if leaks are active contact a qualified roofing contractor for repairs.
