Building and Timber Pest Inspection Report VR

Inspection Date: Fri, 21 Jun 2024

Property Address: 40 Warunda Parade, Point Cook VIC 3030,
Australia

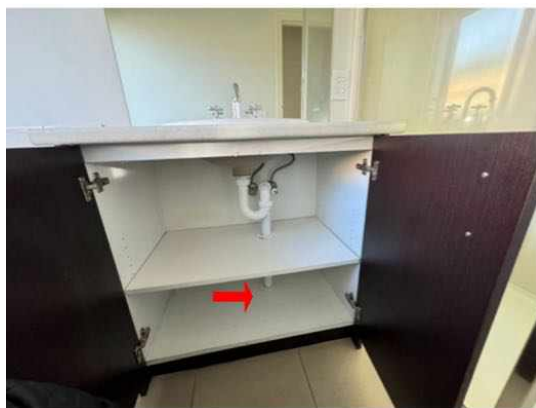
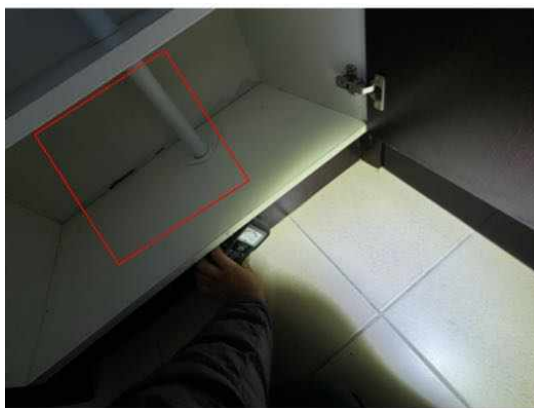
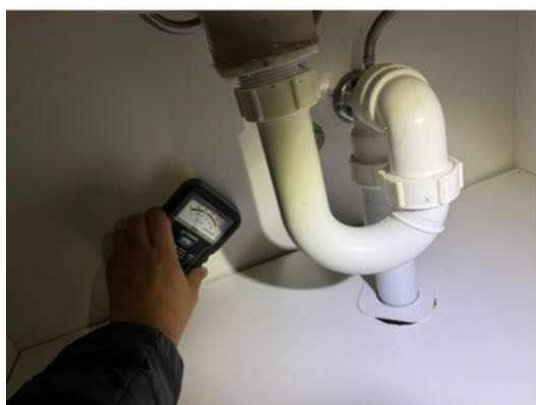
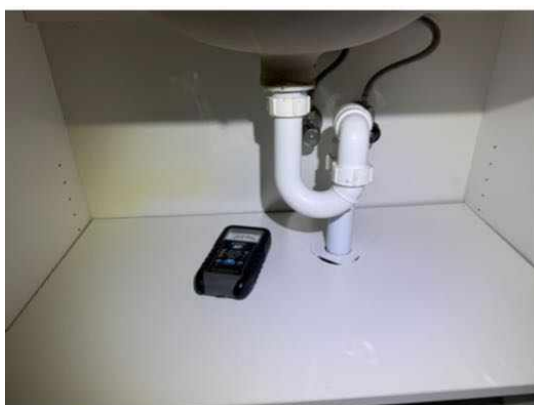
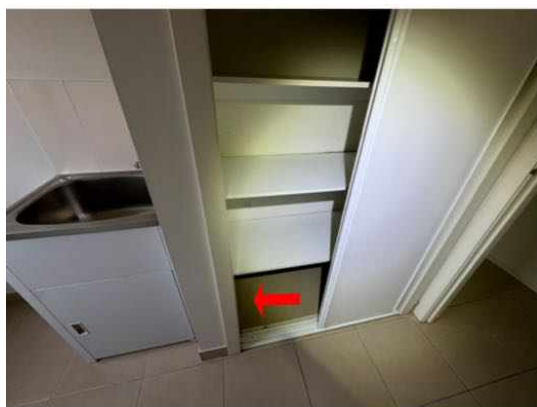
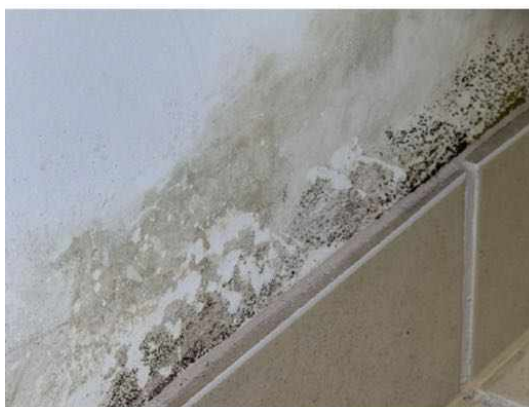
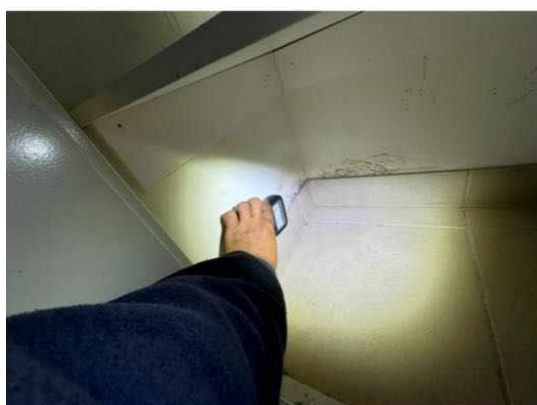
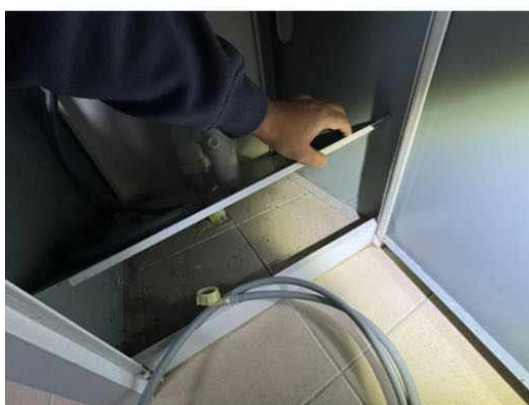
Finding 3.01

Building: Main Building
Location: Bathroom, Laundry
Finding: Previous Water Leak
Information: At the time of inspection, previous water damage was noted under the sink cabinetry in the bathroom due to loose plumbing fittings & in Laundry pantry . It appears the active water leak has been addressed by plumber. However we recommend to client to monitor any water leak in this area and get it addressed immediately by a licensed plumber.

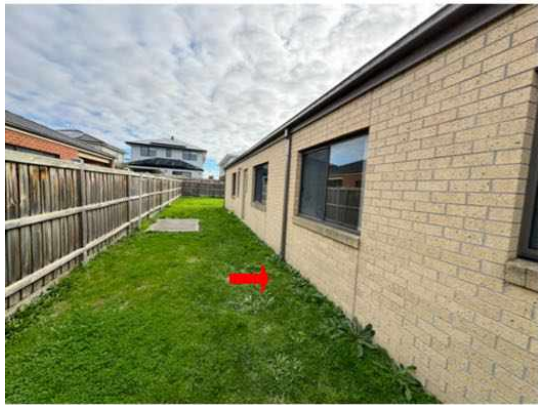
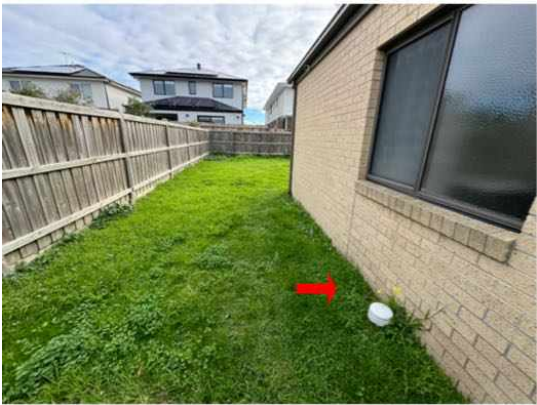
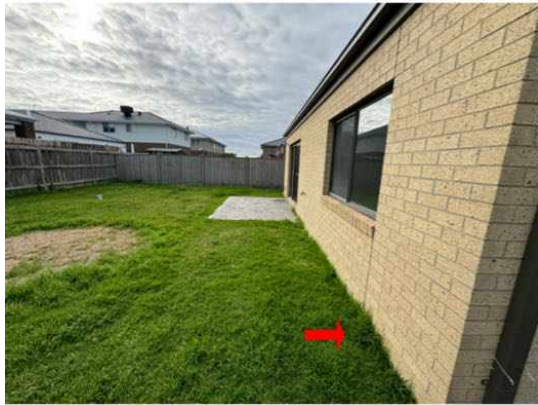
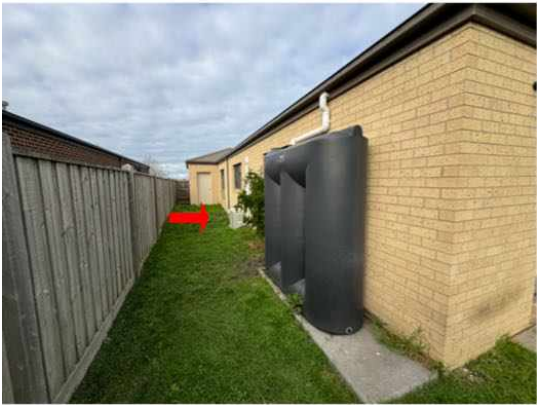
Finding 3.02

Building:	Main Building
Location:	All External Areas
Finding:	Site drainage - Inadequate
Information:	The site drainage in these area was found to be inadequate at the time of inspection, creating potential for subsequent water damage to associated building elements.

It is important that water does not lie against the base of walls; surrounding paths and ground levels should be sloped to drain water away from walls. Downpipes should not disgorge stormwater onto lower walls or plinths. Stormwater should be carried away by large, regularly cleaned drains. Ground levels may need to be lowered to expose a buried DPC.

Where site drainage is inadequate, installation of storm water drain point may be required. Client to check and monitor if any water pooling against the wall in this area during heavy rains. Concrete pavement with drains points around the perimeter of the building also may considered by the purchaser.

A qualified plumber and concrete can be appointed to further inspect the property and perform any remedial works as necessary at client's discretion.

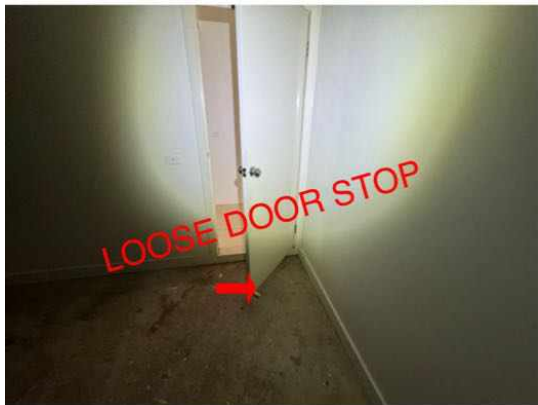
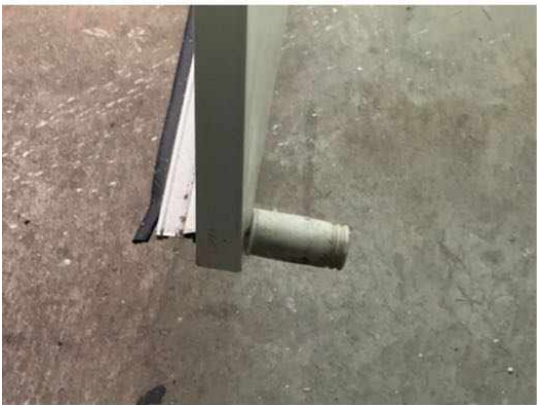
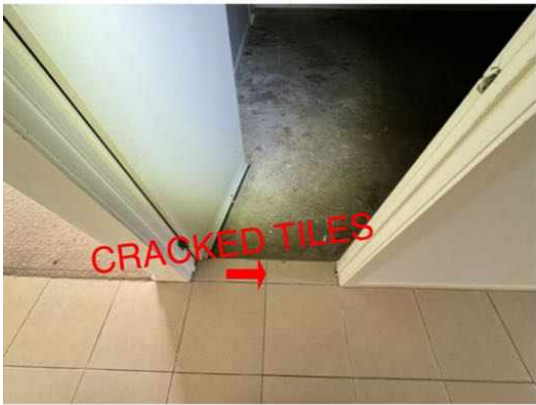
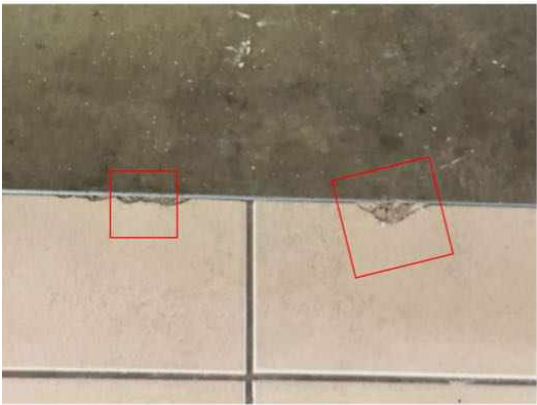
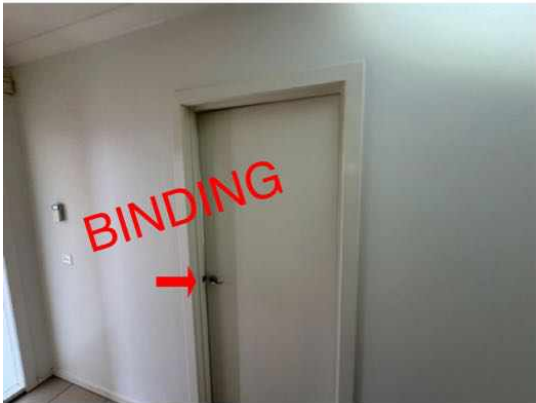
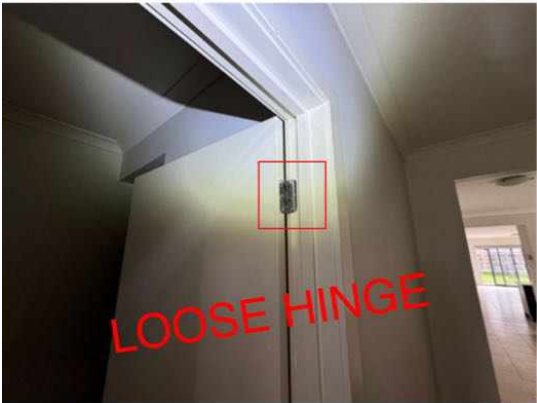
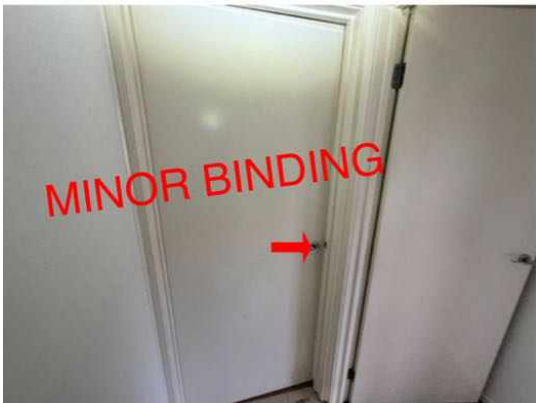
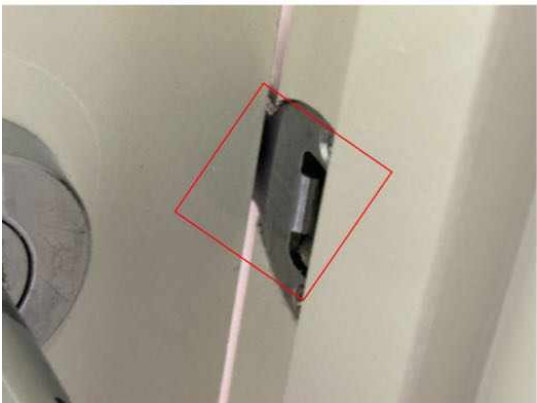
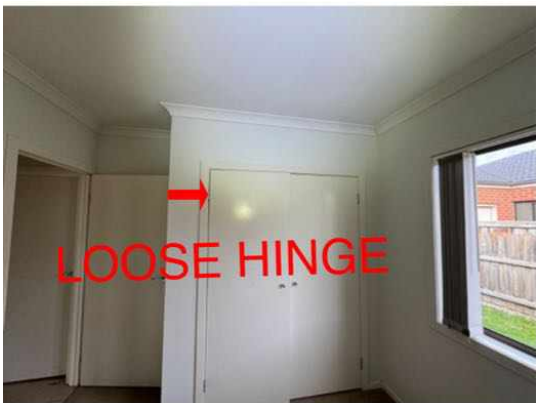
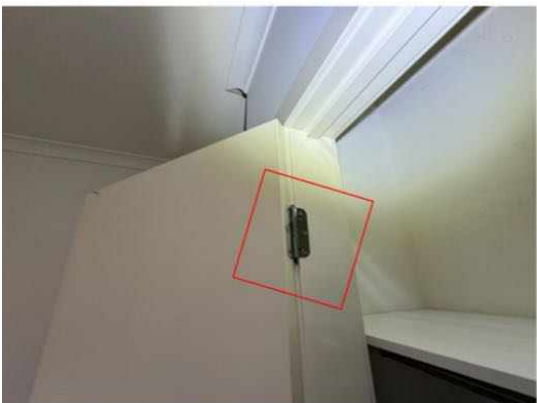
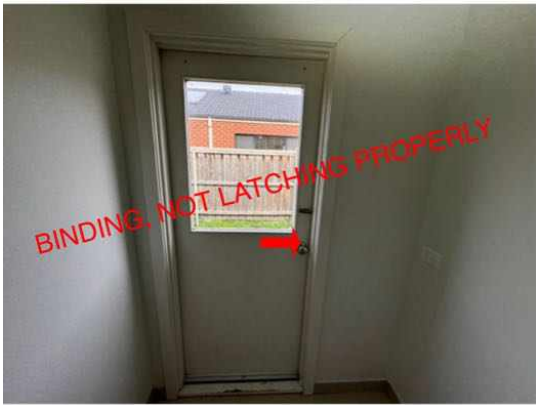
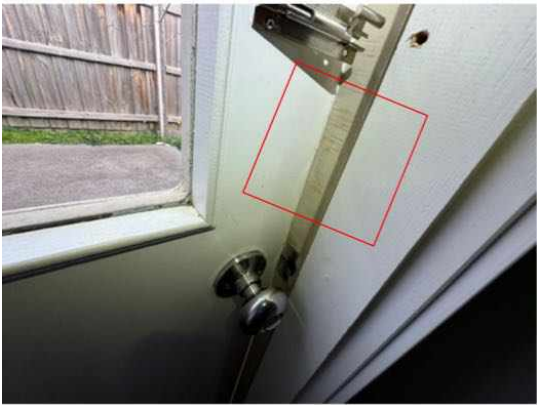
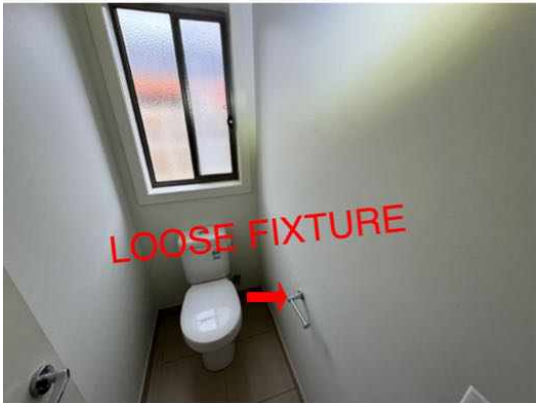
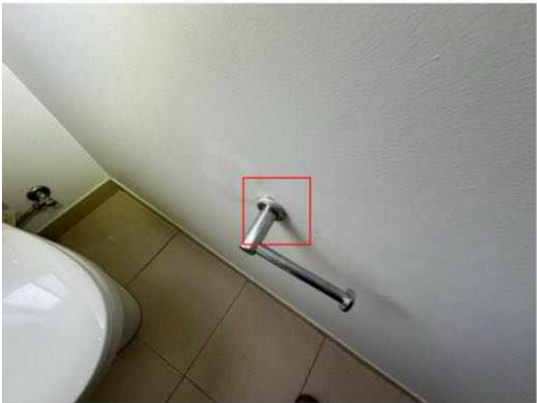
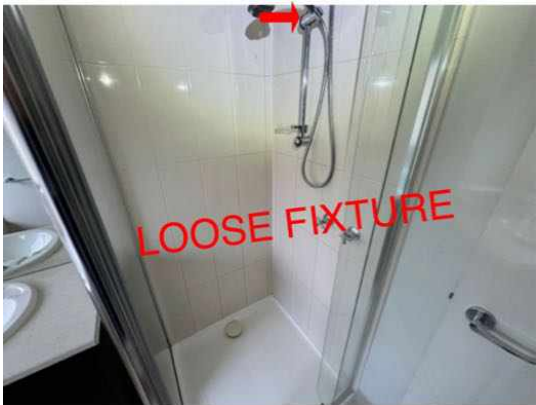
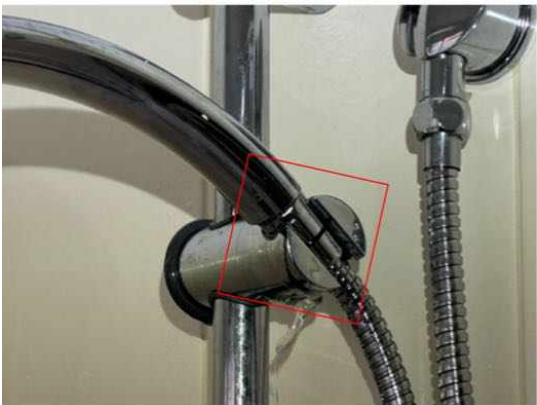
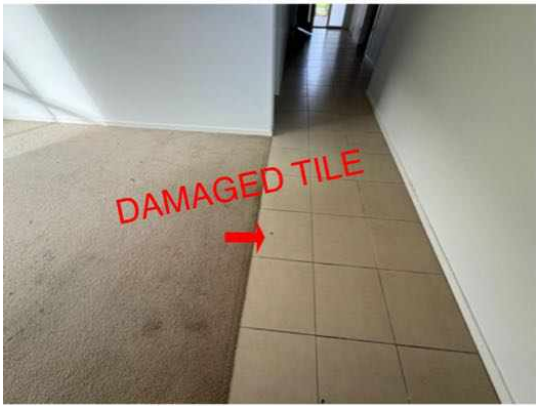
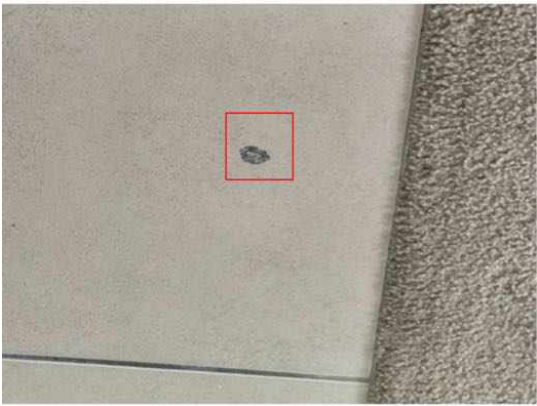
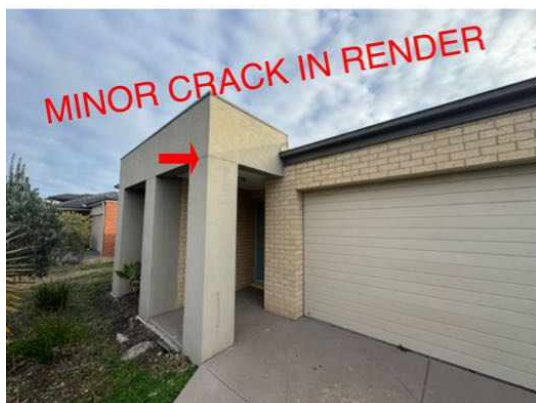
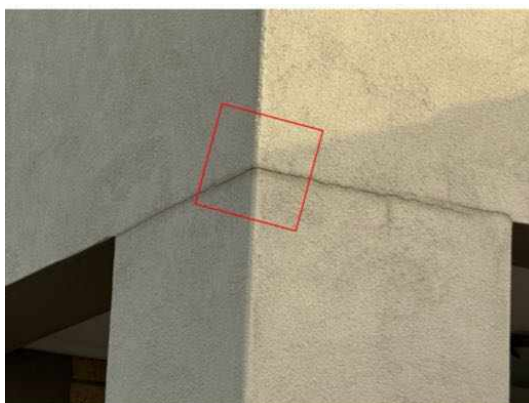
Finding 3.03

Building: Main Building
Location: All Areas
Finding: Maintenance, wear and tear defects
Information:

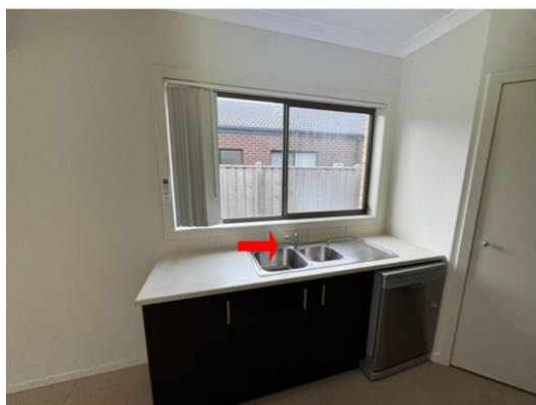
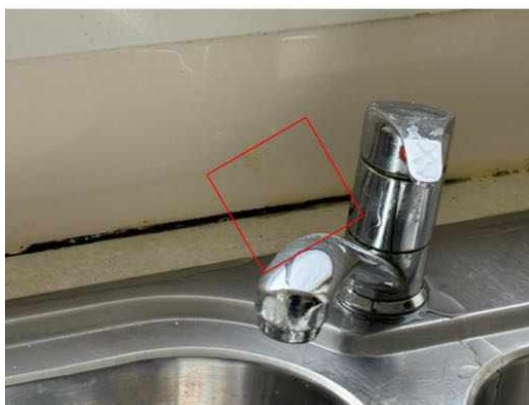
Finding 3.04

Building:	Main Building
Location:	Kitchen
Finding:	Sealant or caulking - replace
Information:	It was noted on inspection that mould in the sealant or caulking on the tile joints which require scrape out and replacement.

Regular maintenance and replacement of damage or missing or damaged sealant is highly recommended to the wet areas, as this is a regular wear and tear defect. A sealant specialist or tiling contractor should be appointed to complete these works as soon as possible

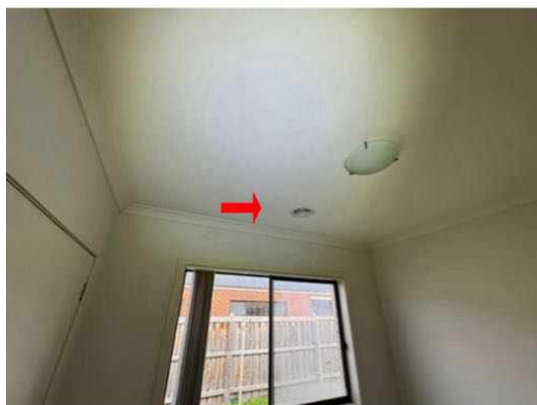
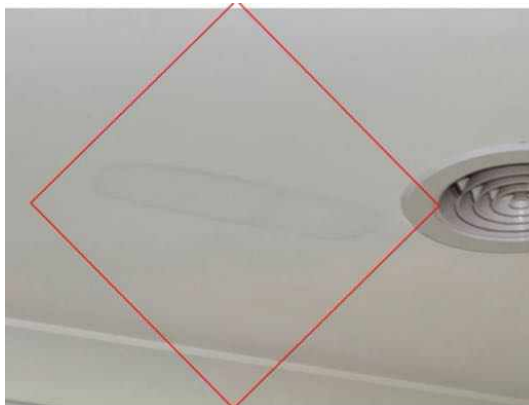
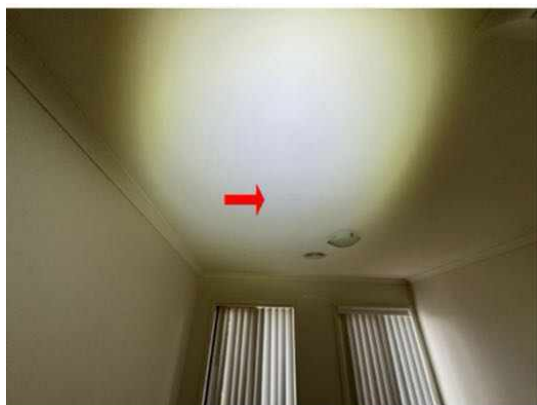
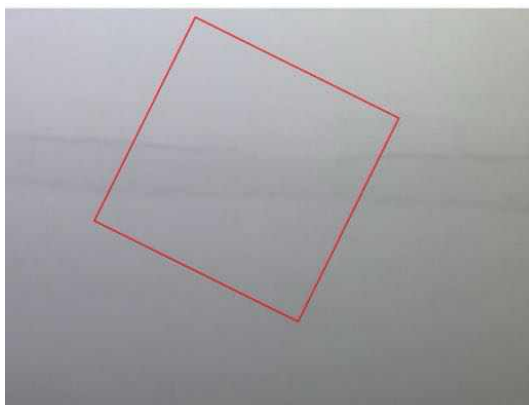
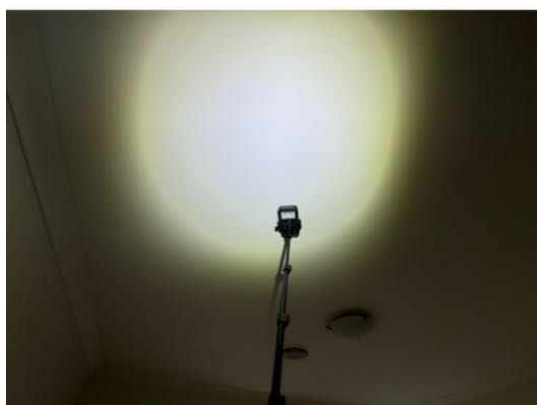
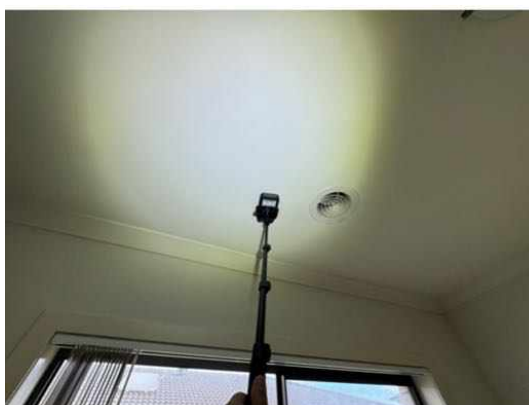
Finding 3.05

Building:	Main Building
Location:	Nominated Areas
Finding:	Ceiling - Water stained
Information:	Water staining to ceiling linings in this area was evident at the time of inspection. Water staining indicates that surfaces have been exposed to excessive moisture over time. The minerals and other elements in the water lead to staining, which may graduate to corrosion and deterioration if left unmanaged.

While mostly an appearance defect, water staining can be indicative of more serious defects, which may be currently concealed by interior ceilings.

Where water staining is active, a licensed plumber must be consulted to identify the cause of the staining and to provide advice on any reparation works that may be required. Replacement of any damaged structures is advised.

Conversely, where water staining is old and inactive, affected building materials may be repaired or replaced at client discretion.

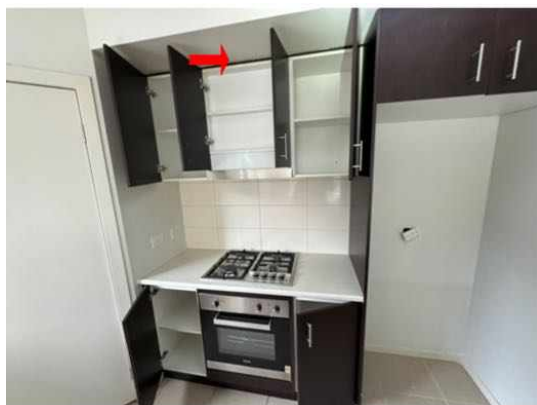
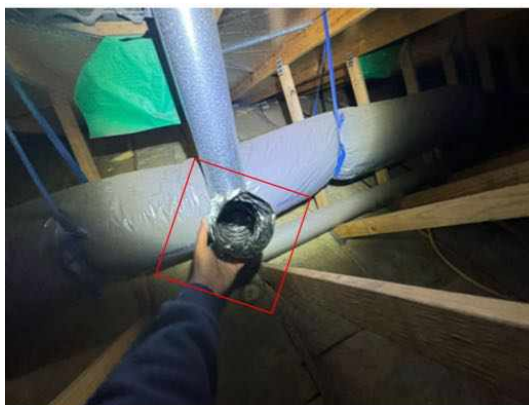
Finding 3.06

Building: Main Building

Location:	Roof Void
Finding:	Rangehood - Vented into roof space
Information:	<p>The range hood flue was found to be disconnected in the roof void. The positioning of this flue is likely to lead to a build-up of grease and grime in the surrounding area within the ceiling void, which can pose as a minor fire hazard in the roof void.</p> <p>Duct should be reconnected to exhaust flue to get the rangehood operational efficiently.</p>

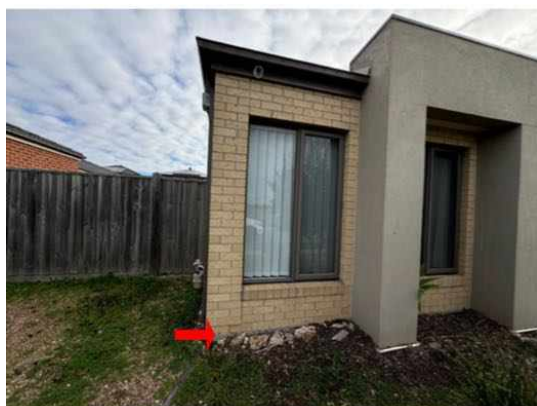
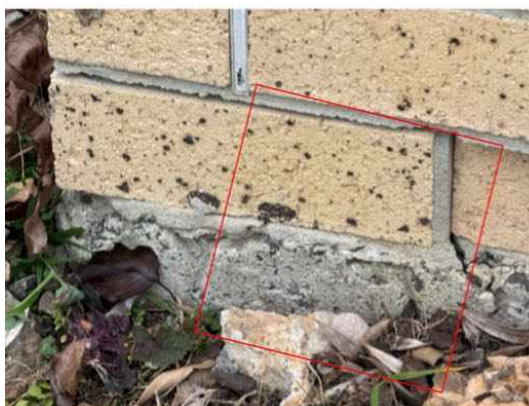
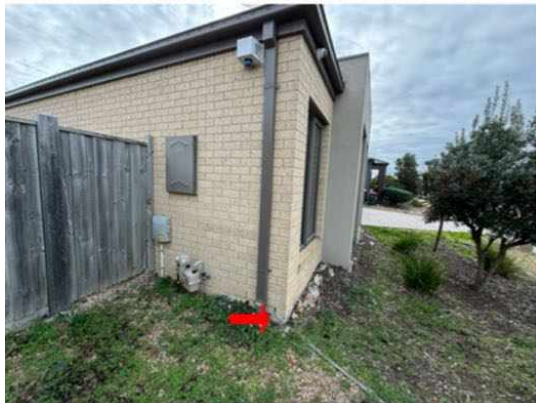
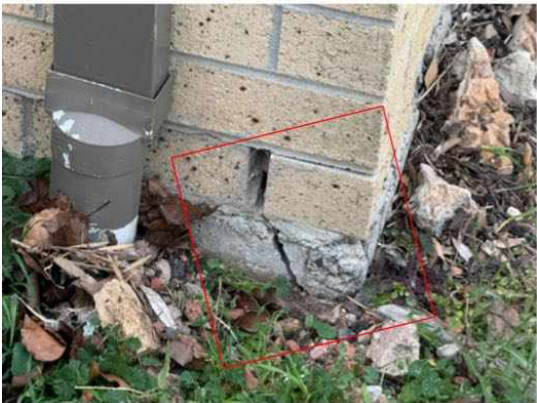
Finding 3.07

Building:	Main Building
Location:	Nominated Area
Finding:	Crack in concrete slab - Category 2
Information:	<p>A crack coded as Category 2 was identified to the edge of slab in this nominated area. A Category 2 crack is described as a distinct crack, with the slab being noticeably curved or changed in level.</p>

Category 2 cracks to slabs should be monitored for a period of 12 months. At the end of the monitoring period, cracks rated greater than Category 2 are considered defects that require rectification.

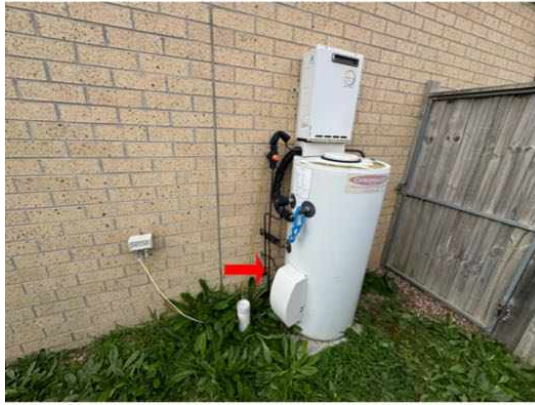
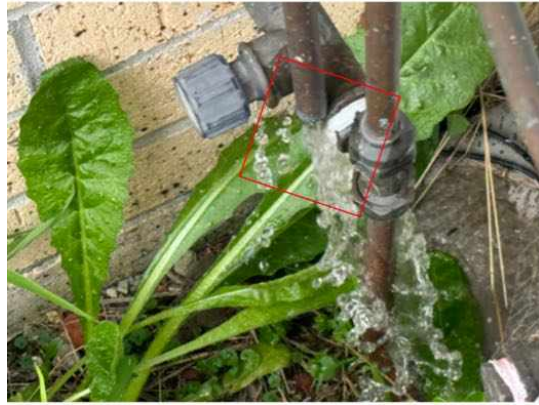
Finding 6.01

Building:	Main Building
Location:	Nominated Area
Finding:	HWS overflow - Not Connected
Information:	The Hot Water System (HWS) overflow was found to be not connected to storm water drainage and will create excessive moisture in the surrounding area.

These damp conditions can lead to secondary defects such as rot, rust or corrosion of associated building elements, the formation of fungal decay. When coupled with poor site drainage, pooling of water may also attract termite activity to this area.

It is highly recommended that a licensed plumber be appointed to connect the HWS overflow in order to prevent such an environment from being created. These minor works should be carried out as soon as possible.
