# Inspection Report

**Inspectrite Australia Pty Ltd**

**395 Newport Rd, Cooranbong, NSW, 2265**

### Pest And Building Inspection

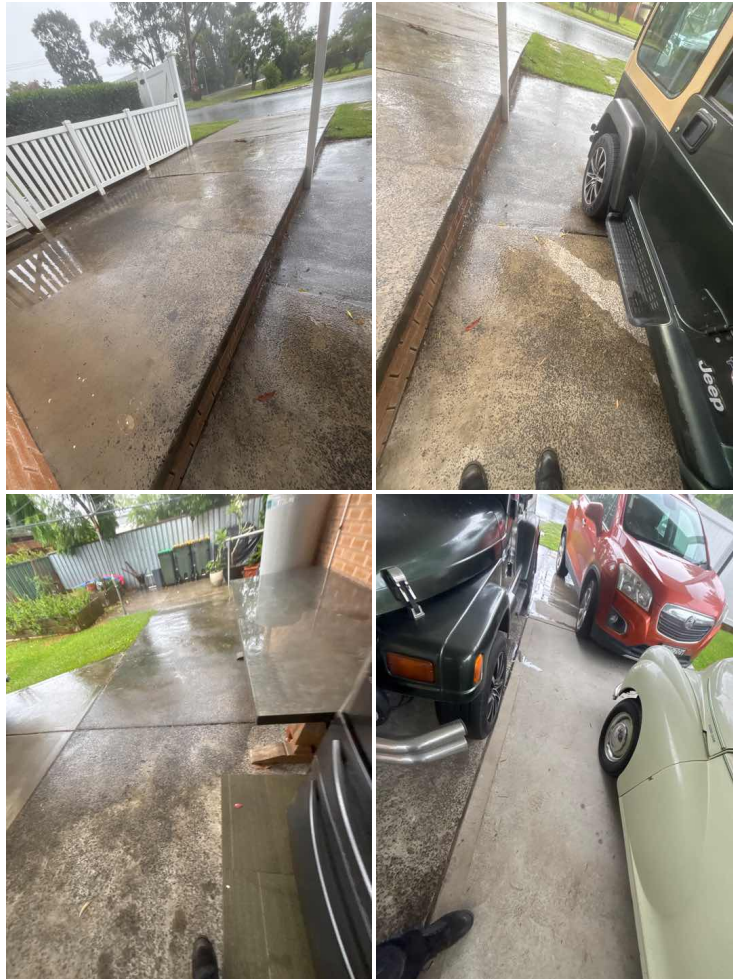
Cracking and settlement was observed within the driveway. Recommend repair as necessary by a suitably qualified tradesperson.

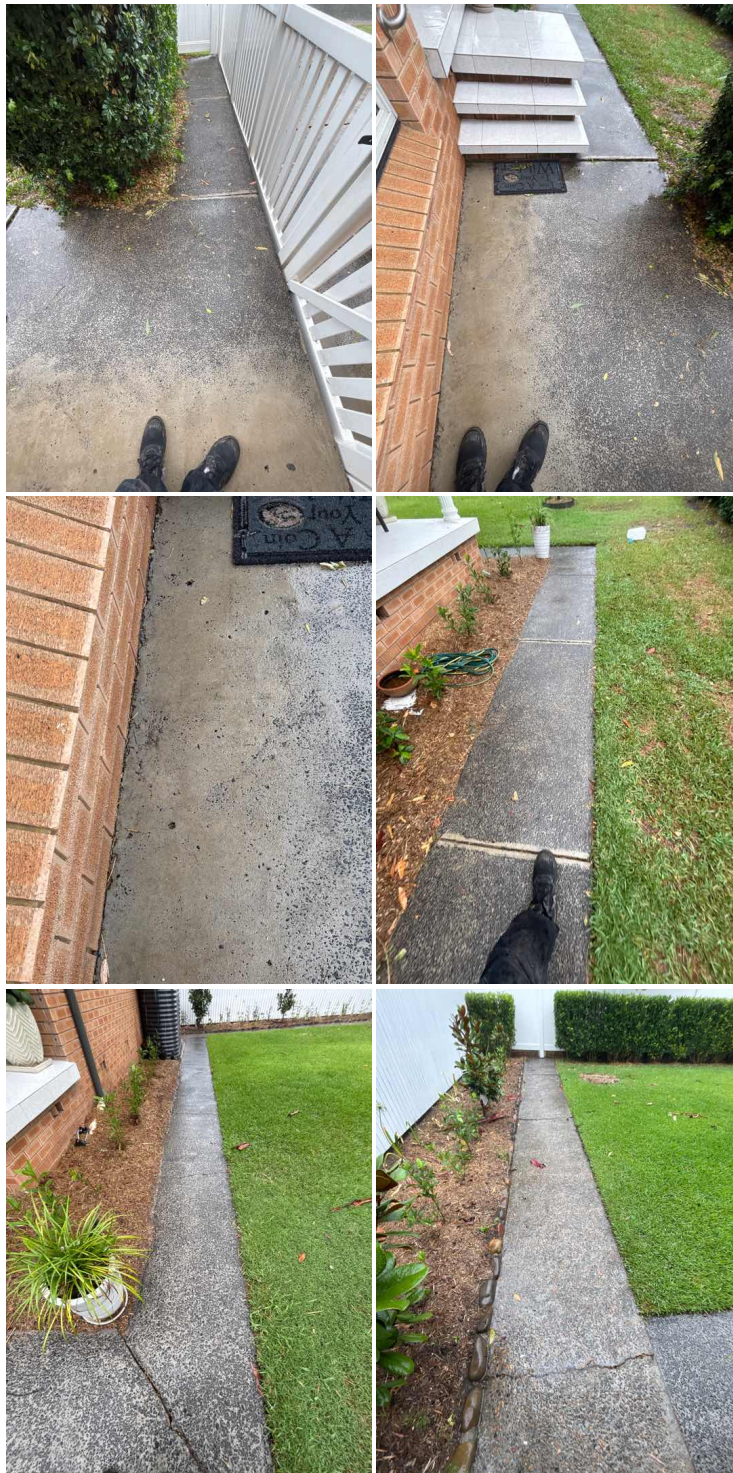
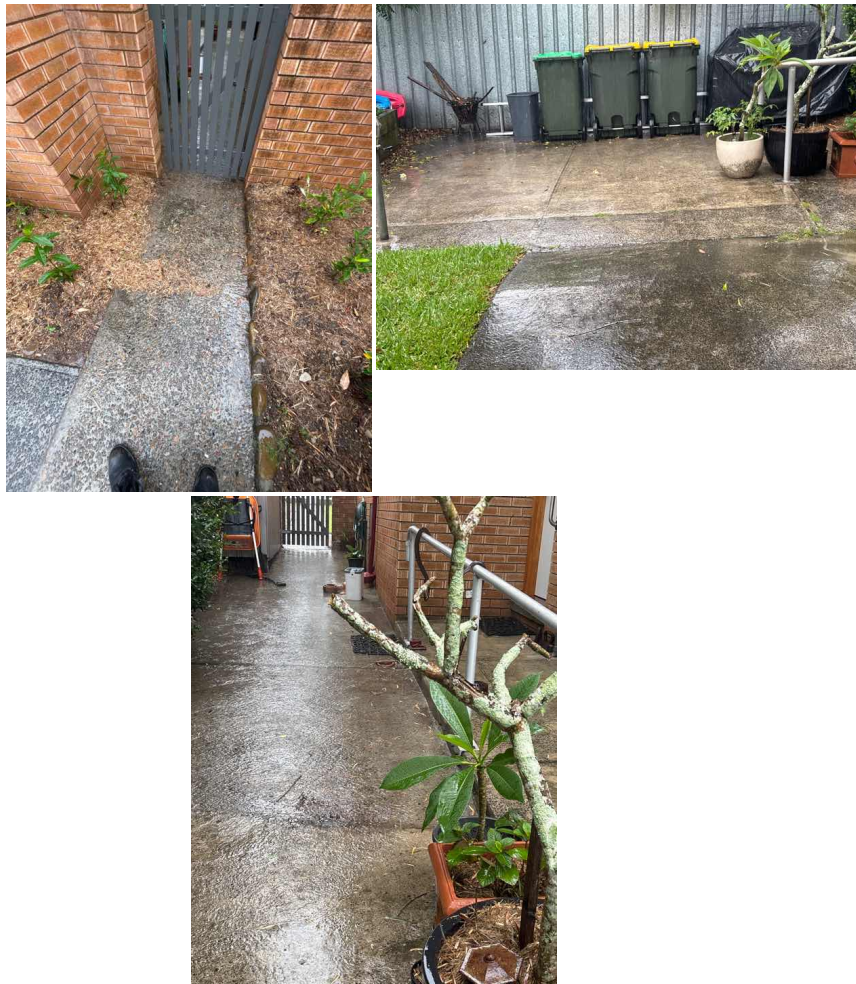
Cracking and settlement was observed within the pathway/patio. Recommend repair as necessary by a suitably qualified tradesperson.

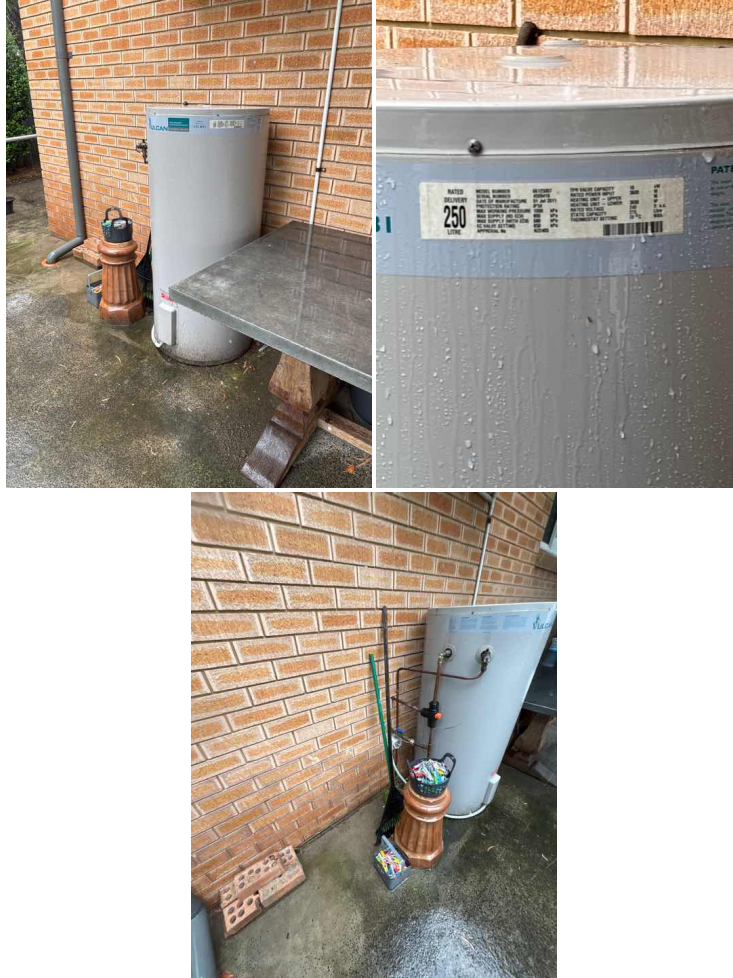
The hot water overflow requires diverting to a drain or further from the dwellings wall or footings. Excess water ponding alongside walls and into perimeter footings has the potential to cause rising damp, differential settlement and wall cracks over time. It is also conducive to termite infestation. Recommendations: Engage a plumber to rectify.

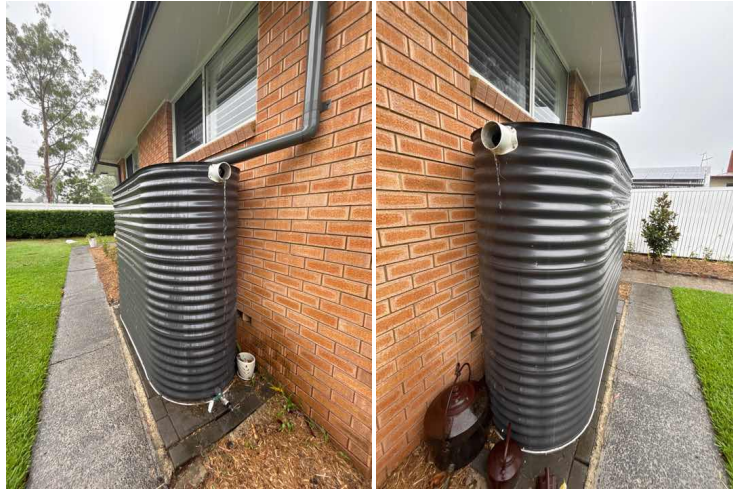
Overflow not connected to point of discharge - This can be conducive to termite infestation and if close to the home can cause differential settlement in the homes footings and associated damp related problems.  
Recommendations: Assessment conducted by a licensed plumber advised.

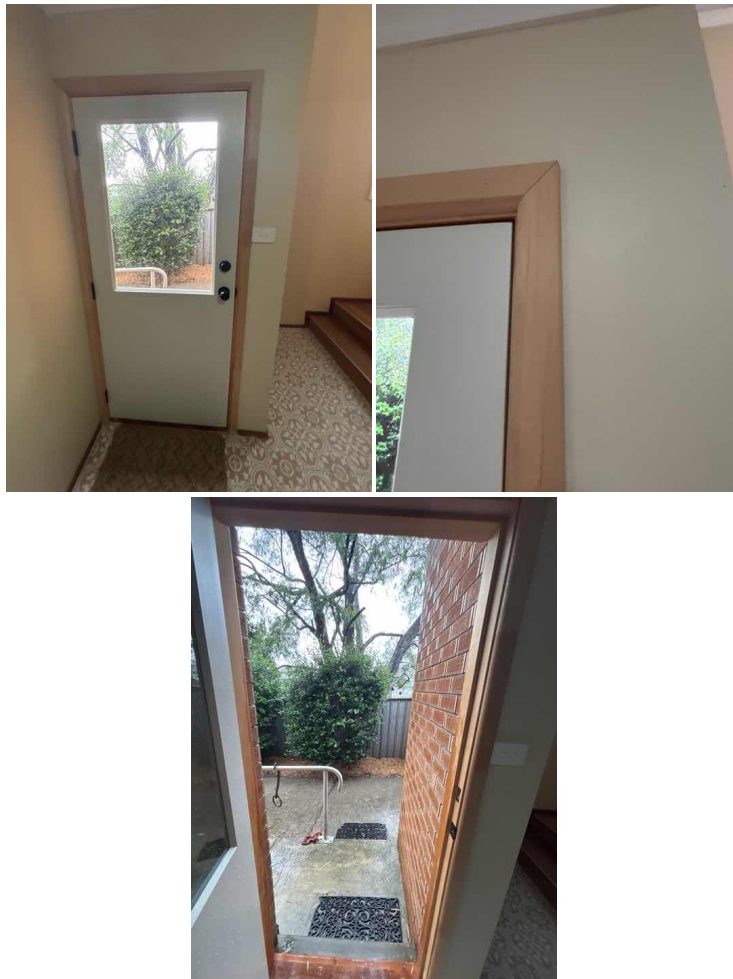
The door frame and trims did not appear to have been sealed or painted.

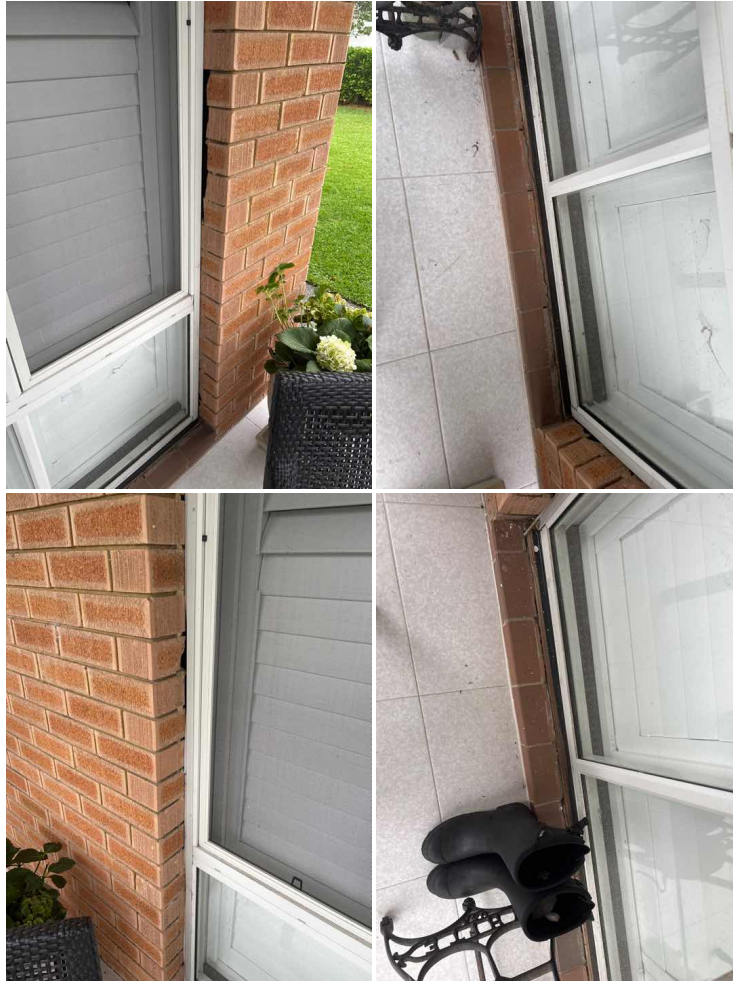
The bedroom 1 window adjacent to the entry porch had some observations and requires repair or completion of the installation (e.g. gaps to the frame, flashing not installed or completed, trims not installed). This has been documented as a minor defect as it is protected from weather by the entry porch roof. However, pest and vermin can access the wall cavity, and leakage could occur in storms. Recommend repair as necessary by a suitably qualified tradesperson.

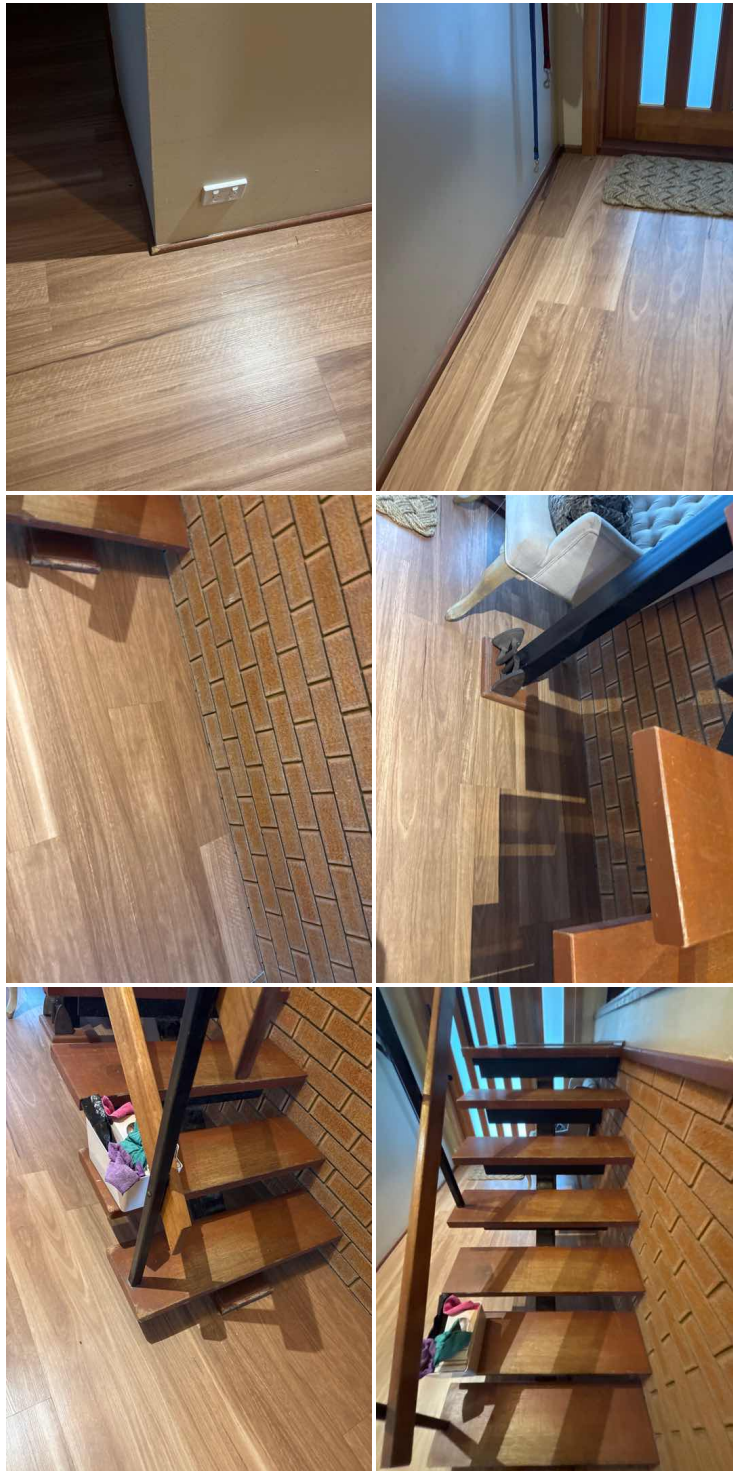
Skirting boards / scotia had general wear and damage, and was not installed in some areas. There was also creaking from the treads and landing. Recommend repair as necessary by a suitably qualified tradesperson.

The stairs had some general wear deterioration (e.g. scratches, minor damage, and the like). Recommend general maintenance and repair as necessary by a suitably qualified tradesperson.

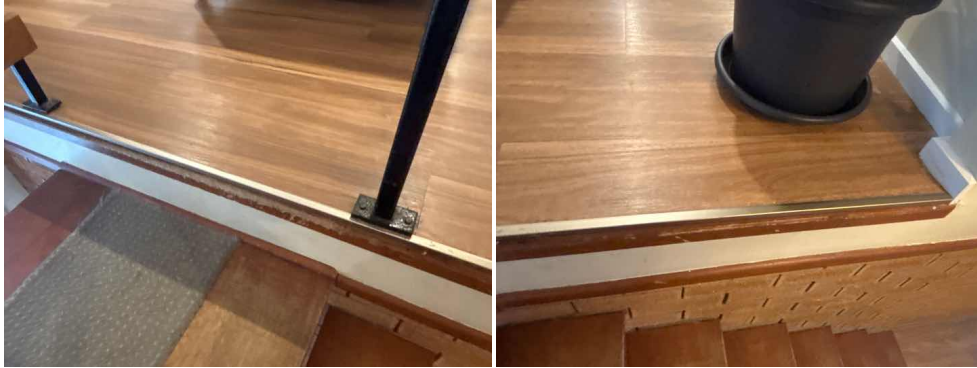
Skirting boards / trims had general wear and damage to areas. Recommend repair as necessary by a suitably qualified tradesperson.

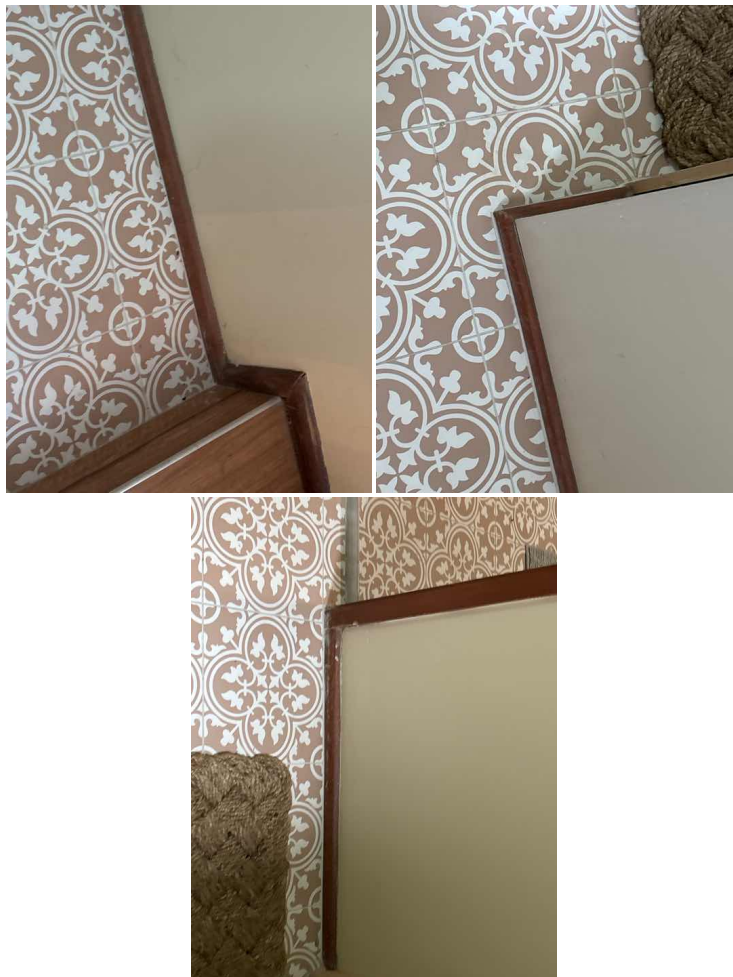
Skirting boards / scotia had general wear and damage to areas. Recommend repair as necessary by a suitably qualified tradesperson.

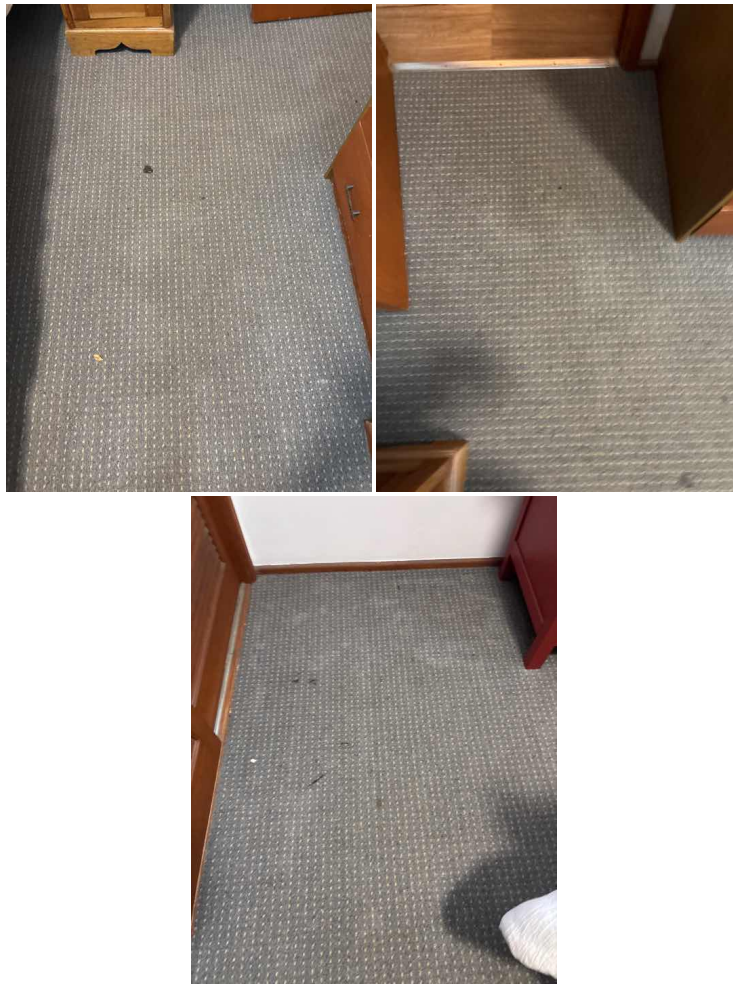
Squeaky/creaking floor boards observed. Re-fixing the flooring may fix this issue. Note: This is sometimes done in conjunction with replacement of floor coverings.

There was deterioration in the carpet (e.g. wear, stains, pulls, discolouration). Recommend repair or replacement as necessary by a suitably qualified tradesperson.

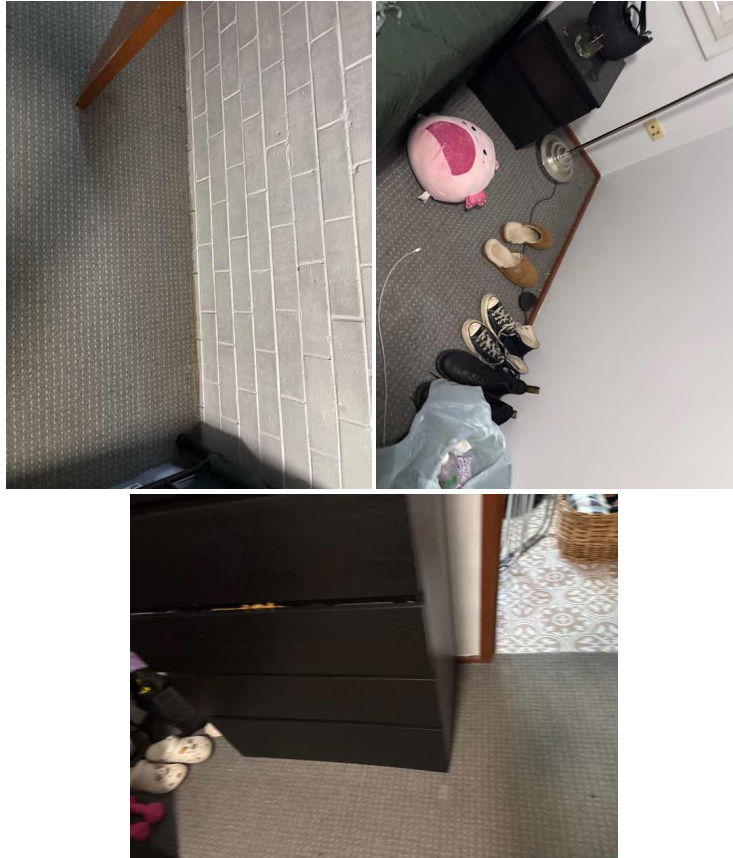
Skirting boards had general wear and damage to areas. Also, some sections were not installed. Recommend repair as necessary by a suitably qualified tradesperson.

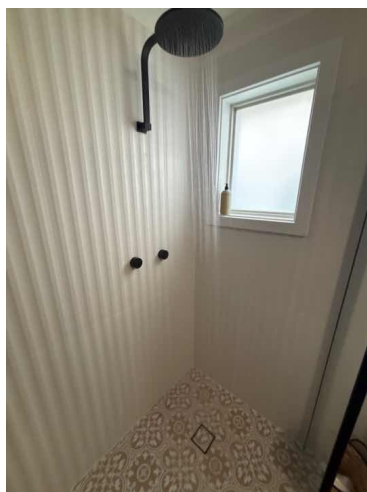
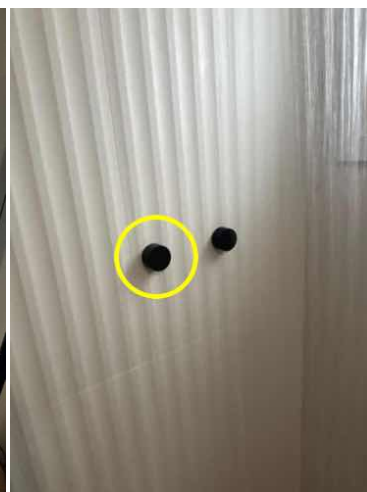
The shower was run for 3-5 minutes and no leaks were observed. However, the hot water tap was stiff. Recommend further evaluation by a licensed plumber.

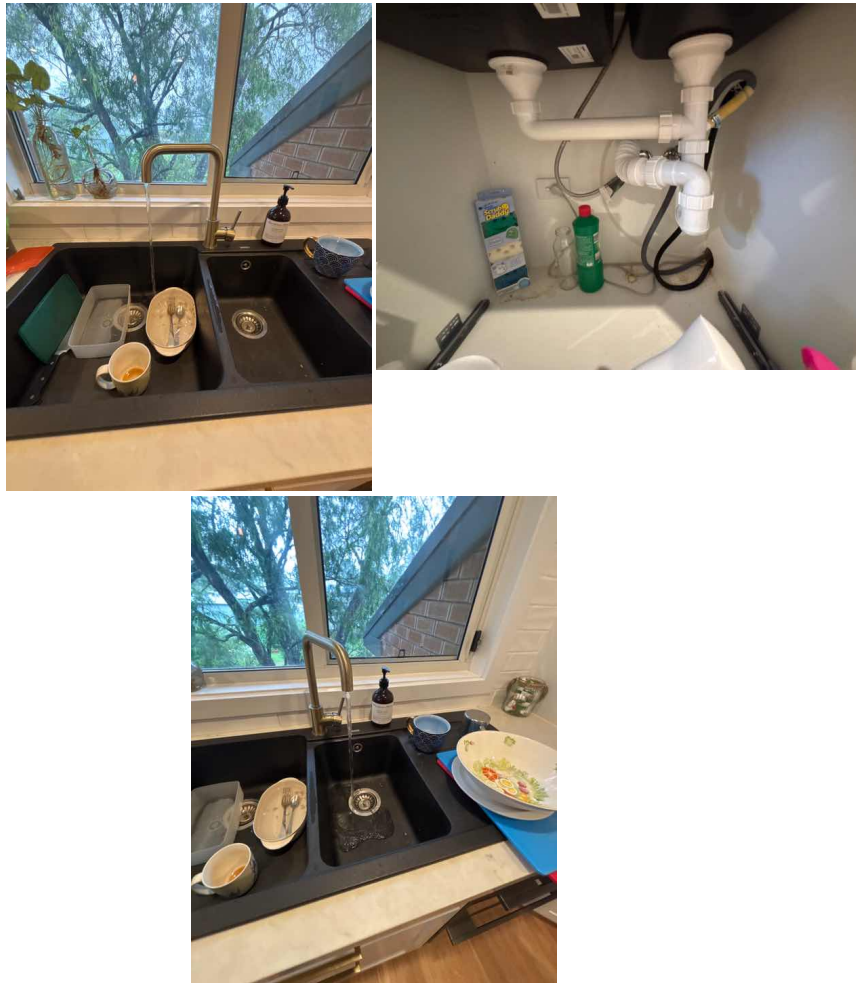
The tap was loose. Might be as simple as tightening or a replacement maybe required. A licensed plumber should be engaged for assessment and recommendations.

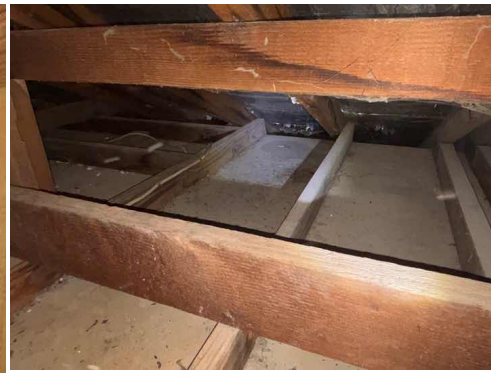
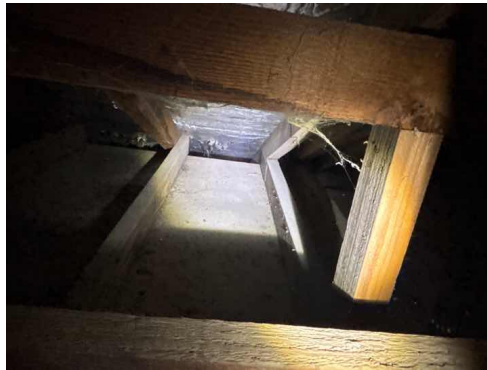
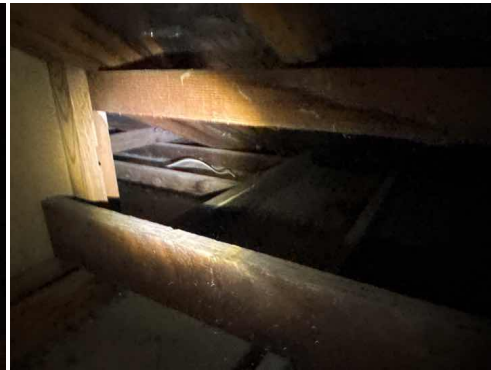
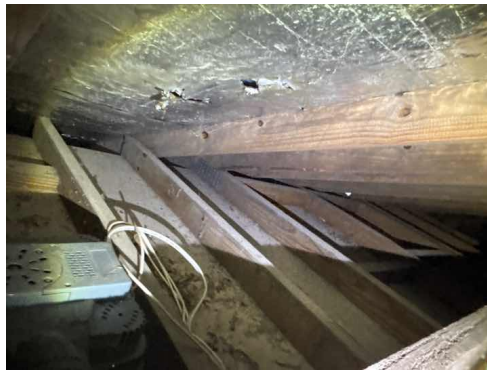
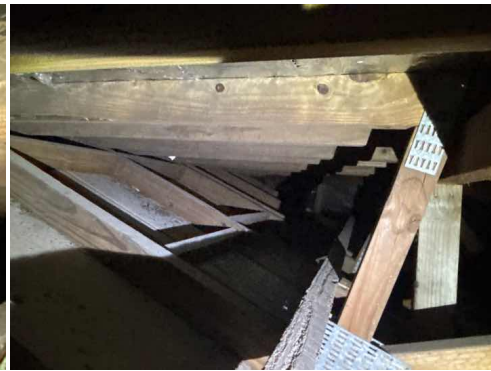
Example of termite workings in top plates, photo from above the bathroom

There is evidence to suggest that there is some leakage into the roof void. In the absence of rain it is difficult to determine if this is an old leak or it's active. Monitoring during periods of rain should reveal and leaks, if leaks are active contact a qualified roofing contractor for repairs. Note: The roof appears to have been recently replaced.

There was termite evidence within the framing timbers in the roof void (e.g. top plates above the bathroom). The timbers appeared to be bearing their intended load. Recommend further evaluation (e.g. invasive / destructive measures may be required) and repair as necessary by a suitably qualified tradesperson. Note: The bathroom has had extensive renovation, therefore we recommend enquiring to the vendor as to the works and the extent of the repairs (e.g. if framing timbers were repaired or replaced).

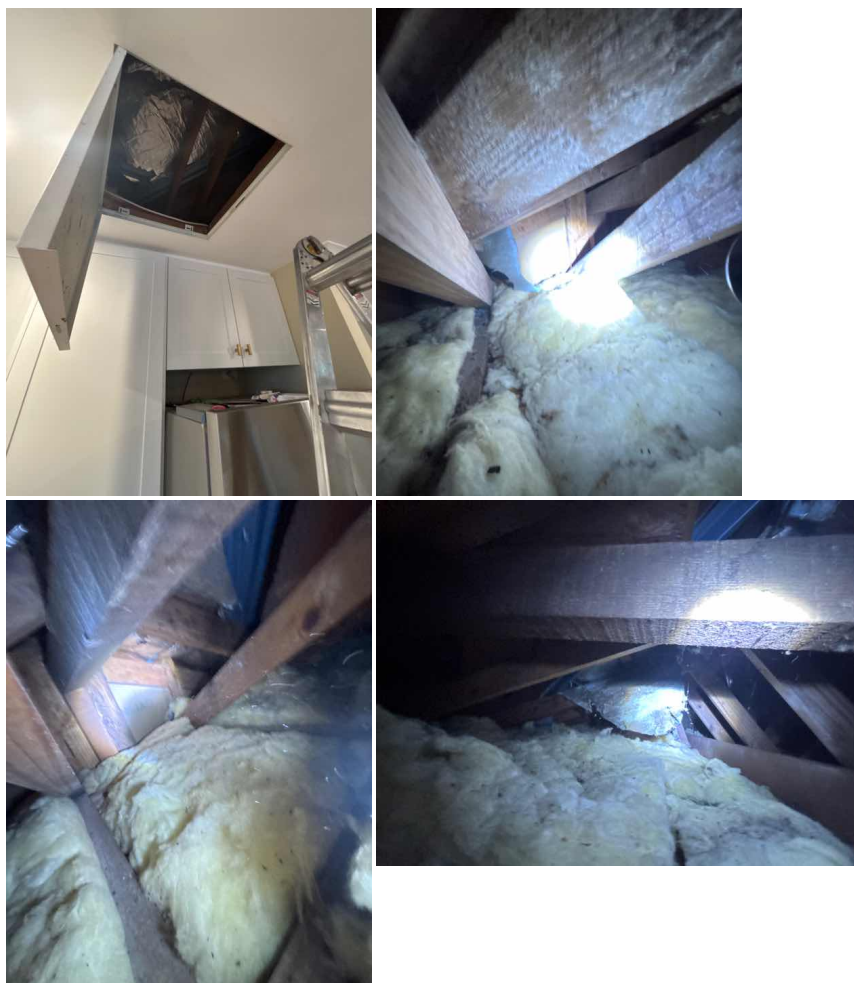
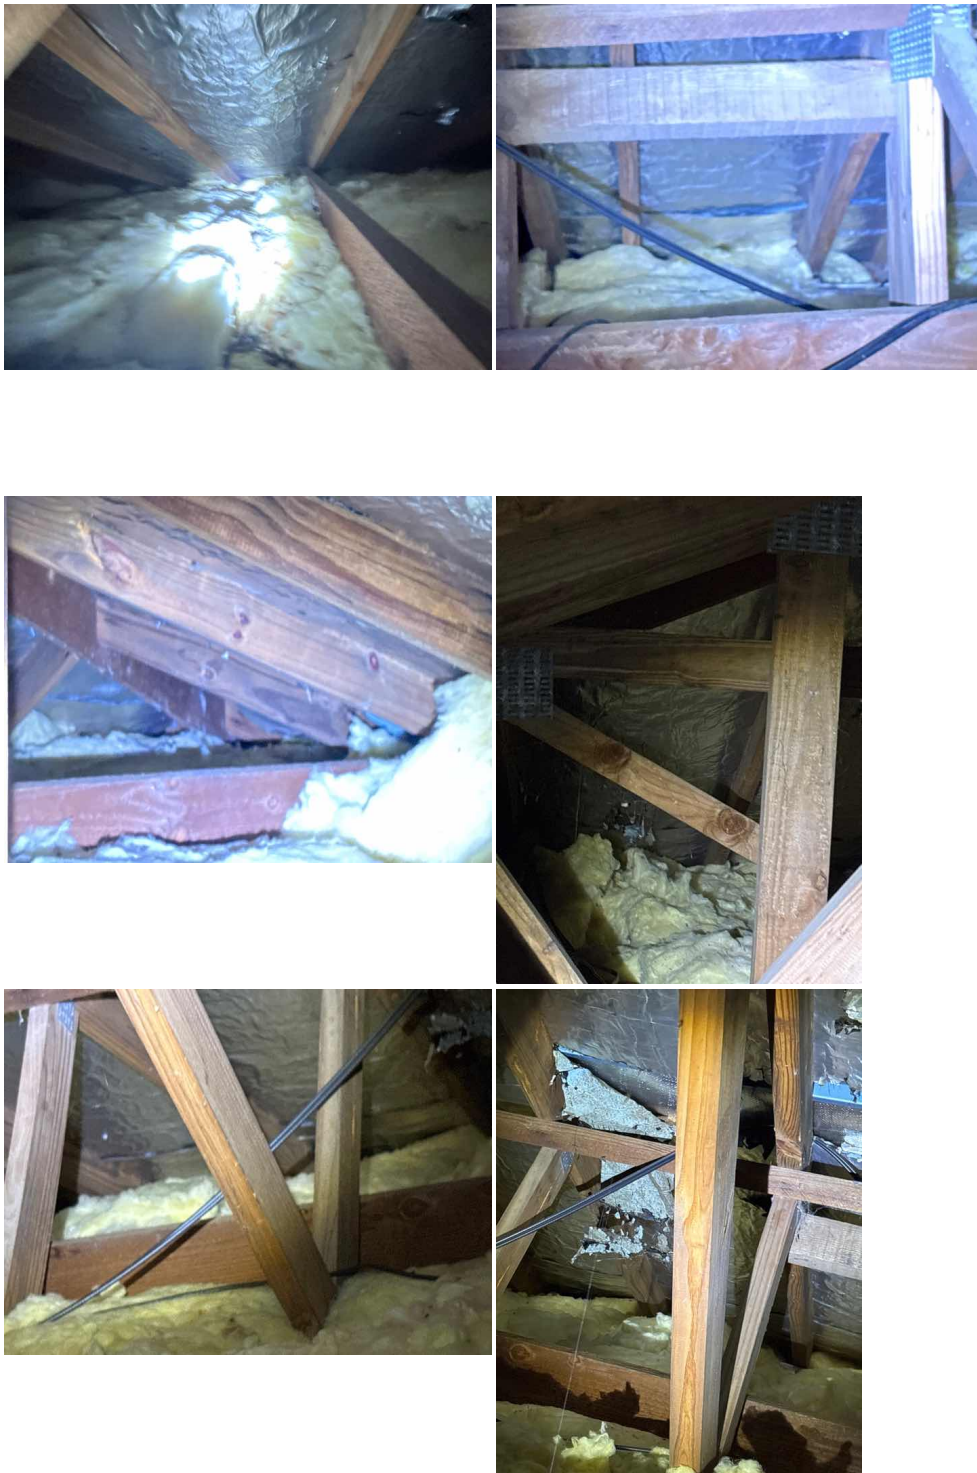
There is evidence to suggest that there is some leakage into the roof void. In the absence of rain it is difficult to determine if this is an old leak or it's active. Monitoring during periods of rain should reveal and leaks, if leaks are active contact a qualified roofing contractor for repairs. Note: The roof cladding appears to have been recently replaced.

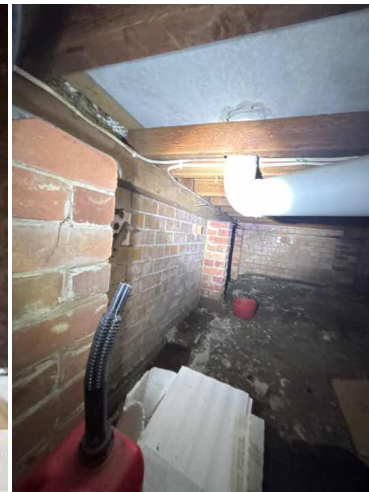
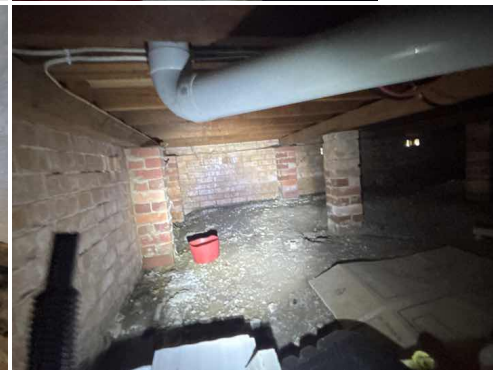
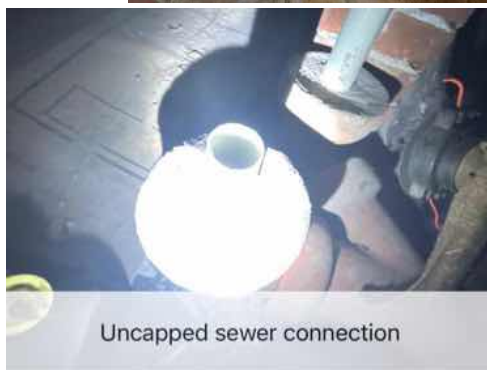
| SUBFLOOR | Sub-Floor Observation. | Floor Timbers | There was evidence of previous termite activity in the subfloor area, particularly beneath the bathroom and adjacent stairs. The timbers appeared to be bearing their intended load. Recommend further evaluation and repair as necessary by a suitably qualified tradesperson. Some invasive/destructive measures may be required. |

Example of joists with decay and termite workings, photo beneath the bathroom

Joist and sole plate with decay and termite workings, photo beneath the bathroom

Sole plates with decay and termite workings, photo beneath the bathroom

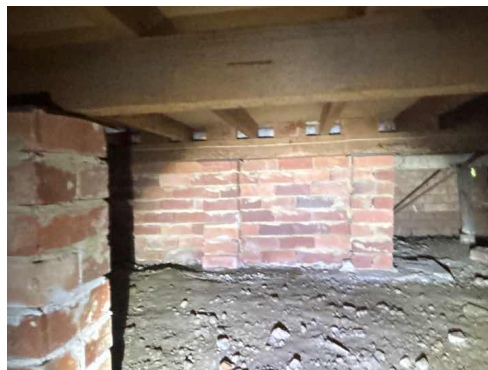
| SUBFLOOR | Sub-Floor Observation. | Dampness | There was water ingress along the northwestern side. This did include some water congregation along the footing. It should be noted that there was substantial rain at the time of inspection and a down pipe connection adjacent to the water ingress was leaking. Recommend repair as necessary by a suitably qualified tradesperson. |

Example of water ingress, photo from the northwestern side

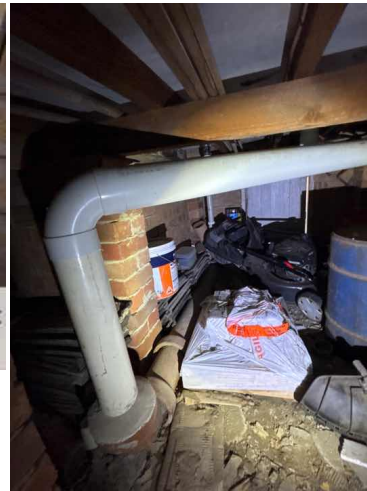
Example of termite workings in stairs adjacent to the bathroom

There deterioration to some localised areas of the superstructure, particularly near the bathroom. The deterioration appeared to be minor/superficial. Recorded repair as necessary by a suitably qualified tradesperson.

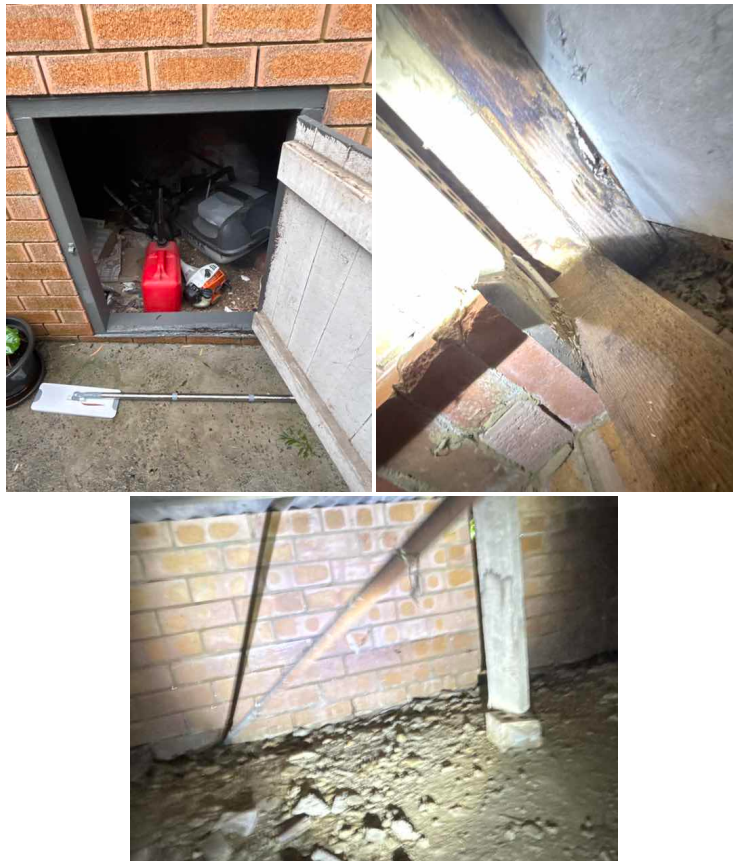
Form work remains (e.g. beneath the entry porch).

The extent of rot damage is considered to be moderate.

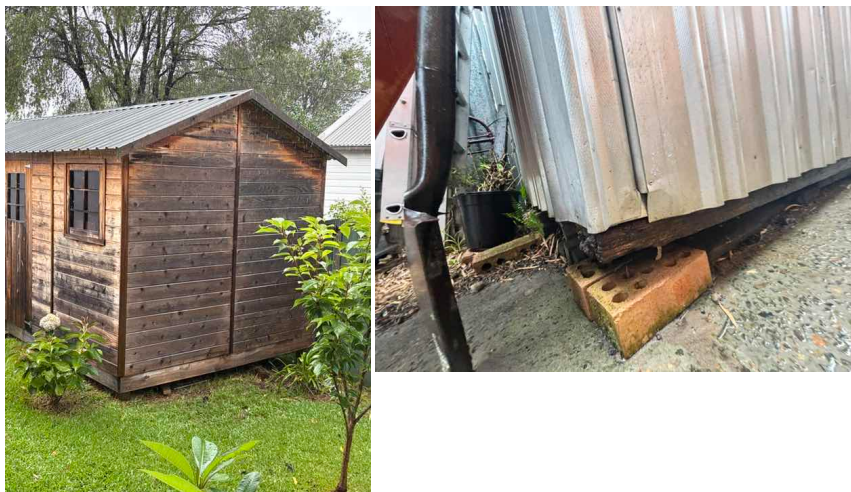
Shed timbers (e.g. superstructures).

The extent of rot damage is considered moderate to be high.

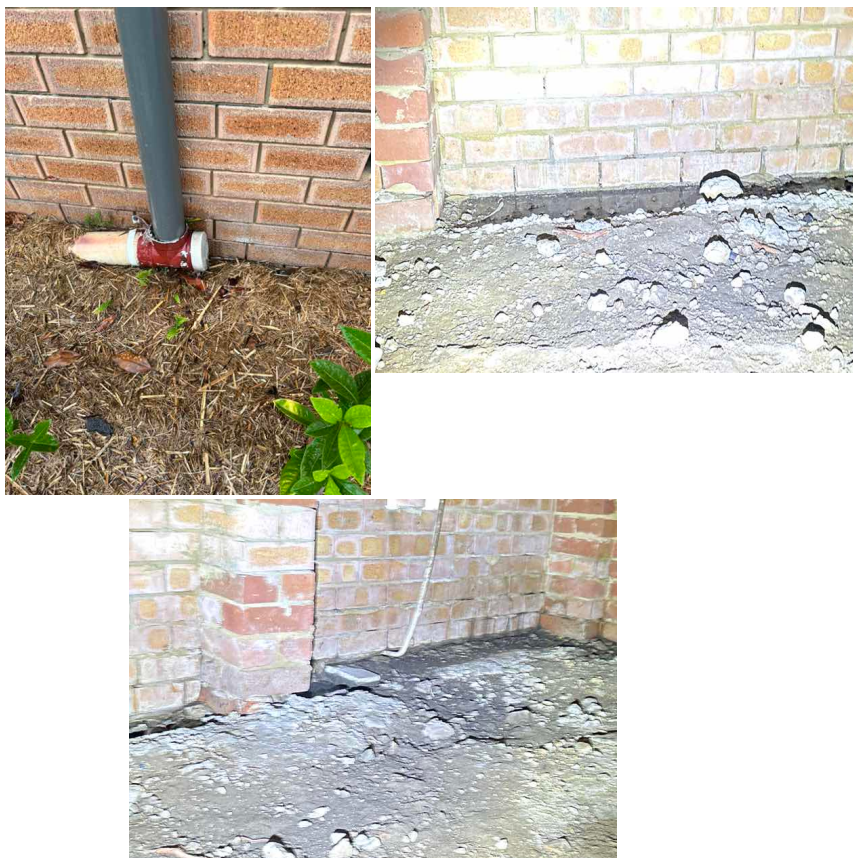
There was inadequate drainage in the subfloor. Recommend a licensed plumber is engaged for advice and rectification.

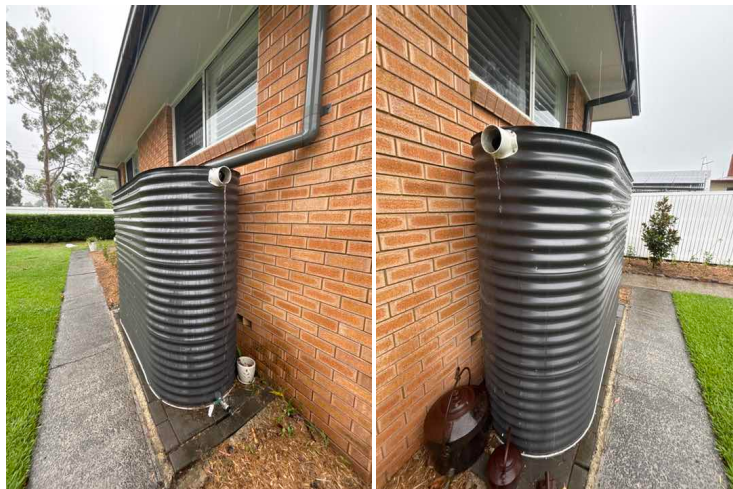
No - Divert overflow away from the building perimeter.

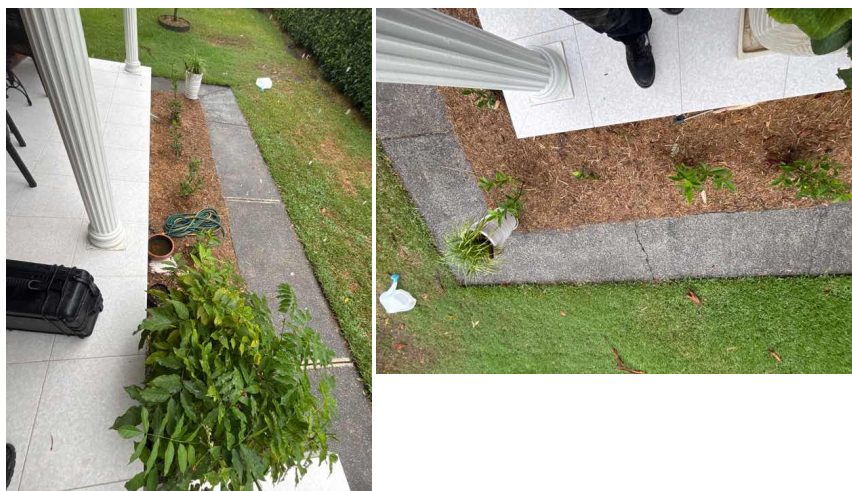
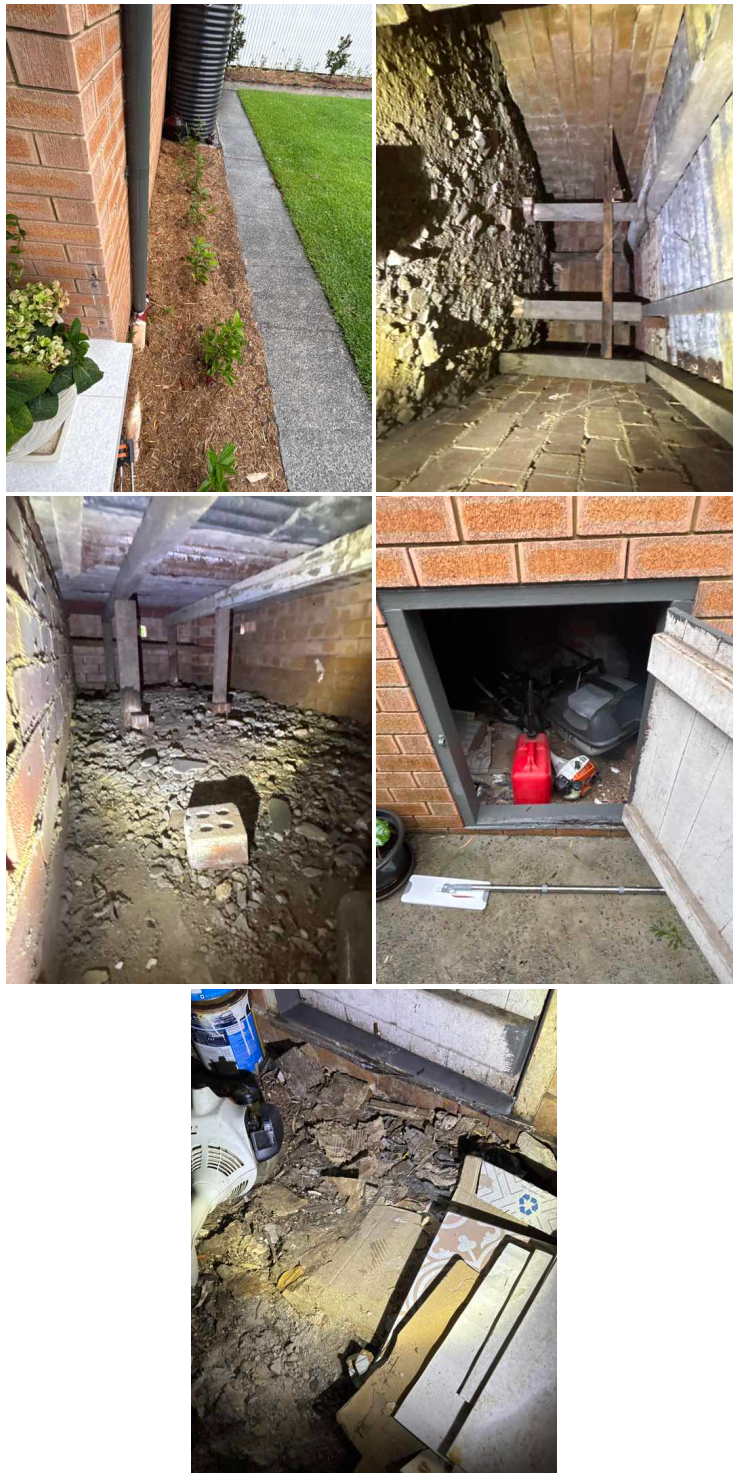
Formwork remains in the subfloor.

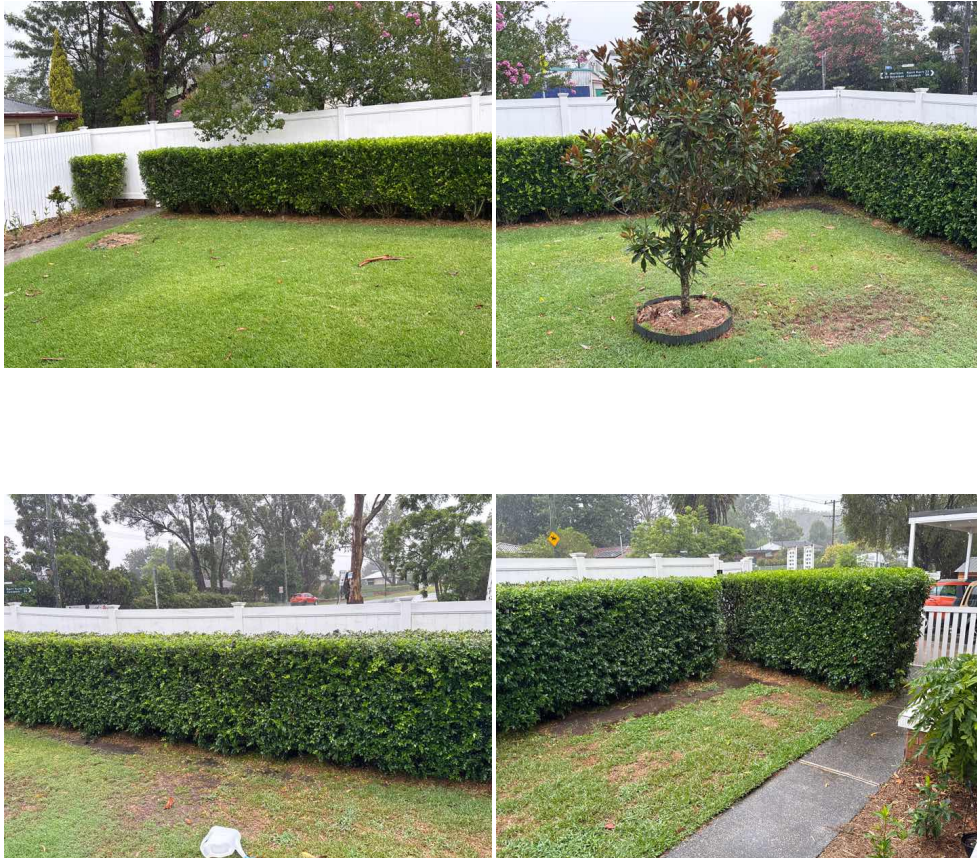
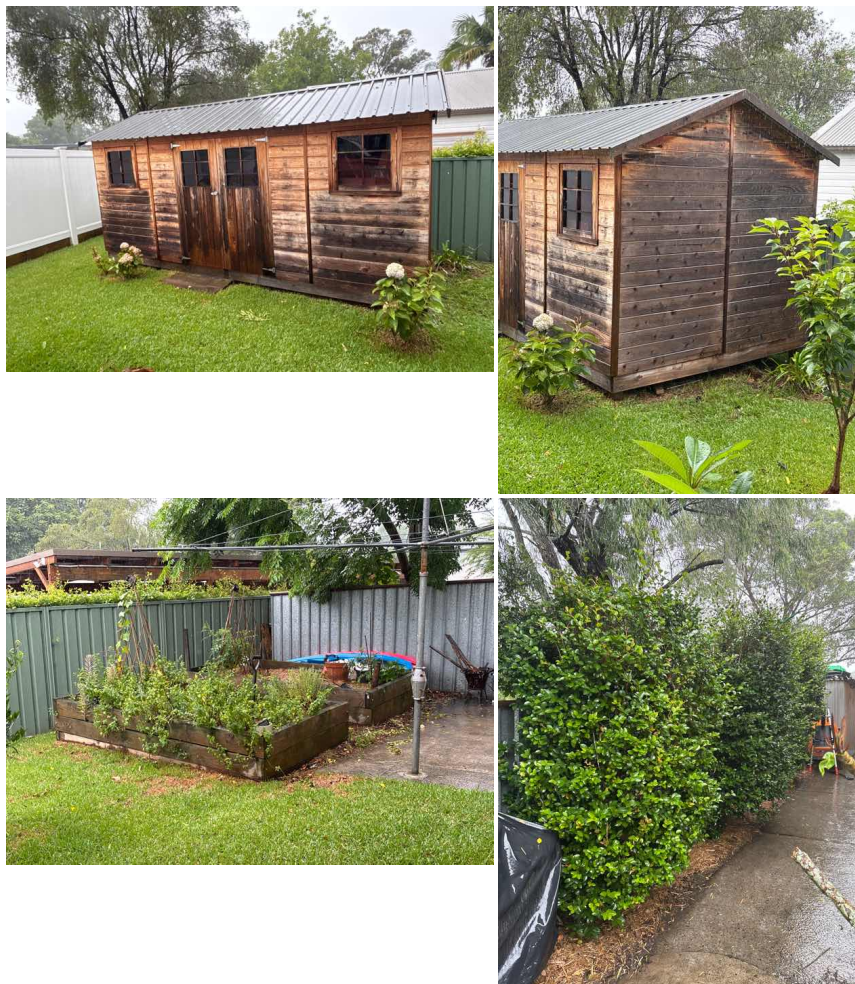
Garden beds and vegetation were located on the property.
