Citation:	Deere, D. (2021) DRDMW HSC DWQMP Audit 2021. Report. Document produced for Hinchinbrook Shire Council and Water Futures Pty Ltd.
File Name:	HSC 2021 DRDMW DWQMP Audit Report V2.docx
Project Director:	Peter Martin
Project Owner:	Hinchinbrook Shire Council
Name of Project:	DRDMW HSC DWQMP Audit 2021.
Name of Document:	Report
Cover:	Logos are © Hinchinbrook Shire Council and Water Futures Pty Ltd. Images are © Water Futures Pty Ltd.
Sensitivity:	This document is copyright and confidential. The document, its concepts and contents are not for citation, circulation or duplication without permission.

This report summarises a standard regular audit of the way in which Hinchinbrook Shire Council (HSC), the Services Provider number SP62, complies with its approved *Drinking Water Quality Management Plan* (DWQMP). The objective of that audit was to:

The version of the DWQMP audited was the *Drinking Water Quality Management Plan*, Revision E, 14 May 2018. The audit covered the HSC drinking water supply scheme including the recharge area, bores, water treatment and distribution systems.

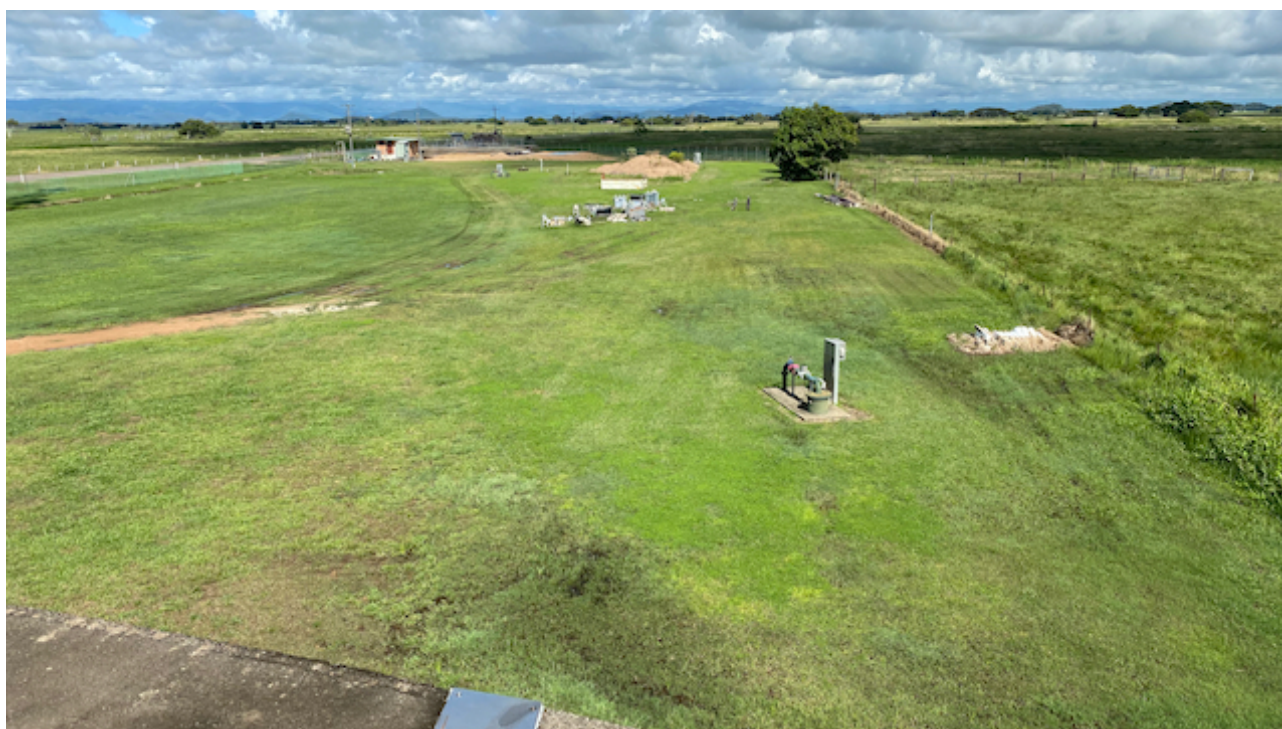
- The closest potential pollution sources within the potential recharge areas and wellhead protection zones of the bores were:
 - Potential Brahman cattle grazing in the paddock adjacent to, and within approximately 10 to 100 m of, the Forrest Beach bores (Figure 6-2). The density of stock surrounding the Forrest Beach bore is not thought to be high with some beef cattle being observed in the distance but no evidence of recent grazing in

Figure 6-1. Forrest Beach borefield showing bores in fenced off area but noting the Brahman cattle paddock adjacent to it. During the audit there was no evidence of recent cattle activity in the paddock. The area was swampy so access if it occurs is more likely during drier periods.

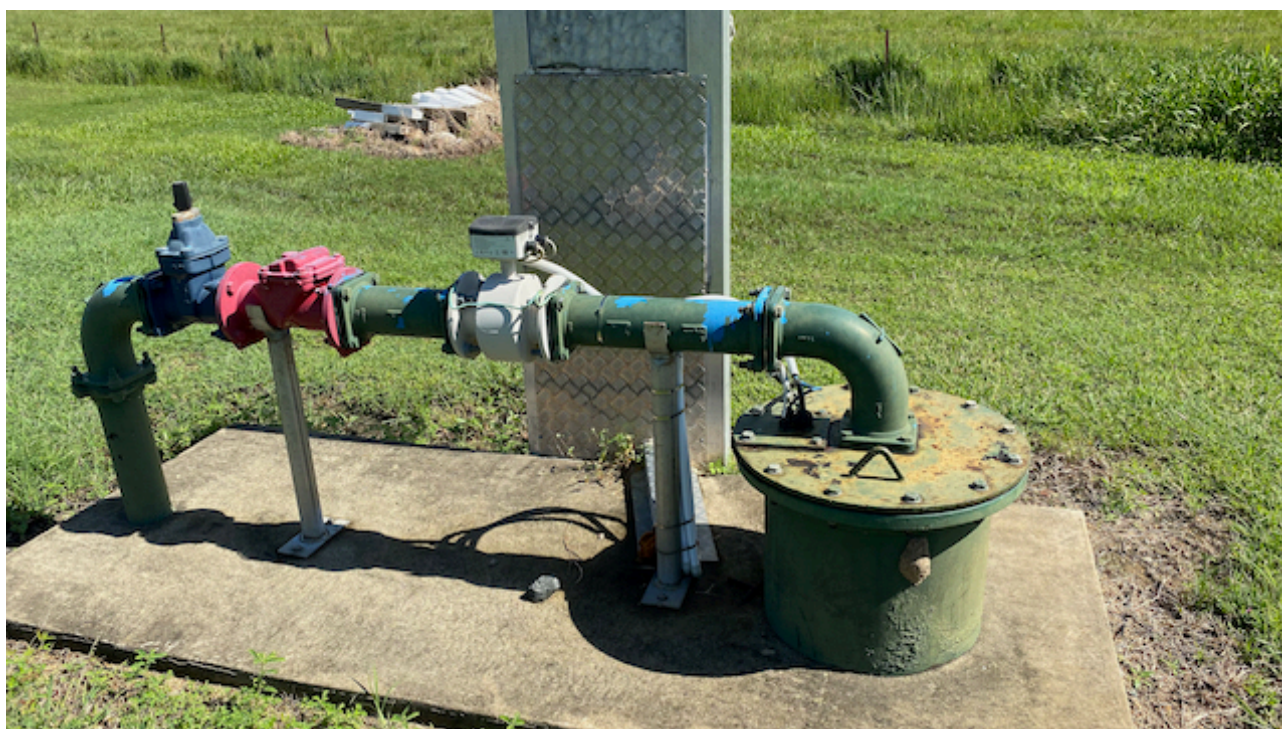
Figure 6-2. Forrest Beach bore number 8 in good surface condition but with a Brahman grazing area in the background.

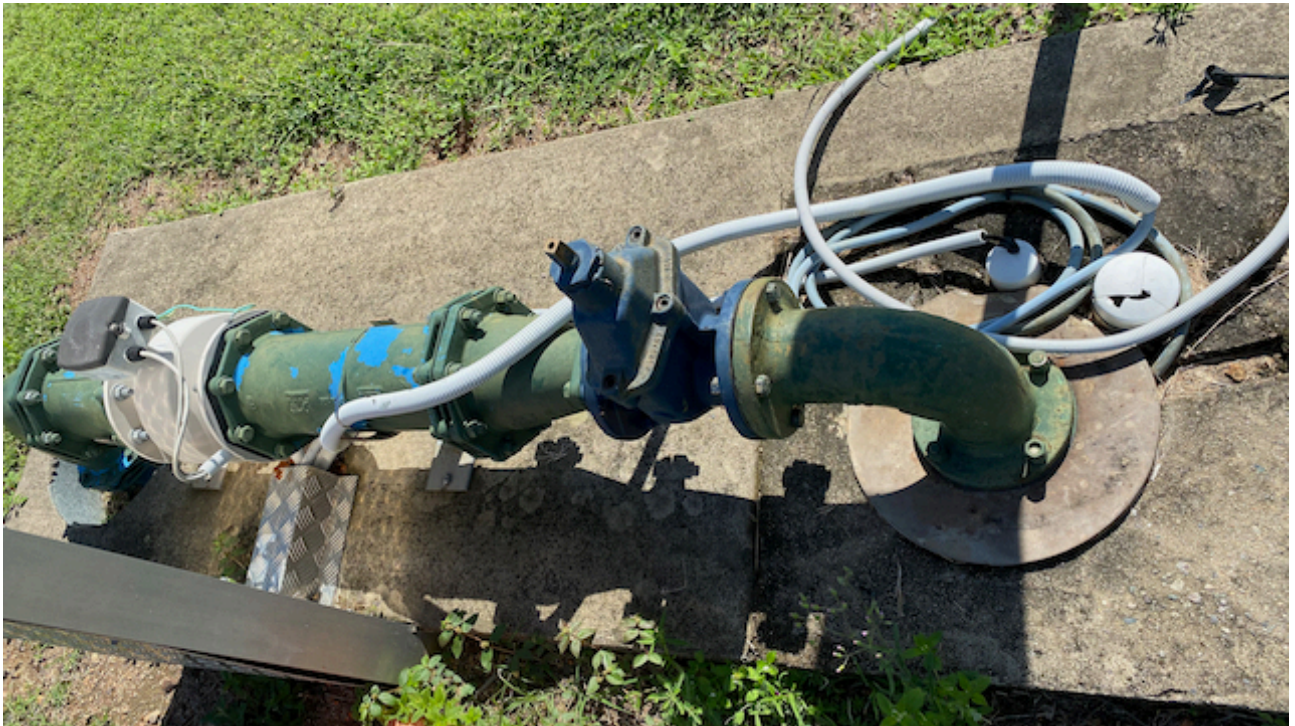
- No evidence was found of significantly cracked or damaged concrete aprons or grouting, casing surface structures or cable entries. Minor damage was found to a plastic cap on an access point to the outer casing of Forrest Beach bore number 7 (Figure 6-3). An OFI is not raised here as this was related to a broader problem of minor defects not being rectified due to organisational capacity which is discussed in section 5.2.5.

Figure 6-3. Forrest Beach bore number 7 in with small crack in PVC access point.

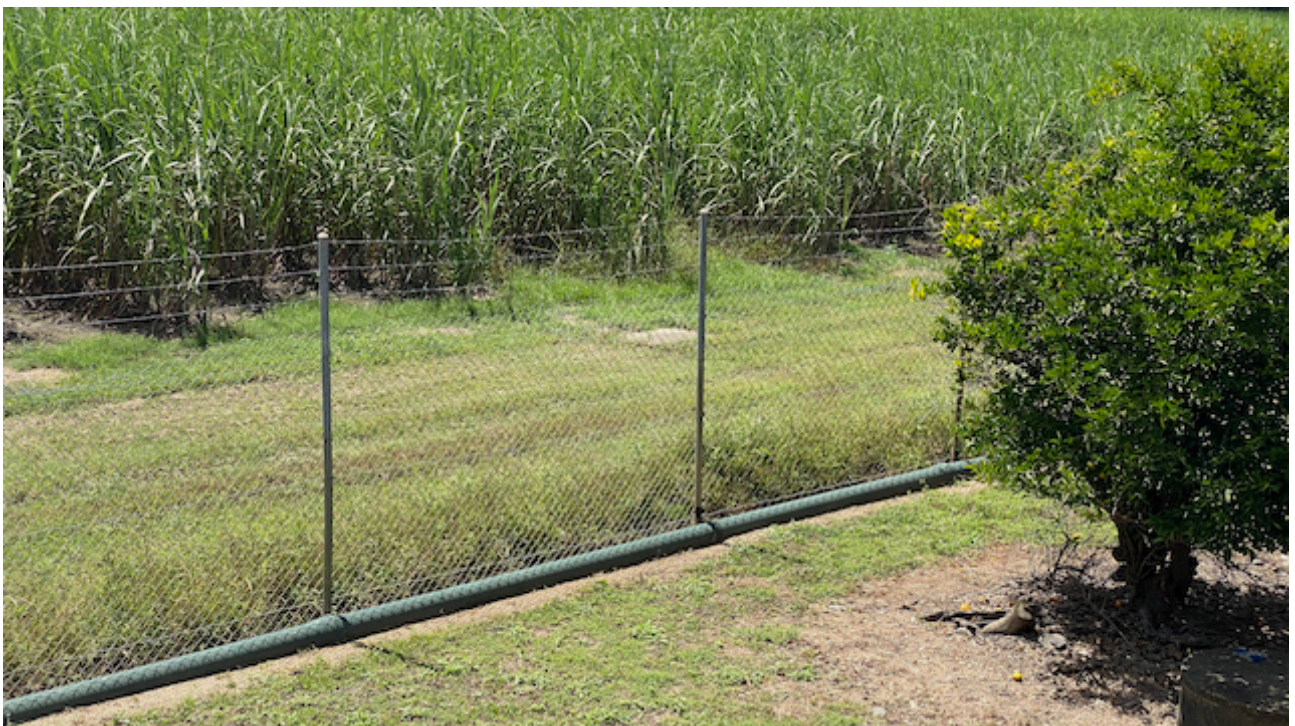
Figure 6-4. One of the Macknade bores in a cane farm.

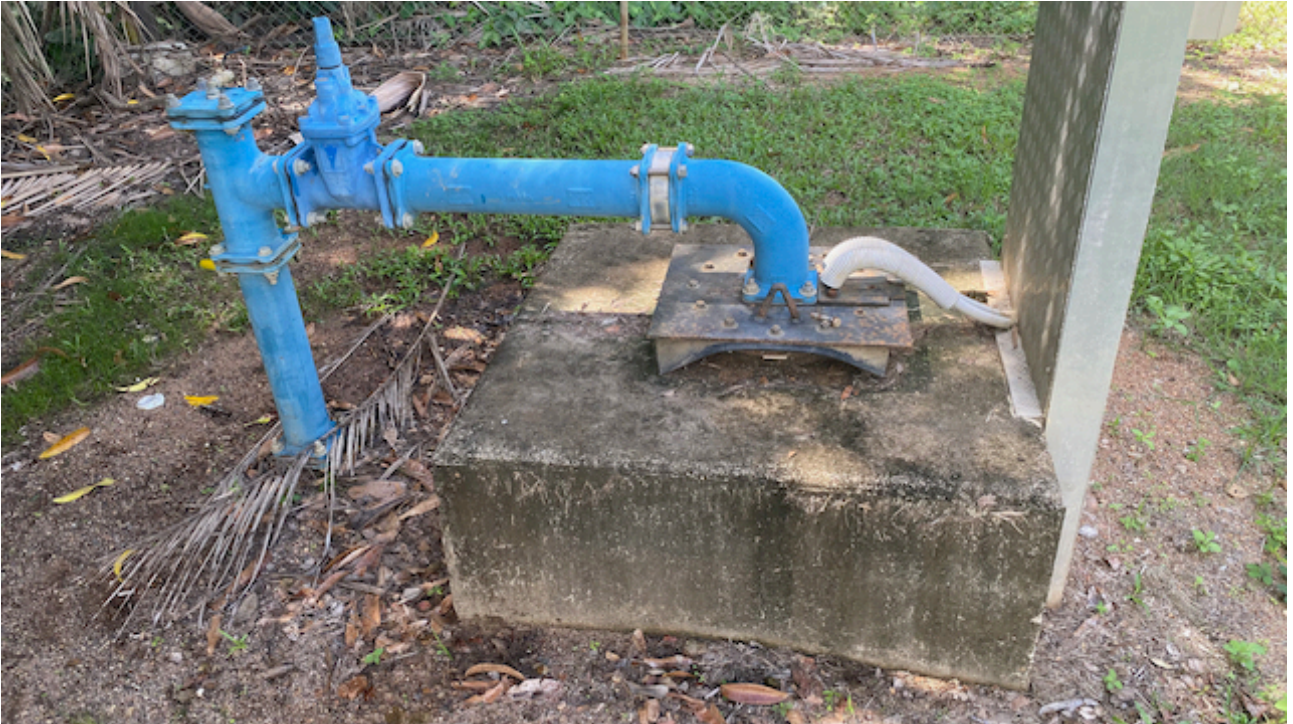
Figure 6-5. One of the Macknade bores in a road reserve on Mill Road with good surface structures but sitting within 50 to 100 m of several onsite sewage management systems on private properties.

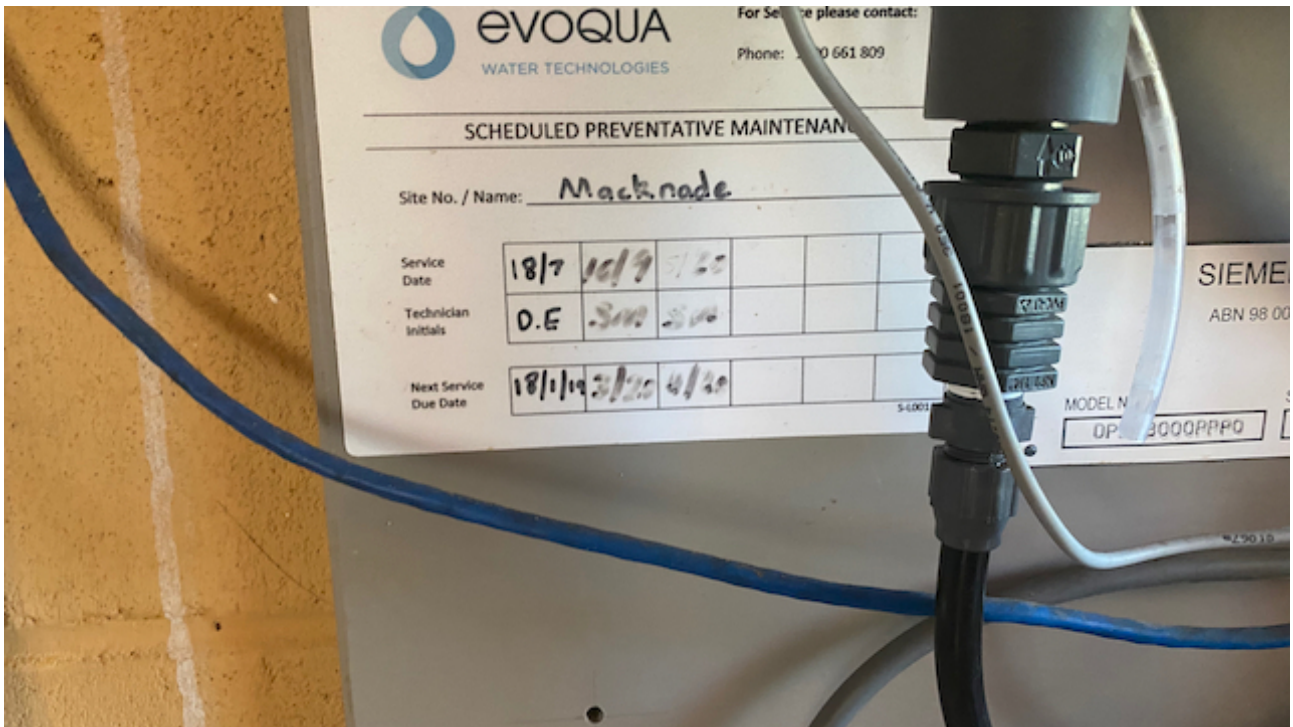
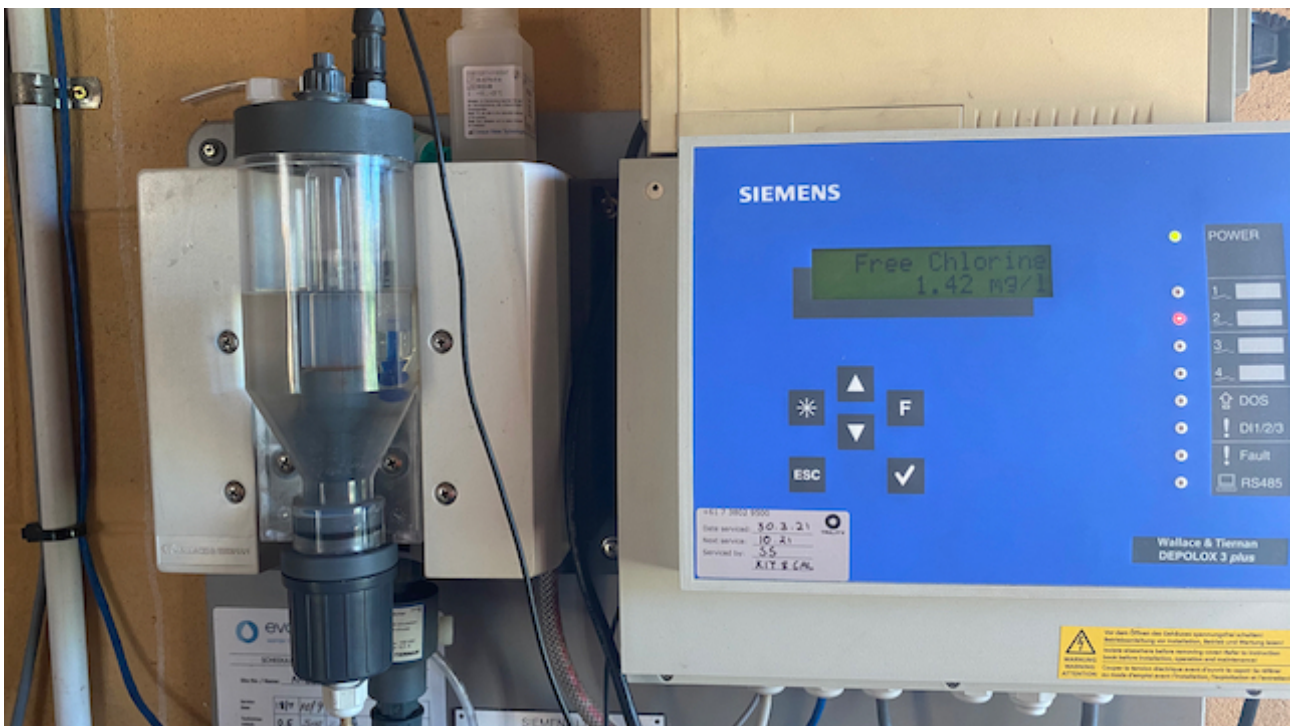
Figure 6-11. Chlorine analysers at Macknade WTP showing evidence of annual service technician maintenance by Evoqua and TRILITY.

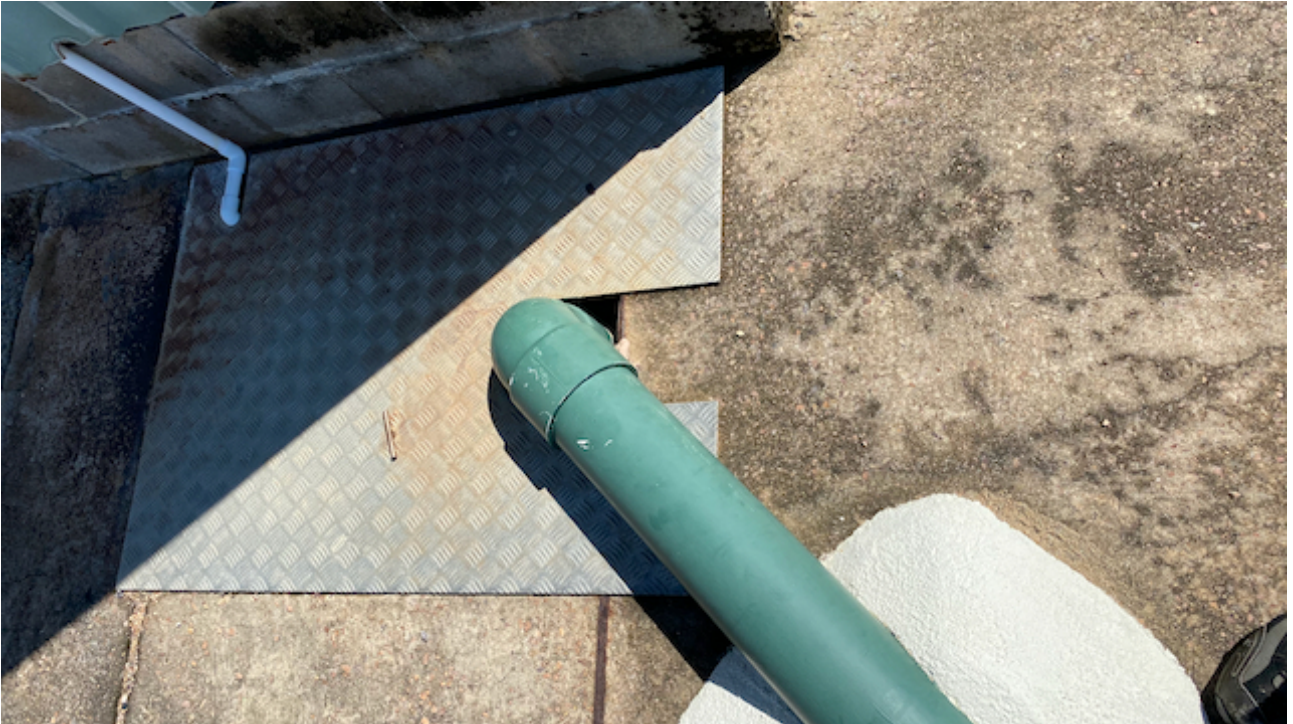
Whilst there is no clear pass/fail standard for protecting treated water storage tanks against ingress from vermin and runoff, the location and size of the entry points was considered to be non-compliant at the time of the field audit with a reasonable definition of a 'closed' treated water storage tank preventive measure. Therefore, the physical infrastructure was not compliant with the DWQMP at the time of the field audit with respect to the integrity of this preventive measure.

In summary, at the time of the field audit, the preventive measures relating to the integrity of the treated water storage tanks as barriers to ingress from vermin and runoff was considered non-compliant. The non-compliance was mitigated to being insignificant from a health risk perspective given the reliable chlorine dosing systems that were in place and the good history of chlorine residuals and *E. coli* results in the treated water storage tanks and the reticulation system. HSC was in the process of rectifying these defects. As a result, DRDMW was not notified immediately. The non-compliance was mitigated to being insignificant from a management system perspective given that Council was already aware of the defects – hence the system was 'working' – and was triggering action to rectify the defects when resources permitted.

Figure 6-14. Forrest Beach clearwater storage tank with potential runoff and vermin ingress point.

- Setting criteria for treated water storage tank integrity preventive measures to ensure they act as barriers to the entry of ingress from vermin and runoff as far as reasonably practicable. Undertaking the works required to raise the standard of treated water storage tank integrity preventive measures to reach or exceeded the agreed criteria. Embedding safe and practicable asset and/or operational management systems to inspect treated water storage tanks and maintain and repair them in a preventive manner.

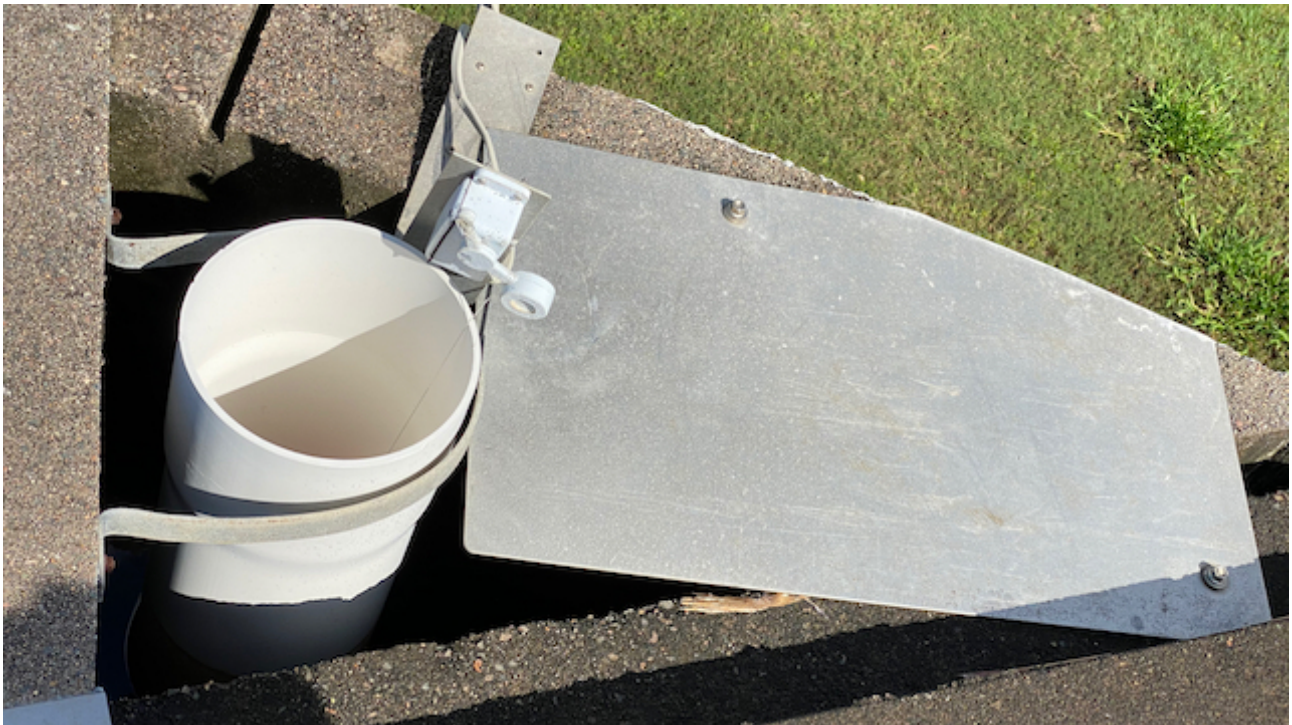
Figure 6-16. Forrest Beach treated water storage tank with potential runoff and vermin ingress point.

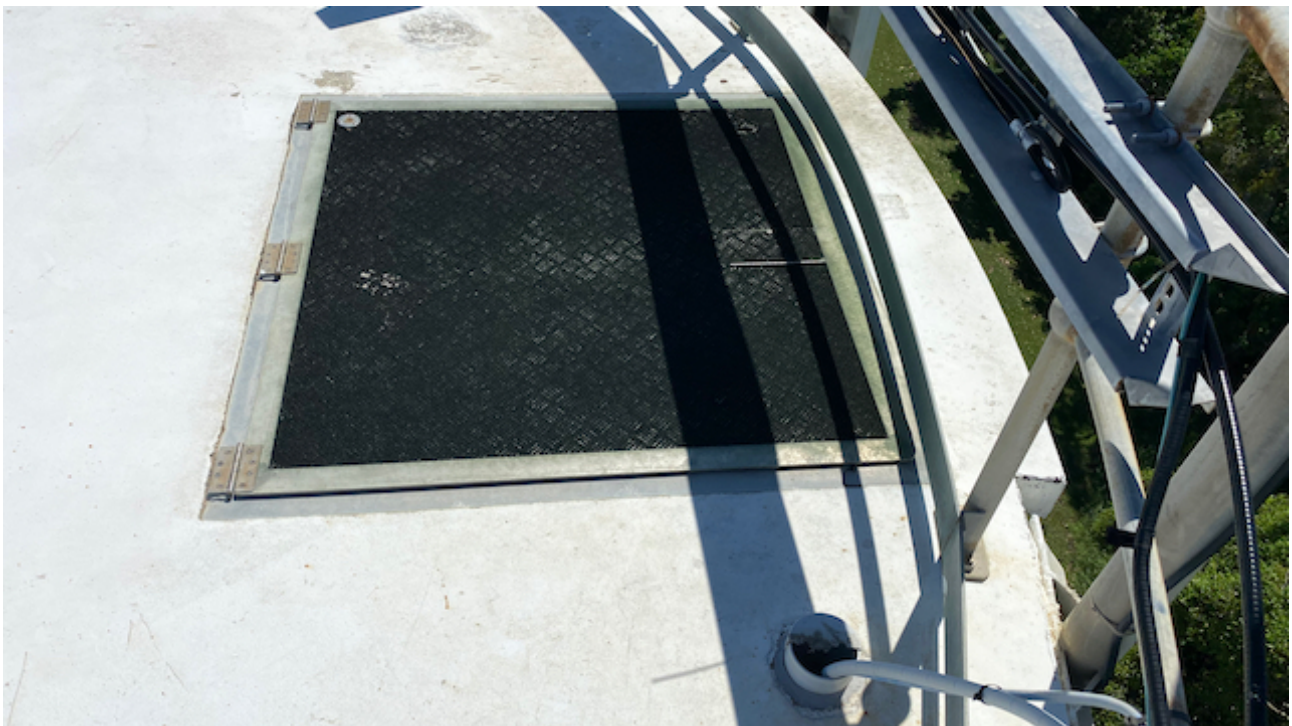
Figure 6-19. Forrest Beach water tower with potential runoff ingress point and vermin.

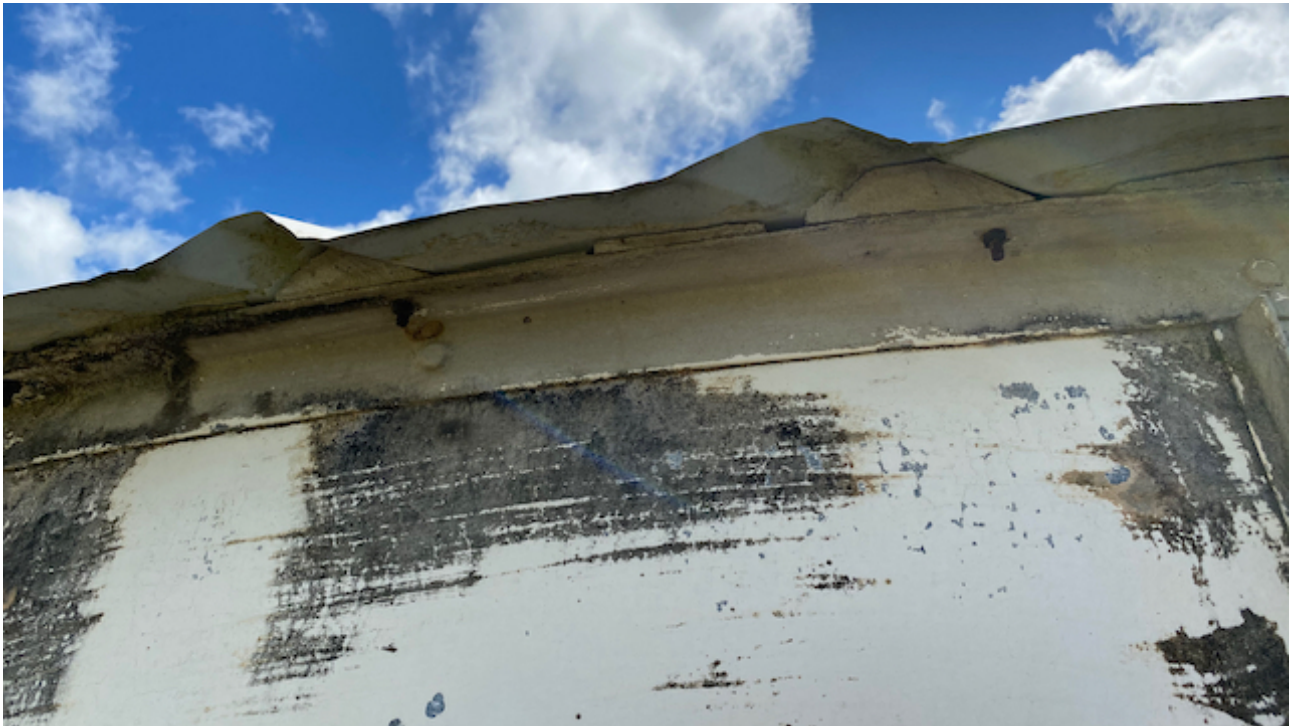
Figure 6-21. Grouted vermin-proofed corrugations on treated water storage tank at Macknade.

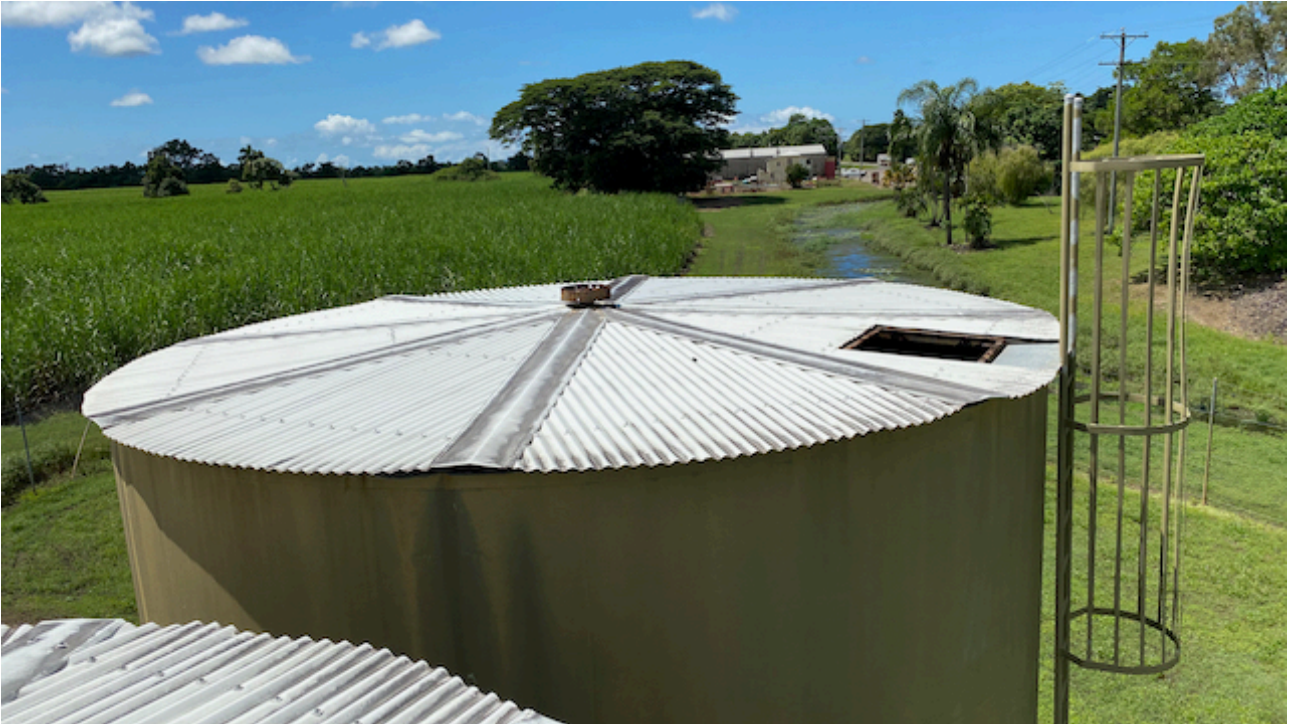
Some recent high wind damage had resulted in some preventive measures not operating as per their design intent and by the time of the field audit these had yet to be rectified. Specifically, the hatch and vent structure on one of the treated water storage tanks had become damaged and a number of other potential ingress points were noted in treated water storage tanks due to loose-fitting roof sheets and other minor damage. HSC was in the process of seeking support to repair these during the field audit but doing so had taken some time.

Figure 6-23. Wind-damaged vent cap and vent on treated water storage tank at Macknade allowing potential vermin and runoff entry.

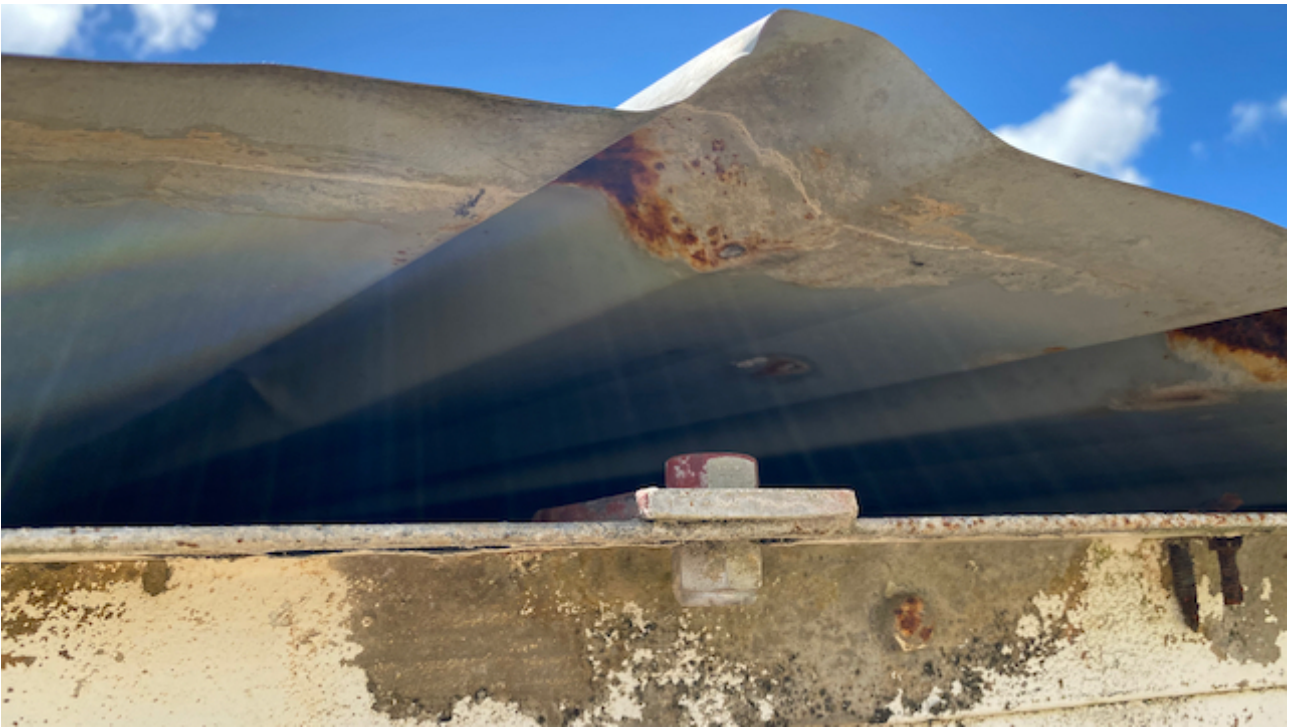
Figure 6-26. Wind-damaged sheeting fastenings on treated water storage tank at Macknade allowing potential vermin entry.

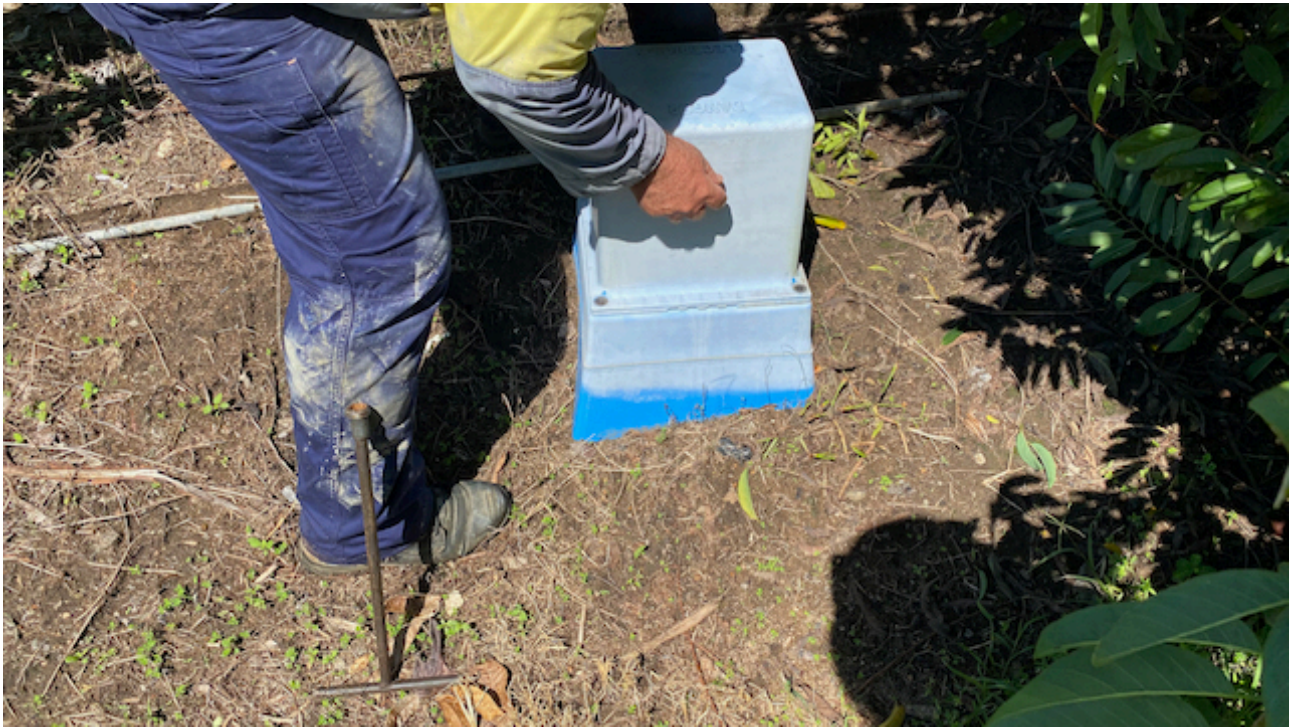
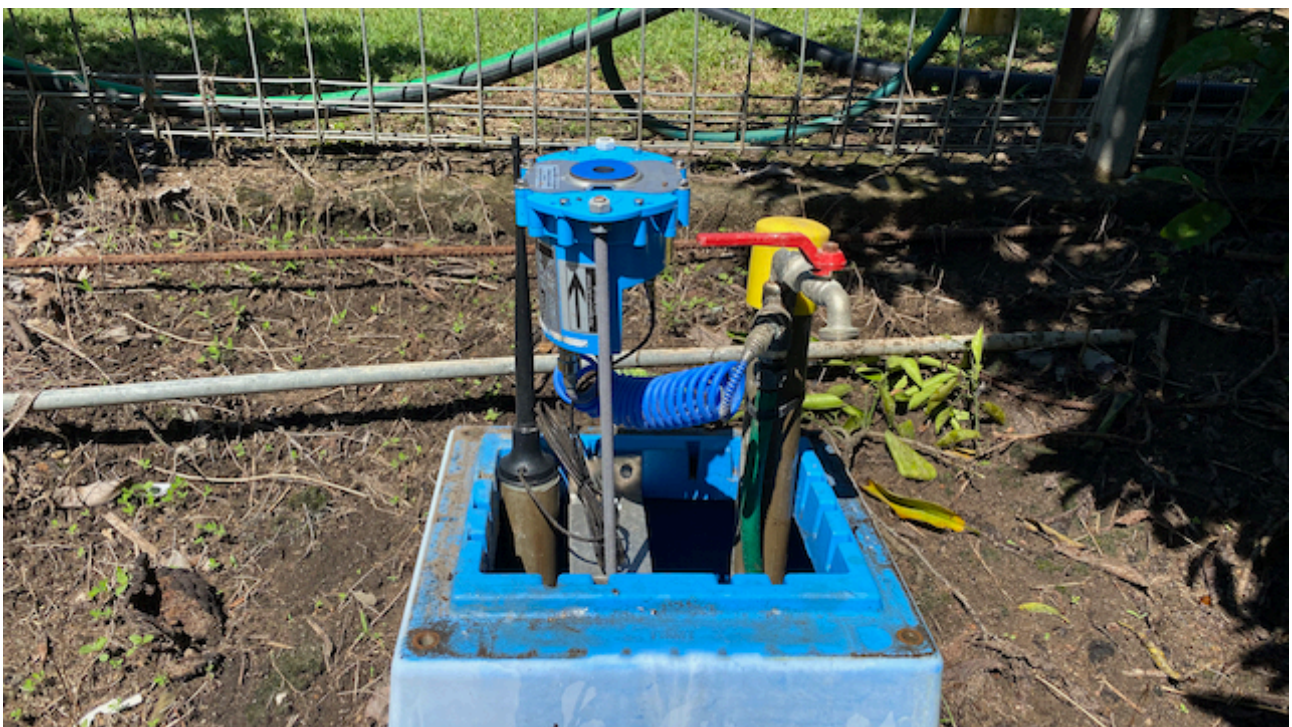
Figure 6-28. Example of excellent sampling tap and covering with online pressure transmitter (Pangola Street, Forrest Beach).

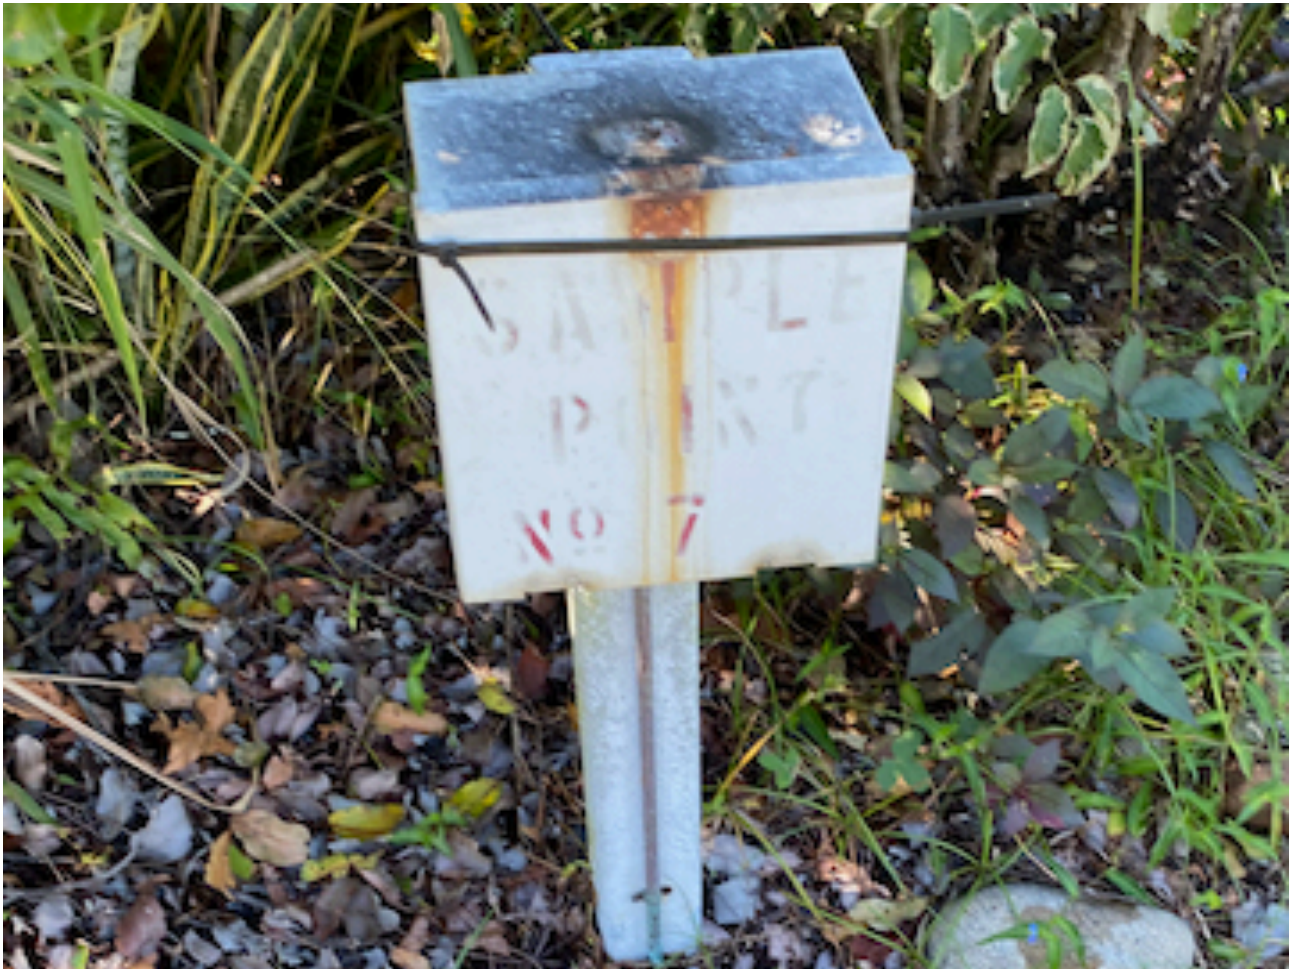
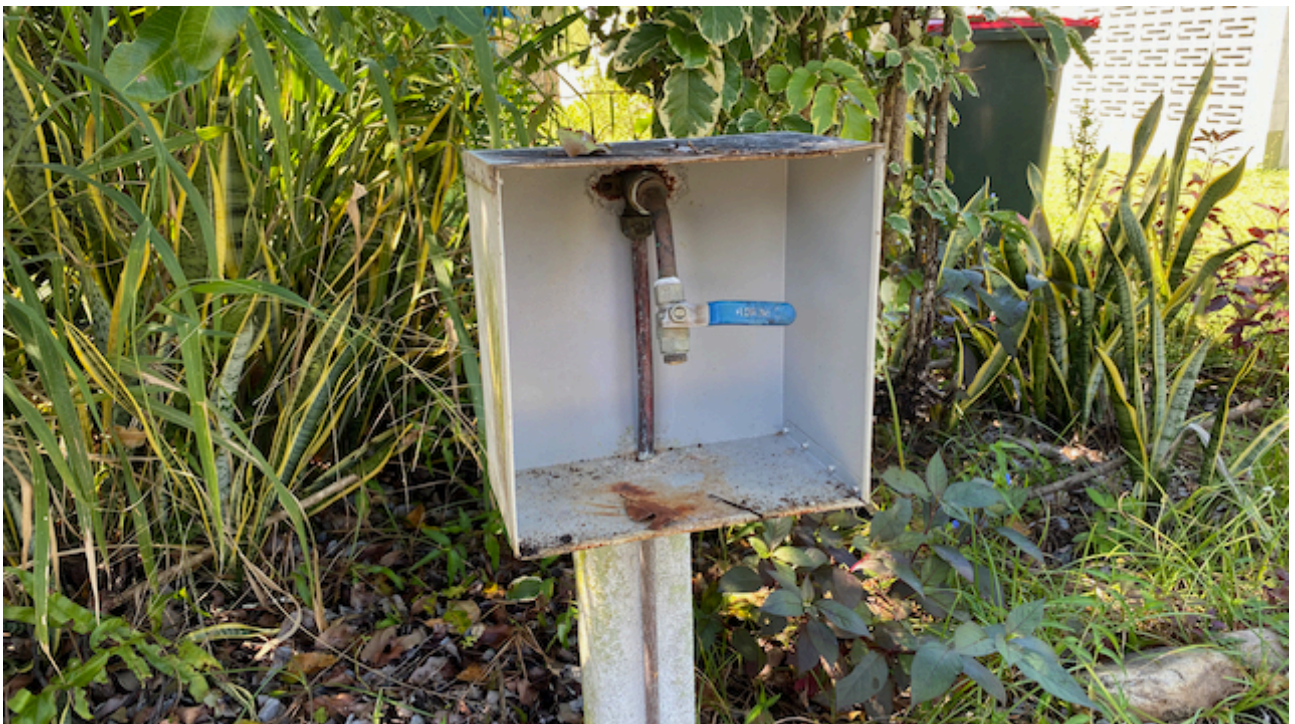
Figure 6-29. Example of an older design of covered sampling tap and covering (Allamanda Avenue, Forrest Beach).

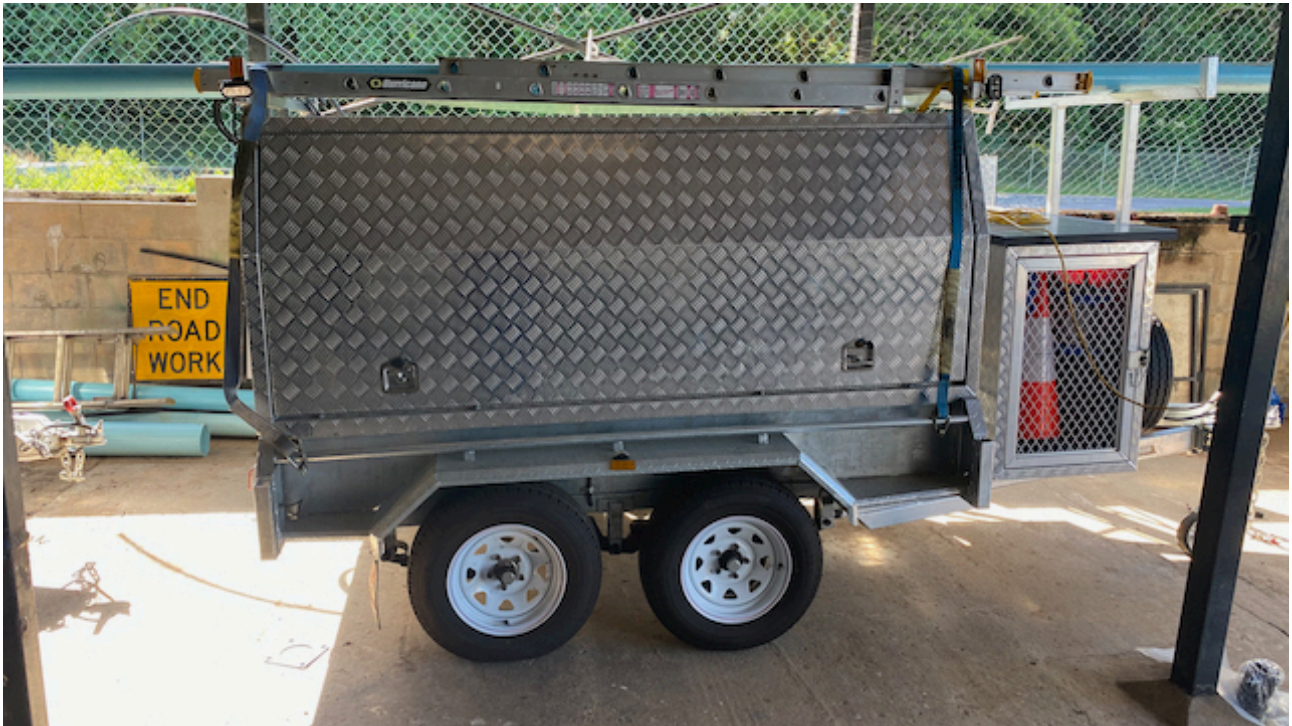
The stores, gang truck and water maintenance trailer were inspected and network operator was interviewed. All parts and fittings found within the stores and on the maintenance vehicle and trailer were fit-for-purpose (e.g. bearing the WaterMark stamp and/or showing AS 4020 compliance markings). The parts and fittings were stored in hygienic conditions undercover away from sun damage. The major parts and fittings in use were the larger diameter PVC pipes and associated couplings (Figure 6-32) and Vinidex PE PN 12.5 smaller diameter pipes (Figure 6-33). Smaller parts (Figure 6-34) and meters (Figure 6-35) were suitable and appropriately stored. The water trailer (Figure 6-36) securely housed appropriate parts and fittings (Figure 6-37).

Figure 6-36. Dedicated water works trailer.

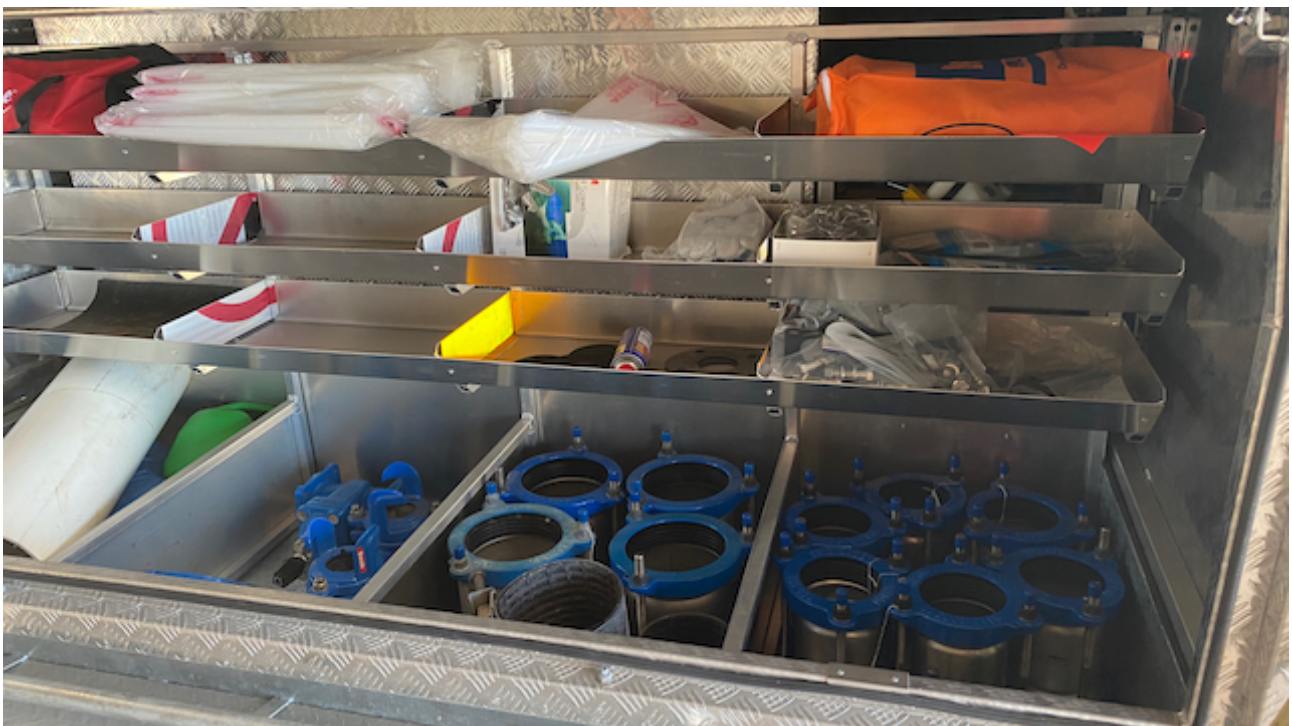
Figure 6-37. Dedicated water works trailer properly equipped with appropriate parts and fittings.
