# Ports North Offsets Management Plan

## GreenCollar Progress Report August 2026

# Progress Report - Ports North Offsets Management Plan – GreenCollar

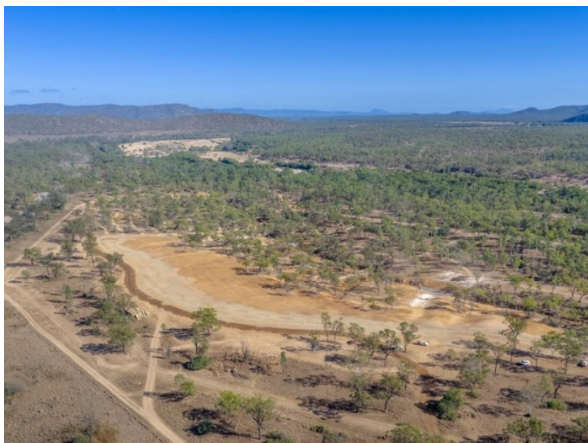
On-ground works at BRGR#1 were completed on the 17<sup>th</sup> of September 2025, with full demobilisation from site occurring on 19 September 2025 (Figure 1). The April 2026 post-wet season inspection confirmed that the BRGR#1 site is performing successfully and that the rehabilitation objectives are being achieved (Figure 2). All engineered structures, including Rock Chutes 1–5, were found to be stable and functioning as intended, with no evidence of significant structural movement or failure. Sediment accumulation within and around the rock chutes indicates effective reduction in flow velocities and ongoing sediment retention, which is supporting vegetation establishment within the gully system (Figure 3).

*Figure 1 Post work -October 2025*

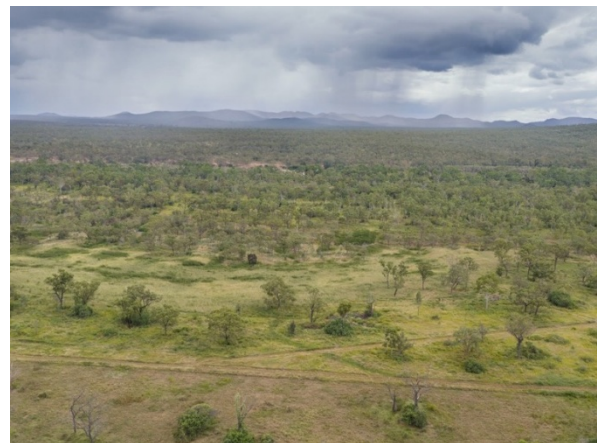
*Figure 2 Post Wet season - April 2026*

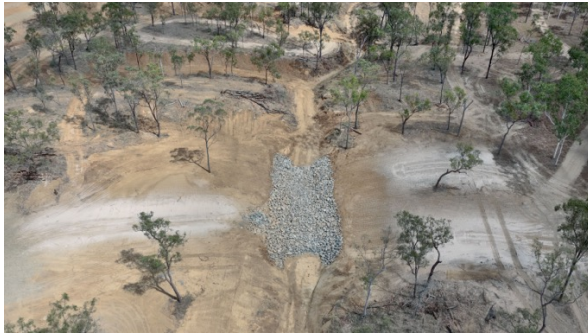
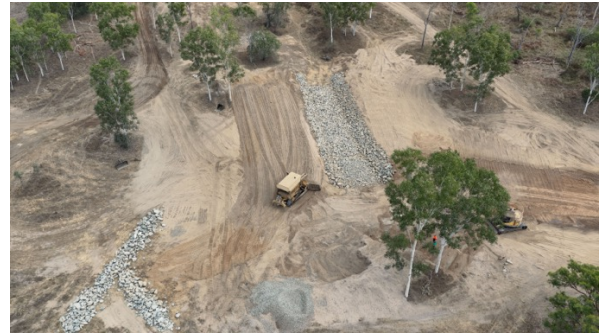
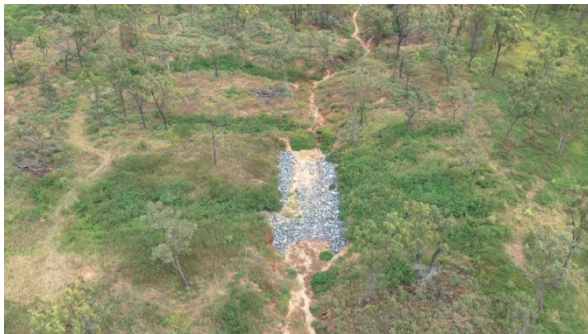
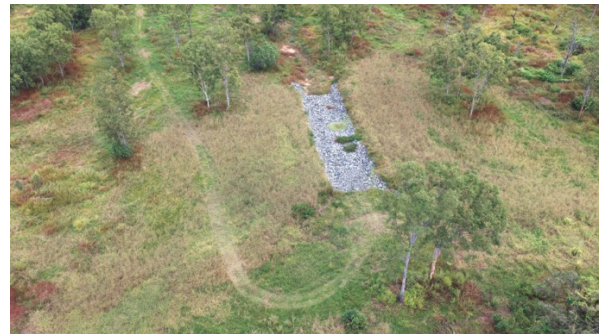
*Figure 3 Rock Shutes post construction and post wet season*

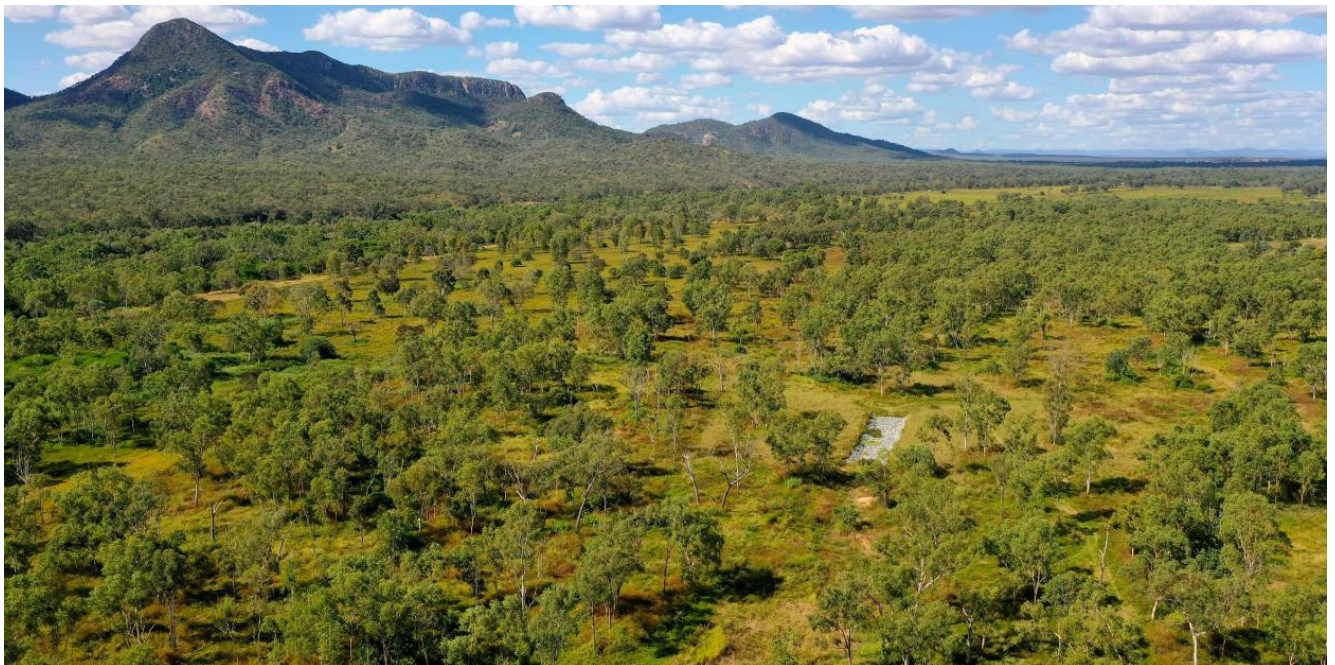
Vegetation establishment across the site has been highly successful, with near-complete ground cover achieved in most rehabilitated areas (Figure 4). Seeded pasture and legume species, together with strong natural regeneration of native grasses, have significantly improved soil stability, reduced erosion risk and enhanced overall land condition compared to pre-construction conditions. While some minor rilling and localised erosion features were identified, these were generally limited in extent, likely associated with early wet-season rainfall events prior to full vegetation establishment, or linked to temporary construction access areas (Figure 10). Prompt remediation of these features is important, as they may compromise the stability of the adjacent abutment protection and potentially affect the integrity of the broader rehabilitation area.

*Figure 4 Aerial image of Mt Wickham Gully Rehabilitation*

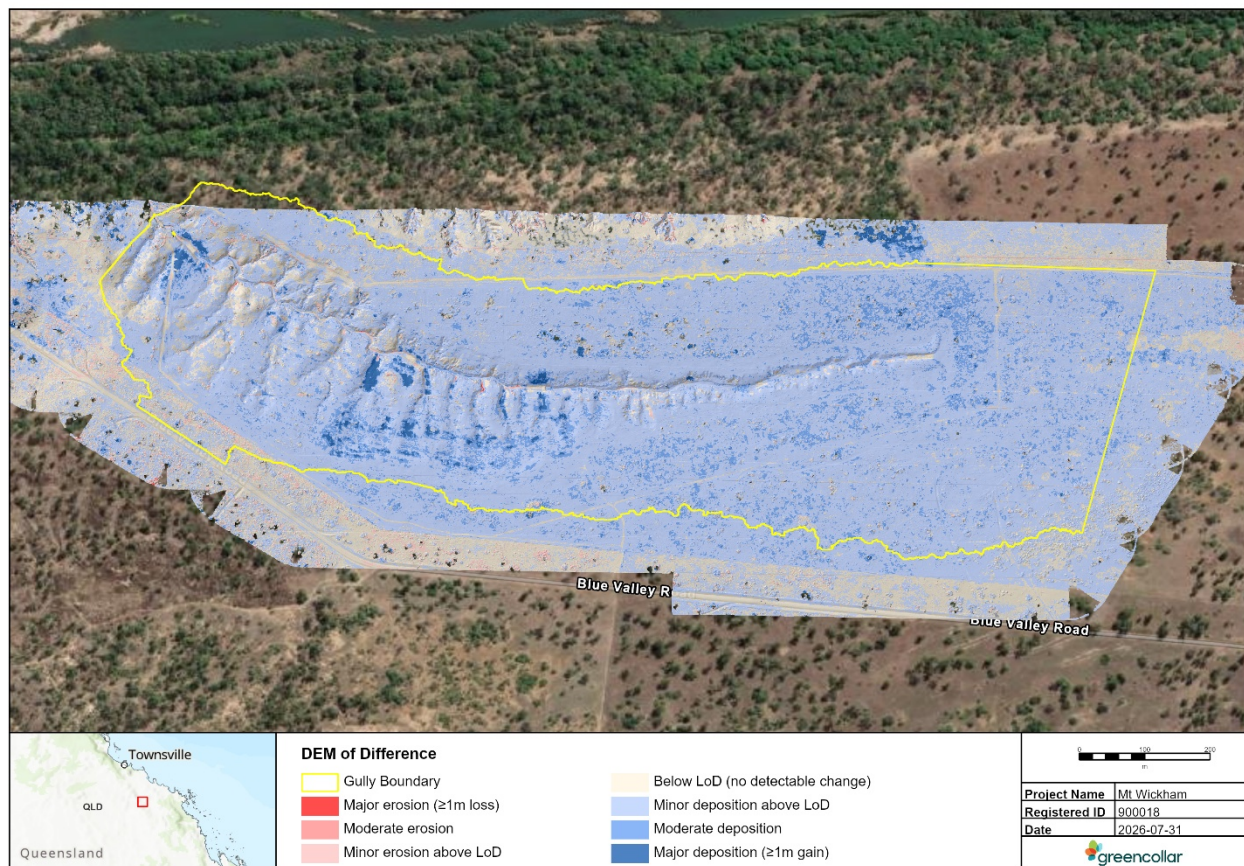
GreenCollar used this data to create a bare earth DEM's for both surveys and then created DEM of Difference (DoD) over the site (Figure 7). High vegetation growth on site post wet season survey interfered with the LiDAR signal returns creating uncertainty in the bare earth DEM leading to false positives in sediment deposition. This is highlighted in areas with >1m deposition (coinciding with areas of dense vegetation). The DoD did highlight small patches of rills (<30cm deep) and gullies (>30cm deep) forming along the batter sections of the rock chutes, these areas are being monitored, and corrective actions will be taken.

Figure 7 Resulting DoD between the post construction and post wet season aerial LiDAR surveys. Areas of major deposition are likely the result of false positive signal returns from high vegetation growth. Small occurrences of erosion in limited sections of the gully will be monitored to see if interventions are required.

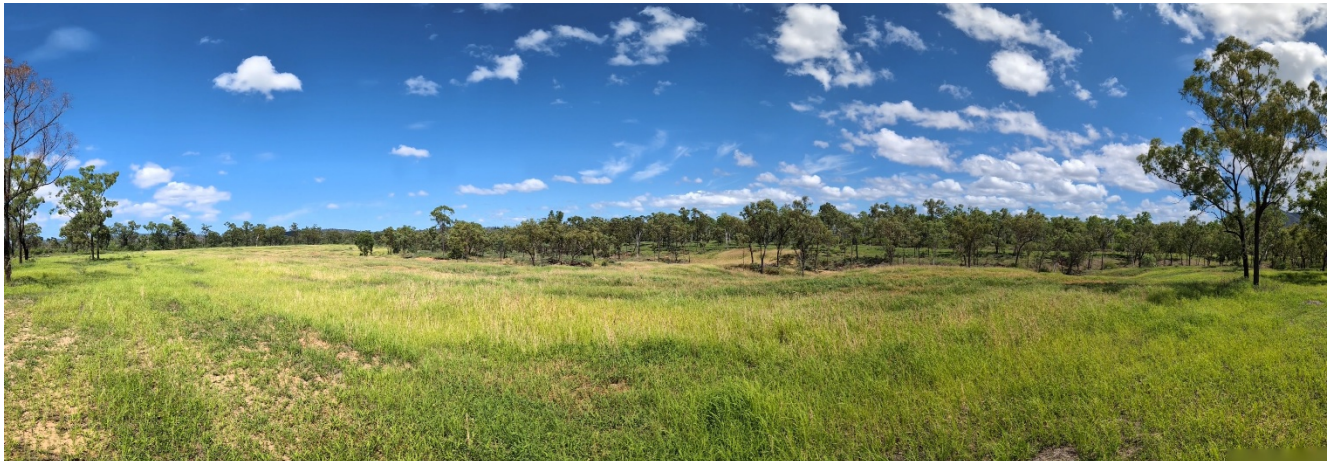
*Figure 8 Erosion scarp reshape area on 19th December 2025 showing successful grass recruitment.*

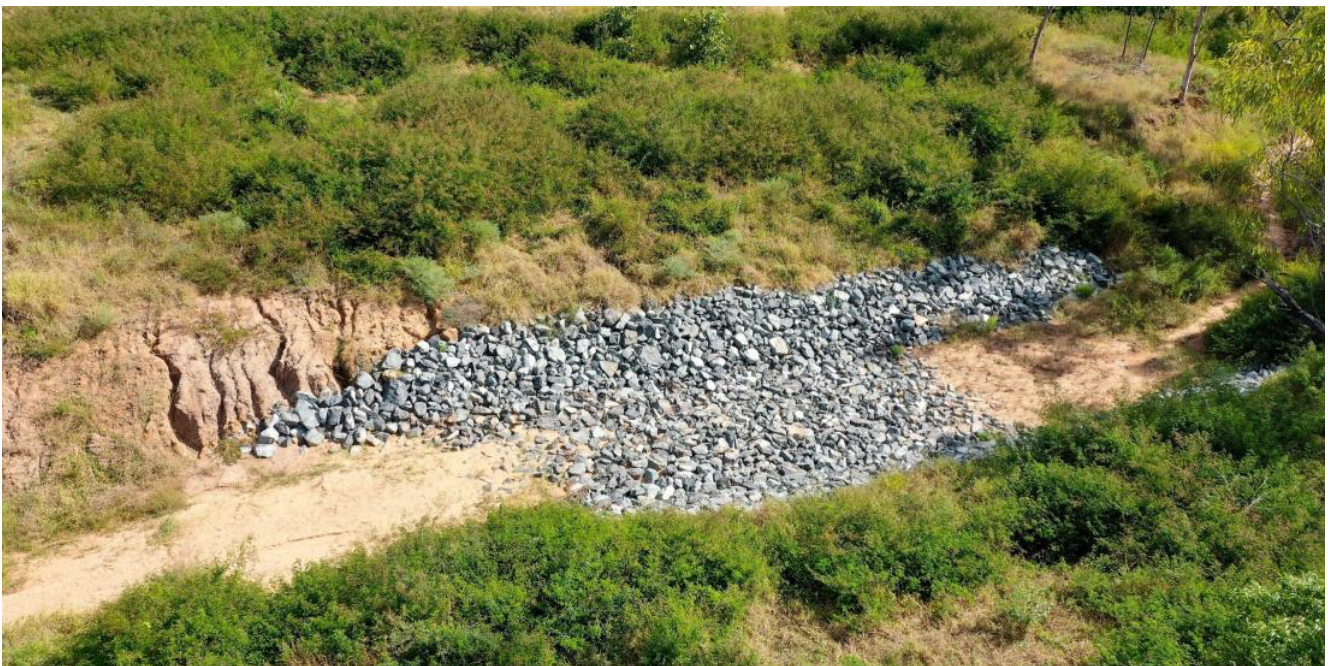
*Figure 10 Rock Chute 4 looking south, evidence of rill and gully erosion on batter. photo supplied by Verterra.*
