## Confidential Inspection Report

101 ELECTRA STREET, BUNDABERG WEST QLD.

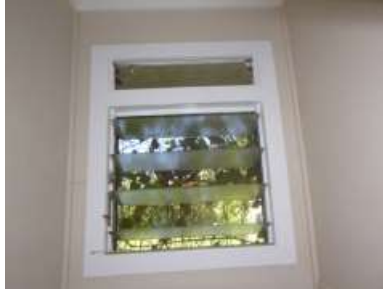
*Sash Operation / Fittings* / Some hardware requires easing.

*Hardware* New slider cliplocks required to various windows.

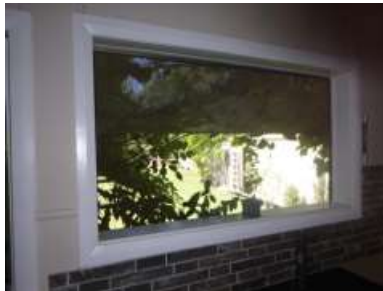
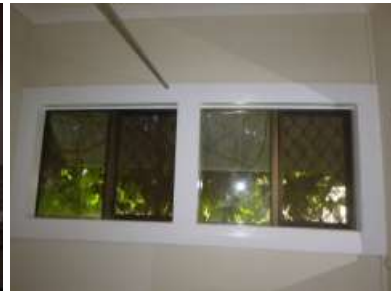
Window to the kitchen is missing.

The two sliders to the bathroom window are missing.

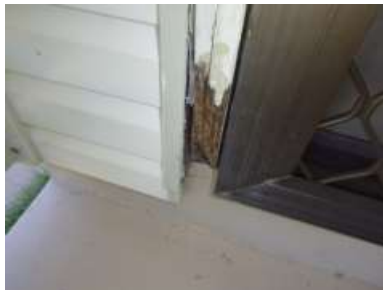
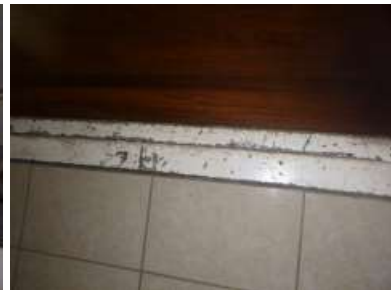
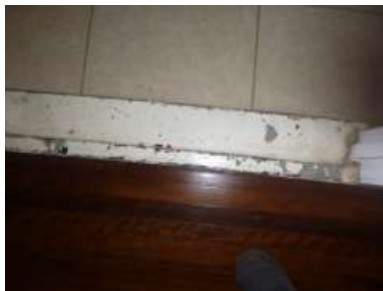
Evidence of weather damage to the base of the timber door frame requires repair / repainting.

Paintwork to some door frames requires touching up / repainting.

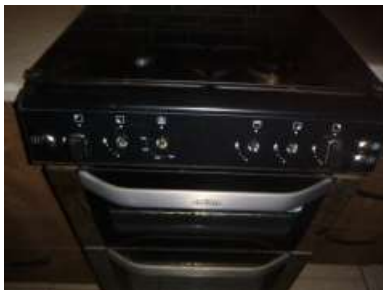
Some knobs to the stove are missing.

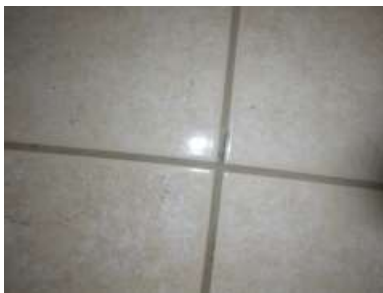
Percussion chips &amp; hairline cracks to some floor tiles.

Some floor tiles to the concrete slabs are drummy, recommend getting them injected.

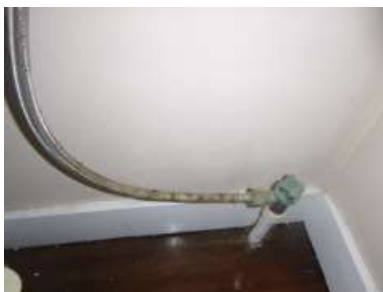
Flexi hose to the toilet is worn, recommend replacing.

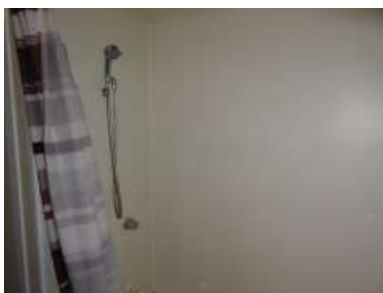
*Other (specify)* The bathroom is old but functional.

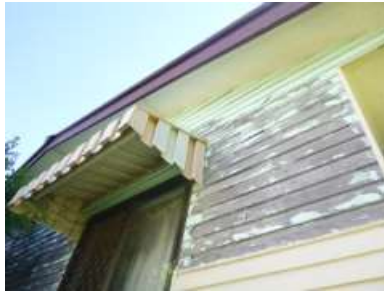
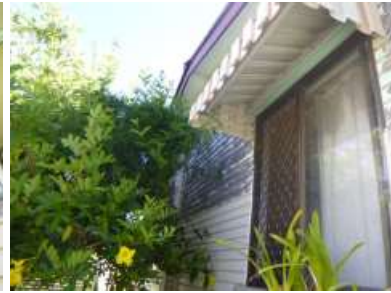
| <i>Condition:</i> | Some external timberwork requires repainting. |

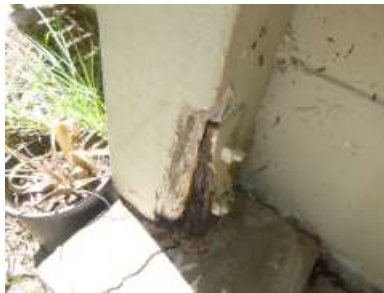
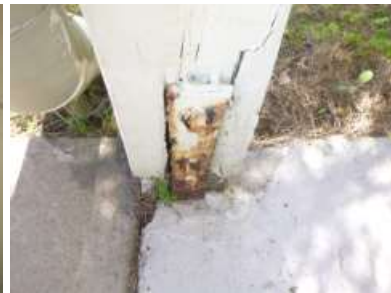
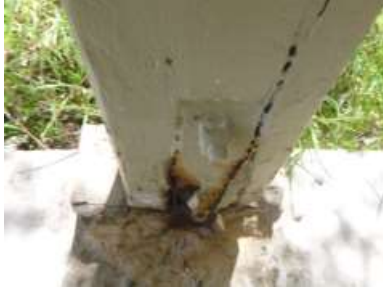
| <i>Condition:</i> | Some verandah / patio support post stirrups & bolts show signs of rust and require repair replacement. |

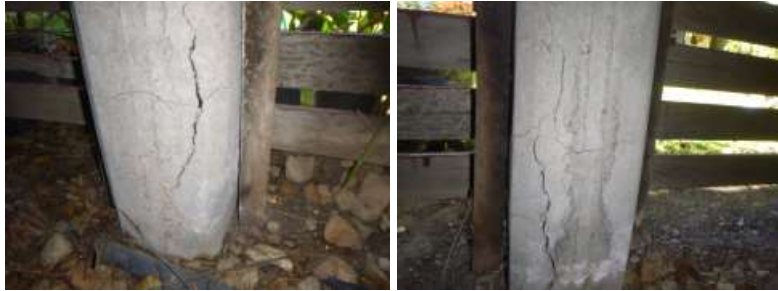
Some concrete piers show signs of concrete cancer and require rectification / replacement. *Concrete cancer occurs when the metal reinforcement within the concrete support piers rusts. The rust expands and cracks / damages the concrete. X 2.*

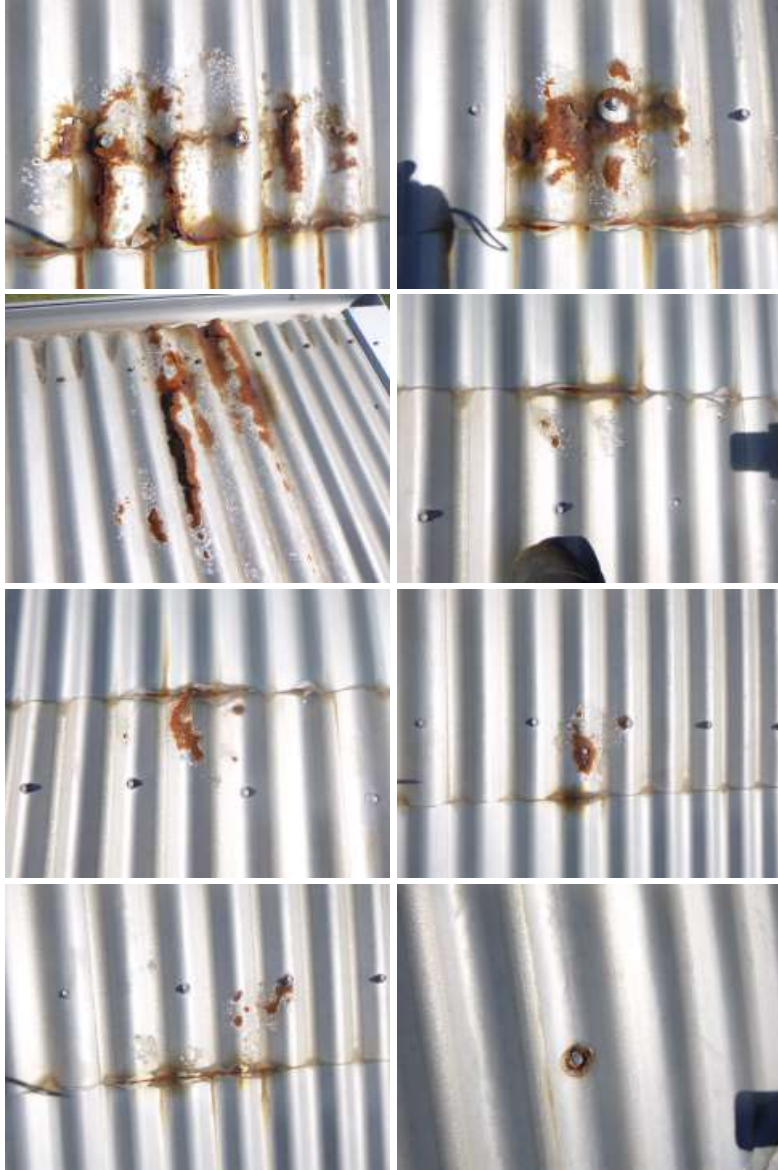
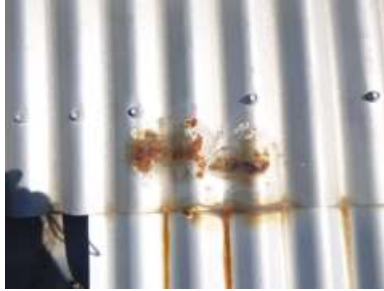
Some rust holes to sheeting and rust to some sheet laps requires repair / patching / painting with Killrust or better. Some sections of roof sheeting may require replacement. I recommend a qualified roofer / plumber be engaged to inspect the roof exterior and quote the cost of rectification prior to a purchase decision being made.

Surface rust present at various rusted screw heads requires repair / painting with Killrust or better.

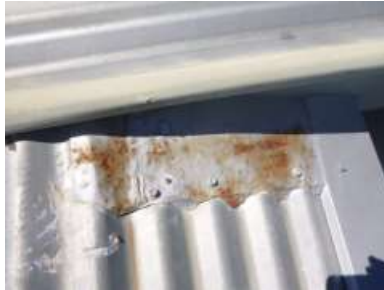
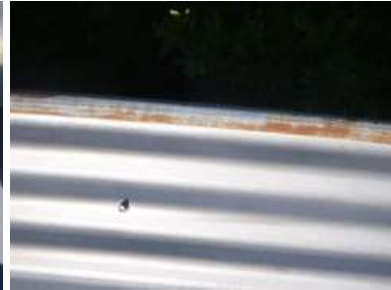
Surface rust to roof flashings requires repair / painting with Killrust or better.

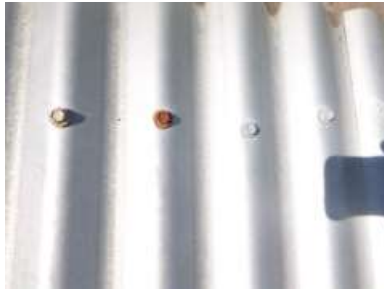
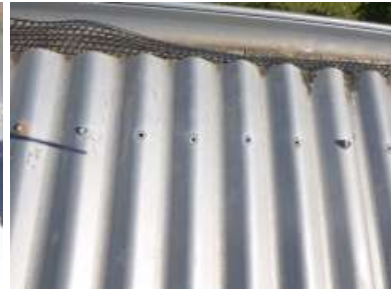
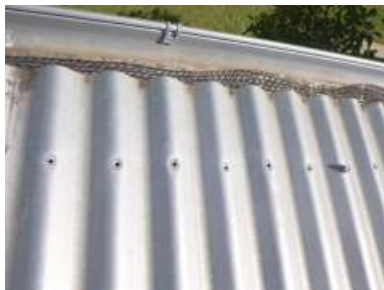
Some roofing screws show signs of rust and require replacement.

Small area of screws are missing to the bottom and require replacing.

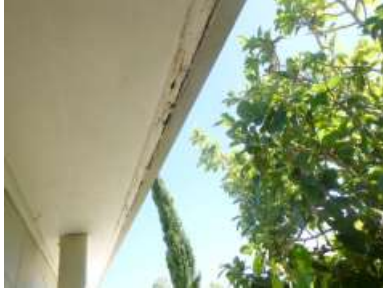
Some soffit cover strips show signs of weather damage and require repair / replacement.

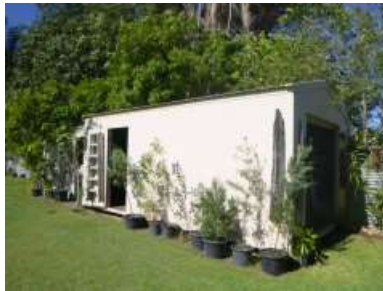
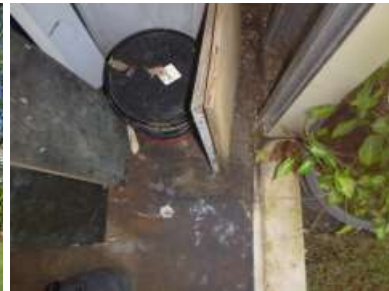
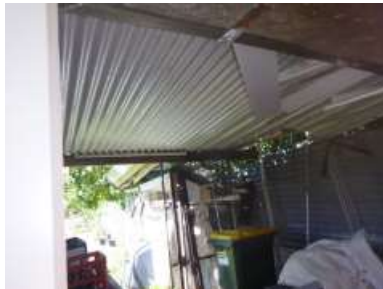
Small area of past water damage to flooring.

As this is a demountable building it requires concrete footing and hold down brackets.

The roofing iron to the lean too off the back is spanning too far and requires more supports.

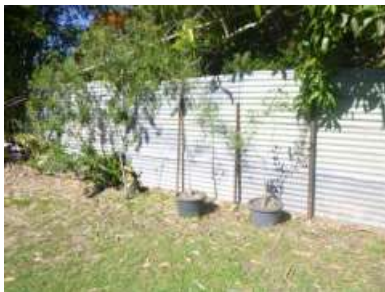
Iron fencing is slightly rough.
