Redcliffs Park

Ground Contamination Investigation

Prepared for
Ministry of Education

Prepared by
Tonkin & Taylor Ltd

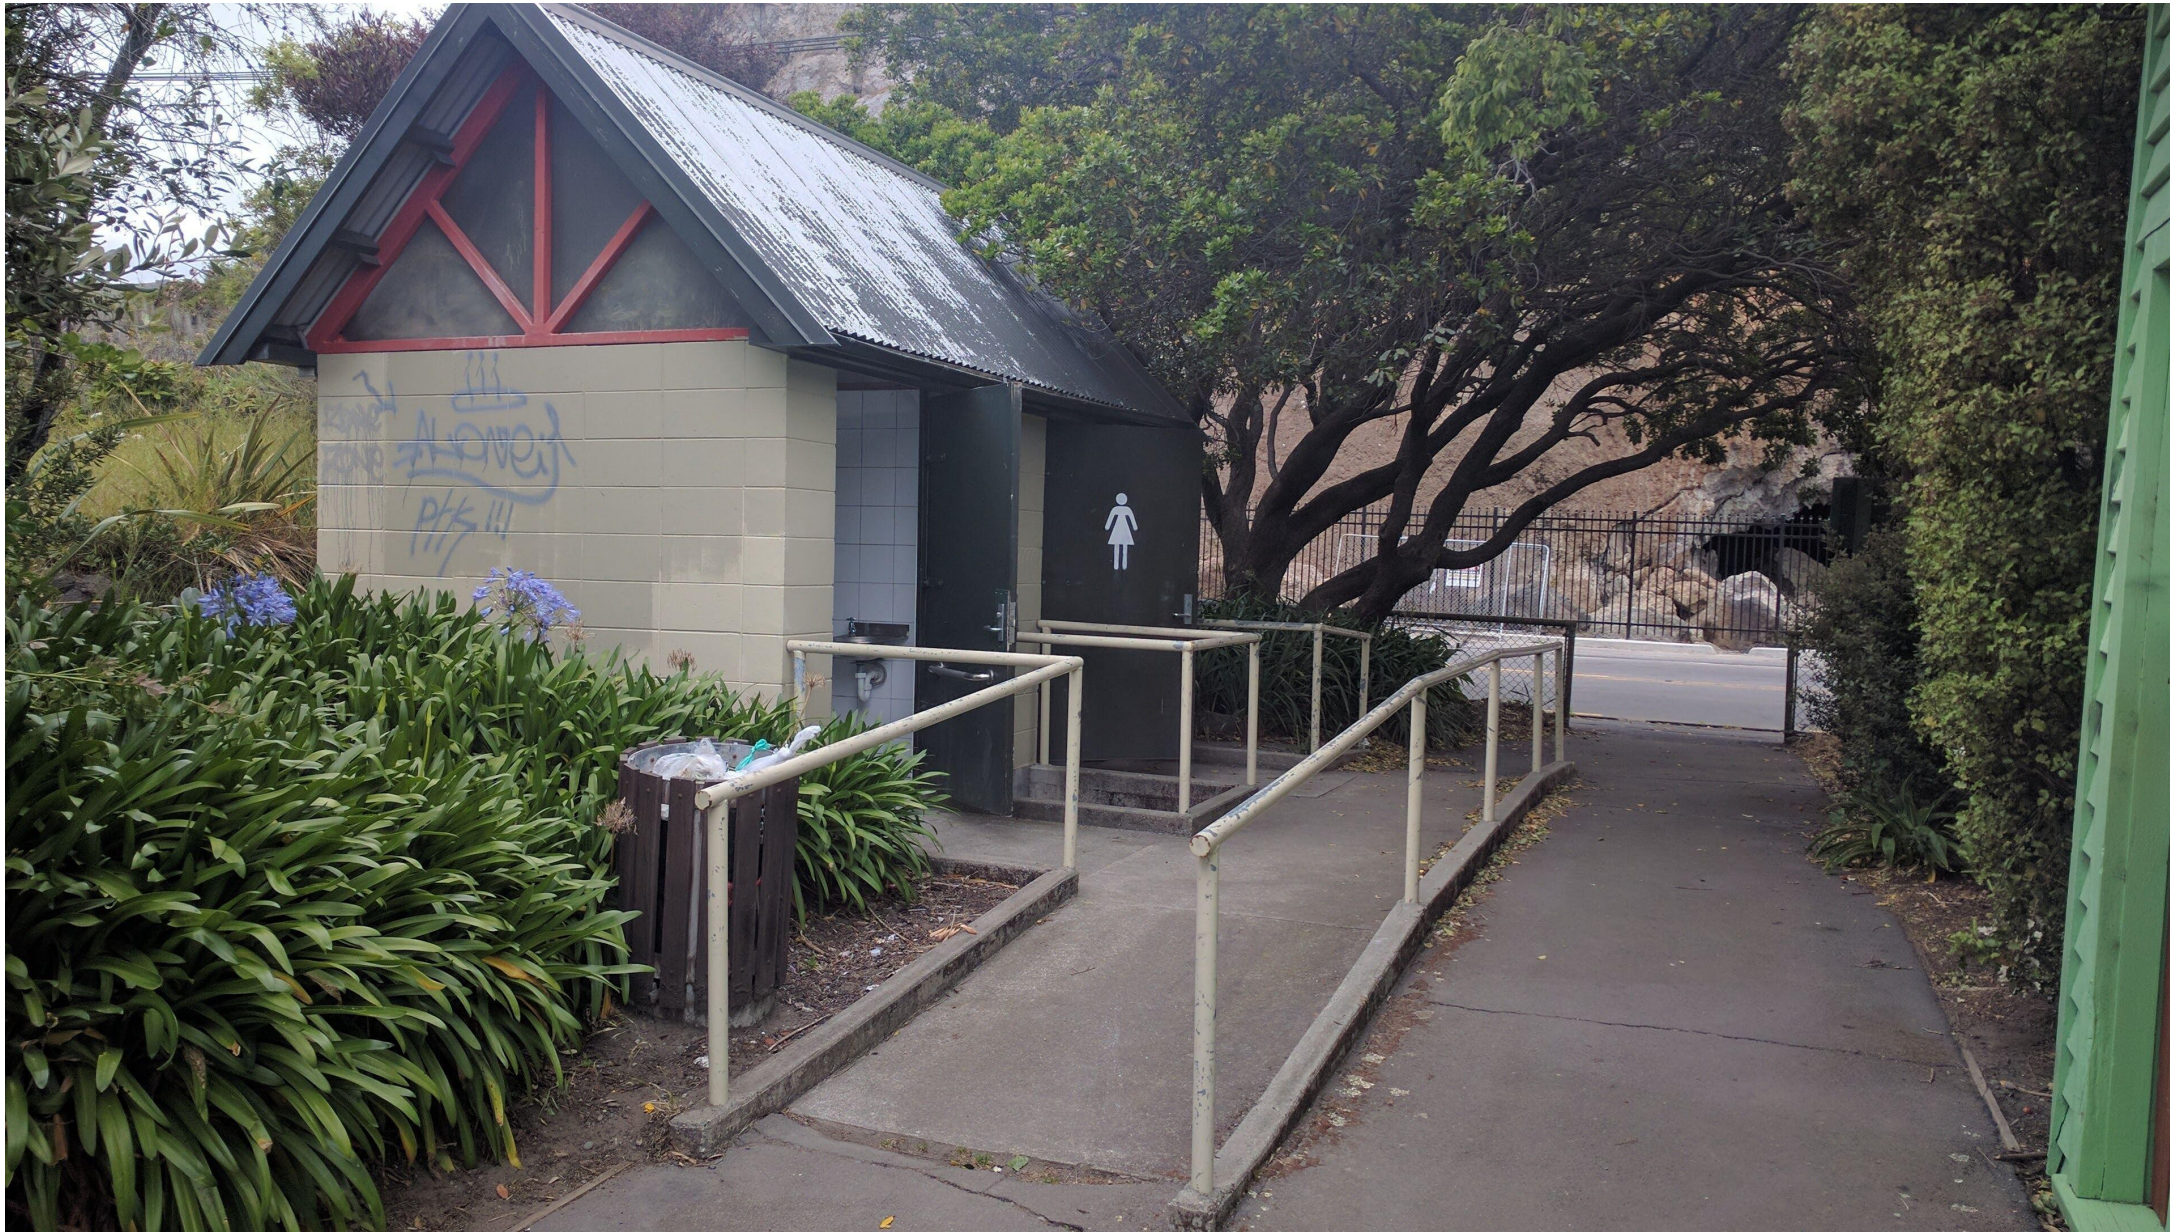
A public toilet block is located along the south-western boundary of the site i.e. on the Main Road frontage (**Photograph 1, Appendix B**). The block is constructed with brick and tile and a tin roof. Pipework appears to be plumbed to the sewage mains rather than to an on-site septic tank. No obvious indications of ground contamination (staining, vegetation stress, etc.) were noted during the walkover.

Photograph 1: Looking south-west at the toilet block

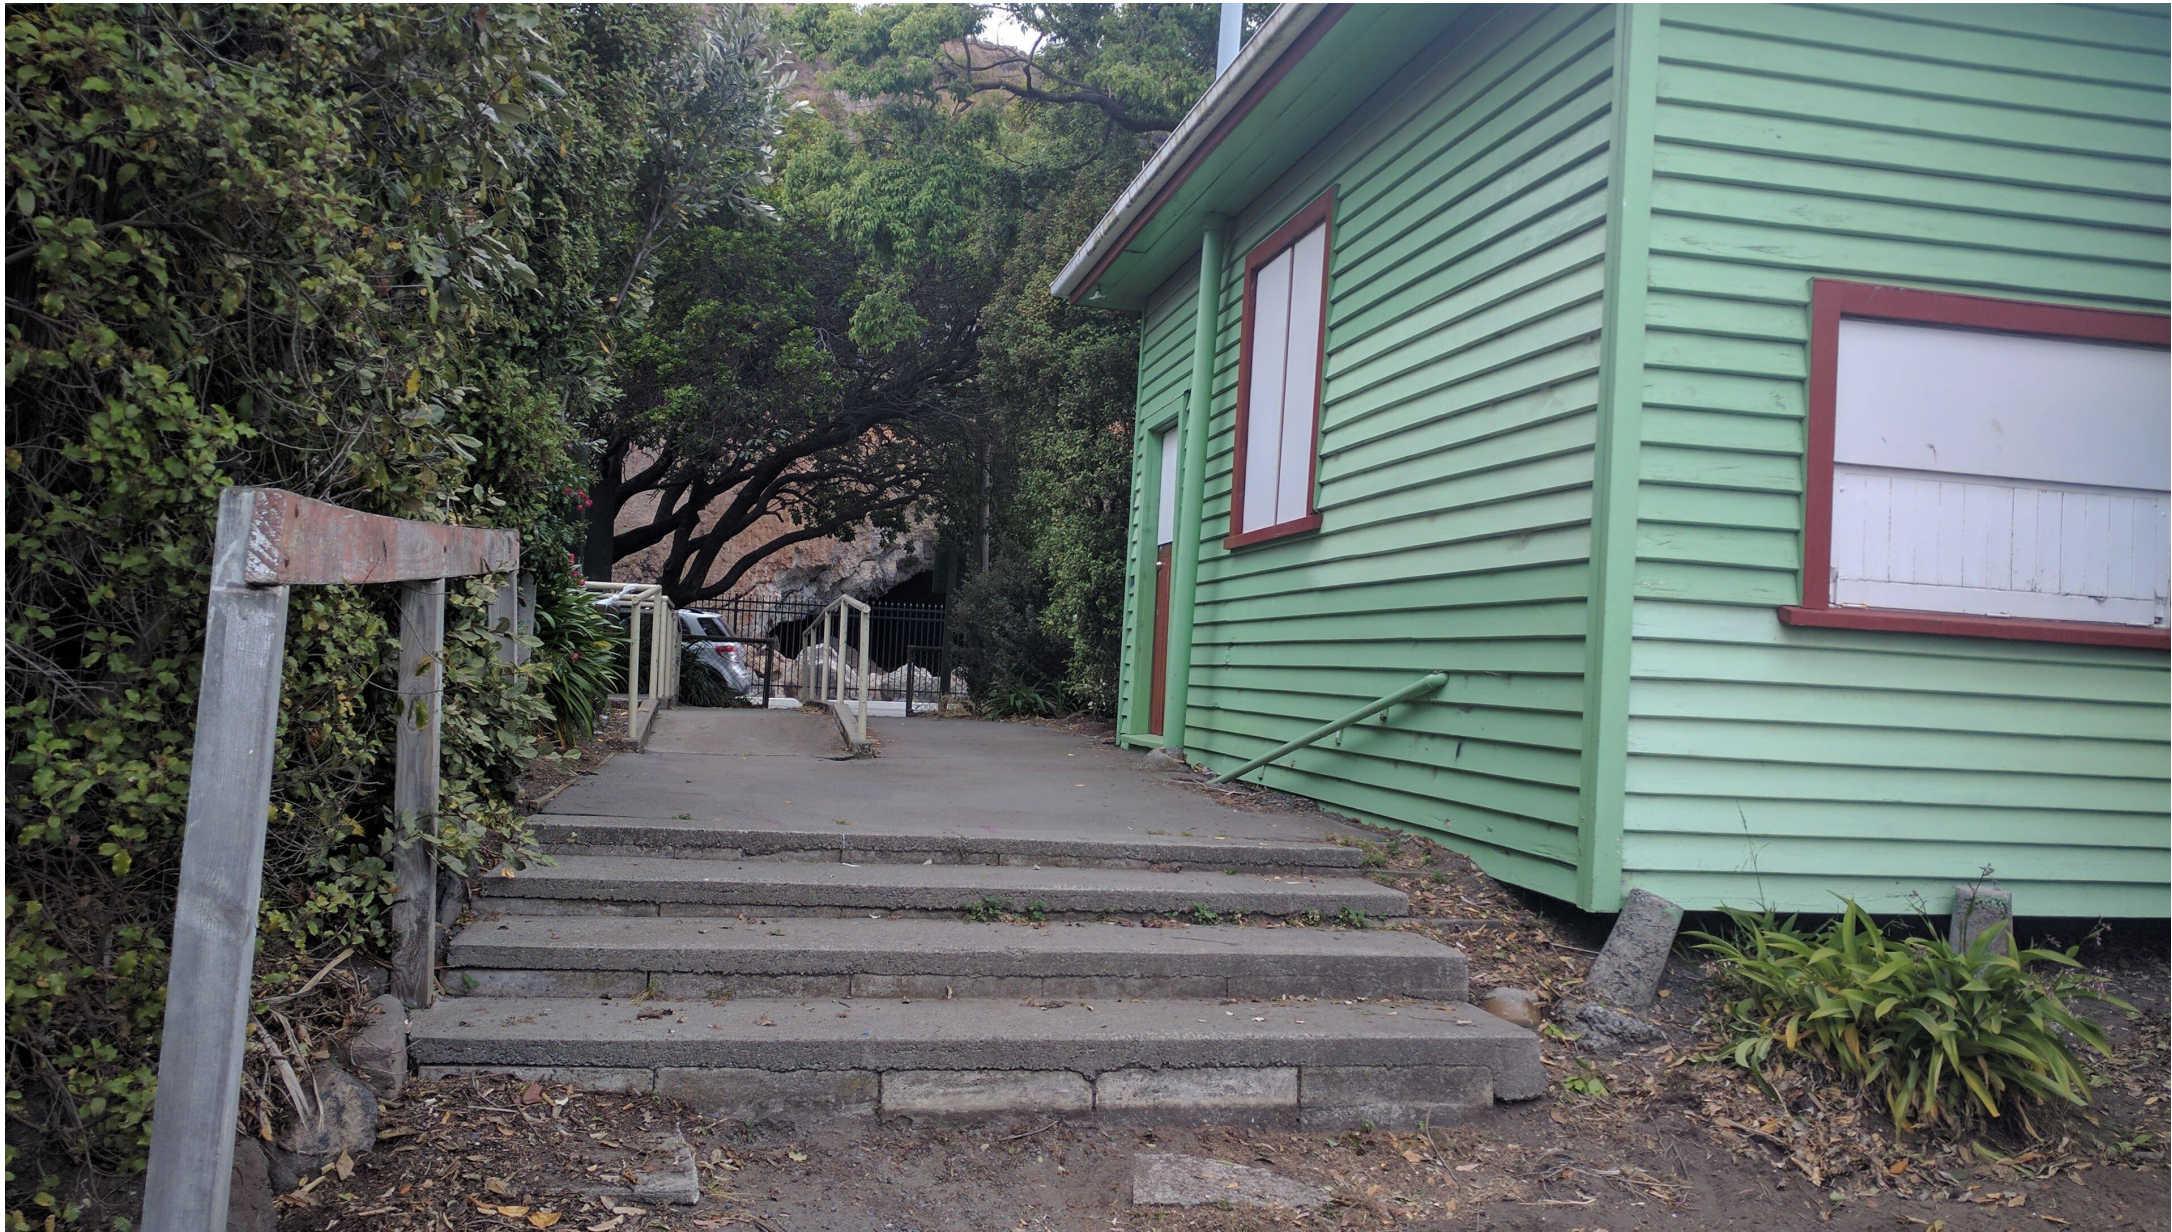
A single level building that housed the Redcliffs Table Tennis Club is present on the site. The building is constructed with weatherboard panels and has a tin roof. The building stood on short concrete piles but has shifted to the south and fallen off the piles (**Photograph 2, Appendix B**). No obvious indications of ground contamination (staining, vegetation stress, etc.) were noted during the walkover.

Photograph 2: Looking south-west at the Redcliffs Table Tennis Club

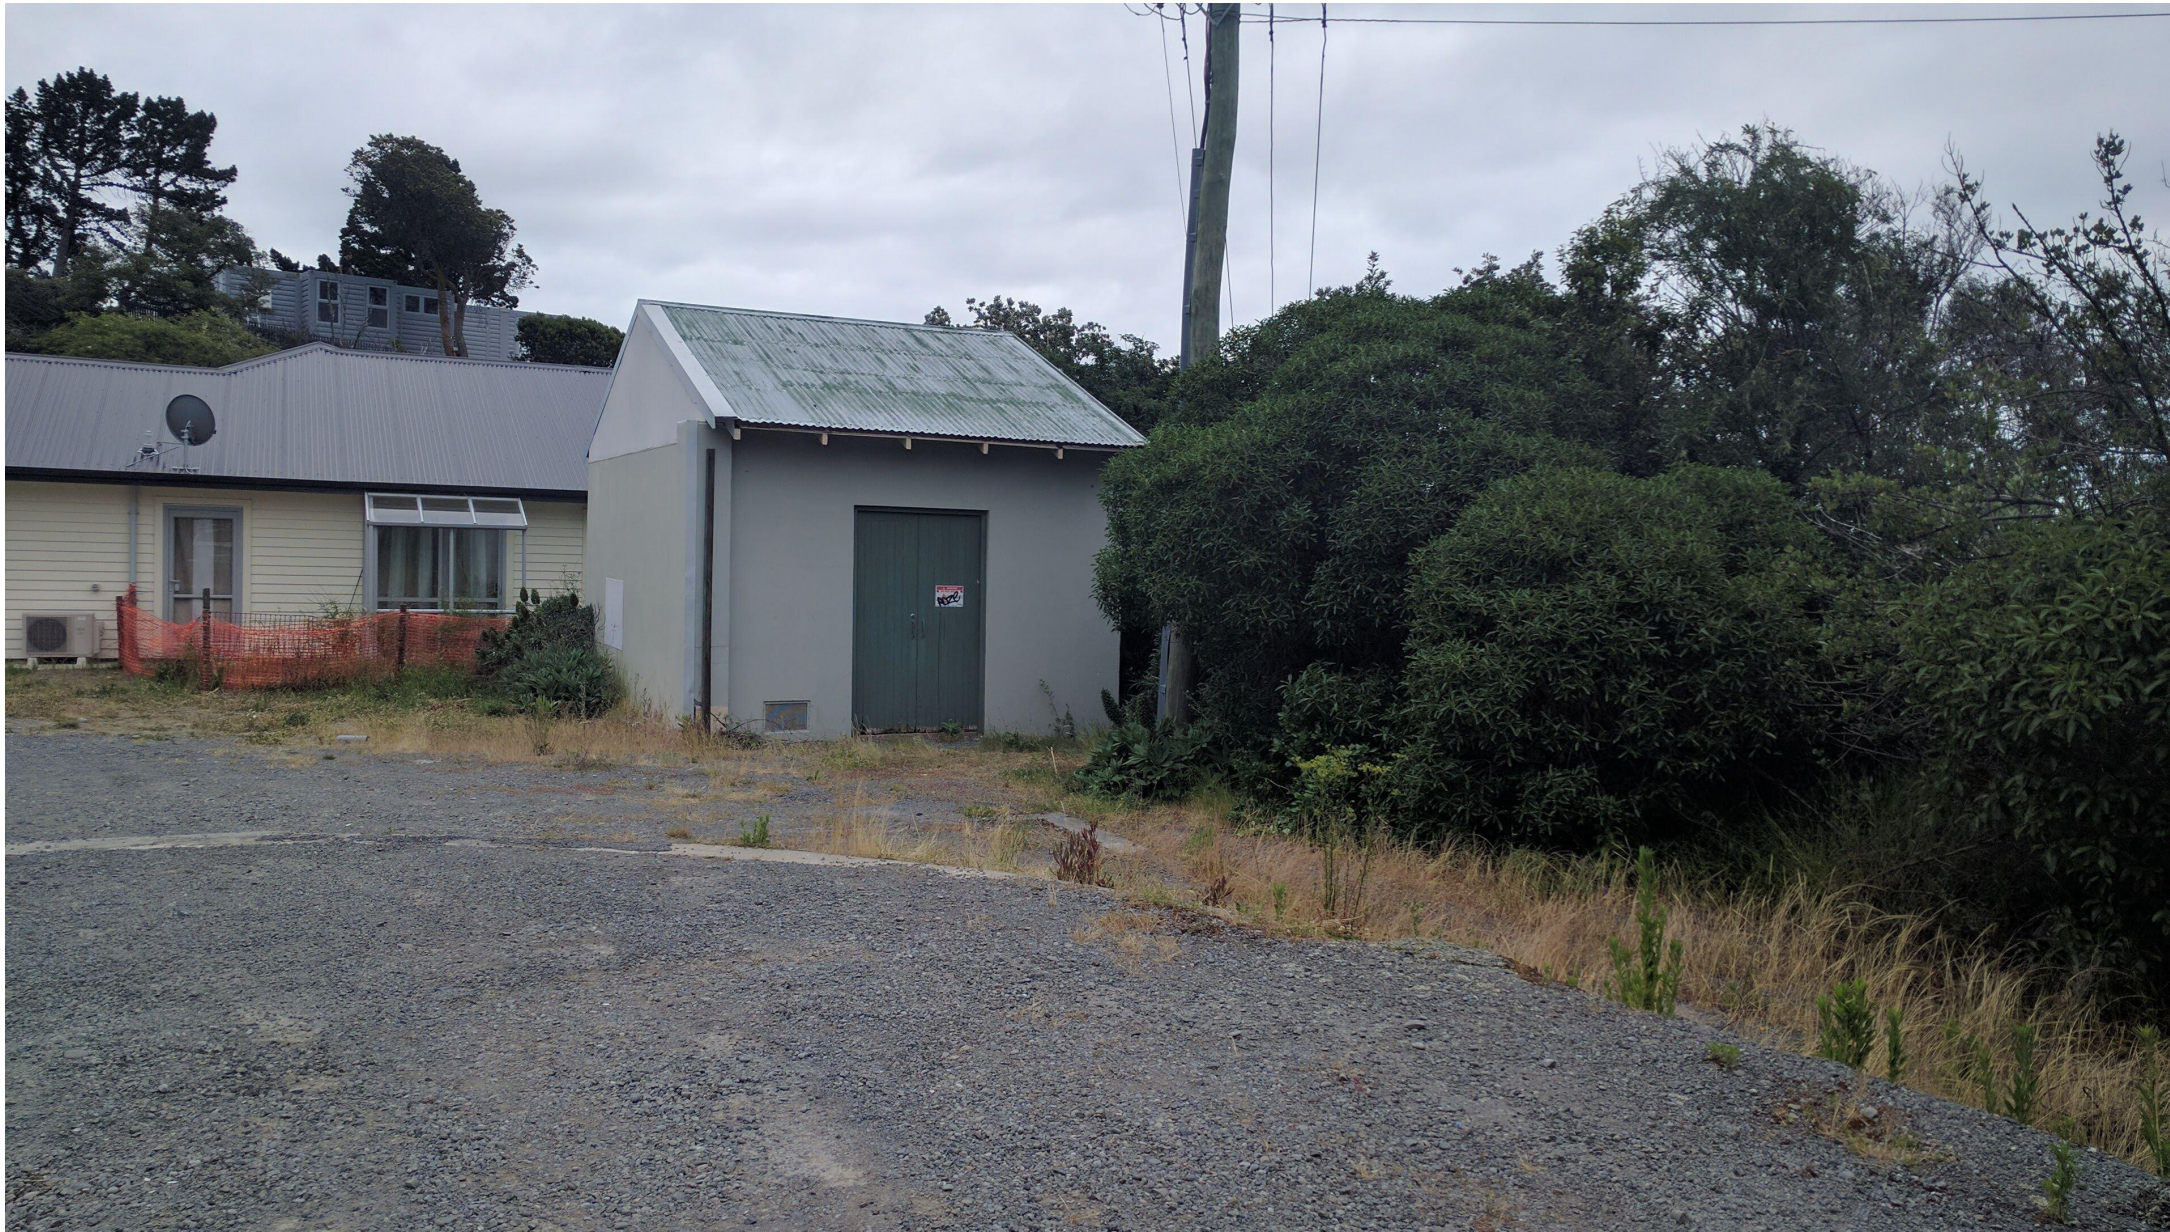
This building is of concrete and timber construction with a tin roof (**Photograph 3, Appendix B**). This building appears to be of relatively modern construction, which was corroborated by anecdotal evidence from a local resident who confirmed that the substation was built in circa 2010. However, aerial photographs indicate that it was constructed no earlier than 2011. It is understood that this building was constructed on the footprint of a previous substation (operated by Southpower). No obvious indications of ground contamination (staining, vegetation stress, etc.) were noted during the walkover.

Photograph 3: Looking north at the Orion substation

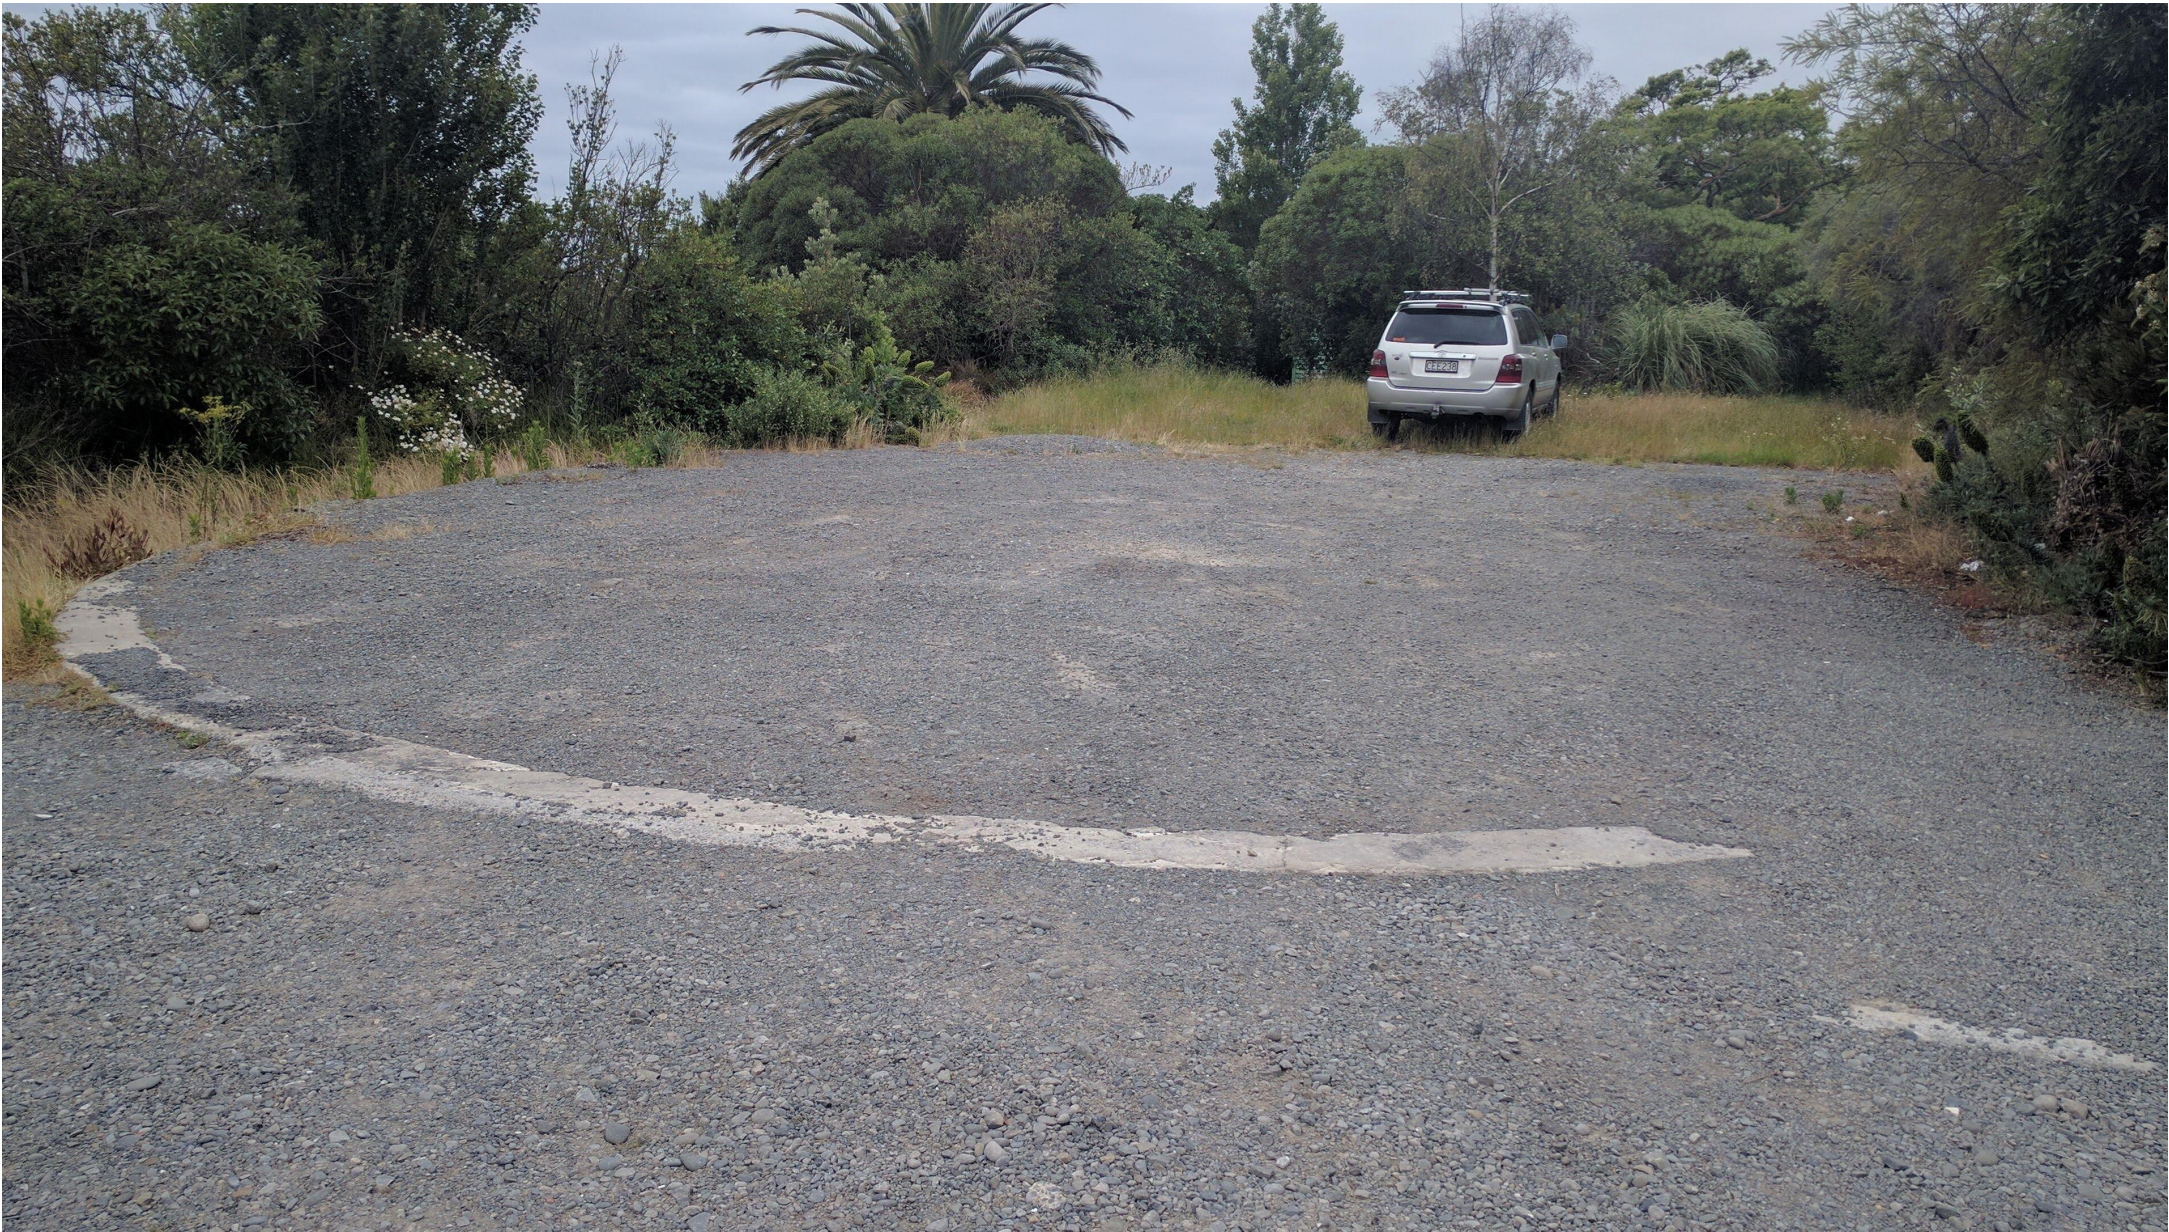
Two former in-ground concrete water reservoirs were located directly north-west of the former Redcliffs Table Tennis Club (**Photograph 4, Appendix B**). Discussions with a local resident indicated that the reservoirs have been filled in with rocks “decades ago”. Plastic fragments and crushed concrete was observed on the ground surface in this area at the time of the site walkover.

Photograph 4: Looking south-east at the former water reservoirs

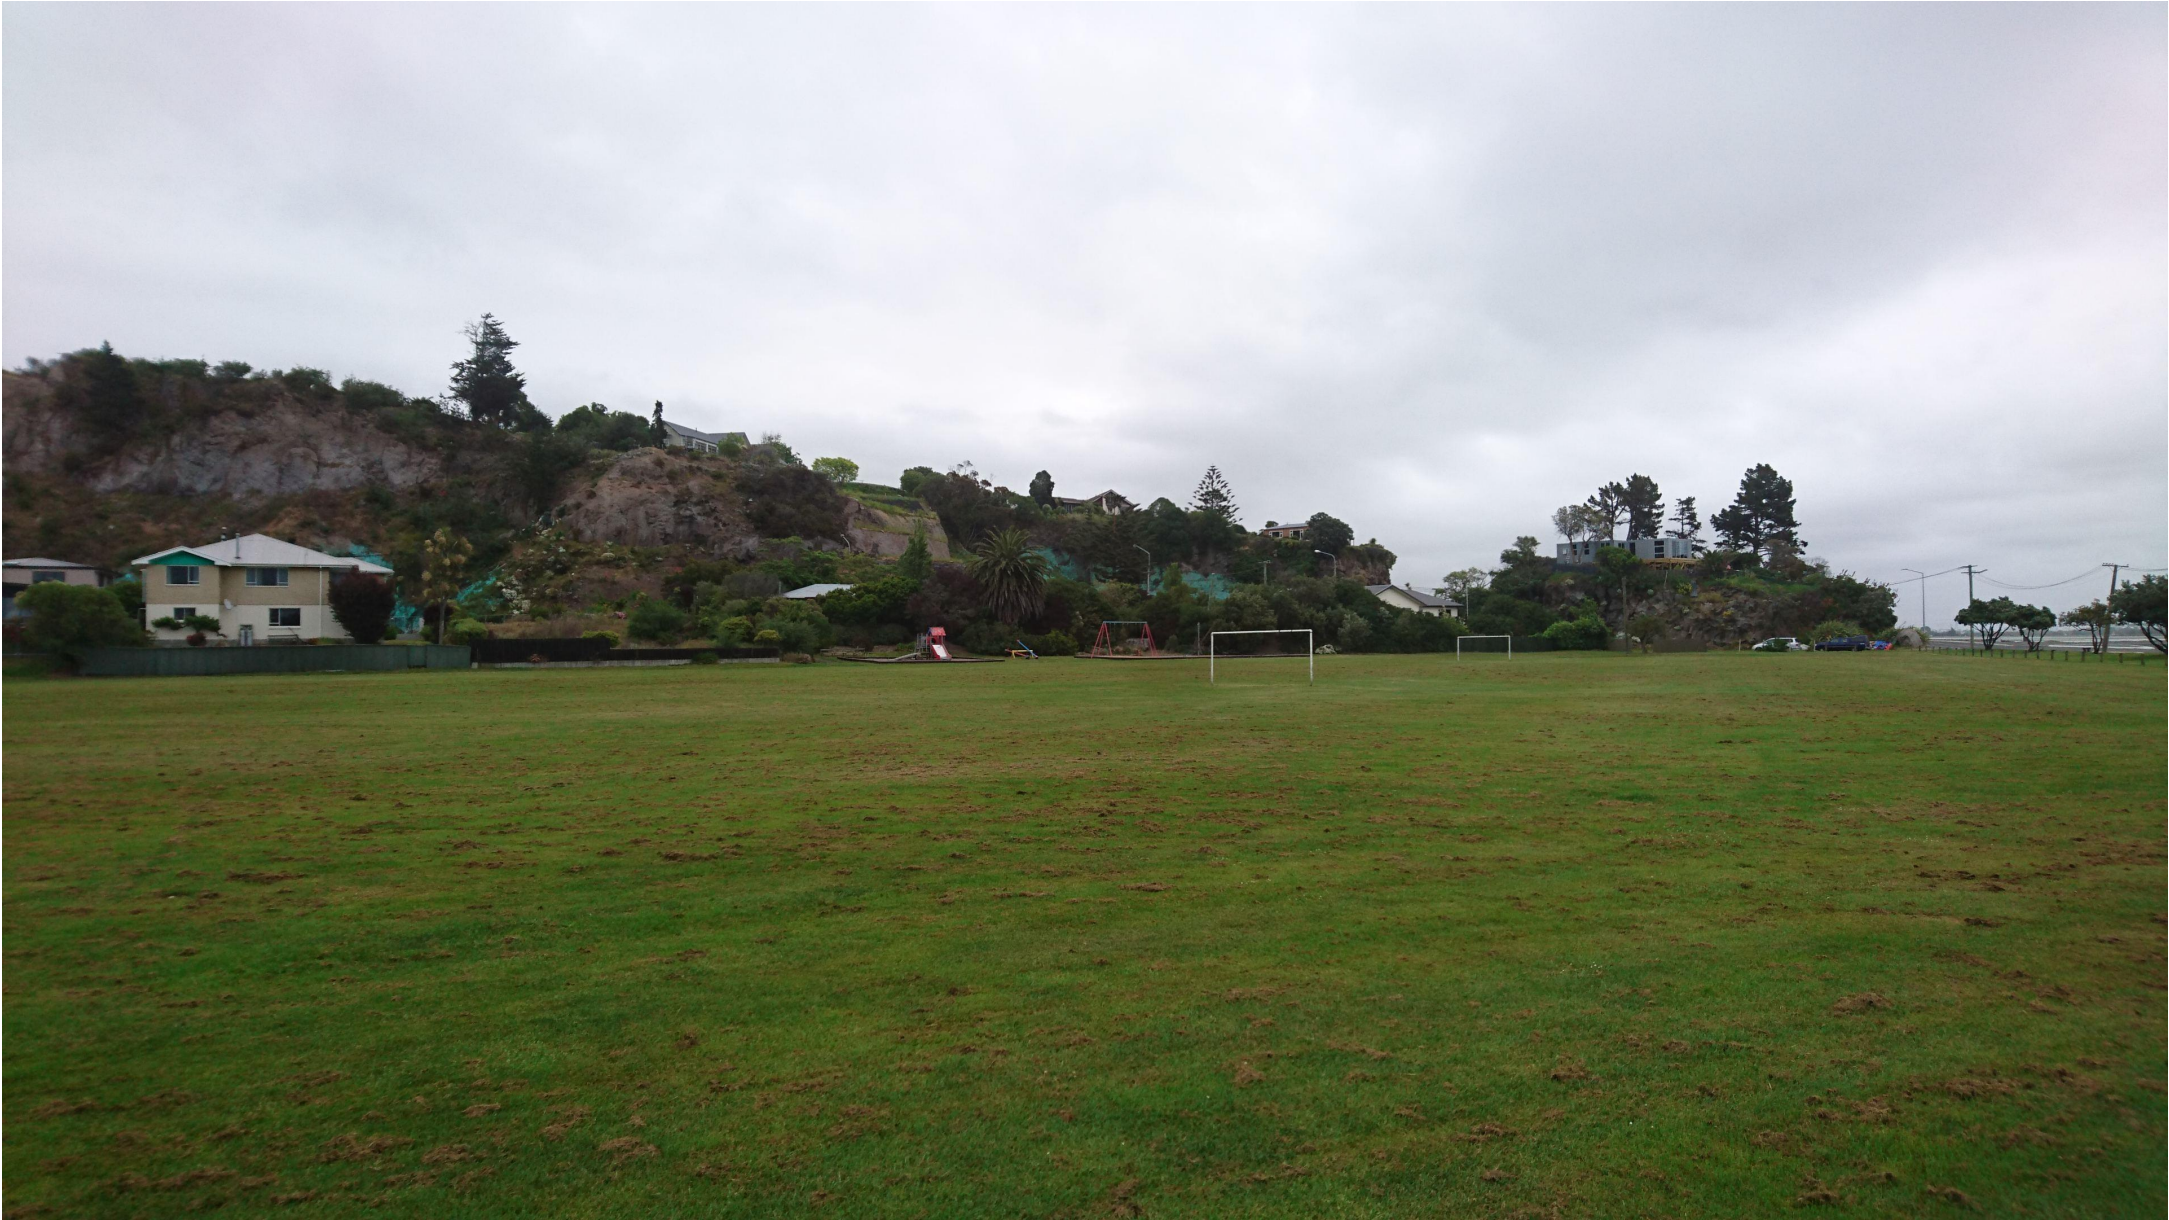
The majority of Redcliffs Park is occupied by sports fields. At the time of the walkover, the sports fields were covered by well-maintained healthy grass (**Photograph 5, Appendix B**). Four football goal posts were observed as well as a children’s playground area located directly south-west of the sports fields. A preliminary desktop review, which included viewing aerial photographs, identified surface scaring along the centre of the sports field extending from the Celia Street and Beachville Road intersection to the playground. At the time of the walkover, the scaring was not visible however paint marks applied by the underground services locator (**Photograph 6, Appendix B**) indicated the presence of two services at 0.35 m and 1.0 m below ground level (bgl). The discolouration and scaring appears to be associated with the laying of these services. No obvious indications of ground contamination were noted during the walkover.

Photograph 5: Looking north-west at the sports field

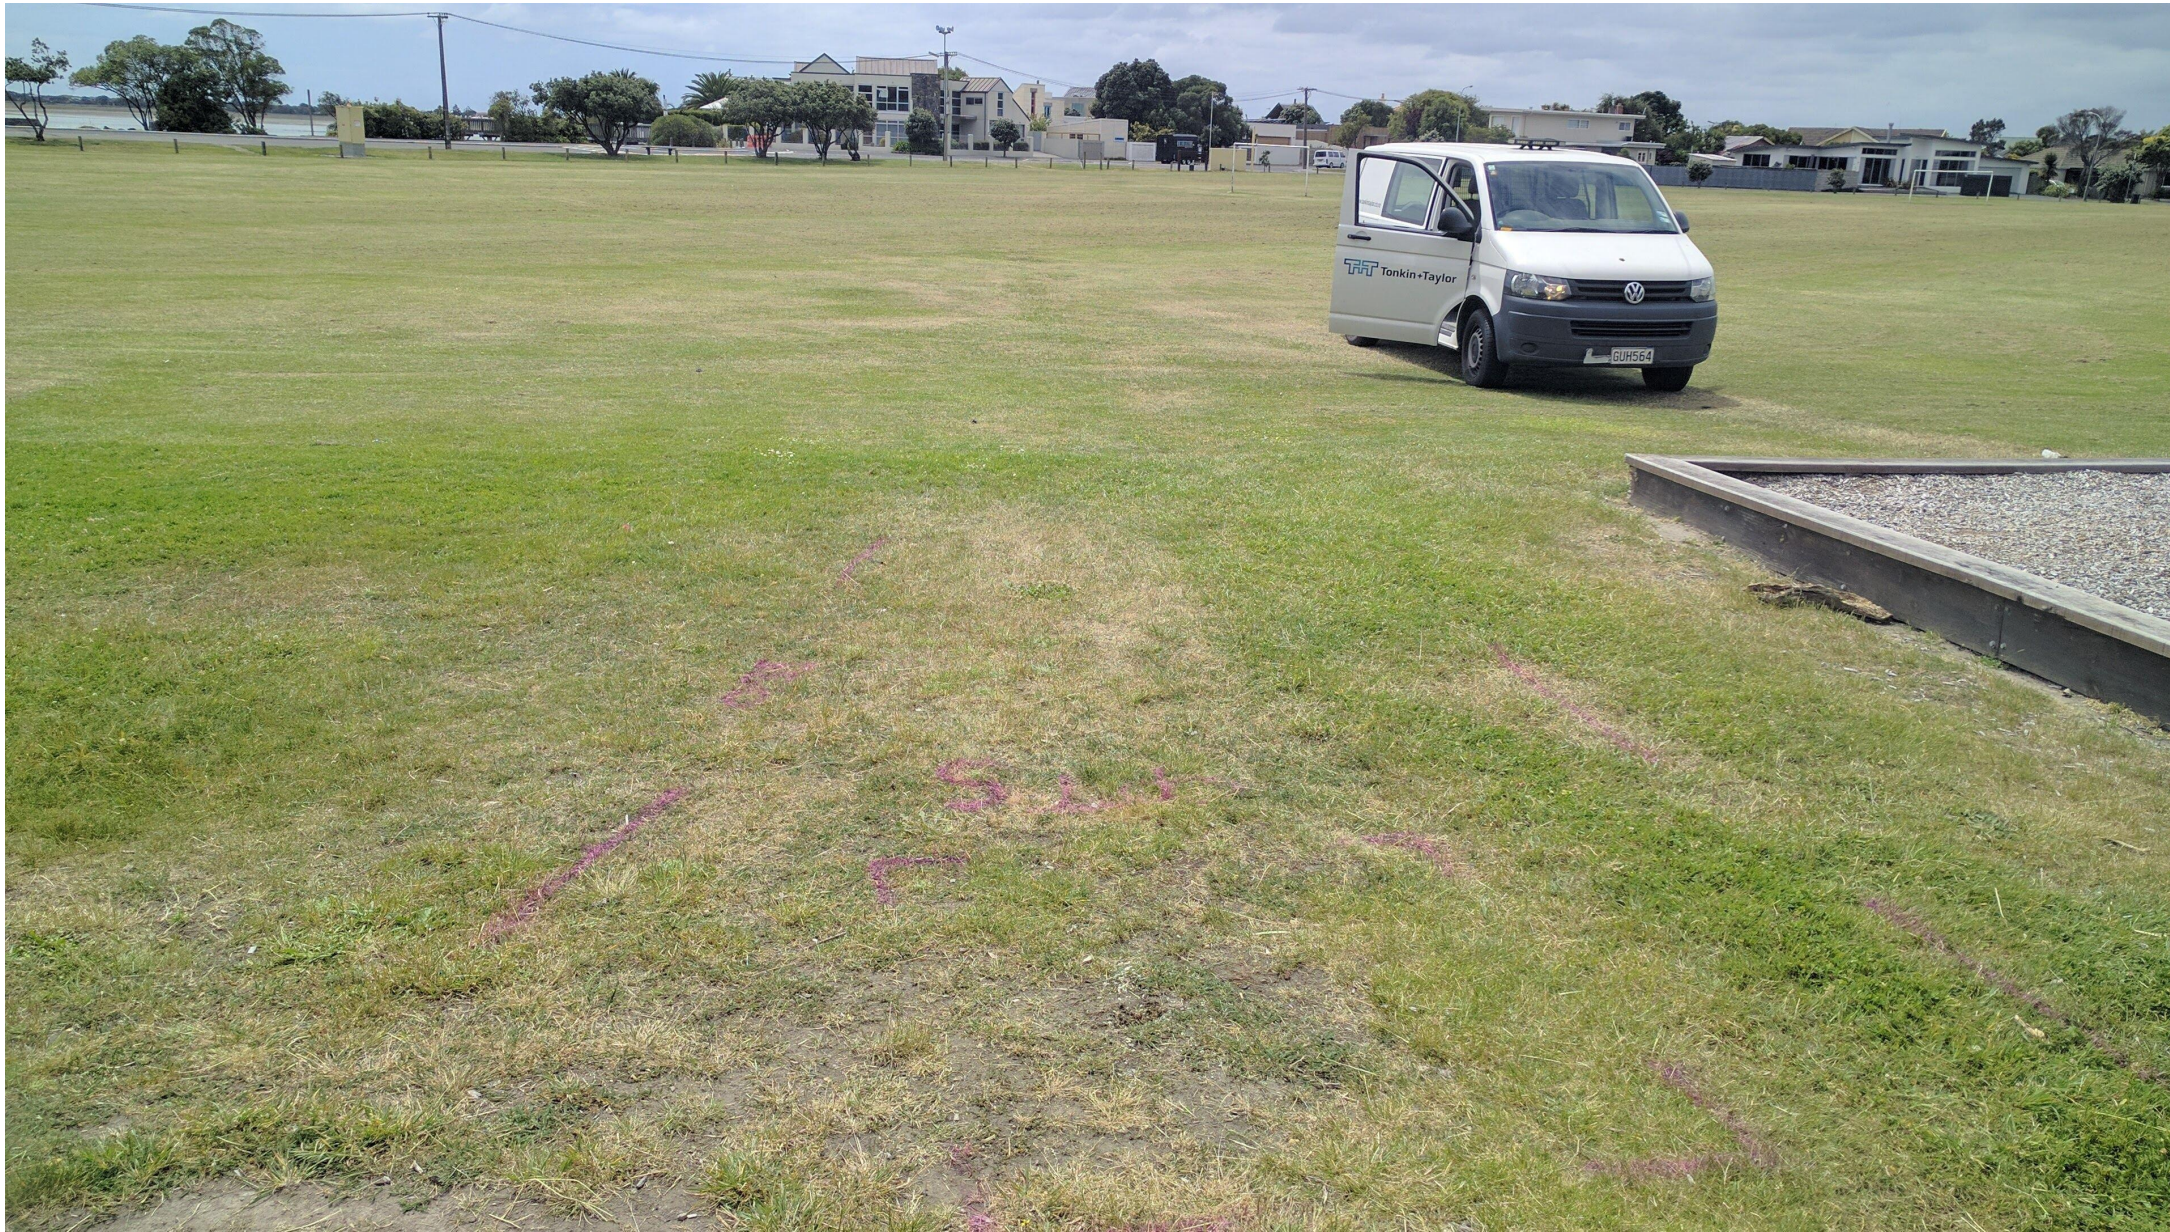
Photograph 6: Looking north-east at the underground services marks

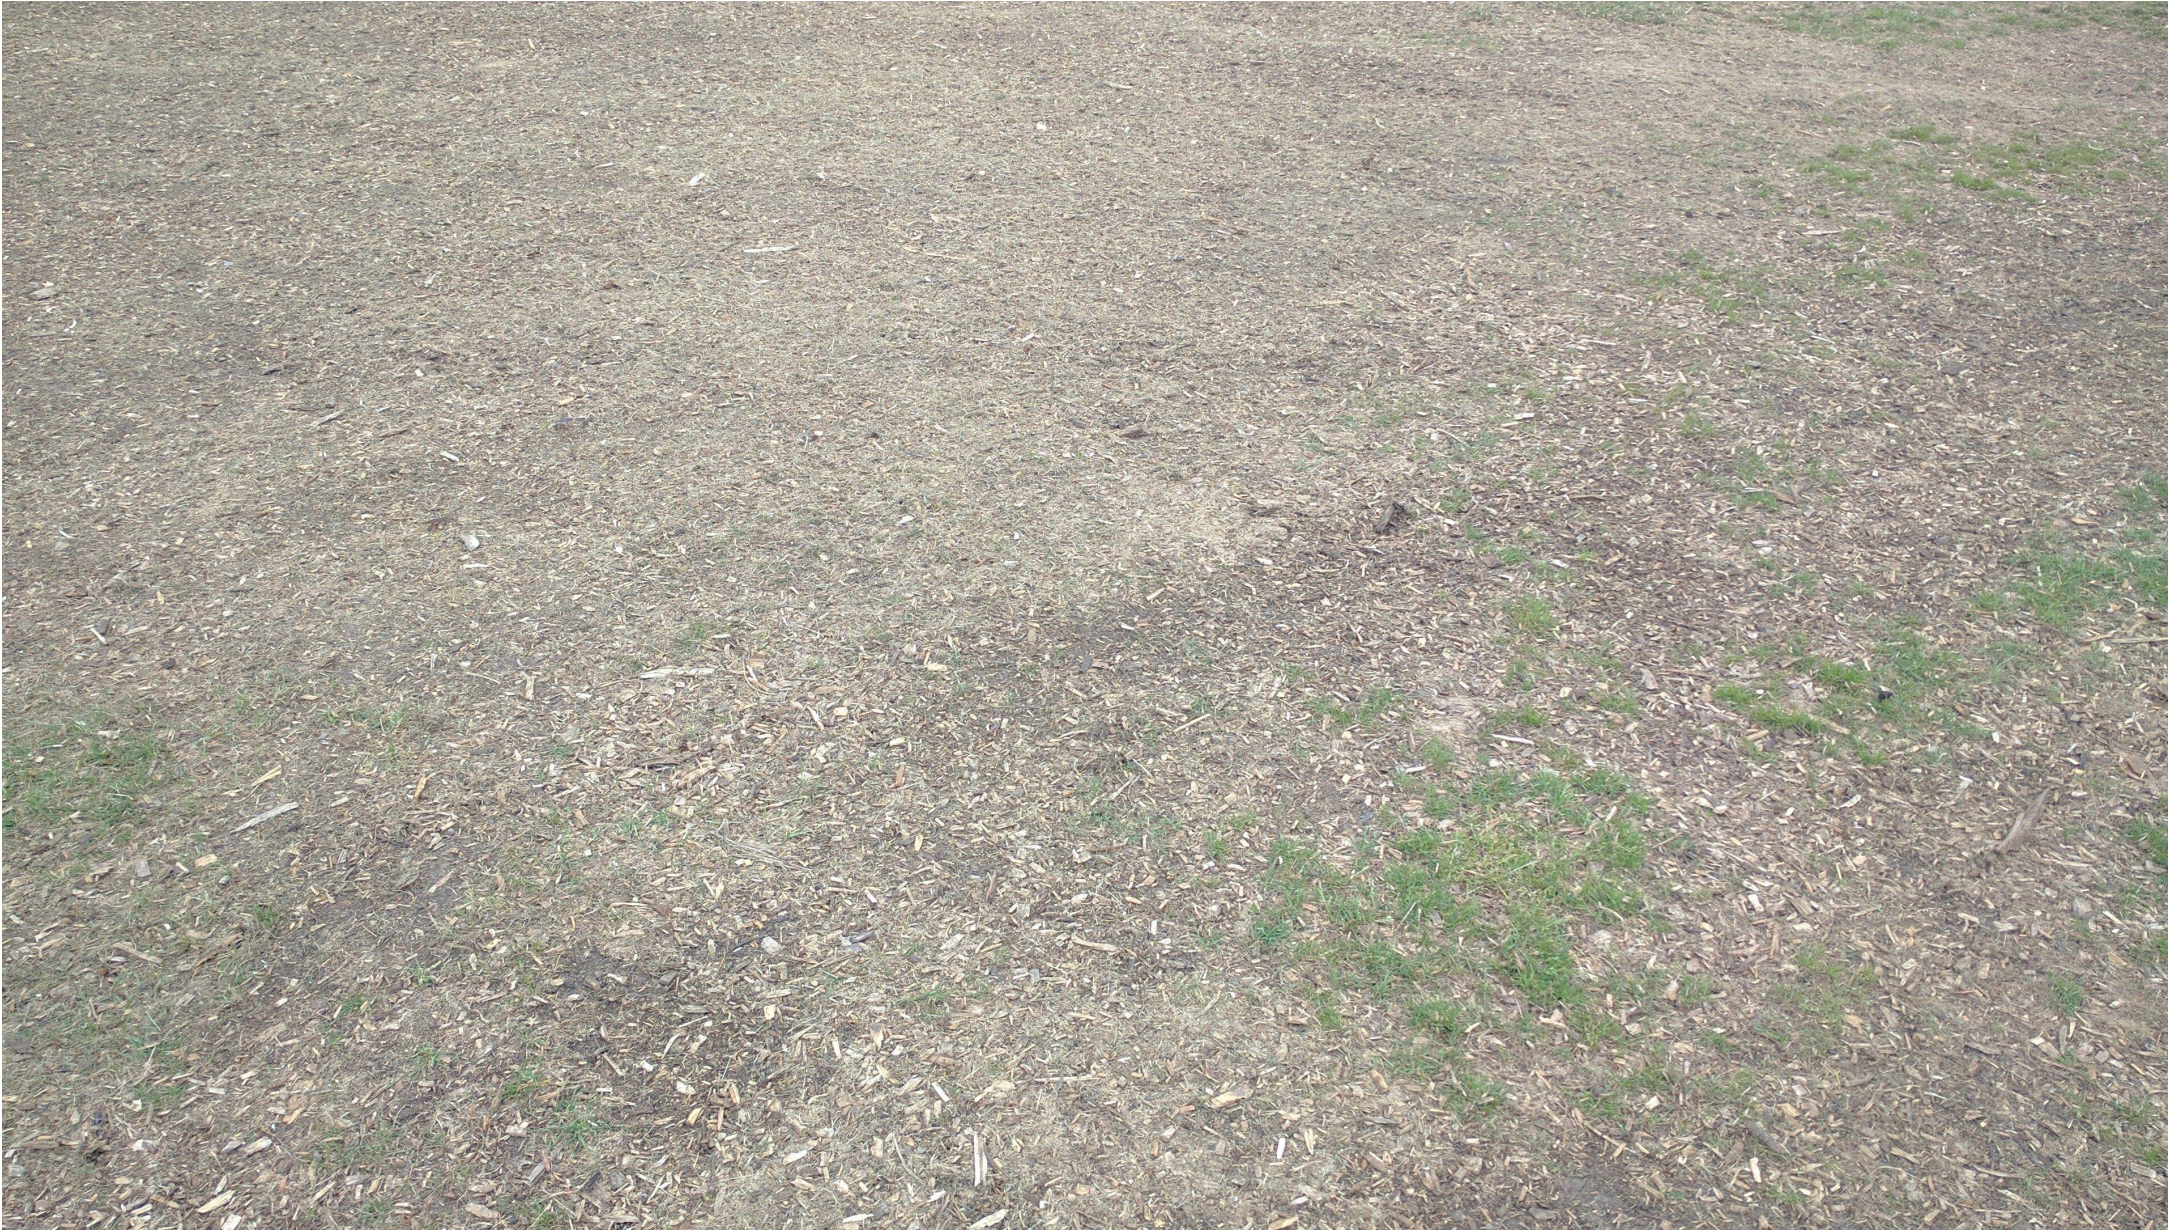
A 20 m x 25 m area on the north-western portion of the sports fields was covered in minor amounts of bark (**Photograph 7, Appendix B**). At the time of the site walkover, visual examination of the surficial soils (0-0.2 m depth) in the area did not indicate any variation from conditions observed elsewhere within the sports fields. It appears that some bark was stored in the area and then later removed (likely used as a staging area during the construction of the playground, where bark is used as surface cover).

Photograph 7: Bark on surface of sports field
