ROOF REPORT

Job: #203504

Address: 14 Mount Street Bonnyrigg Heights 2177 NSW

Event Details: Water damage to garage ceiling

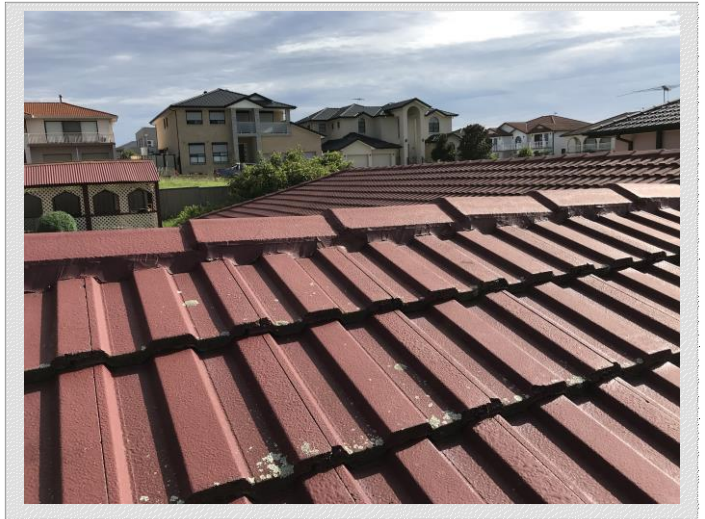
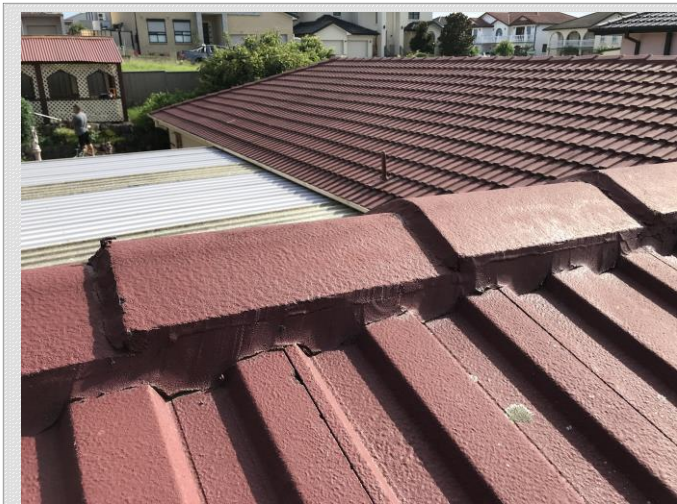
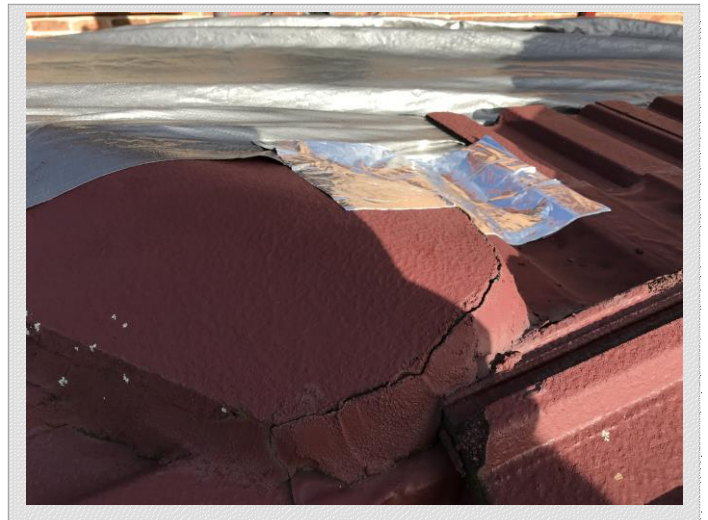
Location: Roof

Weathered and cracked pointing

Pointing is weathered and cracked and weep holes have been filled in.

This issue can cause ingress, so we have listed its repair in maintenance.

Insured to appoint roofing specialist to repoint capping tiles, install weep holes in pointing, replace split apron flashing and replace cracked tile.

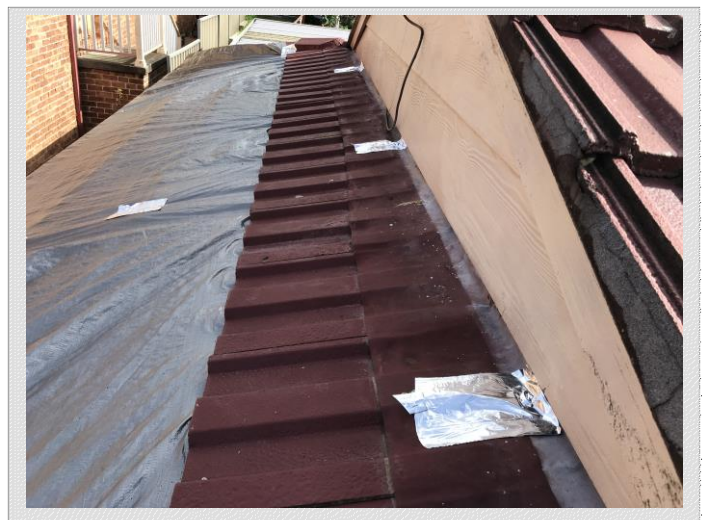
Location: Roof above the garage

Split apron flashings

Apron flashing above the garage has split, allowing stormwater to ingress.

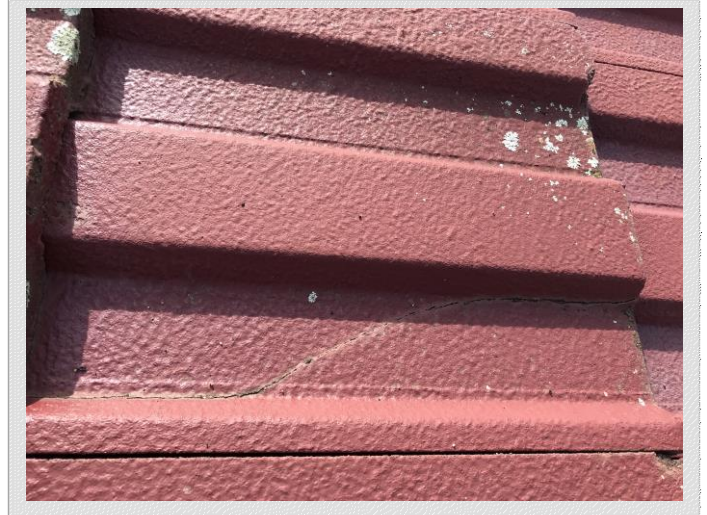
Location: Roof above the garage

Cracked roof tile

We have located a cracked tile which pre-dates the recent ceiling collapse and have listed its repair in maintenance as it is consistent with foot traffic.
