Visual Timber Pest Inspection and Report in Accordance with AS 4349.3-2010

392 Brunner Road Adamstown Heights (Eastern Elevation)

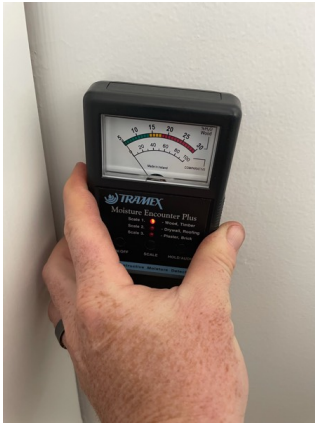
Moisture content in walls of wet areas is under the maximum of 15%

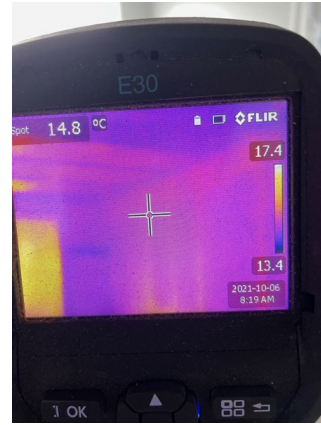
No thermal anomalies present at time of inspection.

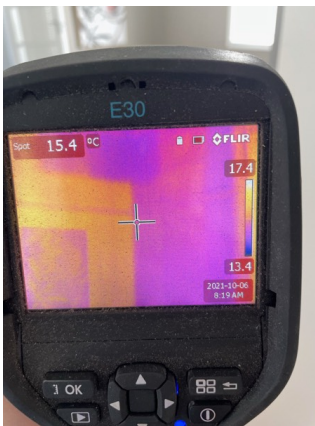
No thermal anomalies present at time of inspection.

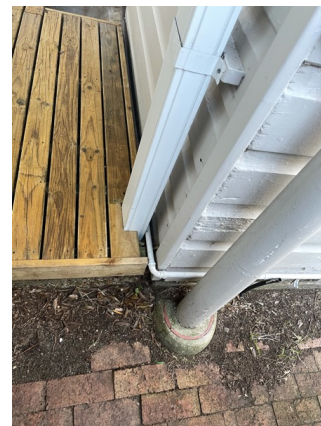
Concrete slab edge concealed around perimeter of laundry

Is there a Termite Inspection Zone Present?	Yes Concrete slab edge is concealed around laundry providing concealed entry points for termites I recommend that you expose 75 mm of slab edge to provide adequate inspections for termites, ant capping is rusted in the subfloor I recommend that you contact a licensed builder to replace defective ant capping to reduce the risk of undetected termite entry.
Is the Inspection Zone Clear?	No. Deck Restricted crawl space in subfloor

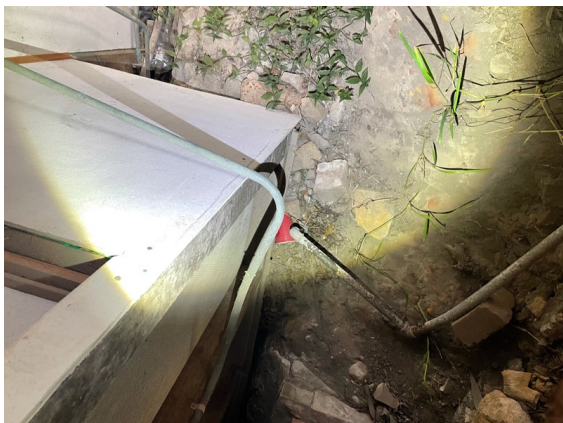
Rusted ant capping subfloor

Drainage Issues Present, Termite Shields Damaged and/or Missing Hot water system pressure relief valve,
I recommend that you contact a licensed plumber to improve subfloor drainage and connect hot water system pressure relief valve to a drain or run 7m away from the perimeter of the building as moisture is conducive to termites, I recommend that you remove timber from in contact with ground and subfloor as it provides concealed entry points for termites. I recommend that you contact a licensed builder to replace defective ant capping to reduce the risk of undetected termite entry.

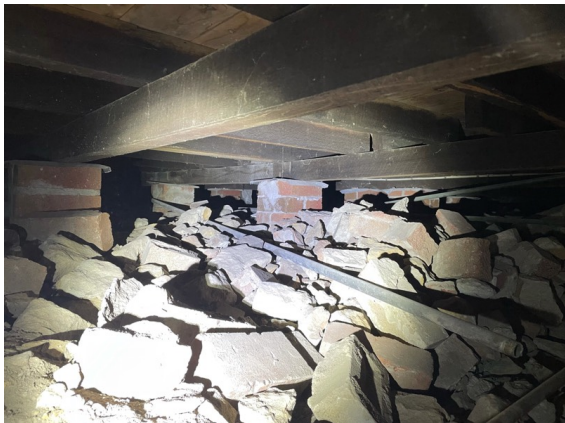
ACCESS ISSUE - Subfloor

Access Issue Type:	Restricted Access
Reason(s) Why:	Height

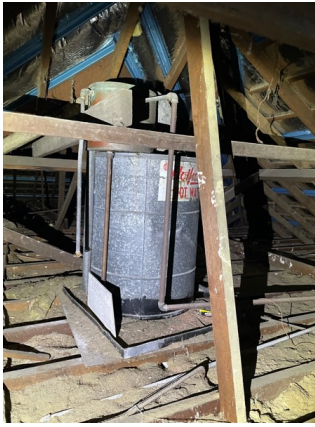
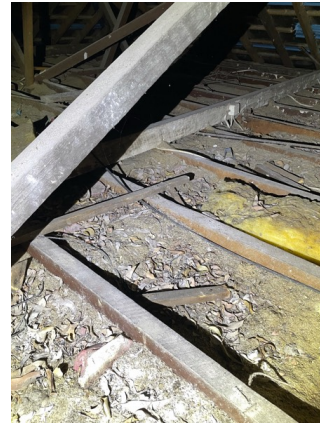
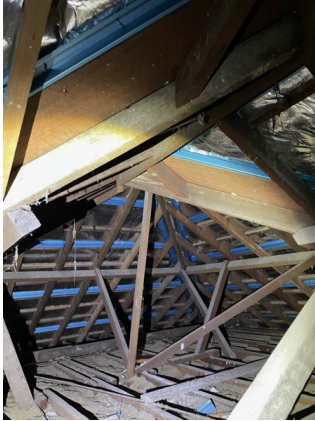
ACCESS ISSUE - Roof Void

Access Issue Type:	Restricted Access
Reason(s) Why:	Foil Insulation, Insulation Old hot water system

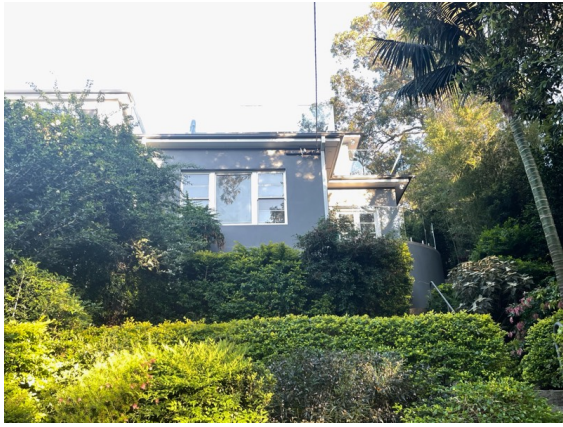
Vegetation Eastern side

Main Structure
I recommend that you remove vegetation away from the perimeter of the building to reduce the risk of undetected termite entry.

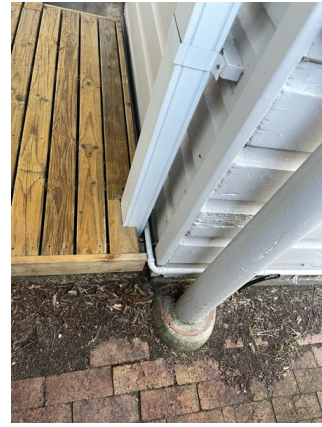
Slab edge concealed around laundry

Airconditioning/Hotwater System Issues Present, Slab Edge Not Exposed or Not Fully Exposed
I recommend that you contact a licensed plumber to connect hot water system pressure relief valves and air conditioning overflow to a drain or run 7 m from the perimeter of the building as moisture is highly conducive to termite. I recommend that you expose 75 mm of slab edge around perimeter of the laundry to provide adequate inspection for termites and reduce the risk of undetected termite entry.

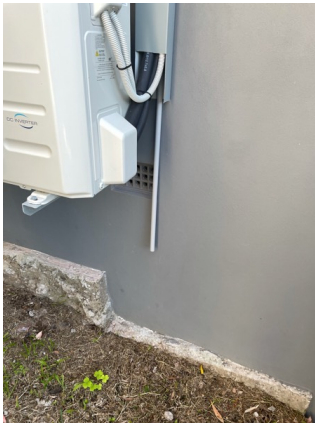
Air conditioning overflow Southern side

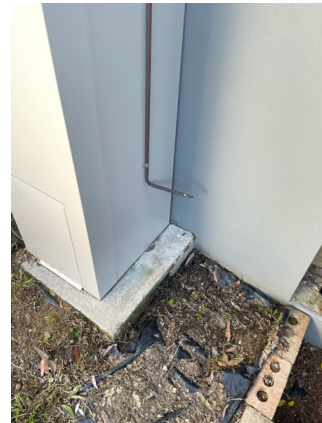
Hot water system pressure relief valve Southern side

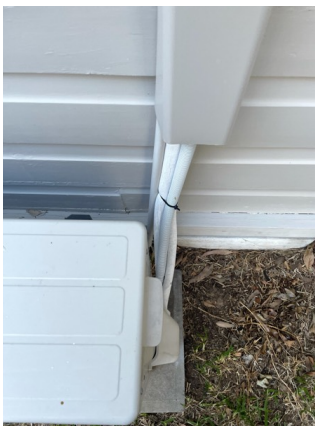
Air conditioning overflow Western side

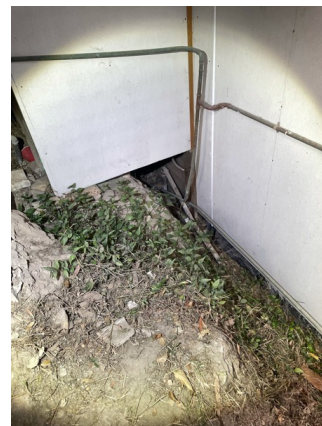
Drainage subfloor and timber in contact with ground

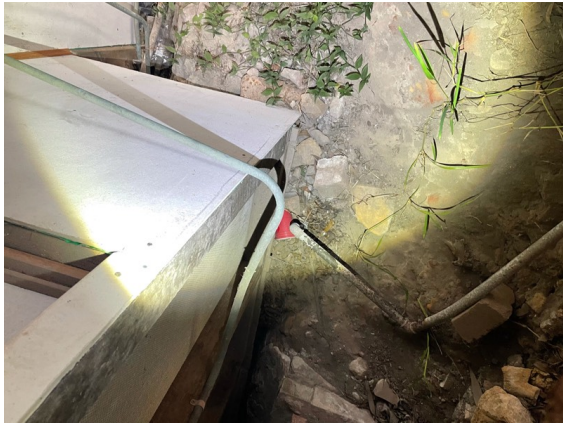
Rusted ant capping subfloor

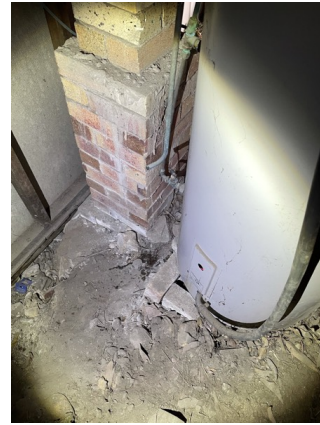
Hot water system pressure relief valve subfloor

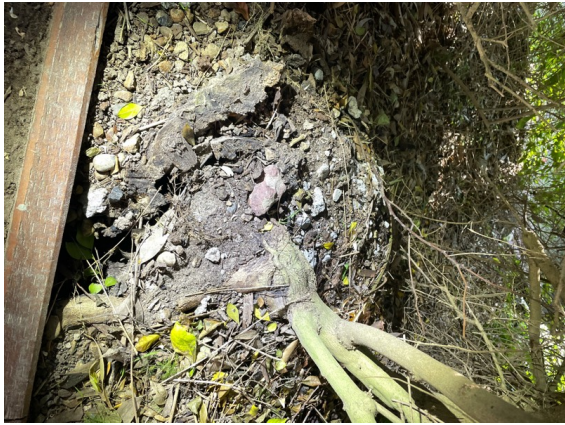
Fungal Decay Damage Extent: Moderate to Extensive

Rotting stump Eastern side

I recommend that you remove rotting stumps and timber from site as rotting timber is highly conducive to termites. I recommend that you contact a licensed builder to replace rotting fencing with non-susceptible timbers as rotting timber provides a food source for termites.

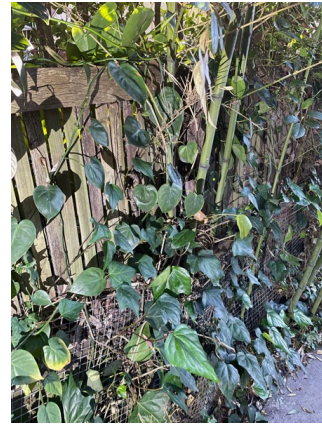
Rotting fencing Northern side

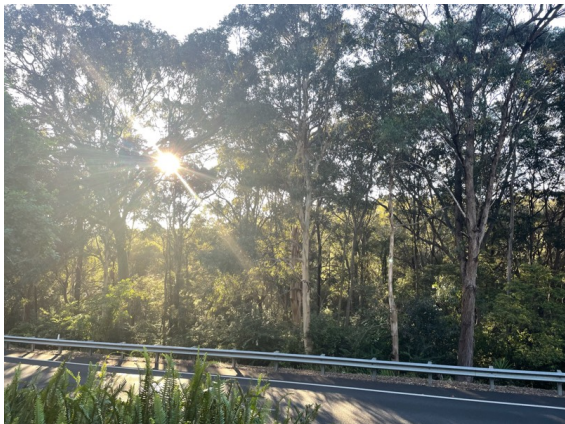
With wooded areas surrounding the property the environmental termite pressure of the area is high. I recommend that you remove wood chip from site as they provide a good source for termites.

Surrounding wooded areas
