STANDARD PROPERTY & TIMBER PEST REPORT

Report number: **1604913661804**
Inspection date: **05-11-2020**
Client:
Property address: **44 Florida Avenue New Lambton**

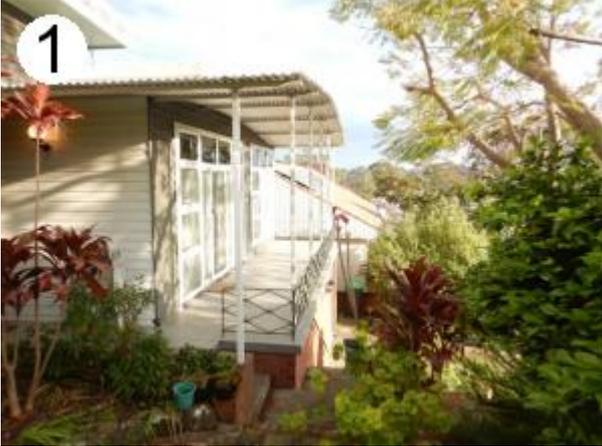
#1. Handrail doesn't meet current standard, however is in reasonable condition

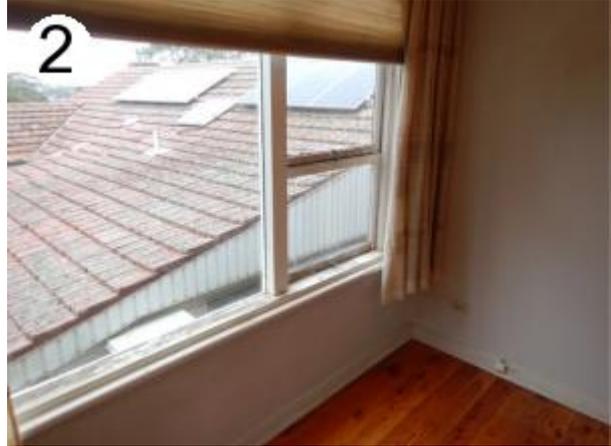
#2. Rear RH side bedroom window sill heights are <865mm from finished floor height and fixed fly screens are not installed, this creates a potential fall hazard

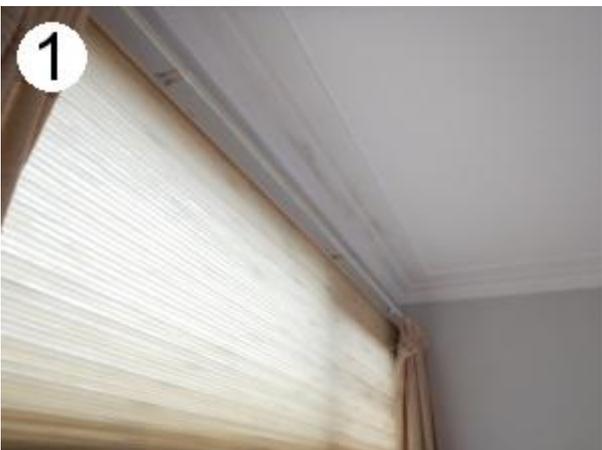
#1. Mould on the ceiling in areas, building should be well ventilated as it has been locked up for some time, monitor condition and repair as required

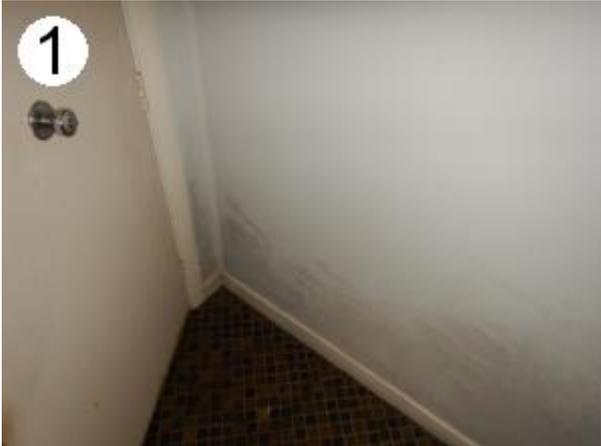
#1. Mould is present on Internal walls in areas, as the property is vacant building should be well ventilated and areas monitored.

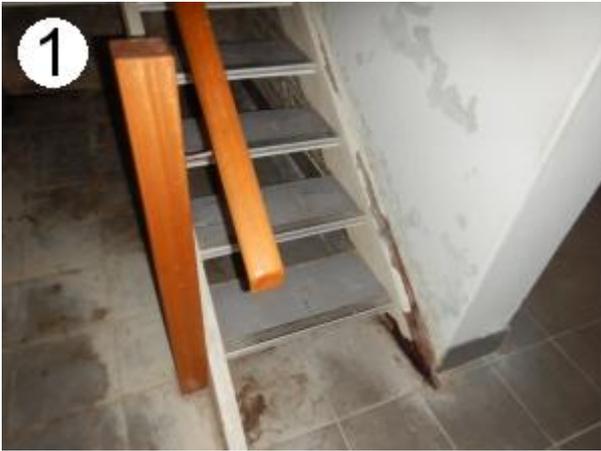
#1. Stair stringer is been affected by fungal decay, this is consistent with rising damp and elevated moisture, contact carpenter for further advice

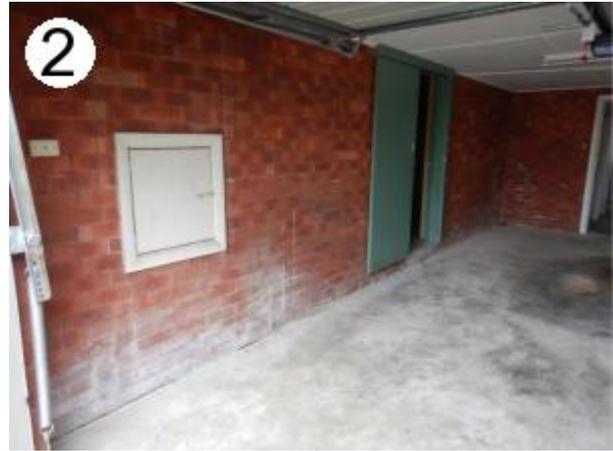
#2. Sodium on brick work is consistent with rising damp and poor drainage, monitor condition and repair as required

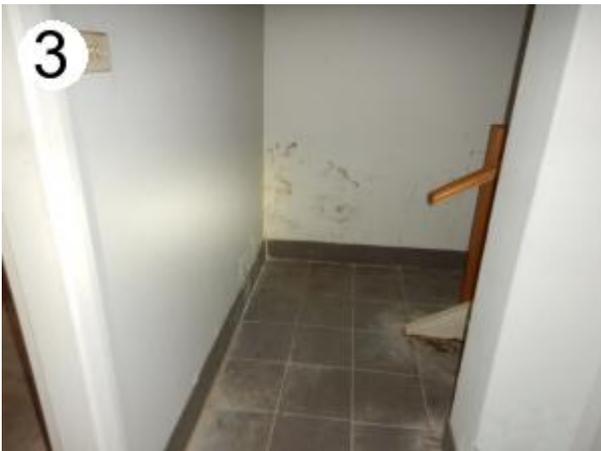
#3. Sodium on brick work and paint peeling is consistent with rising damp and poor drainage, monitor condition and repair as required

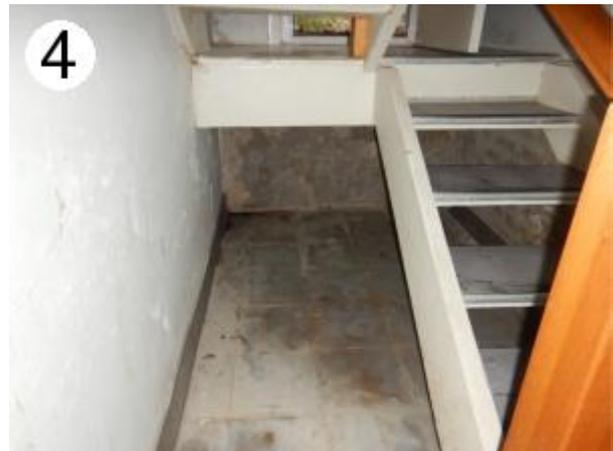
#4. Flooring is wet under stairs, this is consistent with the age of the property no poor site drainage, monitor condition and repair as required

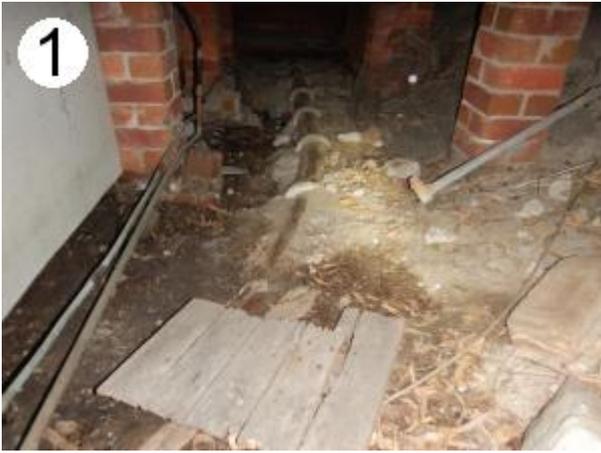
#1. Subfloor is damp in areas, site drainage should be improved

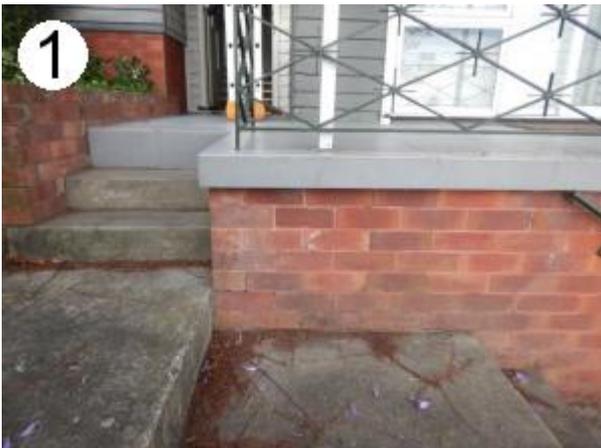
#1. Settlement cracking to front foundation wall, this is consistent with the age of the property, monitor condition

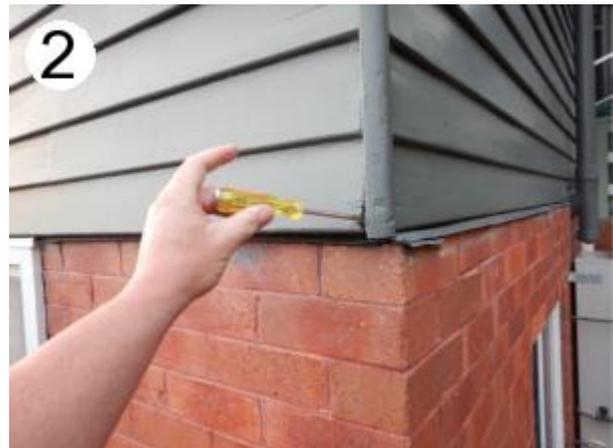
#2. External boards have been affected by fungal decay in areas, this is consistent with the age of the property, monitor condition and repair as required

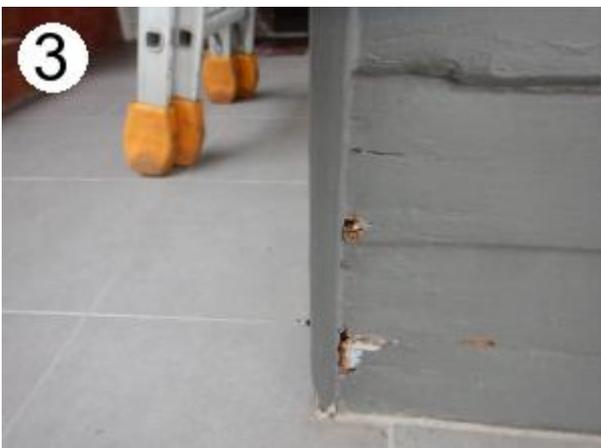
#3. External boards have been affected by fungal decay in areas, this is consistent with the age of the property, monitor condition and repair as required

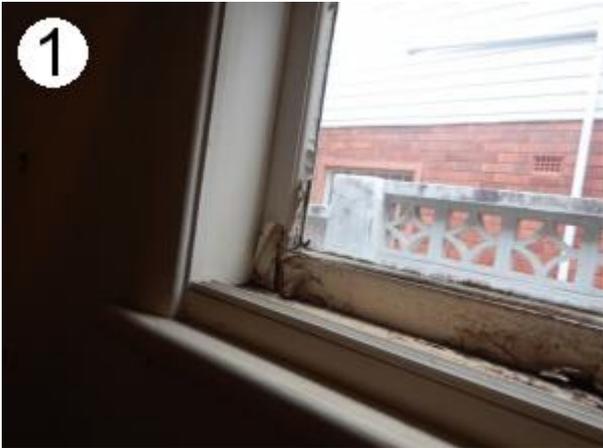
#1. Timber windows have been affected by moisture in areas, this is consistent with the age of the property, monitor condition and repair as required, regular maintenance is required

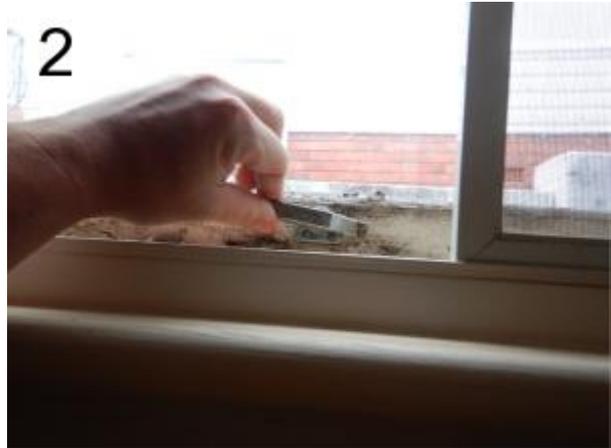
#2. Windows are tight to operate, regular maintenance is required

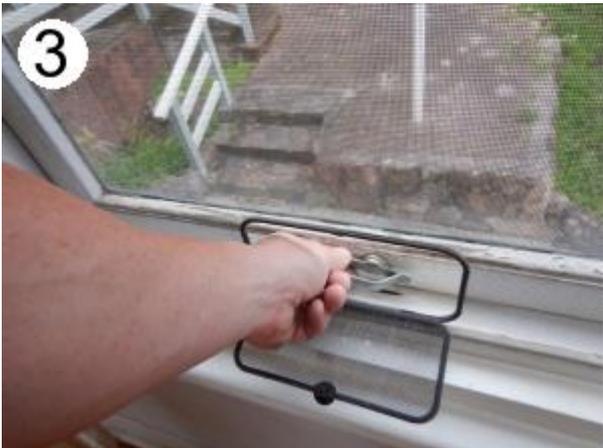
#3. Windows are tight to operate and are weathered, regular maintenance is required

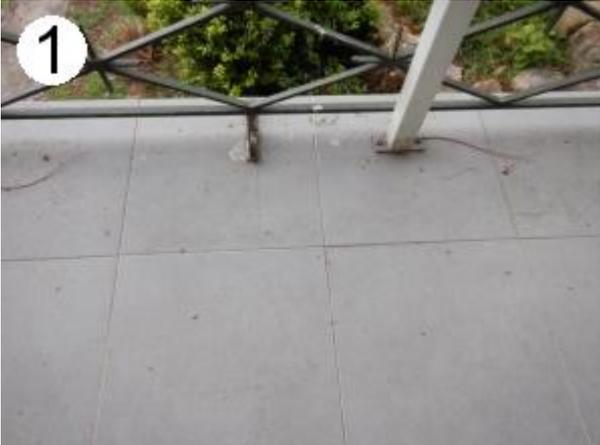
#1. Tile is cracked to the front patio

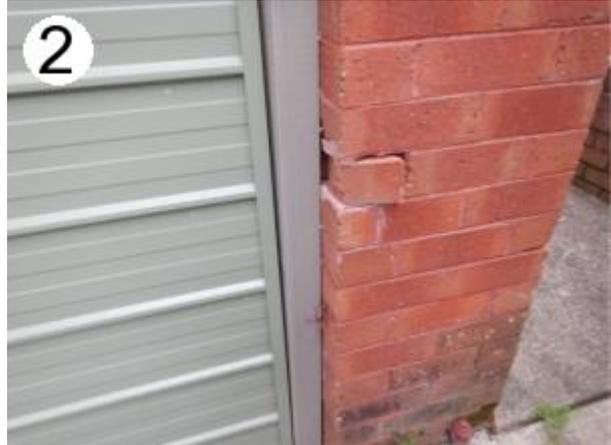
#2. Brick is not secured as intended

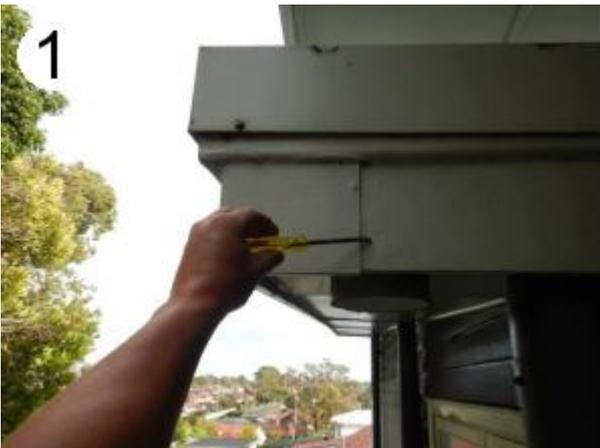
#1. Fungal decay is affecting fascia boards to the rear of the building, this is consistent with the age of the building, monitor condition and repair as required

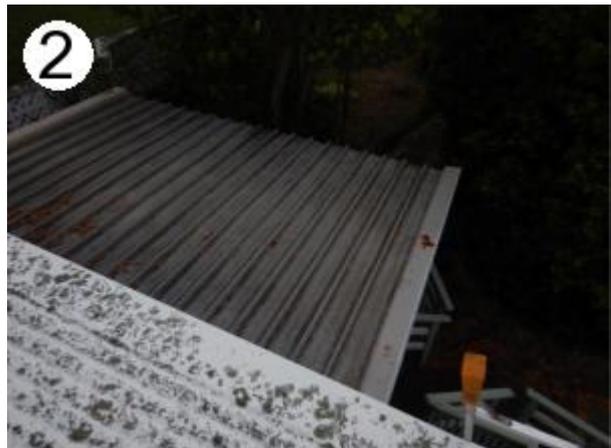
#2. Flashing above decking area are showing signs of rusting in places, monitor condition and repair as required, this is consistent with the age of the property

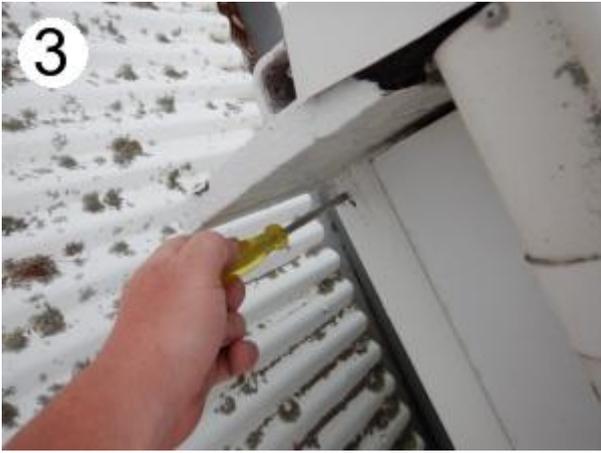
#3. Fungal decay is affecting timber barge board, this is consistent with the age of the property, monitor condition and repair as required

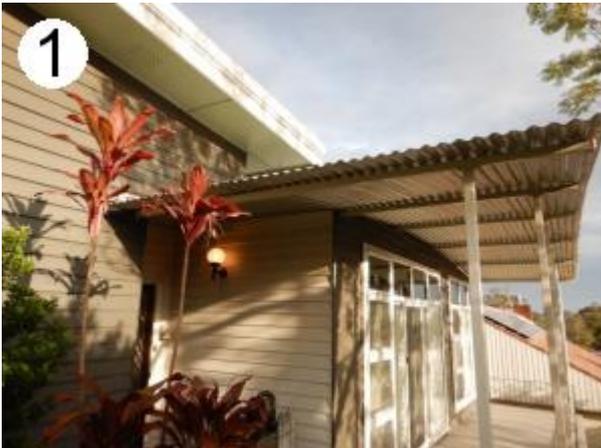
#1. Guttering should be installed to both sides of the front patio

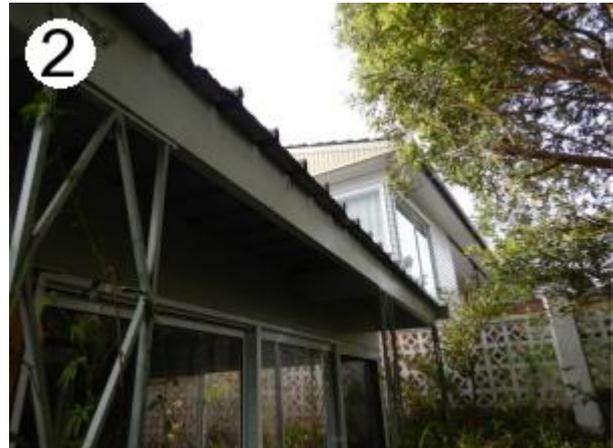
#2. Guttering should be installed to the rear of the decking

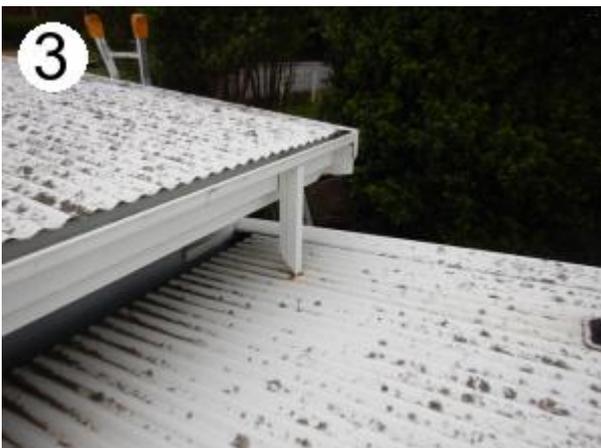
#3. Down pipe is showing signs of rusting, monitor condition

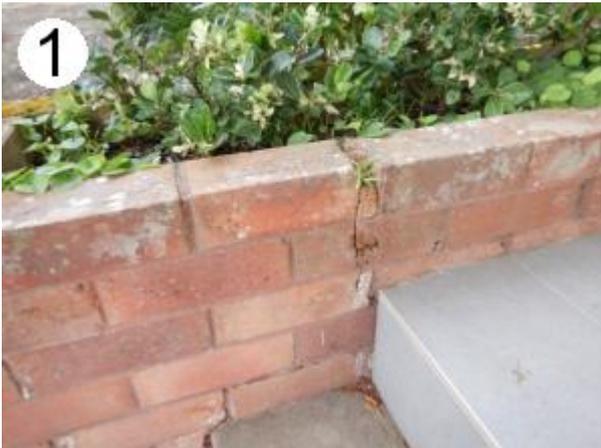
#1. Brick garden edging is cracked in places, this is consistent with the age of the property, monitor condition and repair as required

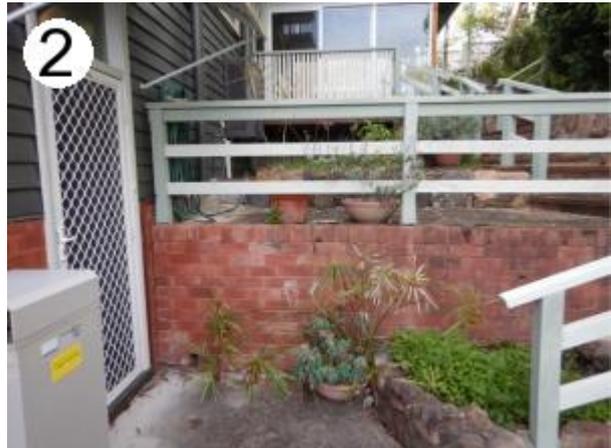
#2. Settlement cracking to brick retaining wall, this is consistent with the age of the property, monitor condition

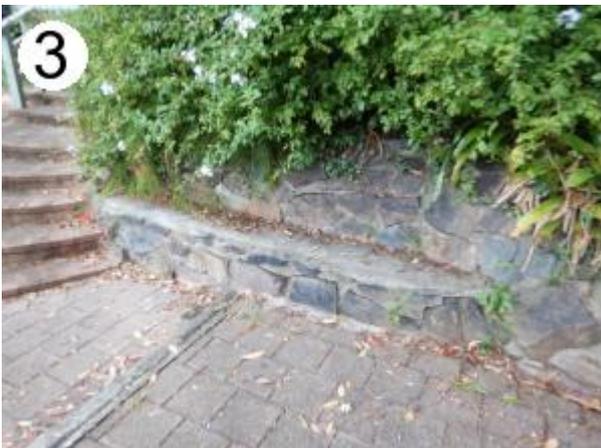
#3. Settlement cracking bush rock retaining wall in areas, this is consistent with the age of the property, monitor condition

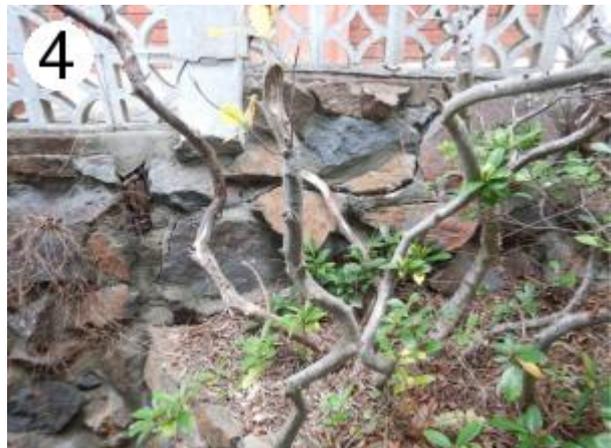
#4. Settlement cracking bush rock retaining wall in areas, this is consistent with the age of the property, monitor condition

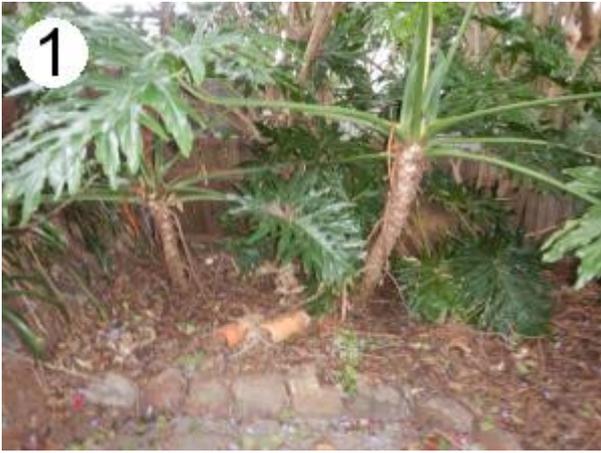
#1. Rear fence is in poor condition as it's leaning over, vegetation restricted access

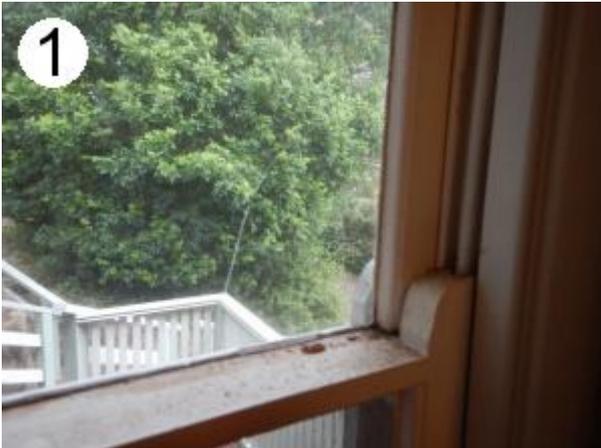
#1. Window is cracked rear bedroom

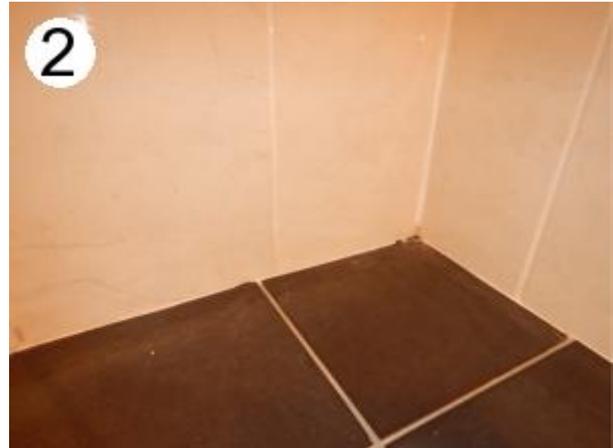
#2. Grout is cracked between wall and floor tiles to the bathroom in areas, this is consistent with the age of the property and movement with in the building, monitor condition, recommended to be repaired with a suitable silicone material

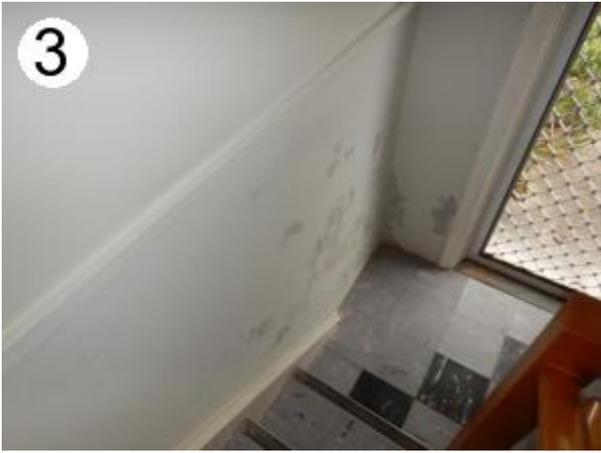
#3. Paint is peeling in areas to brick work to lower level, this is consistent with an elevation in moisture, monitor condition and repair as required

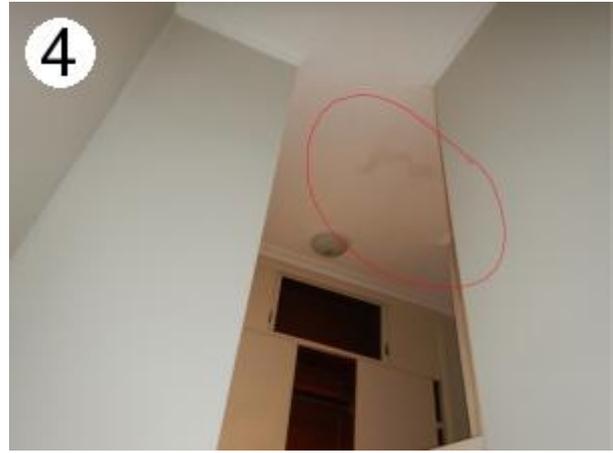
#4. Moisture staining to ceiling near bathroom, area was tested for moisture and no elevated moisture was detected, monitor condition

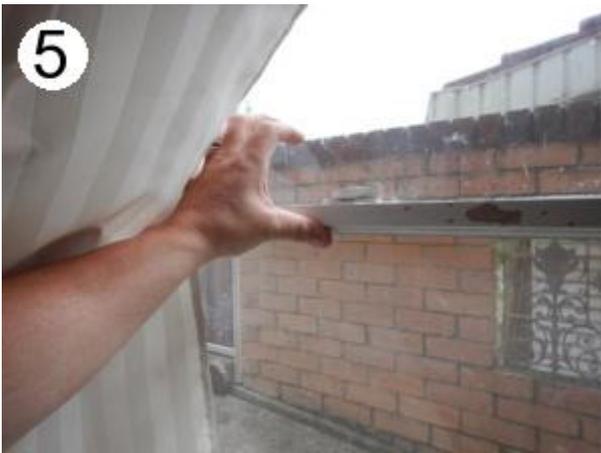
#5. Laundry window has been screwed closed

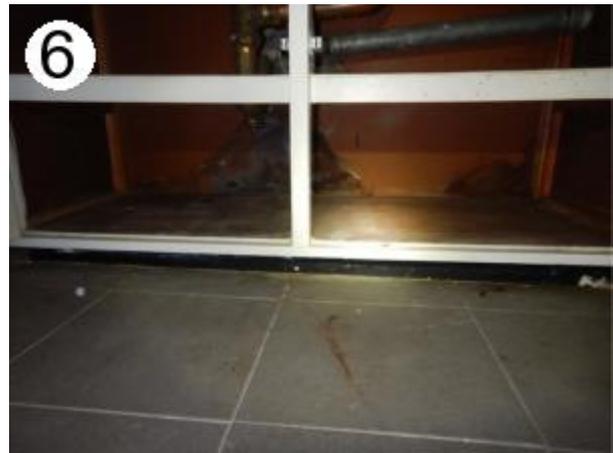
#6. Old moisture damage under laundry sink

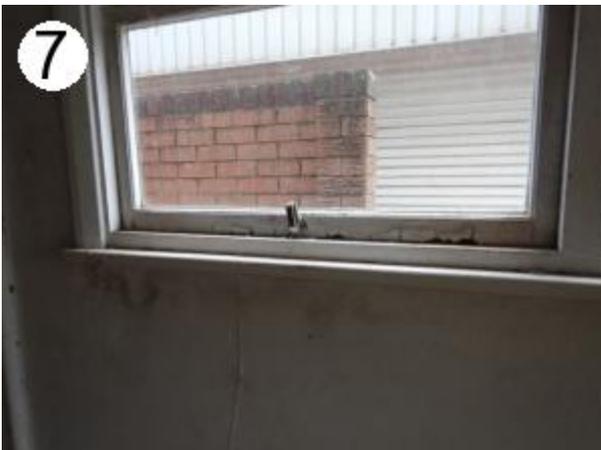
#7. Moisture has affected garage window causing fungal decay, monitor condition and repair as required

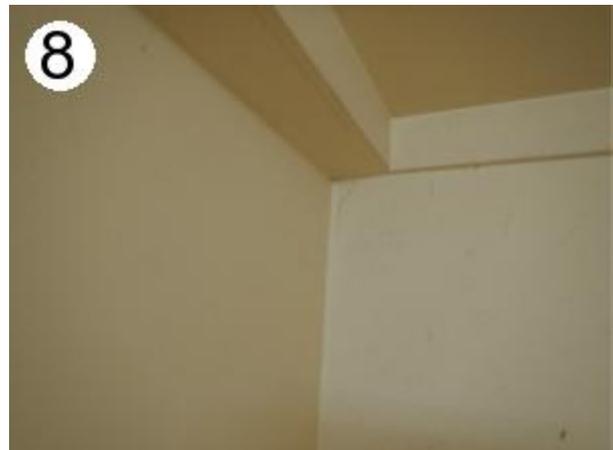
#8. Wall in storage area has cracked, this is consistent with the age of the property and movement with in the building, monitor condition

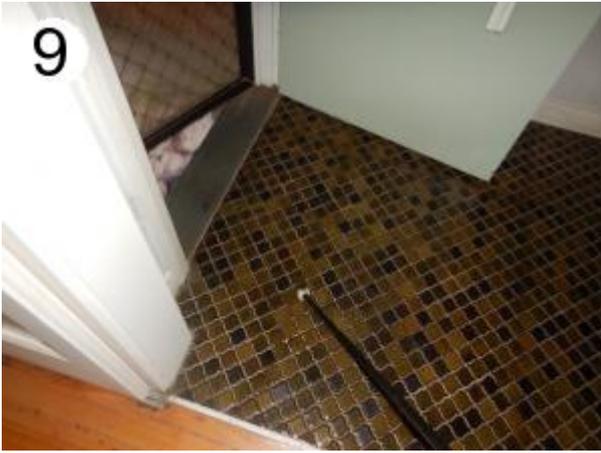
#9. Tiles are drummy in areas, this is consistent with the age of the property, monitor condition and repair as required

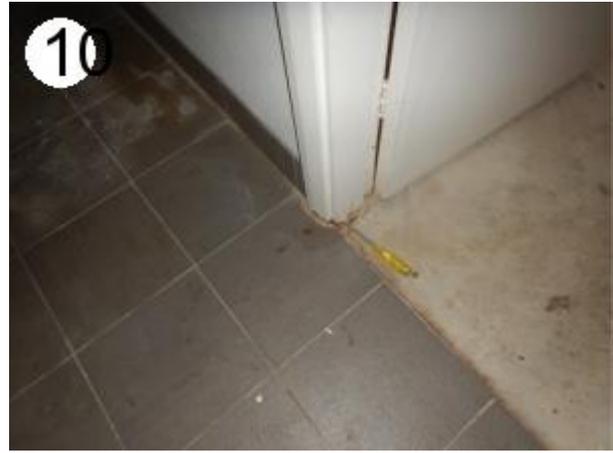
#10. Laundry door jamb has been affected by fungal decay, monitor condition and repair as required

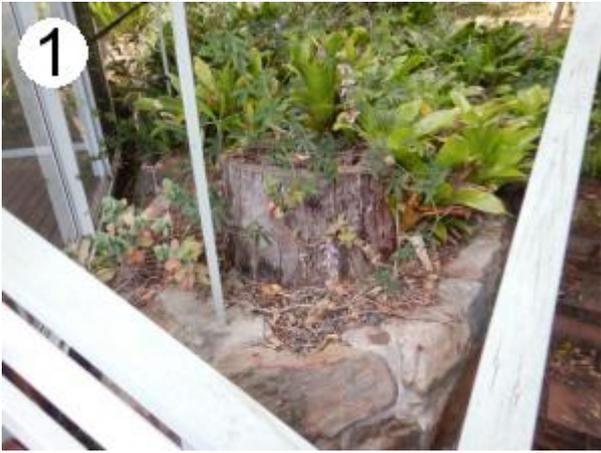
#1. Old termite damage was found to stump and vegetation

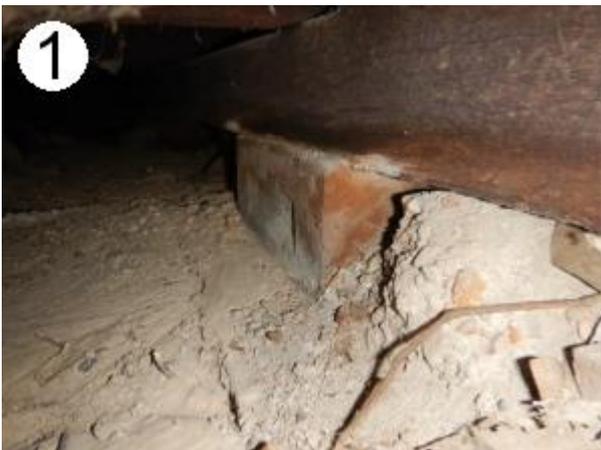
#1. Chemical delignification is slightly affected timber floor framing in places, this is consistent with the age of the property, monitor condition

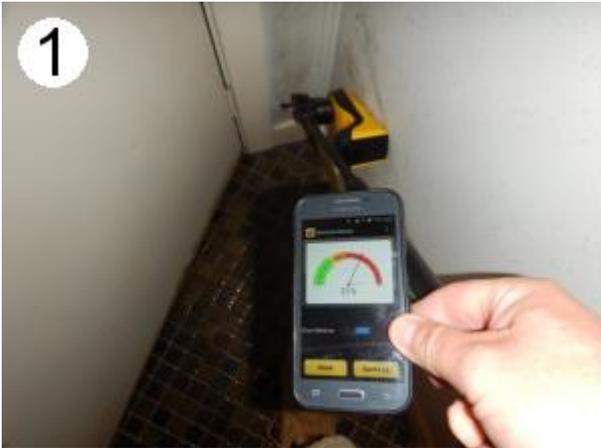
#1. Elevation in moisture was found near front door, monitor condition and repair as required, this is consistent with the mould growth

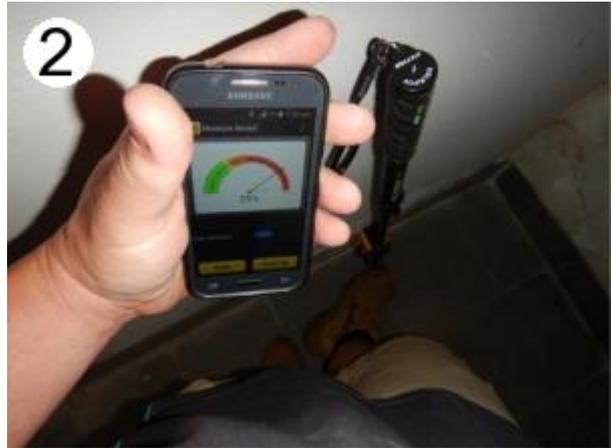
#2. Elevation in moisture was found to lower ground floor brick work, this is consistent with the age of the property and rising damp, monitor condition and repair as required

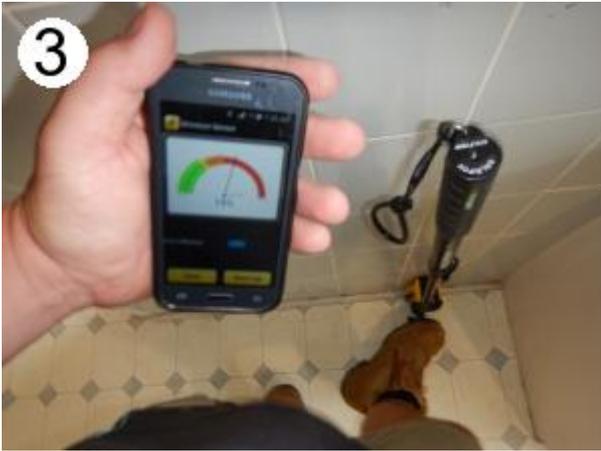
#3. Elevation in moisture was found around kitchen, area was radared for termite activity and no activity was detected, no visible signs of moisture were found under flooring, this could be a false reading due to material type, monitor condition

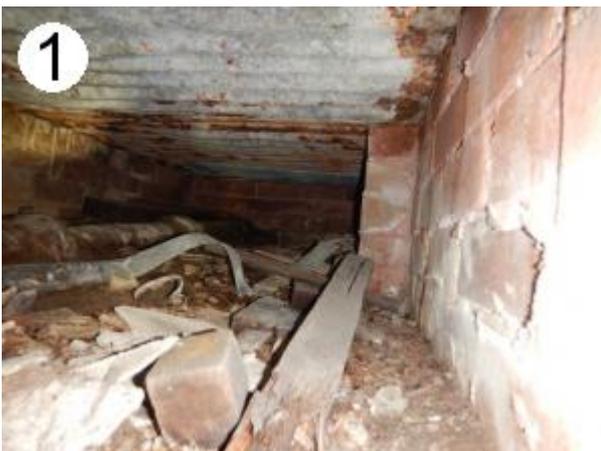
#1. Timber debris should be removed from the subfloor

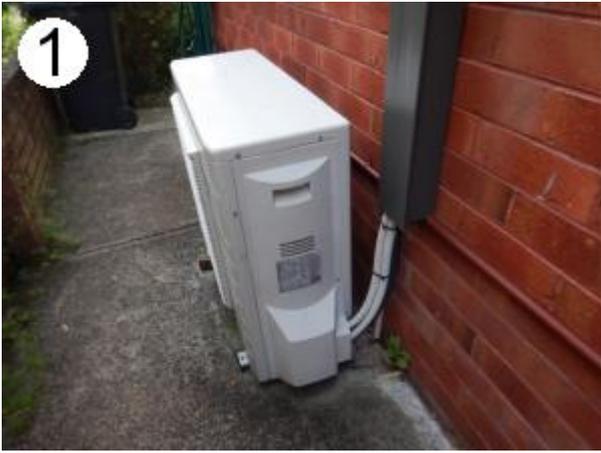
#1. AC drain is not connected into a drain, this can allow moisture to gather

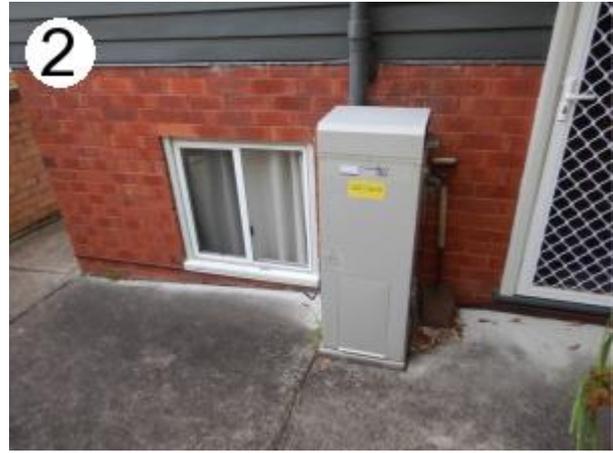
#2. Hot water over pressure pipe is not connected into a drain, this can allow moisture to gather
