Inspection Report

37 Alexander Parade, Charlestown, NSW, 2290

Pest And Building Inspection

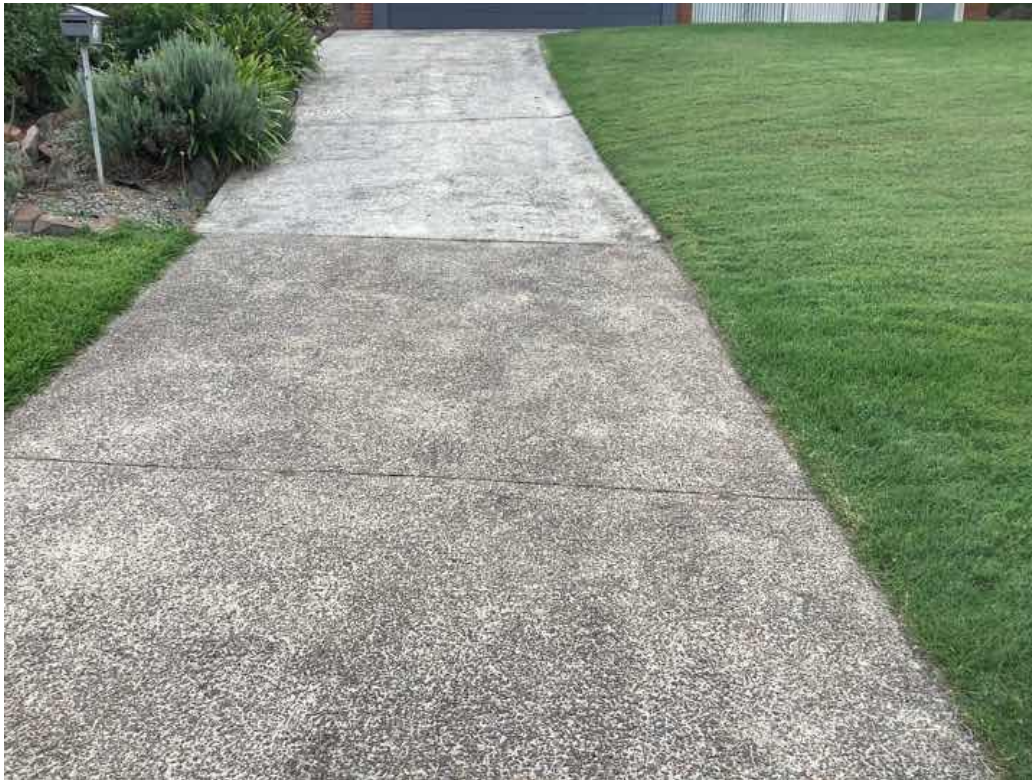
Driveway Condition

Common cracks & settlement were observed on the driveway. Maintenance is recommended. Note: Whilst these cracks appeared to be minor at the time of inspection, we strongly recommend you monitor these cracks and if worsening occurs contact a concreter for further advice.

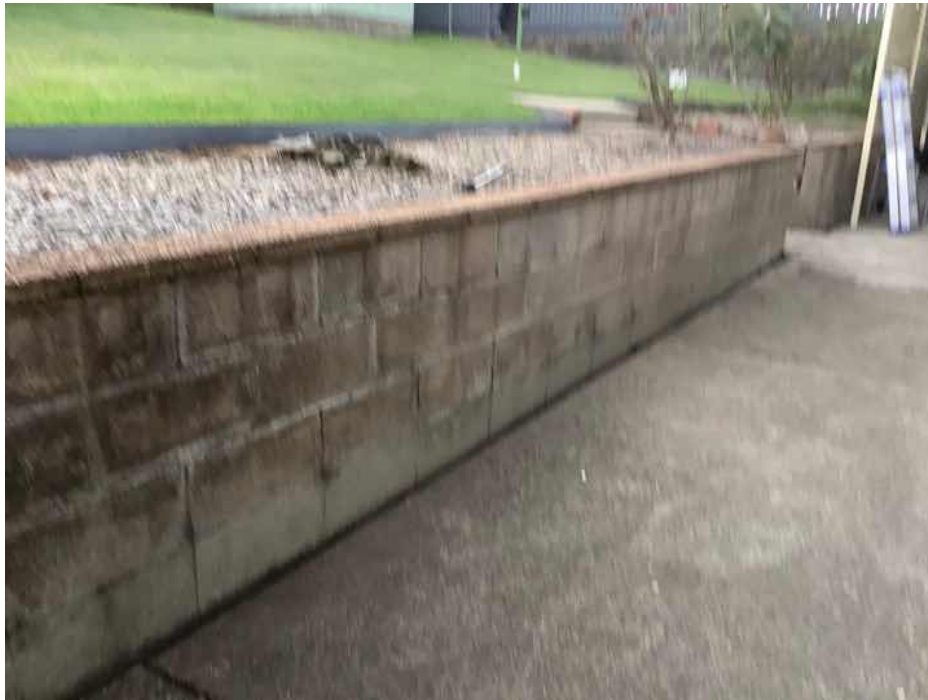
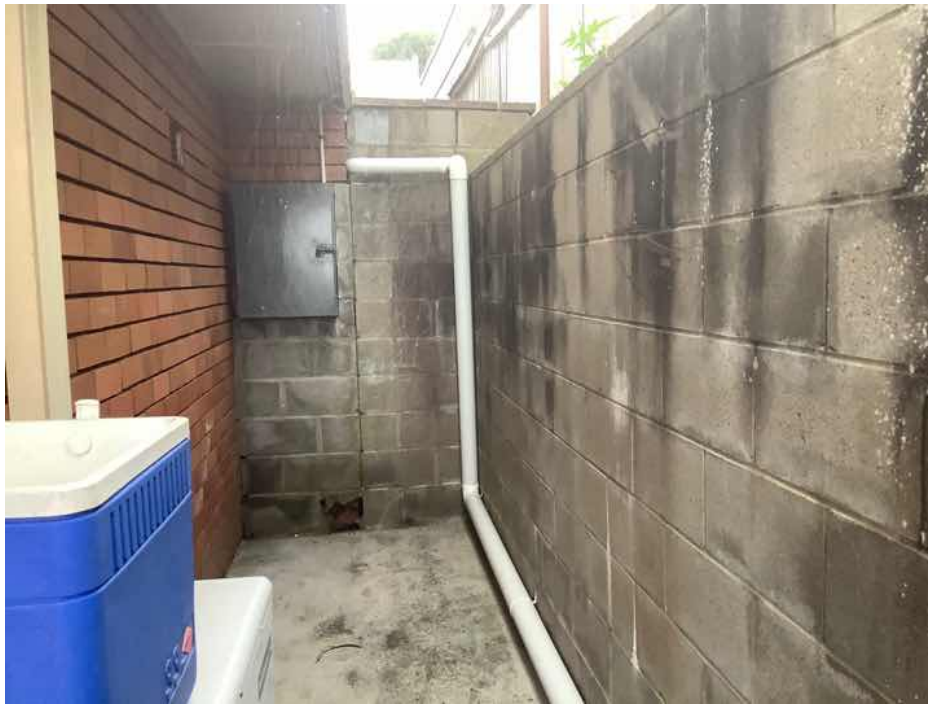
Retaining wall cracking - Recommendations: A qualified brick layer should be engaged for advice and recommendations.

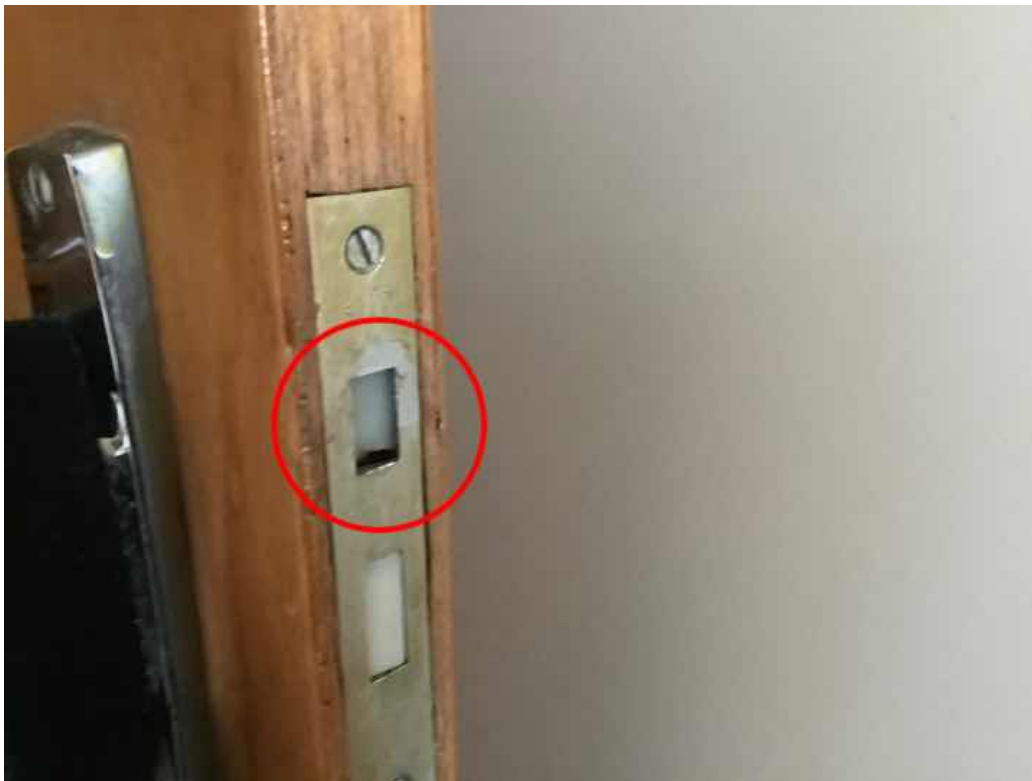
Door latch sticking - Recommendations: A qualified carpenter should be engaged for advice and recommendations.

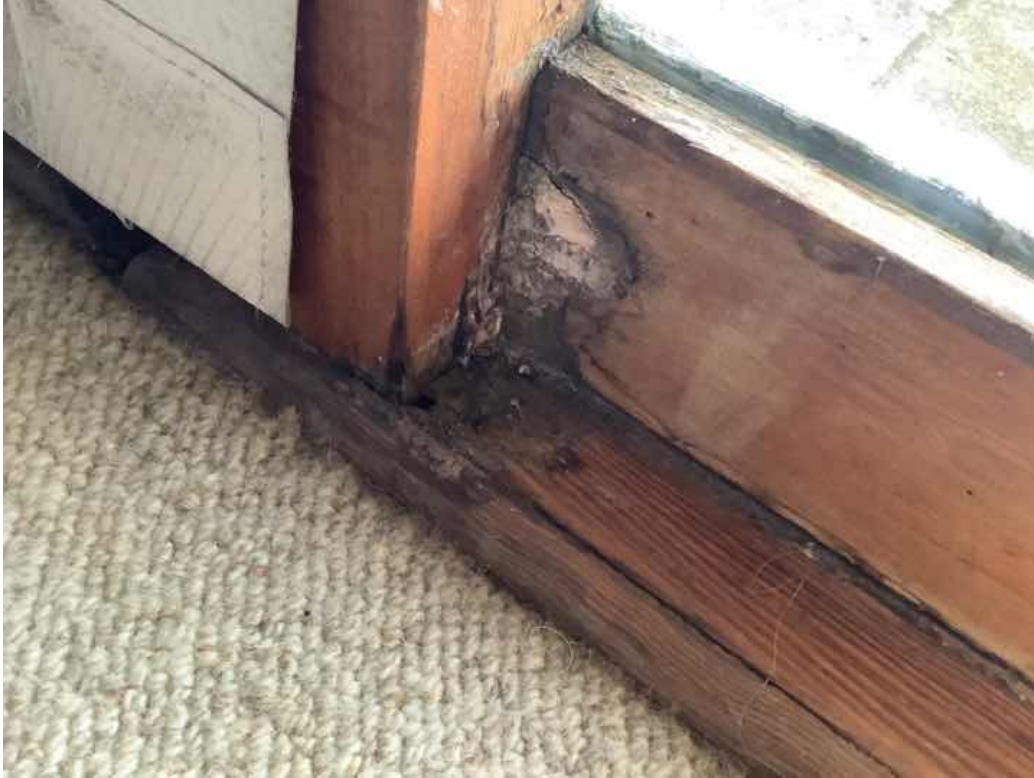
Windows

Patching has been carried out on sections of the window frames. Patching should only be carried out when all decay (rot) has been removed recommendations: A qualified carpenter should be engaged for advice and recommendations.

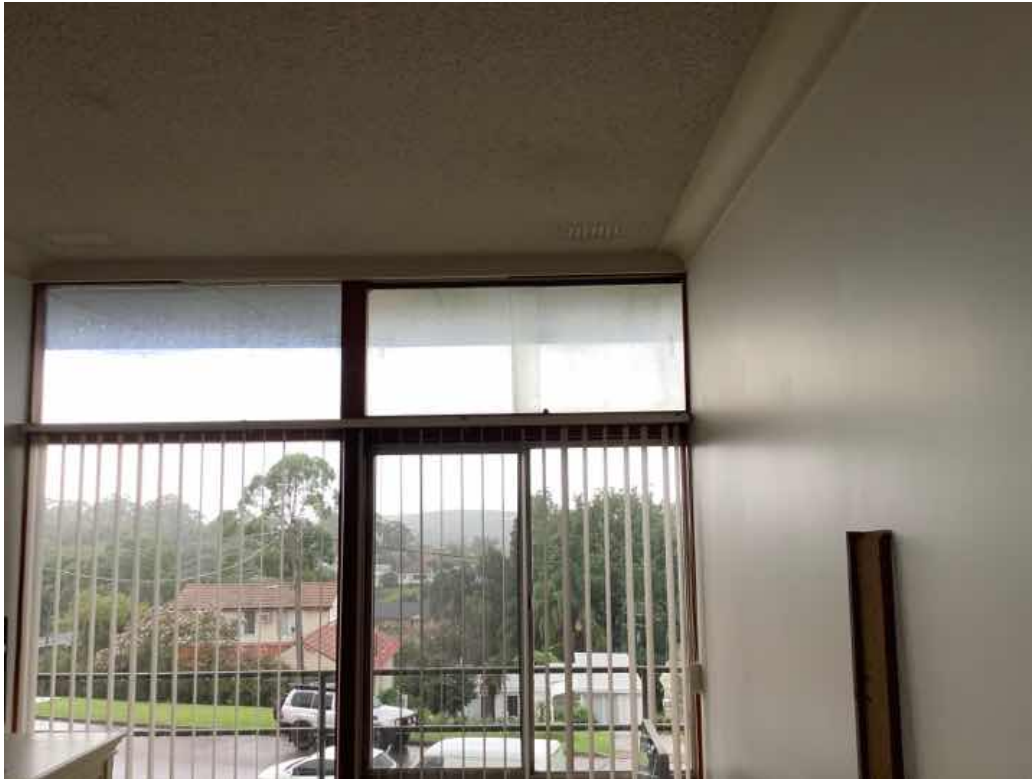
Flooring

Unevenness visible in floor - Recommendations: A qualified carpenter should be engaged for advice and recommendations re levelling.

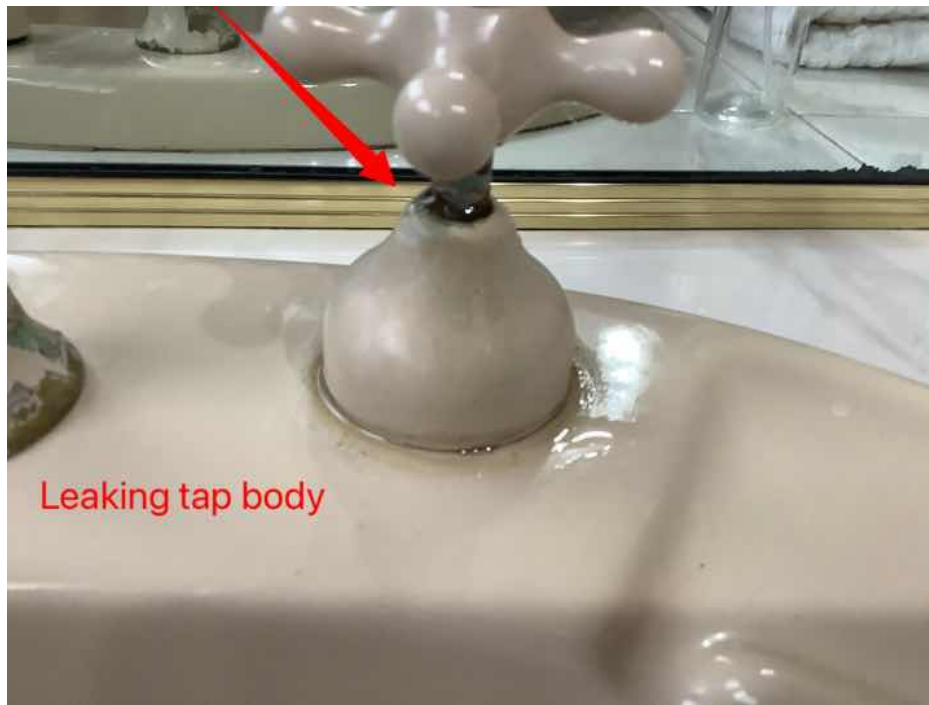
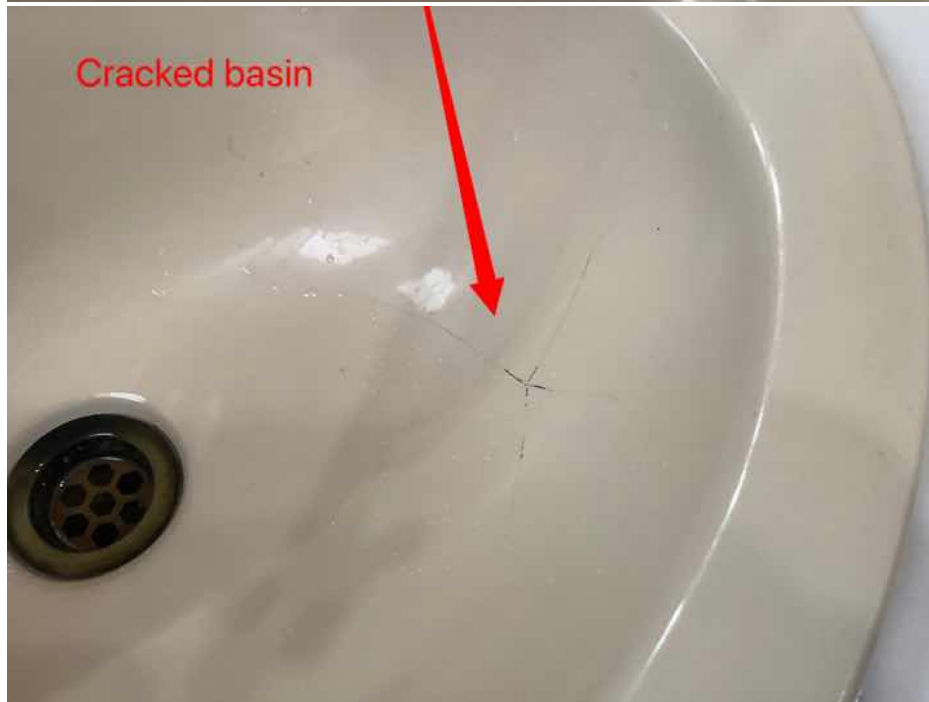
Sink

General deterioration and wear to drop in sink. Replacement sink recommended.
The tap / tap head is leaking . A qualified plumber should be engaged for repairs.

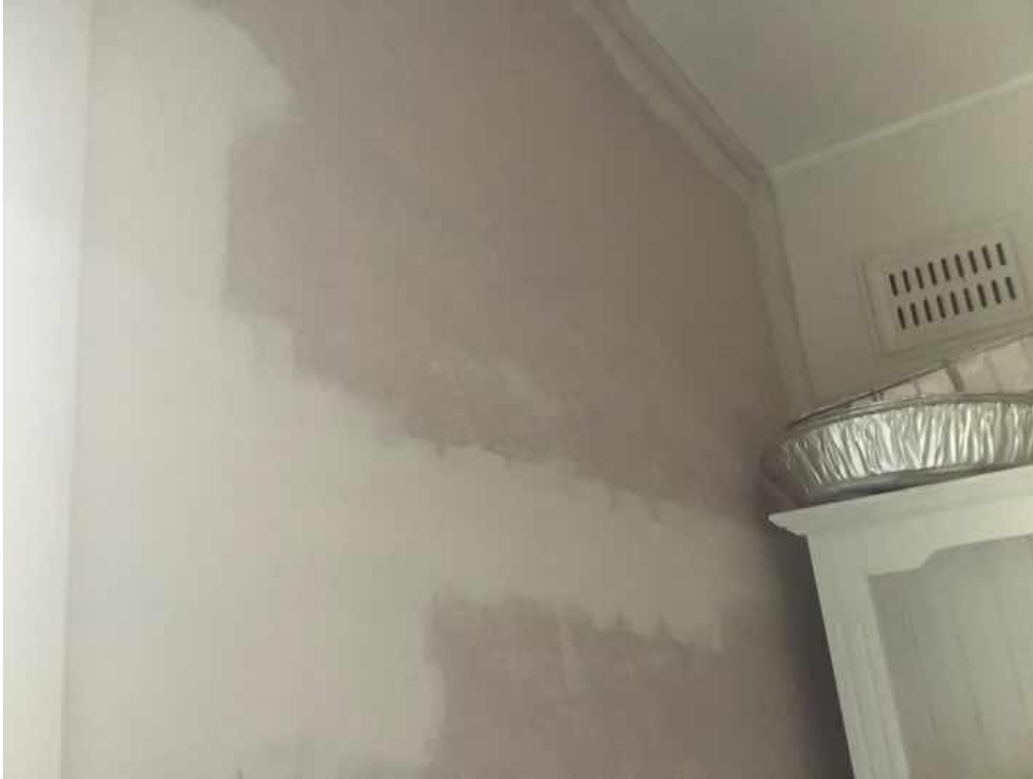
Walls

Incomplete Patch/Paint repairs noted. Call a licensed painter for repairs

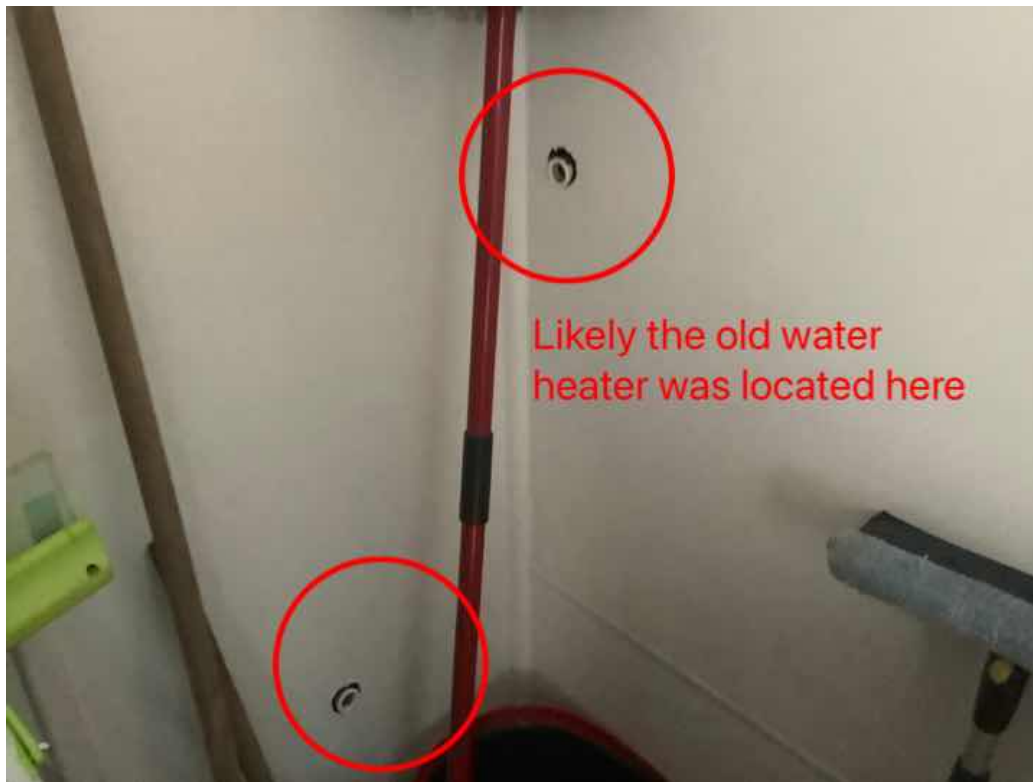
Taps and Tub

Pipe Penetration openings - As per the guide to standards & tolerances 2007 - Clause 7.08 - Pipe penetrations through external walls and inside cupboards - Plumbing holes are defective if they are not properly grouted; or in the case of cabinet work, fitted through neat minimum size penetrations, or fitted with tight fitting cover plates or collars with penetrations kept to the smallest size practicable. Recommendations: Engage a plumber to assess.
