OUR REF: 2110-17

DATE: 6.10.2021

BUILDING INSPECTION STANDARD REPORT
(Australian Standards No 4349.1 - 2007)

ON DWELLING: **5/15 Rowes Lane**
 CARDIFF HEIGHTS, NSW

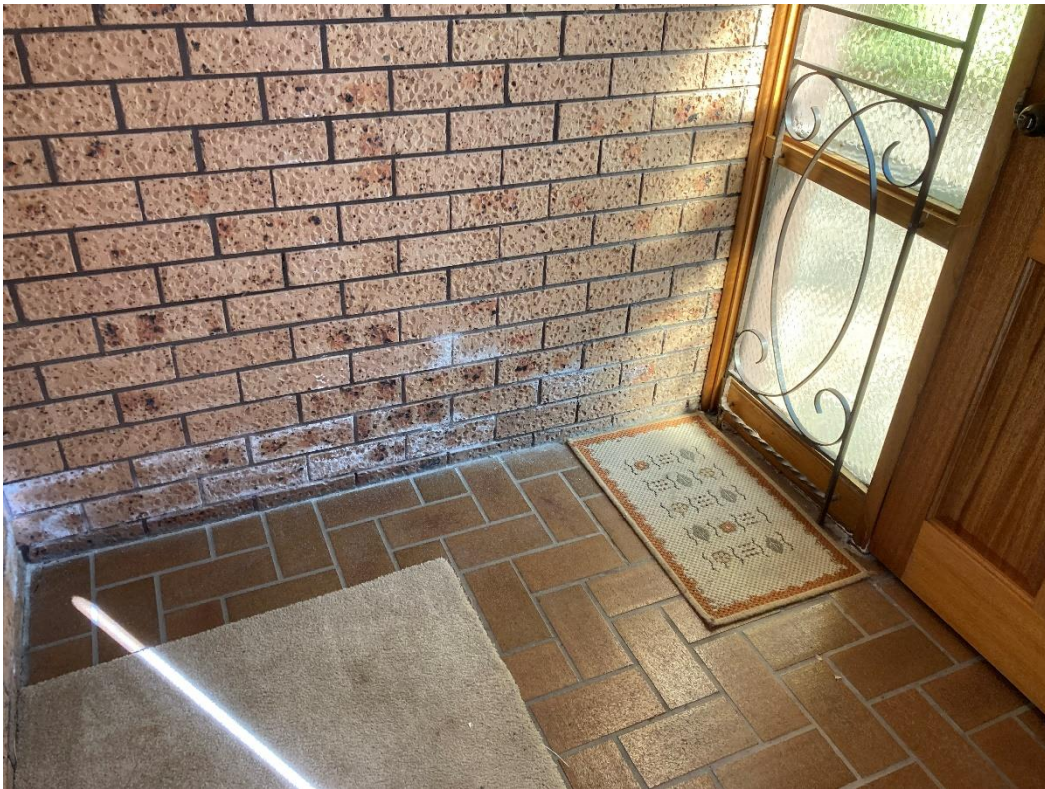
The southern elevated masonry wall has ground salts appearing to the internal surface, this indicates that the wall and the edge of the concrete slab will become damp during prolonged wet weather conditions; this is a result of the adjoining subfloor area not having adequate subfloor drainage systems installed

As a result after heavy pro-longed wet weather conditions due to the slop of site water ingress into the subfloor area is ponding against this masonry wall then ingressing to the internal room area.

Water ingress has caused minor fungal decay to the bottom edge of the timber entrance door frame and adjacent metal door frame to the carport area.

Ground salts are appearing to the masonry wall in the front entrance; indicating lateral moisture penetration during pro-longed wet weather conditions.

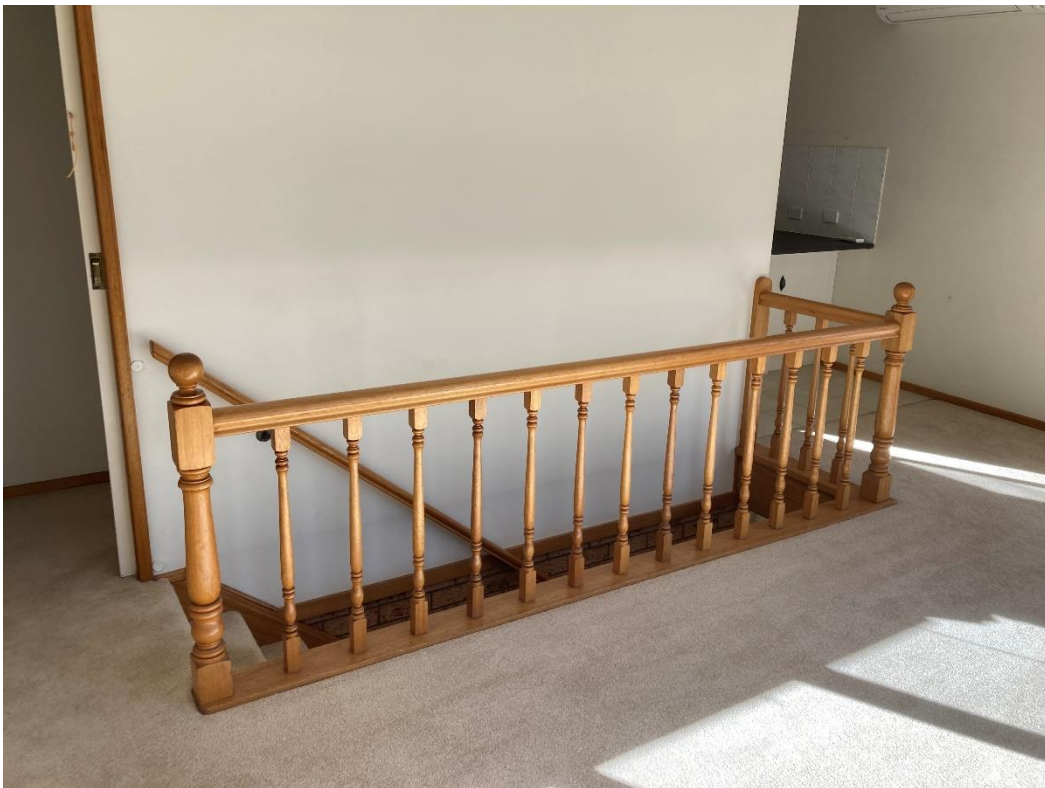
The timber balustrades surrounding the internal staircase would not be compliant with current building requirements which state that the minimum height of a balustrade to be 1 metre, all openings in a balustrade must not exceed a sphere of 125mm.

Internal timber staircase balustrade is not compliant with current building requirements.

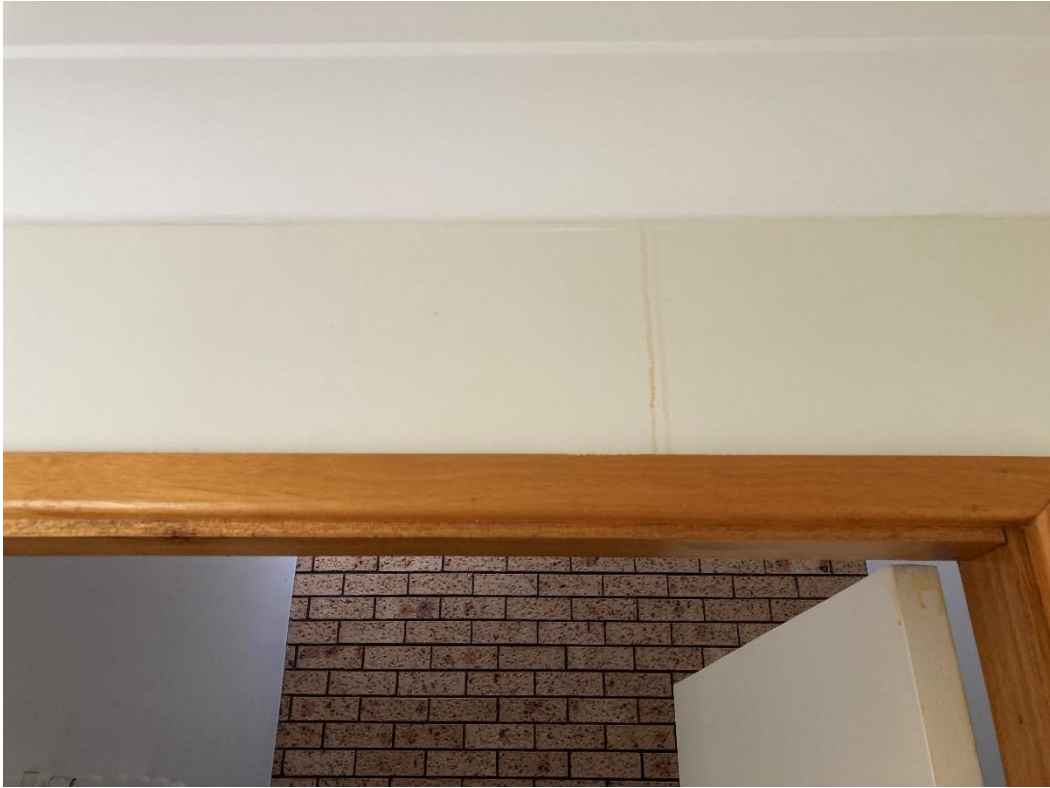
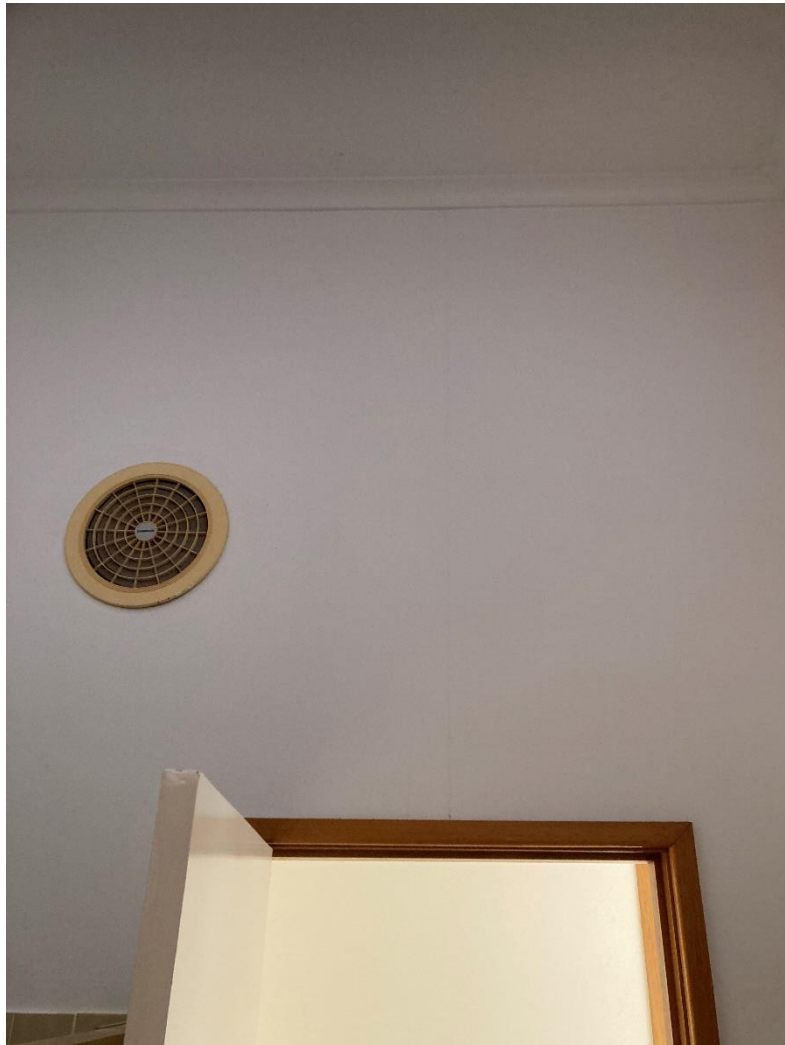
There has been a previous water leak into the roof void above the bathroom door opening; as a result of water ingress around wall and roof flashings.

Evidence of rainwater ingress into the roof void above the bathroom door opening.

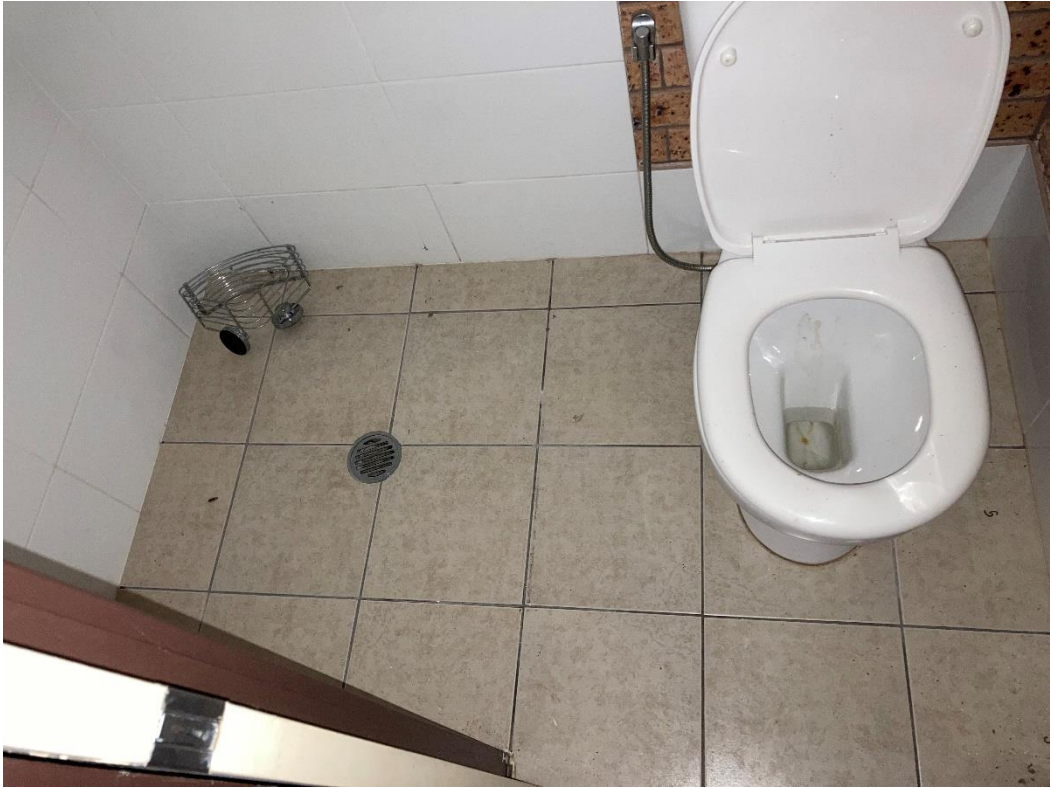
The shower recess' waterproofing membrane was not water pressure tested; as the recess has not been in use for some time and therefore it may give a false reading.

Ground floor bathroom shower recess waterproofing membrane was not water pressure tested.

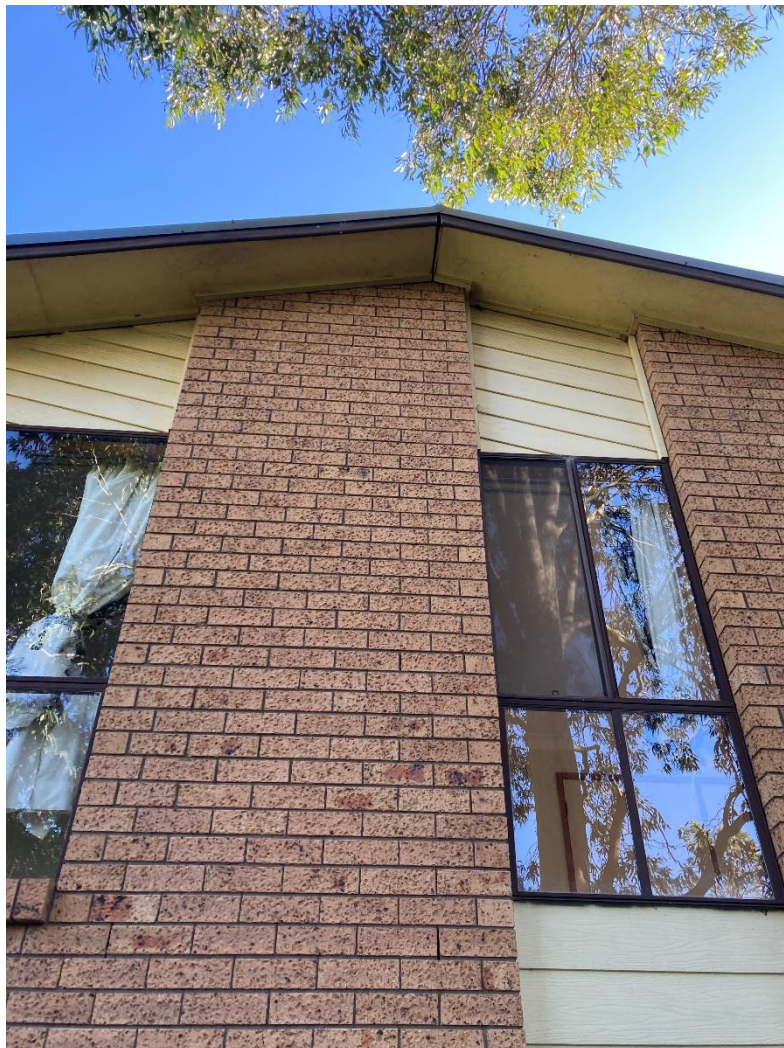
Spreading of the timber roof frame on the eastern elevation at the top apex.

There has been a settlement movement to the roof frame and the eastern elevation has spread at the apex; monitoring for further movements will be ongoing.

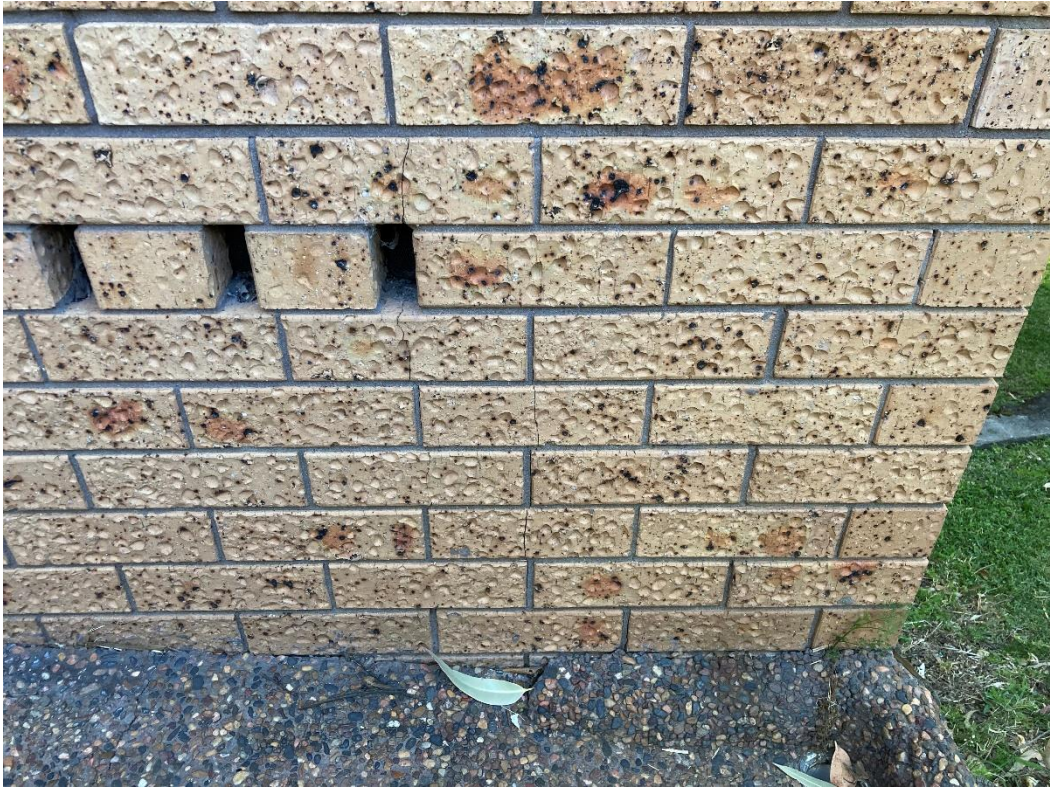
There is hairline vertical cracking on the southern elevated wall under bedroom 2.

This is a result of no articulation joints being incorporated in the brickwork at the time of construction to allow for brick growth under climatic changes.

This type of cracking is of little concern.

Vertical cracking to the brickwork under bedroom 2.

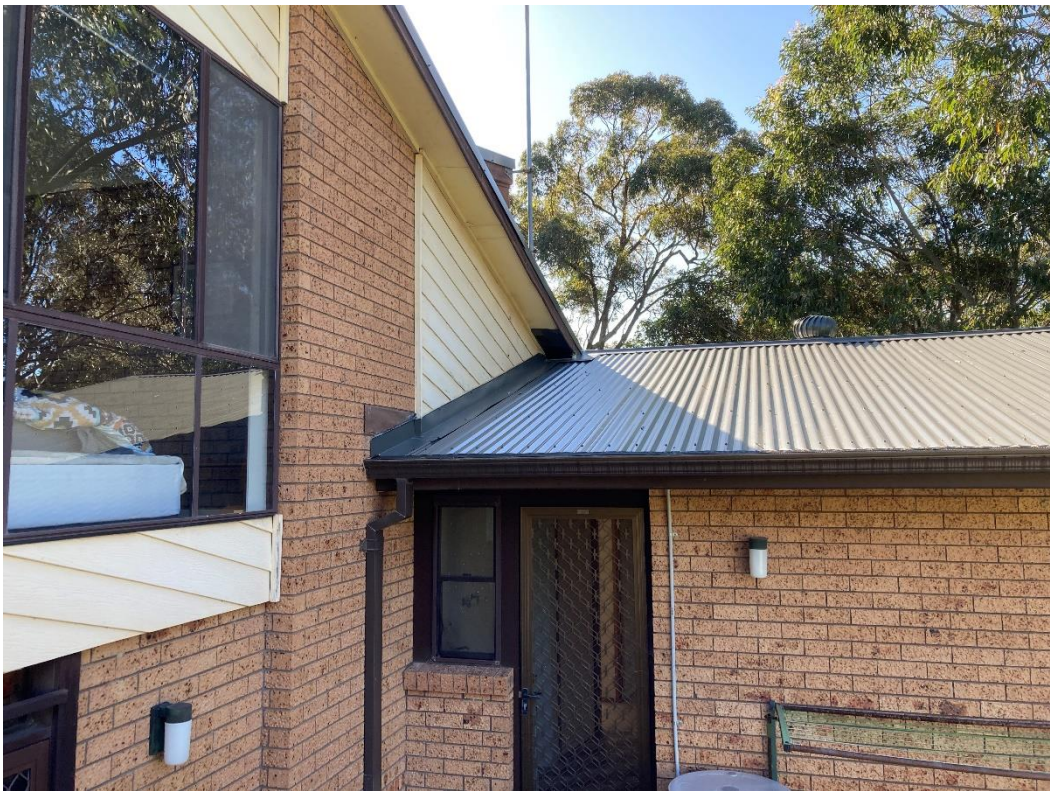
The wall and roof flashings to these metal roof sheets have extensive silicone sealant repairs and flashings have been poorly installed using the incorrect profile against fibre-cement weatherboards; monitoring for water ingress into the roof void will be ongoing.

Wall and roof flashings to the roof sheets have been poorly installed.

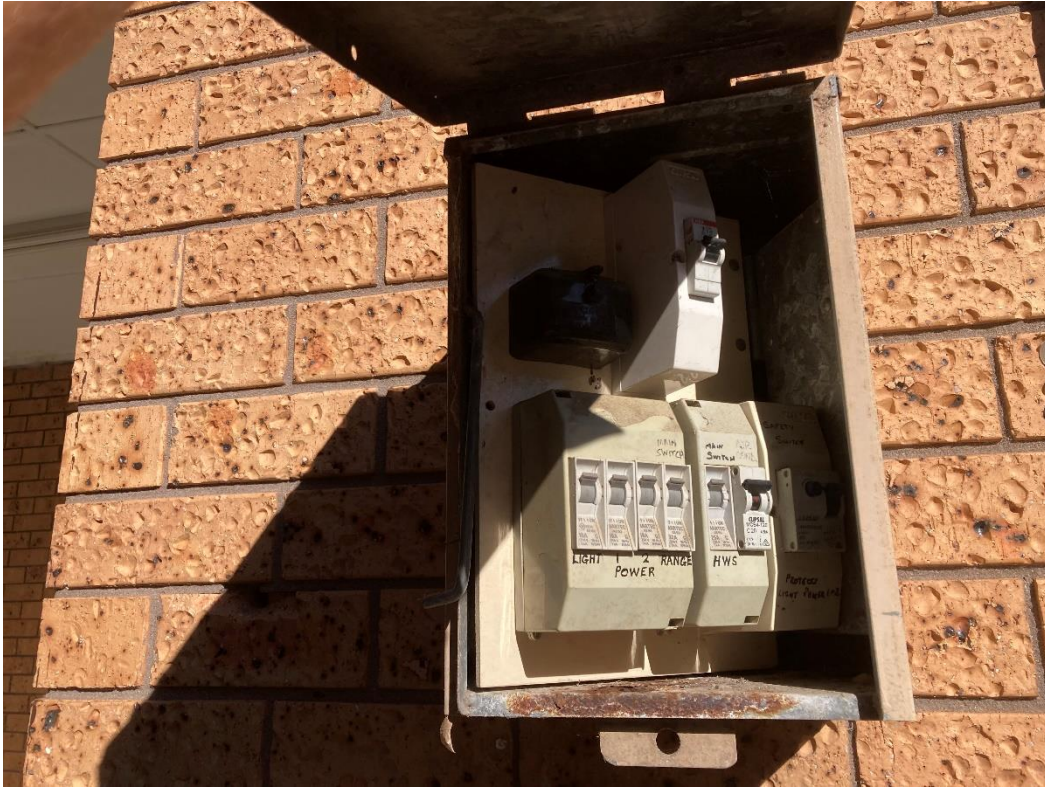
Electrical meter box has earth leakage circuit breakers. There are no termite sticker notices installed in the meter box on any previous termite management systems.

The dwelling’s electrical wiring has earth leakage circuit breakers. It is recommended the wiring be checked by a licensed Electrician for compliance & safety.

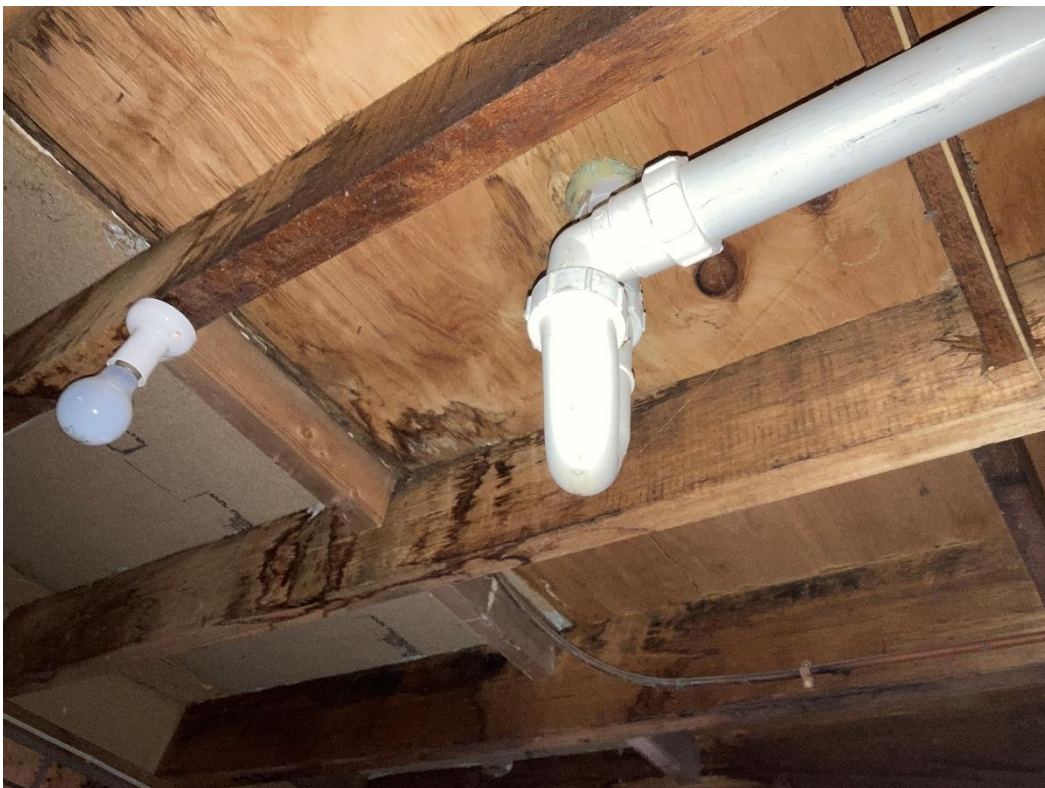
The shower recess' waterproofing membrane was water pressure tested; Evidence in the subfloor area revealed that water is excapeing from the waterproofing membrane and this shower recess has had past waterproofing problems with surrounding structural pine board floor sheeting being recently replaced and there are extensive silicone sealant repairs to the floor and wall tile junctions inside the shower recess.

First-floor bathroom shower recess waterproofing membrane was water pressure tested; evidence in the subfloor area revealed that water is escaping from the waterproofing membrane.

The bathroom will need to be renovated in an upcoming maintenance programme.

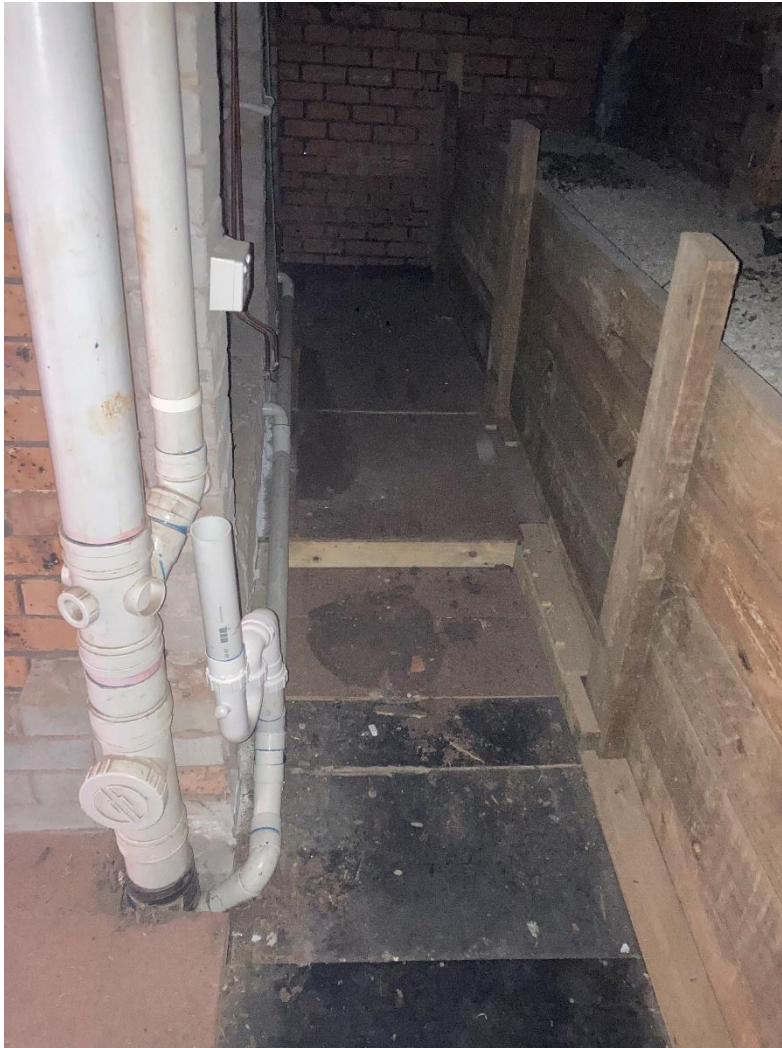
There is also a subfloor timber-framed floor frame installed; this floor frame now is extensively termite damaged confirmation that active termites have been eradicated remains unconfirmed and further confirmation on termite activity into the subfloor area needs to be obtained by the current owner.

Significant termite damage to the subfloor timber floor frame. Confirmation that the active termites have been eradicated remains unconfirmed and further advice is recommended by the current owner.

- The electrical wiring and plumbing services checked by licensed tradespeople.
- Remove subfloor timber floor frame and confirm no active termites into the property.

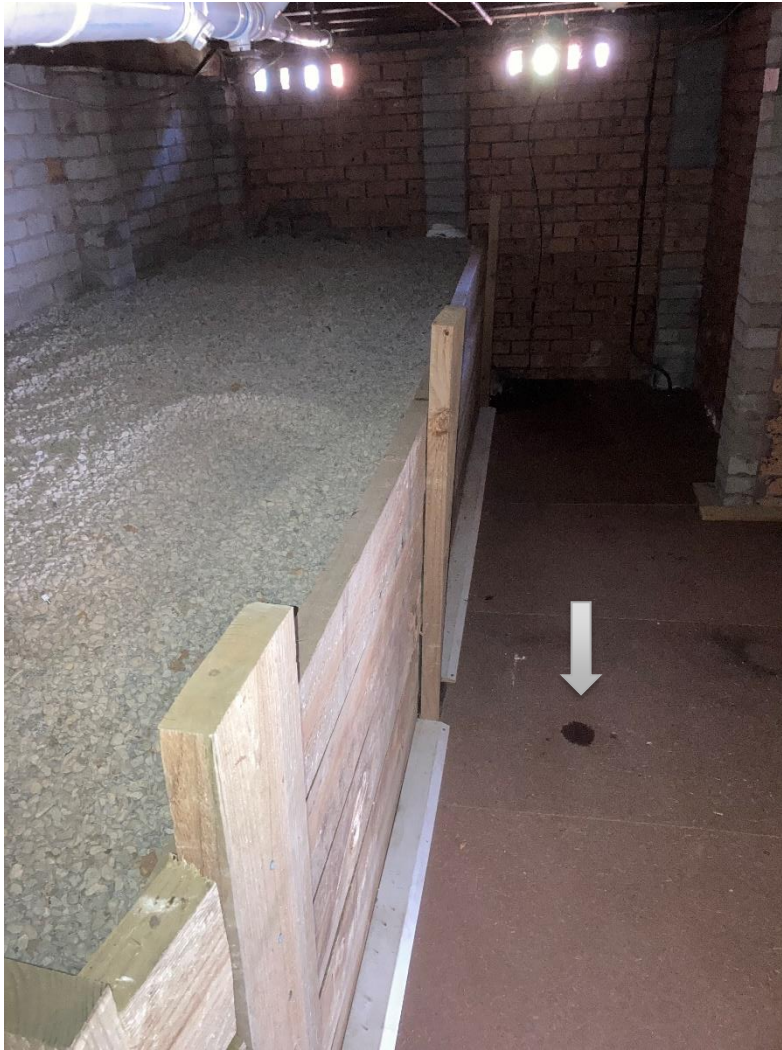
Drainage in preventing surface and seepage water from entering the subfloor area is poor. There have been attempts to install subfloor drainage systems with new treated timber retaining walls, which are poorly constructed and exhibit rotation outwards due to hydrostatic pressure.

Treated timber retaining wall in the subfloor area is poorly constructed; having a significant rotation outwards due to hydrostatic pressure caused by the poor subfloor drainage system.

NOTE: There is a drip on the particleboard flooring from the leaking shower recess above – refer to the arrow.
