# Inspection Report

## Reliant Pest And Building

**35 The Avenue , Maryville , NSW, 2293**

### Pest And Building Inspection

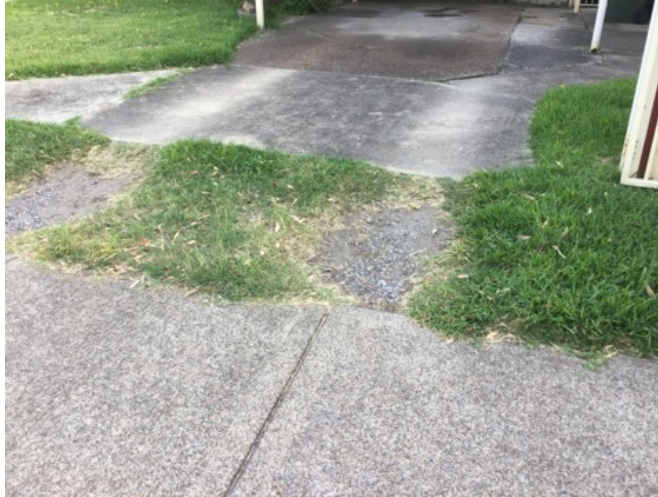
Incomplete contact a licensed concreter for unfinished concrete over council strip.

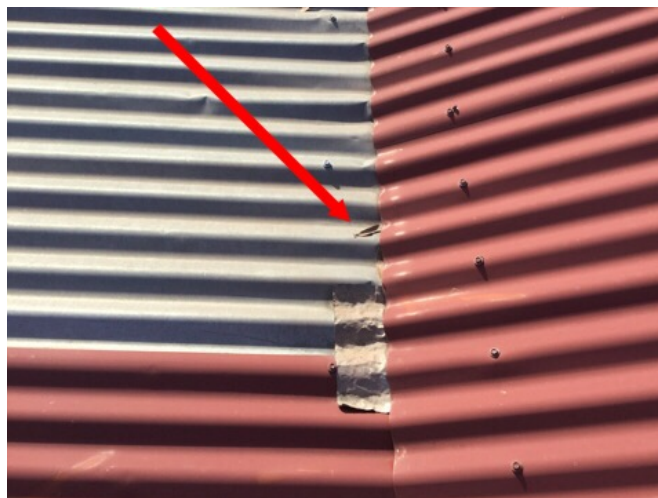
Recommend installing a transition flashing to prevent potential water ingress into roof cavity.

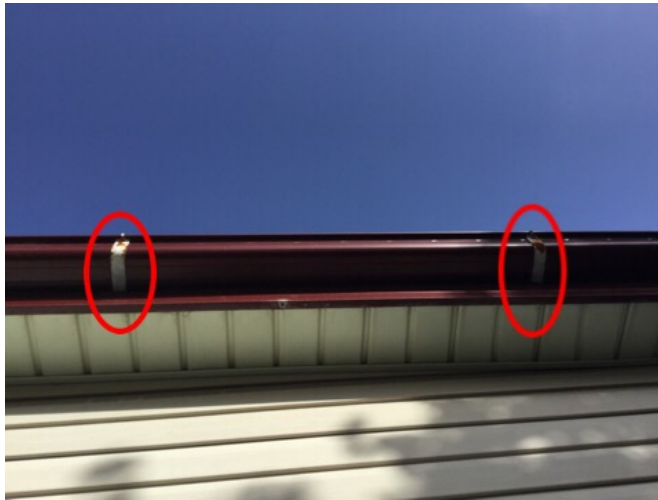
The gutter clips have deteriorated in areas. Recommendations: This can be rectified by maintenance contractors.

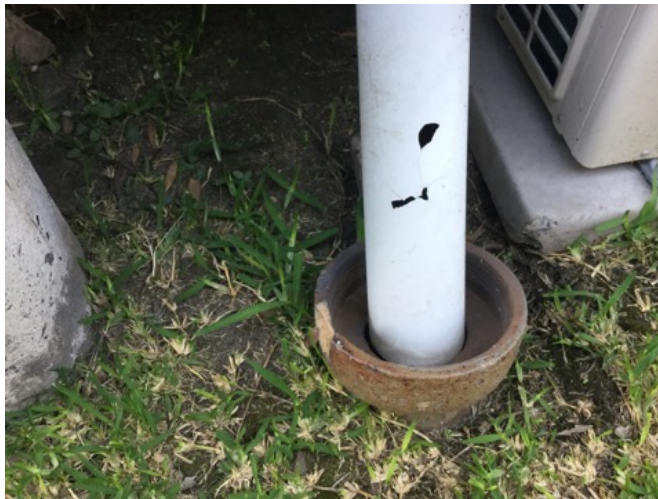
The down pipe base is damage/cracked. This has the potential to cause leaking. Recommendations: A qualified plumber should be engaged for repairs.

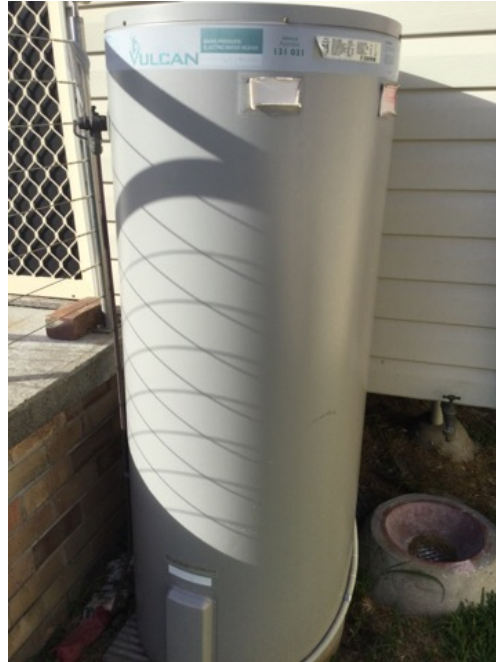
The hot water unit was poorly footed/unstable or uneven. Recommendations: Engage a licensed plumber for advice and recommendations.

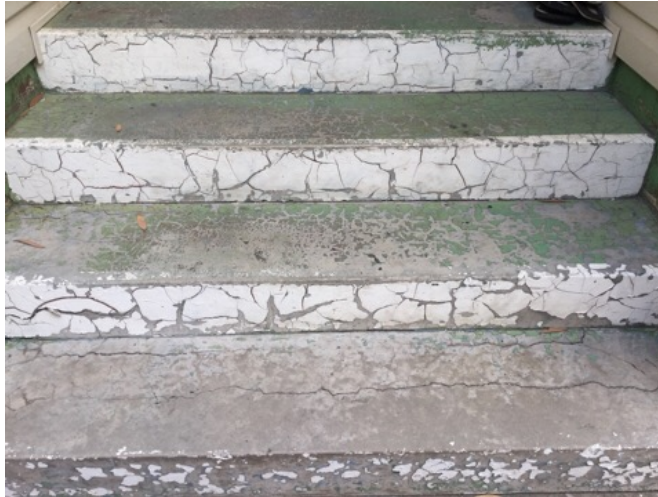
Settlement/movement cracking. Recommendations: A qualified brick layer or concreter should be engaged for advice and recommendations.

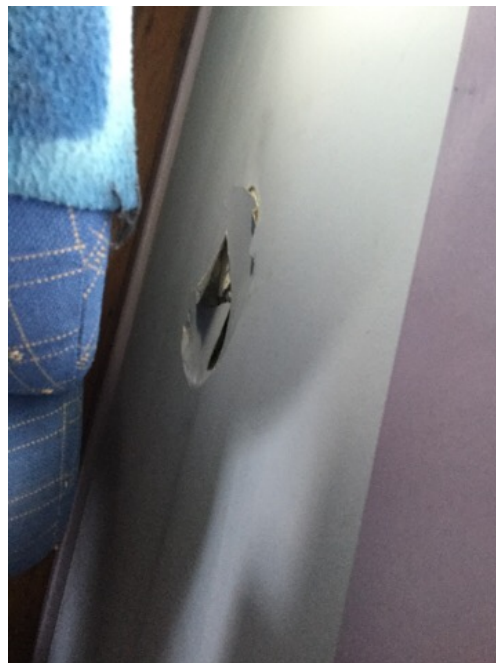
Impact damage noted. Contact a licensed plasterer for repairs.

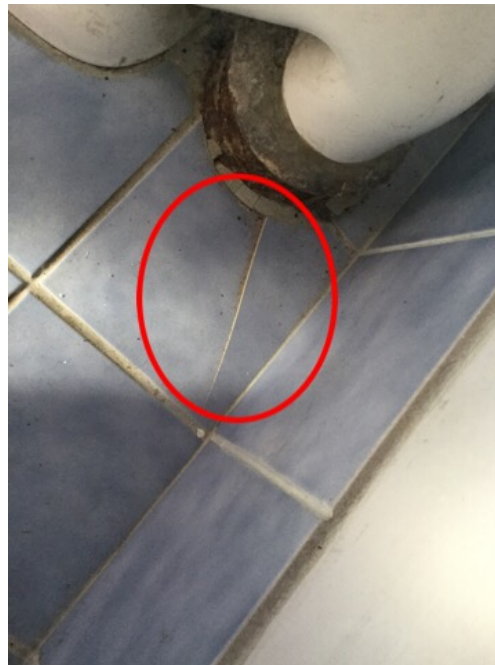
Cracked tile noted. A qualified tiler should be engaged for advice and recommendations.

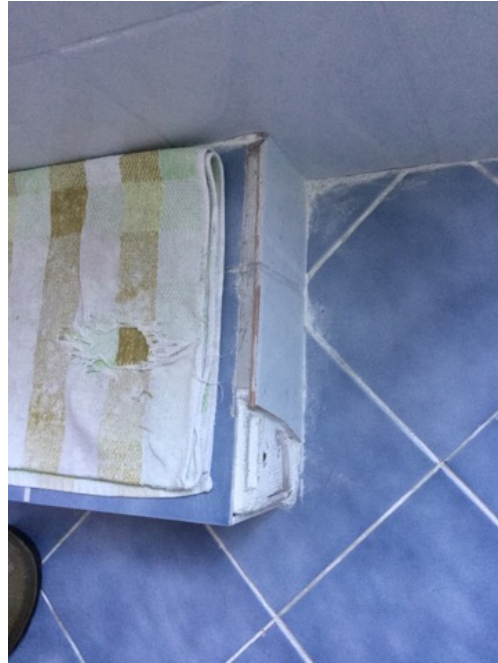
Cracked step tile - Recommendations: A qualified tiler should be engaged for advice and recommendations.

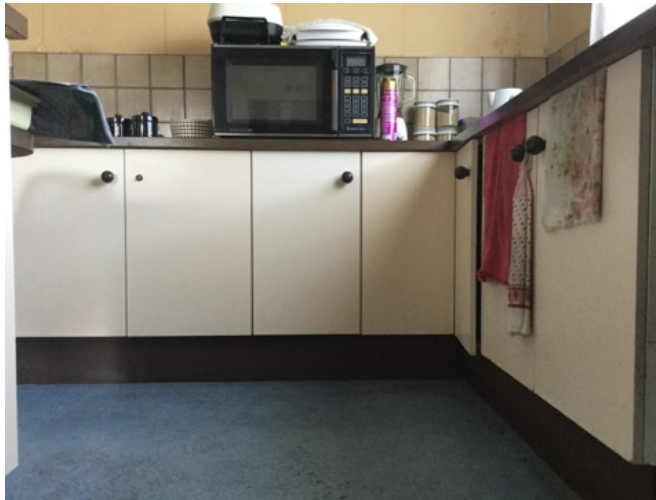
General age/damage has occurred to kitchen and components. Recommendations: A qualified cabinet maker and plumber should be engaged for advice and recommendations regarding renovations

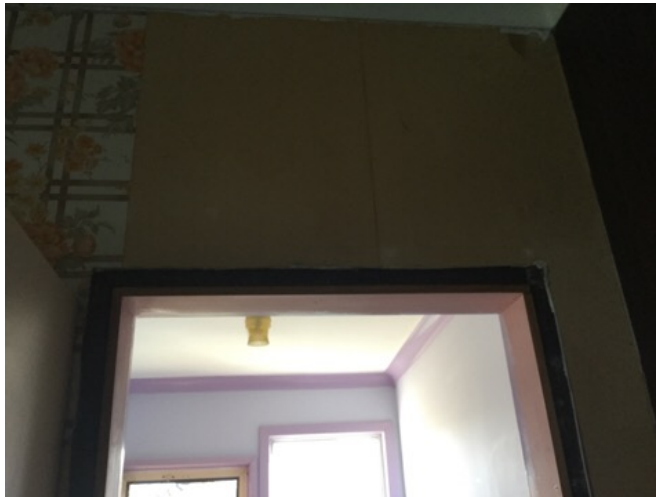
Incomplete Patch/Paint repairs noted, wall paper half removed. Call a licensed painter for repairs

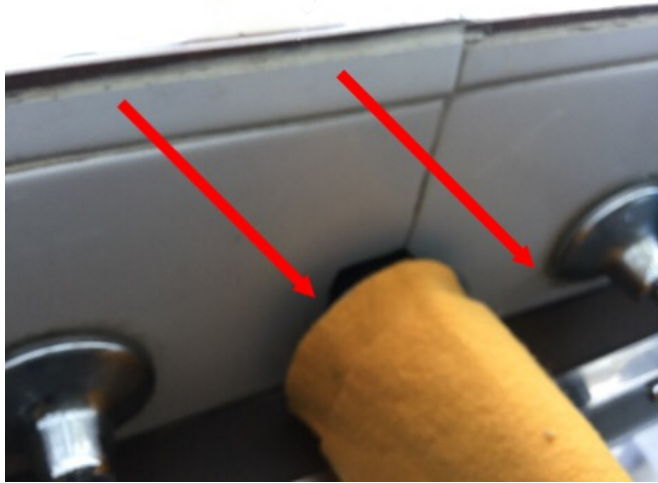
Splash back tile cracking visible - Recommendations: Repairs by qualified tiler.

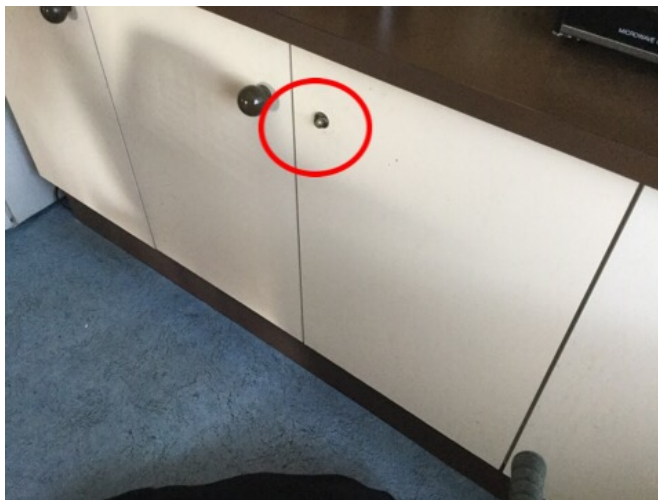
Broken handle. Recommend replacement handle be installed.

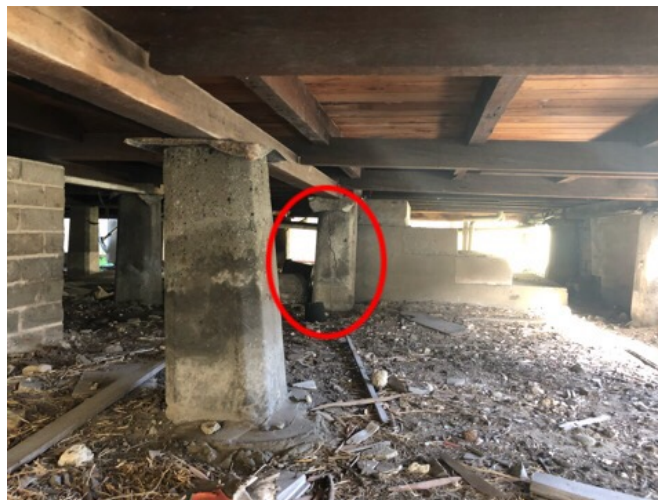
Rusted ant capping noted. Ant capping is not designed to prevent termite entry but to force the termites to show themselves by means of mud packing. Rusted, missing or defective ant capping will allow the termites to enter the building undetected. This should be repaired.

Stump damage/cracking evident in some footings. Recommendations: A qualified re-stumping contractor should be engaged for advice and recommendations.

Contact a licensed brick layer for further advice
