Pre-Purchase Inspection - Residential Building Report

2 Gretel Crescent Booragul (Southern Elevation)

Property Inspected	
Property Inspected Details:	2 Gretel Crescent Booragul NSW

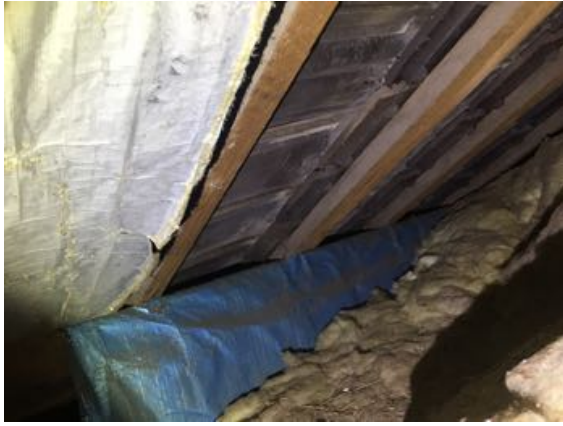
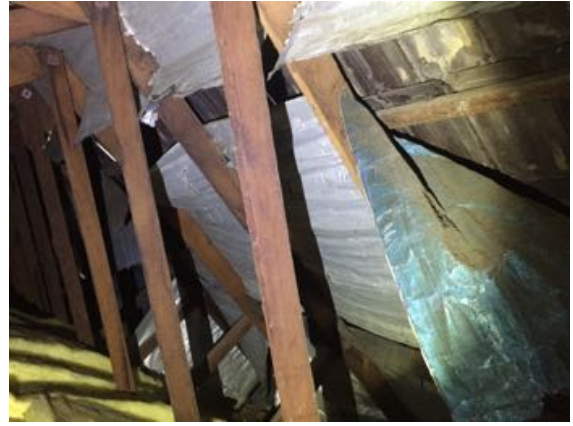
Defect - Roof Void**Defect Location:**

North Side, West Side, South Side, East Side

Defect Summary:

Sarking

Type of Defect:

Damage

Description:

Sarking torn

Ongoing Consequence:

Water ingress into building

Note: This defect should be referred to a qualified building professional for further advice on the cost and scope of the repairs/work required.

Building Professional Required: Builder

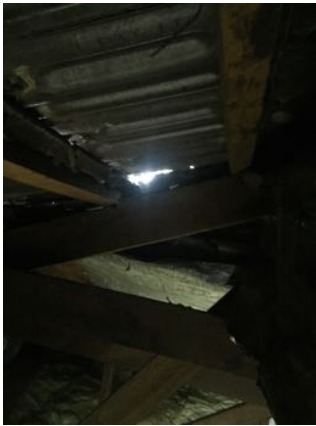
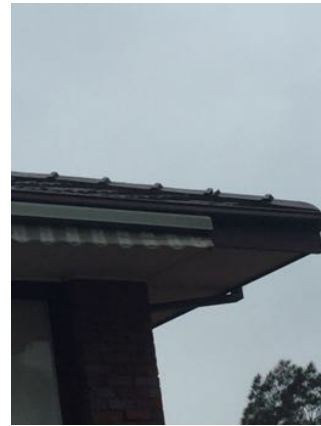
Defect - Roof Exterior	
Defect Location:	South Side, East Side
Defect Summary:	Roof Coverings
Type of Defect:	Distortion, warping, twisting
Description:	Cracked pointing
Ongoing Consequence:	Water ingress to Roof Void, Damage to ceilings
Opinion of Cracking:	
Building Professional:	<p>Note: This defect should be referred to a qualified building professional for further advice on the cost and scope of the repairs/work required.</p> <p>Building Professional Required: Roof Tiler</p>

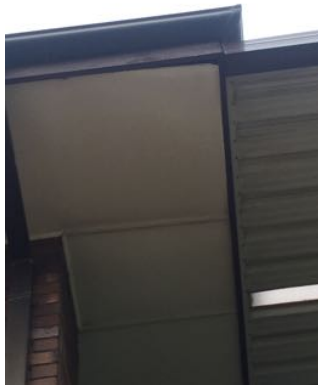
Defect - Roof Exterior	
Defect Location:	East Side
Defect Summary:	Eaves, Fascia and Barges
Type of Defect:	Distortion, warping, twisting
Description:	Loose eaves sheet
Ongoing Consequence:	Damage to surrounding elements
Opinion of Cracking:	
Building Professional:	<p>Note: This defect should be referred to a qualified building professional for further advice on the cost and scope of the repairs/work required.</p> <p>Building Professional Required: Builder</p>

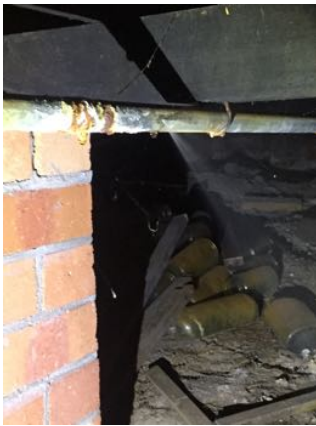
Defect - Subfloor	
Defect Location:	Not Applicable
Defect Summary:	Water pipe Northern area leaking
Type of Defect:	Water penetration, dampness, Material deterioration
Description:	Corrosion to gal pipes
Ongoing Consequence:	Increased water bills and moisture is highly conducive to termites.
Opinion of Cracking:	Not Applicable
Building Professional:	<p>Note: This defect should be referred to a qualified building professional for further advice on the cost and scope of the repairs/work required.</p> <p>Building Professional Required: Plumber</p>

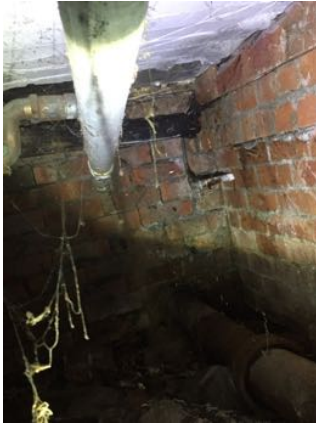
Defect - Subfloor	
Defect Location:	Not Applicable
Defect Summary:	Floor Framing
Type of Defect:	Water penetration, dampness, Material deterioration
Description:	Decay bearer under Northern side bathroom and laundry appears to be a water leak
Ongoing Consequence:	Ongoing damage from timber pests to the timber elements of the property
Opinion of Cracking:	
Building Professional:	<p>Note: This defect should be referred to a qualified building professional for further advice on the cost and scope of the repairs/work required.</p> <p>Building Professional Required: Builder</p>

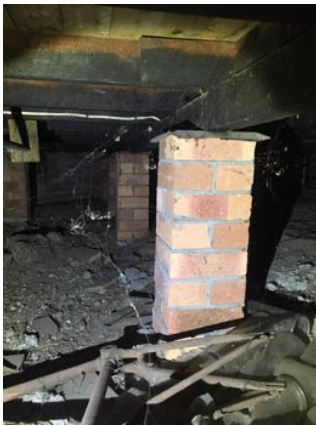
Defect - Subfloor	
Defect Location:	Not Applicable
Defect Summary:	Piers and Foundation Walls
Type of Defect:	Distortion, warping, twisting
Description:	Piers appear to be rotating
Ongoing Consequence:	Floor may begin excessive bounce
Opinion of Cracking:	Not Applicable
Building Professional:	<p>Note: This defect should be referred to a qualified building professional for further advice on the cost and scope of the repairs/work required.</p> <p>Building Professional Required: Builder</p>

Slightly rotating piers middle area

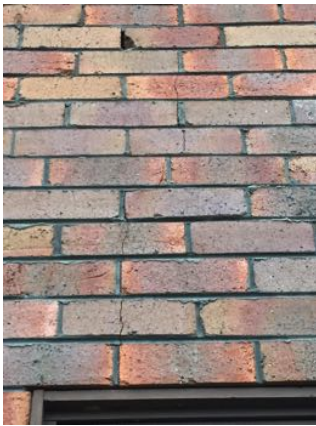
Eastern side

Defect - Exterior	
Defect Location:	South Side, East Side
Defect Summary:	Walls - Brick
Type of Defect:	Distortion, warping, twisting
Description:	There is stepped cracking
Ongoing Consequence:	Serviceability of surrounding elements negatively affected
Opinion of Cracking:	Serviceability cracking
Building Professional:	<p>Note: This defect should be referred to a qualified building professional for further advice on the cost and scope of the repairs/work required.</p> <p>Building Professional Required: Builder</p>

Cracking of Masonry and/or Concrete			
Type	Area	Description	Opinion of Cracking
Exterior	South Side, East Side	There is stepped cracking	Serviceability cracking

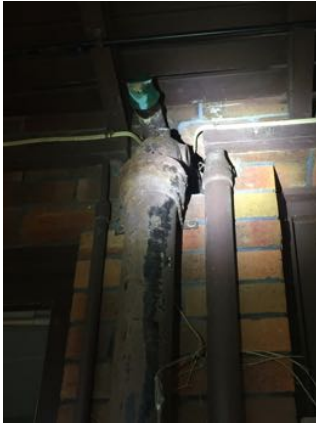
Defect - Exterior	
Defect Location:	North Side
Defect Summary:	Walls - Brick
Type of Defect:	Installation
Description:	Excessive hole in face brickwork
Ongoing Consequence:	Serviceability of surrounding elements negatively affected
Opinion of Cracking:	Not Applicable
Building Professional:	<p>Note: This defect should be referred to a qualified building professional for further advice on the cost and scope of the repairs/work required.</p> <p>Building Professional Required: Builder</p>

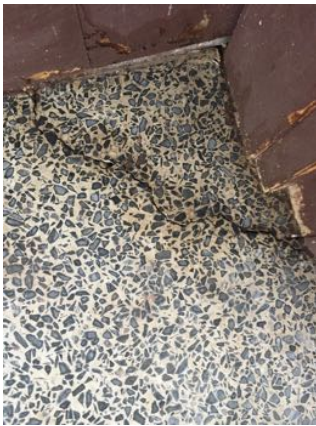
Defect - Exterior	
Defect Location:	North Side
Defect Summary:	External door threshold
Type of Defect:	Distortion, warping, twisting
Description:	Cracked threshold
Ongoing Consequence:	May continue to crack
Opinion of Cracking:	Not Applicable
Building Professional:	<p>Note: This defect should be referred to a qualified building professional for further advice on the cost and scope of the repairs/work required.</p> <p>Building Professional Required: Builder</p>

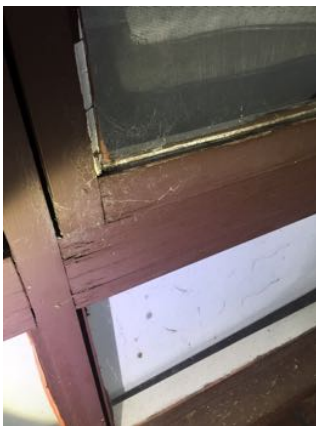
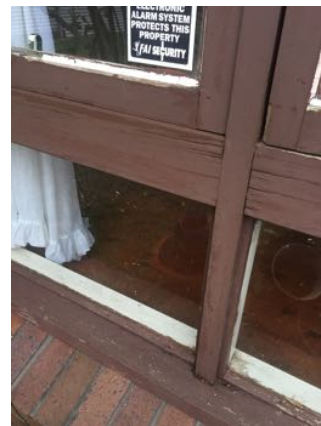
Defect - Exterior	
Defect Location:	South Side
Defect Summary:	Walls - Brick - Windows
Type of Defect:	Material deterioration
Description:	Moderate decay windows and missing putty around glazing
Ongoing Consequence:	Damage to window
Opinion of Cracking:	
Building Professional:	<p>Note: This defect should be referred to a qualified building professional for further advice on the cost and scope of the repairs/work required.</p> <p>Building Professional Required: Builder</p>

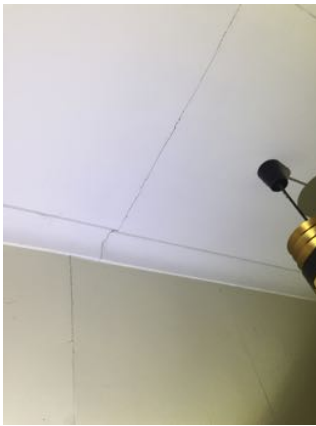
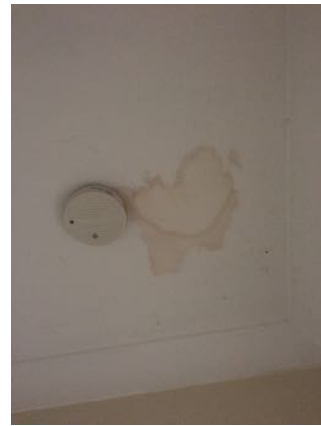
Defect - Interior	
Defect Location:	Hallway up stairs
Defect Summary:	Cracking and water stained ceiling
Type of Defect:	Distortion, warping, twisting, Water penetration, dampness
Description:	Settlement cracking and previous leak
Ongoing Consequence:	Possible further cracking and look unsightly
Opinion of Cracking:	Not Applicable
Building Professional:	<p>Note: This defect should be referred to a qualified building professional for further advice on the cost and scope of the repairs/work required.</p> <p>Building Professional Required: Builder</p>

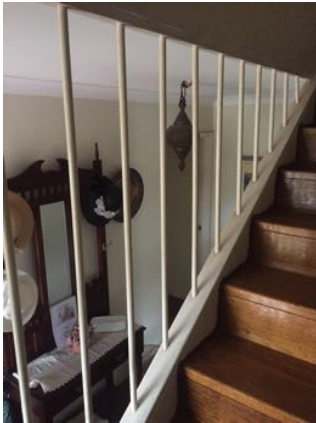
Defect - Interior	
Defect Location:	Stair case
Defect Summary:	Stairs
Type of Defect:	Safety hazard
Description:	Tread width too small min 240mm and gaps between balustrade too big max 125mm
Ongoing Consequence:	Personal injury
Opinion of Cracking:	Not Applicable
Building Professional:	<p>Note: This defect should be referred to a qualified building professional for further advice on the cost and scope of the repairs/work required.</p> <p>Building Professional Required: Builder</p>

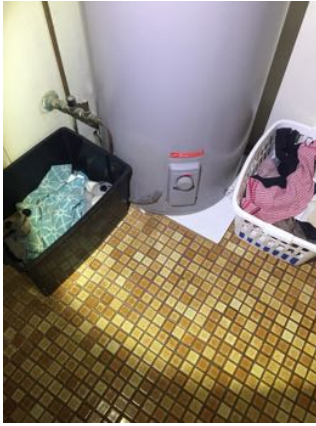
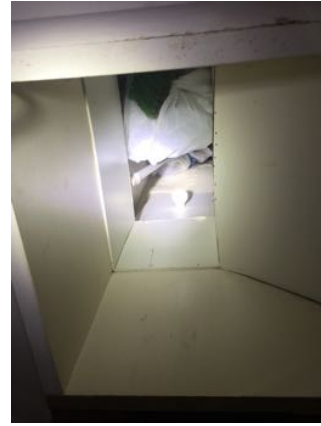
Defect - Interior	
Defect Location:	Laundry
Defect Summary:	Water stained wall in laundry Shute, no floor waste, no safety tray under hot water system
Type of Defect:	Water penetration, dampness, Material deterioration, Operational
Description:	Water stained laundry Shute possible from previous leaking vent pipe, no floor waste or safe tray under HWS
Ongoing Consequence:	Look unsightly and possible water damage to internal areas
Opinion of Cracking:	Not Applicable
Building Professional:	<p>Note: This defect should be referred to a qualified building professional for further advice on the cost and scope of the repairs/work required.</p> <p>Building Professional Required: Builder, Plumber</p>

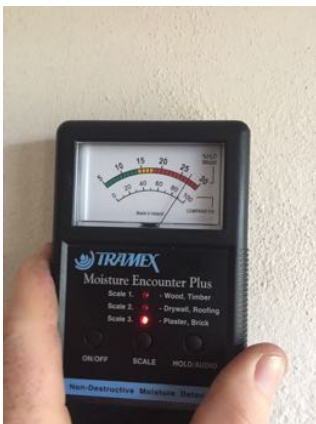
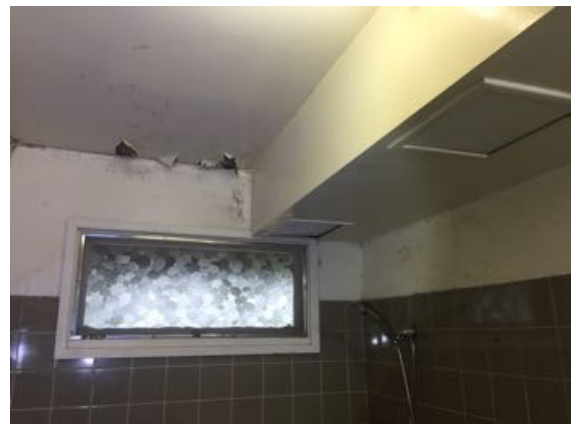
Defect - Interior	
Defect Location:	Bathroom Down stairs
Defect Summary:	High comparative moisture shower walls, mould ceilings and walls.
Type of Defect:	Water penetration, dampness, Material deterioration, Operational
Description:	Posible leaking shower recess, inadequate natural light air flow and ventilation, General deterioration
Ongoing Consequence:	Posible further leaking and development of unhealthy allergins, bathroom needs upgrading
Opinion of Cracking:	Not Applicable
Building Professional:	<p>Note: This defect should be referred to a qualified building professional for further advice on the cost and scope of the repairs/work required.</p> <p>Building Professional Required: Builder</p>

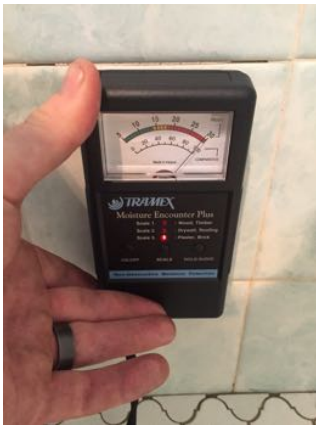
Defect - Interior	
Defect Location:	Bathroom Up stairs
Defect Summary:	High comparative moisture reading shower walls, toilet operation, damaged wall tiles in shower recess
Type of Defect:	Distortion, warping, twisting, Water penetration, dampness, Material deterioration, Operational
Description:	Posible leaking shower recess, float in toilet cistern appears to need replacing, cracked wall tiles in shower recess
Ongoing Consequence:	Posible further leaking and damage to surrounding elements, toilet doesnt function as expected.
Opinion of Cracking:	Not Applicable
Building Professional:	Note: This defect should be referred to a qualified building professional for further advice on the cost and scope of the repairs/work required. Building Professional Required: Builder, Plumber

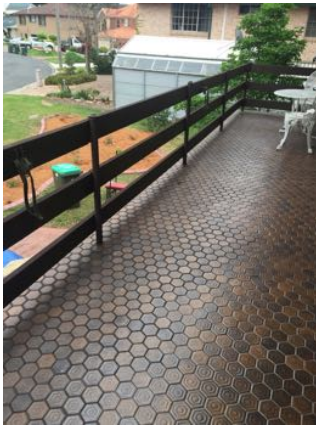
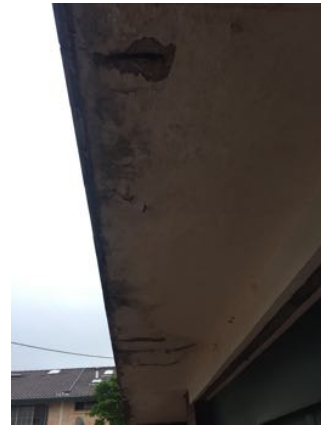
Site Defect - Decks	
Type of Defect:	Distortion, warping, twisting, Material deterioration, Safety hazard
Direction (North being front of Structure):	South
Description:	Handrails appear to be low, Gap between balusters appears to be too large, Horizontal balusters Loose tiles and Minor spalling to underside of suspended deck slab.
Ongoing Consequence:	Low handrail may allow a person to fall over the edge, Wide balusters may allow a child to crawl through, Horizontal balusters present as a climbing aid on the handrail, Personal injury, Further deterioration
Opinion of Cracking:	
Building Professional:	Note: This defect should be referred to a qualified building professional for further advice on the cost and scope of the repairs/work required. Building Professional Required: Builder

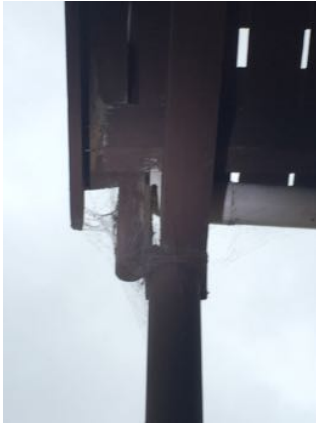
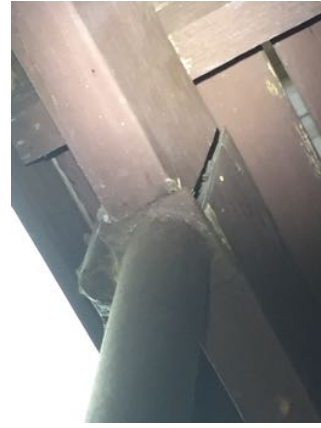
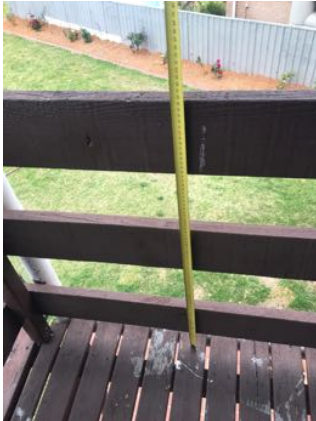
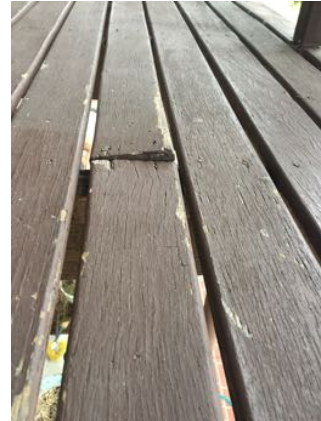
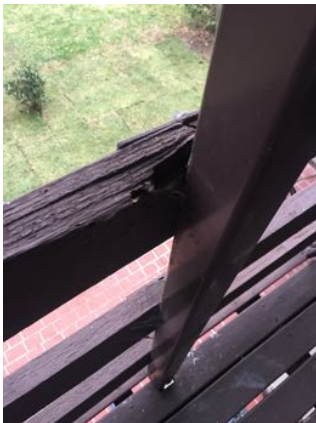
Site Defect - Decks	
Type of Defect:	Distortion, warping, twisting, Installation, Safety hazard
Direction (North being front of Structure):	North
Description:	Decay to handrails, Handrails appear to be low, Gap between balusters appears to be too large, Horizontal balusters, Handrails are loose, Some deck boards are loose Inadequate fixings bearer to steel posts
Ongoing Consequence:	Handrails may collapse, Damage to surrounding elements, Low handrail may allow a person to fall over the edge, Wide balusters may allow a child to crawl through, Horizontal balusters present as a climbing aid on the handrail, Personal injury, Tripping hazard, Further deterioration
Opinion of Cracking:	
Building Professional:	Note: This defect should be referred to a qualified building professional for further advice on the cost and scope of the repairs/work required. Building Professional Required: Builder

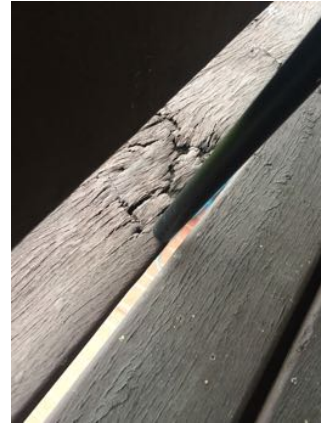
Site Defect - Decks	
Type of Defect:	Material deterioration
Direction (North being front of Structure):	North
Description:	Decay to decking DEcay to bearer
Ongoing Consequence:	Further deterioration
Opinion of Cracking:	
Building Professional:	<p>Note: This defect should be referred to a qualified building professional for further advice on the cost and scope of the repairs/work required.</p> <p>Building Professional Required: Builder</p>

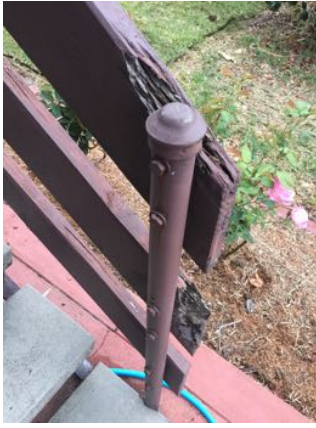
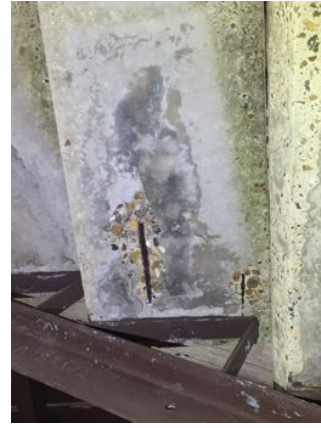
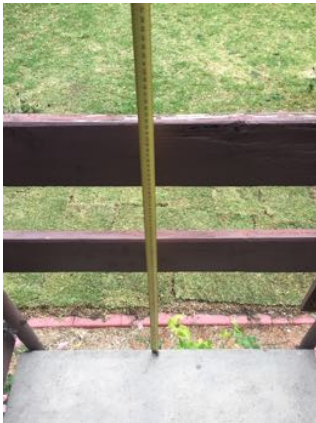
Site Defect - Steps	
Type of Defect:	Damage, Material deterioration, Safety hazard
Direction (North being front of Structure):	North
Description:	Handrail is loose, Gap between balustrades appears to be too large Missing balustrade and decay balustrade, minor spalling to underside of step,
Ongoing Consequence:	Ongoing of Timber Pest Damage, Personal injury Possible collapse of handrail, continued spalling to step treads.
Opinion of Cracking:	
Building Professional:	<p>Note: This defect should be referred to a qualified building professional for further advice on the cost and scope of the repairs/work required.</p> <p>Building Professional Required: Carpenter</p>
