Visual Timber Pest Inspection and Report in Accordance with AS 4349.3-2010

2 Gretel Crescent Booragul (Southern Elevation)

INSPECTOR DETAILS	
Name Of Inspection Firm:	CTP Pest and Building Inspections
Contact Phone:	0402 679 087
Technician Name:	Craig Pearce
Report Prepared Date:	11/10/2017

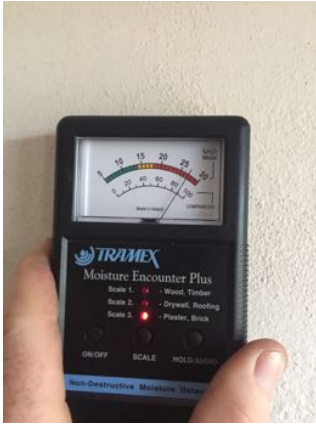
High comparative moisture readings in down stairs shower walls

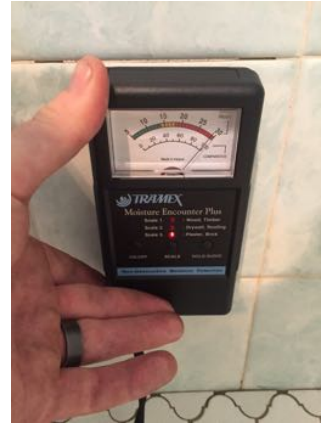
High comparative moisture readings in upstairs shower walls

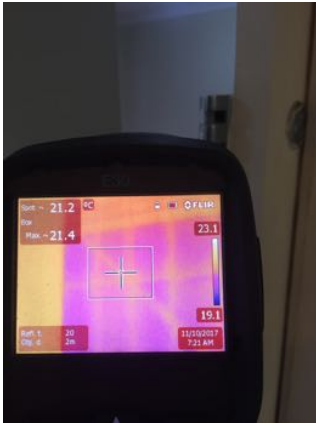
No thermal anomalies present at time of inspection

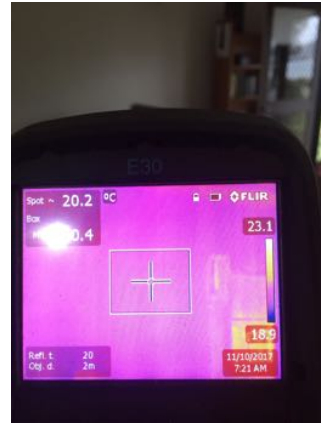
No thermal anomalies present at time of inspection

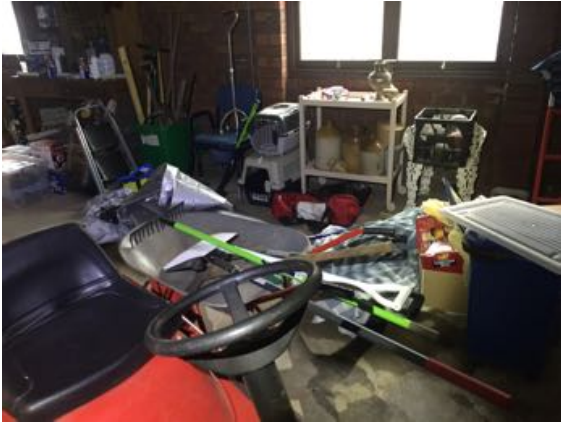
ACCESS ISSUE - Attached Garage	
Access Issue Type:	Restricted Access
Reason(s) Why:	Heavy Stored Goods / Equipment

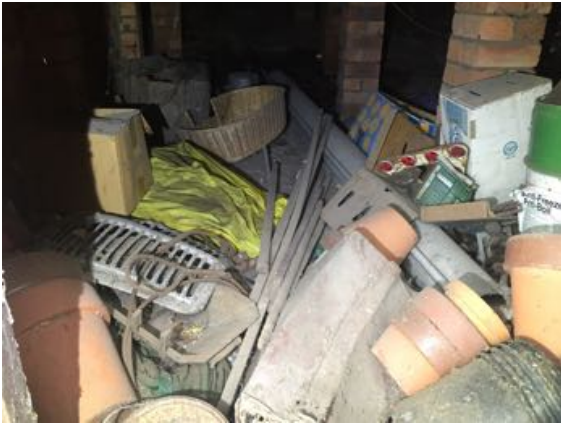
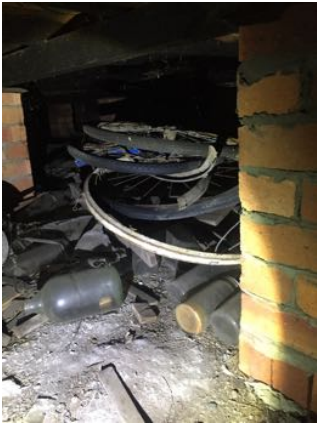
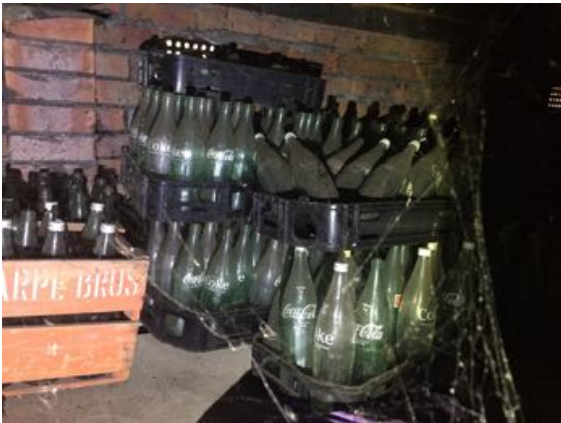
ACCESS ISSUE - Subfloor	
Access Issue Type:	Restricted Access
Reason(s) Why:	Stored Goods

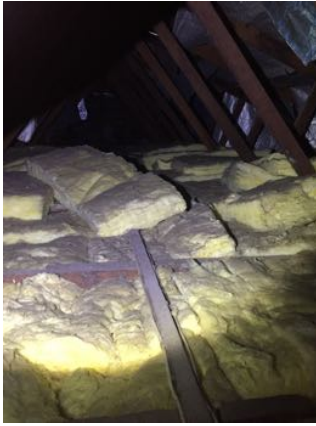
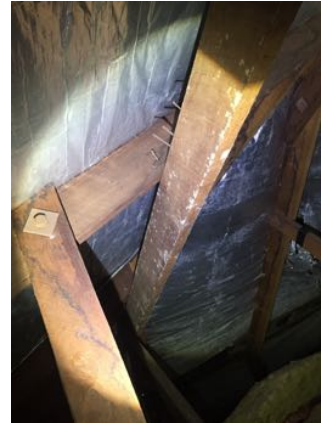
ACCESS ISSUE - Roof Void	
Access Issue Type:	Restricted Access
Reason(s) Why:	Insulation, Sarking

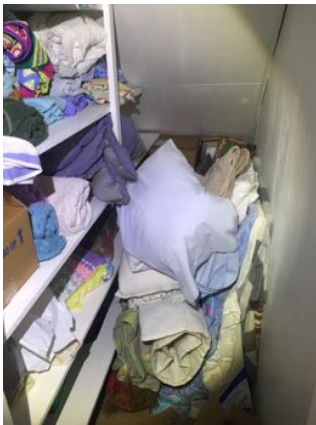
ACCESS ISSUE - Under internal stairs case	
Access Issue Type:	Restricted Access
Reason(s) Why:	Stored Goods

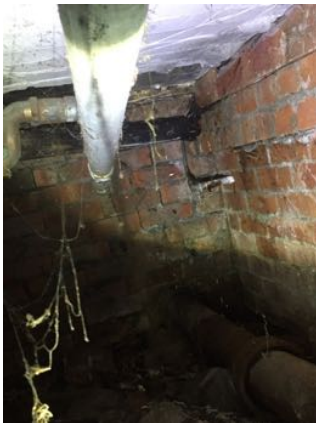
TIMBER PEST ISSUE - Subfloor	
Moisture:	Normal
Termite:	No Termite Evidence Identified Refer to the advice in Section 3: Invasive Inspection
Borer:	No Borer Identified
Fungal Decay:	Fungal Decay Identified WARNING: SEE NOTE ON FUNGAL DECAY Fungal Decay Visible Fungal Decay Damage Extent: Extensive
Location of Threats Not Limited To:	Fungal Decay: Bearers
Other Comments:	I recommend that you contact a licensed builder to assess source of moisture and fix and replace rotting timbers with non-susceptible timbers as rotting timber is highly conducive to termites.
Is an invasive inspection recommended?	No
Are there Major Safety Hazards Related to Timber Pests?	No Important Note: Where a Major Safety Hazard is identified above, it must be attended to and rectified to avoid the possibility of personal injury &/or death.

Rotting bearer Northern side under bathroom and laundry.

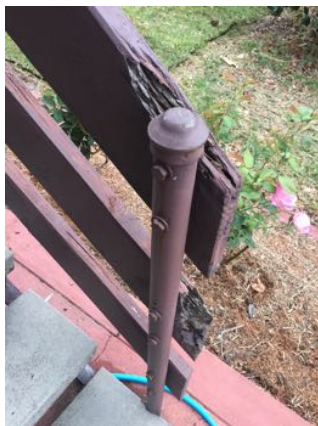
TIMBER PEST ISSUE - Northern side steps	
Moisture:	High WARNING: SEE SECTION 3. Point 2. High Moisture Moisture is highly conducive to wood rot
Termite:	No Termite Evidence Identified Refer to the advice in Section 3: Invasive Inspection
Borer:	No Borer Identified
Fungal Decay:	Fungal Decay Identified WARNING: SEE NOTE ON FUNGAL DECAY Fungal Decay Visible Fungal Decay Damage Extent: Extensive
Location of Threats Not Limited To:	Fungal Decay: Handrail and balustrade steps
Other Comments:	I recommend thta you contact a licensed builder to replace rotting balustrade with non-susceptible timbers to reduce the risk of further decay and personal injury
Is an invasive inspection recommended?	No
Are there Major Safety Hazards Related to Timber Pests?	Yes Important: Refer to the Timber Pest Issue section of this report. The Timber Pest associated safety hazard is: Rotting handrail and balustrade The Timber Pest associated safety hazard is located Northern side stairs Important Note: Where a Major Safety Hazard is identified above, it must be attended to and rectified to avoid the possibility of personal injury &/or death.

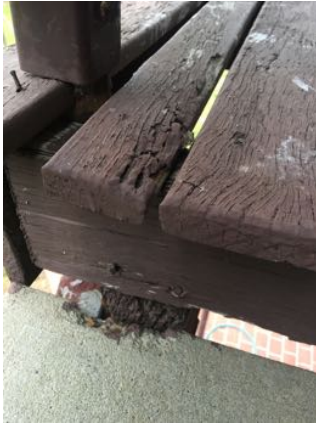
TIMBER PEST ISSUE - Northern side deck	
Moisture:	High WARNING: SEE SECTION 3. Point 2. High Moisture Moisture is highly conducive to wood rot
Termite:	No Termite Evidence Identified Refer to the advice in Section 3: Invasive Inspection
Borer:	No Borer Identified
Fungal Decay:	Fungal Decay Identified WARNING: SEE NOTE ON FUNGAL DECAY Fungal Decay Visible Fungal Decay Damage Extent: Moderate
Location of Threats Not Limited To:	Fungal Decay: Handrail/balustrade, decking boards, bearer
Other Comments:	I recommend that you contact a licensed builder to assess extent of wood rot and replace rotting timbers with non-susceptible timbers to reduce the risk of further decay and personal injury
Is an invasive inspection recommended?	No
Are there Major Safety Hazards Related to Timber Pests?	Yes Important: Refer to the Timber Pest Issue section of this report. The Timber Pest associated safety hazard is: Rotting decking boards, handrail/balustrade The Timber Pest associated safety hazard is located Northern side deck. Important Note: Where a Major Safety Hazard is identified above, it must be attended to and rectified to avoid the possibility of personal injury &/or death.

Rotting decking boards and bearer

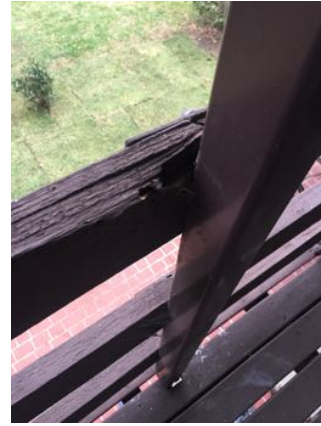
Rotting handrail/balustrade

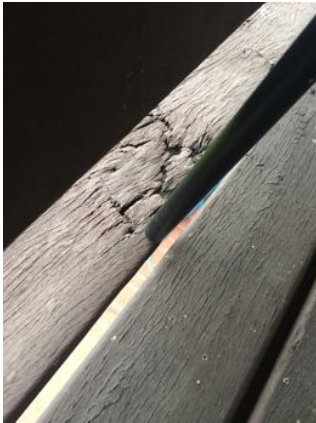
Rotting deckingboards

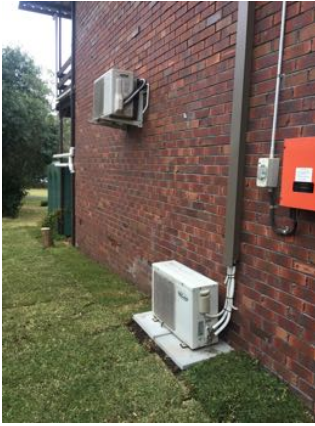
Air conditioning overflows Western side

Hot water services, air conditioning units which release water alongside or near to building walls need to be connected to a drain. If this is not possible then their water outlet needs to be piped several meters away from the building, as the resulting wet area is highly conducive to termites.

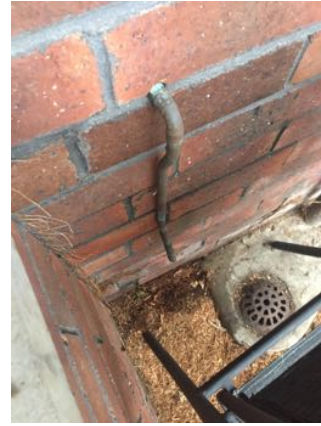
Hot water system pressure relief valve Northern side

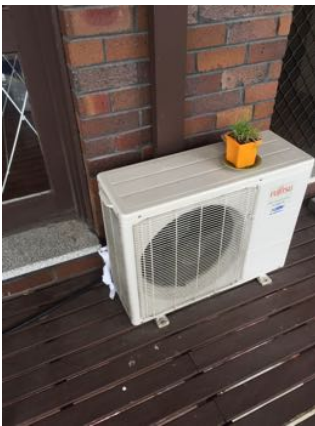
Air conditioning overflow Northern side

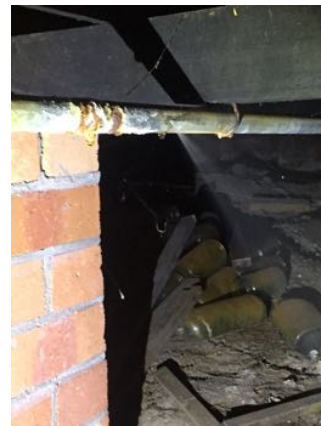
CONDUCTIVE CONDITIONS TO TIMBER PEST INFESTATION AND/OR TERMITE ENTRY	
Subfloor Conditions:	Ventilation Issues Present, Water Leaks Present I recommend that you contact a licensed plumber to fix leaking water supply as moisture is highly conducive to termites. I recommend that you contact a licensed builder to improve sub-floor ventilation as poor ventilation creates an environment conducive to timber pests and unhealthy allergens.
Exterior Conditions:	Airconditioning/Hotwater System Issues Present I recommend that you contact a licensed plumber to connect air conditioning overflows and hot water system pressure relief valve to a drain or run 7m away from the perimeter of the building as moisture is highly conducive to termites.
Interior Conditions:	Moisture Present High comparative moisture readings present in both bathroom shower walls, I recommend that you contact a licensed builder to assess source of water ingress and fix as moisture is highly conducive to termites and wood rot.

Leaking water pipe Northern area sub-floor

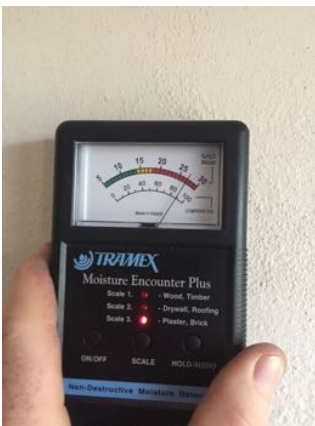
High comparative moisture reading walls of down stairs shower recess

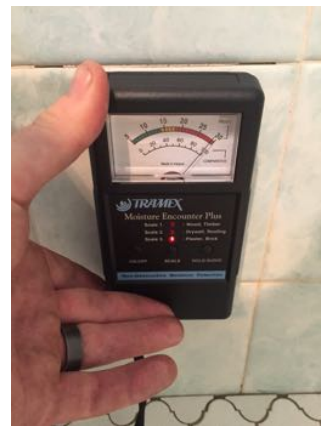
High comparative moisture reading up stairs shower recess

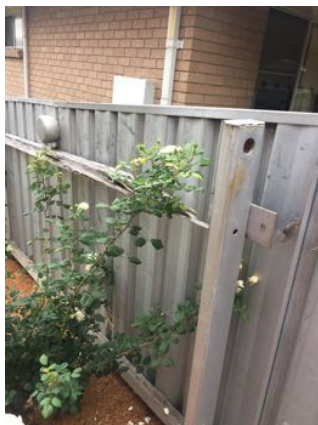
SITE TIMBER PEST ISSUE - Around the yard	
Moisture:	Normal
Termite:	No Termite Evidence Identified Refer to Important Warnings: Invasive Inspection
Borer:	No Borer Identified
Fungal Decay:	Fungal Decay Identified WARNING: SEE NOTE ON FUNGAL DECAY Fungal Decay Visible Fungal Decay Damage Extent: Moderate to Extensive
Location of Threats Not Limited To:	Fungal Decay: Side fences
Other Comments:	I recommend you contact a licensed builder to replace rotting timbers with non-susceptible timbers as rotting timber is highly conducive to termites.
Is an invasive inspection recommended?	No
Were any major safety hazards related to Timber Pest Activity and/or Damage identified?	No Important Note: Where a Major Safety Hazard is identified above, it <u>must</u> be attended to and rectified to avoid the possibility of personal injury &/or death.

Rotting fencing Eastern side

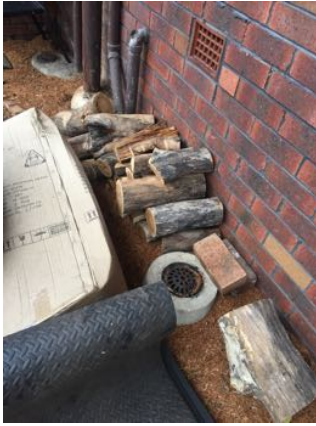
SITE CONDUCTIVE CONDITIONS PRESENT	
Conductive Conditions Present:	Yes. Site adjacent to wooded areas., Wood piles
Comments:	With wooded areas surrounding the property the environmental termite pressure of the area is high. I recommend that you remove wood piles from site as they provide a food source for termites.

Wood piles Northern side
