STANDARD RESIDENTIAL BUILDING INSPECTION REPORT

6 PLYMOUTH CLOSE, MACQUARIE HILLS

Property Address: 6 PLYMOUTH CLOSE
MACQUARIE HILLS NSW 2285

Inspection Date/Time: 29/03/2018 8:58 AM

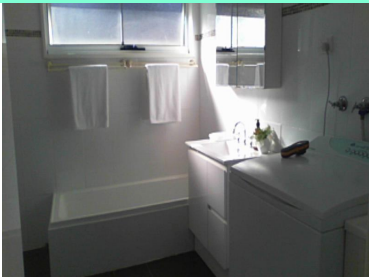
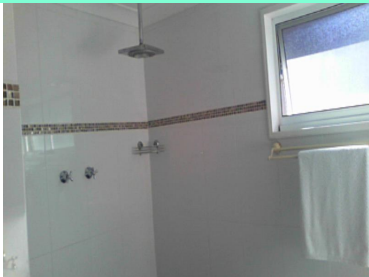
BATHROOM

Pelmet is damaged/missing and needs repair to restore correct function and appearance

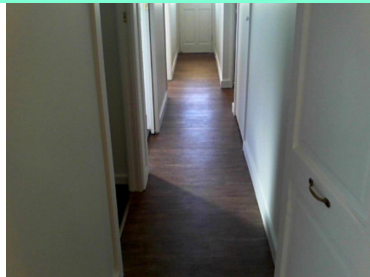
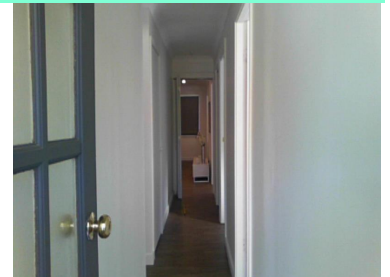
HALL / PASSAGE

Door	Binding, will need adjusting to ensure correct operation.
Walls	OK, The item described is performing the function it was designed for and its condition is very typical for it's age
Ceiling	Patches are incomplete and or damaged will need finishing to restore appearance

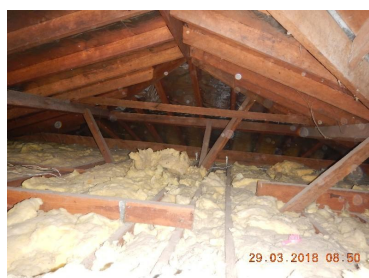
Sarking

Damaged sisalation was noted, this needs repair to ensure correct function

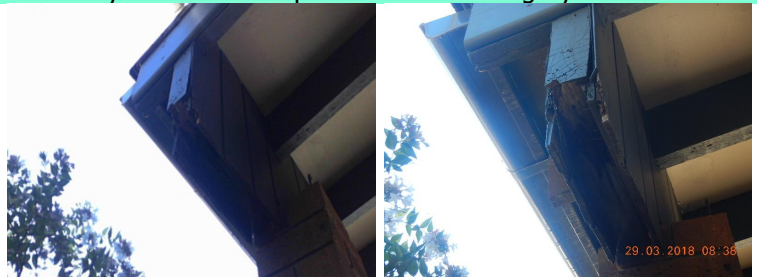
CARPORT Timber framing elements are wood decayed will need repairs to ensure integrity

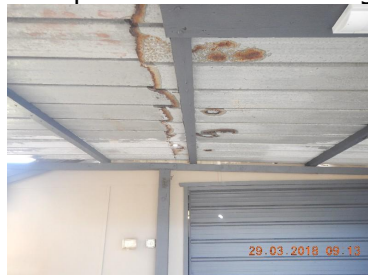
Ceilings	Not lined
Roofing	Rust holes in roof sheeting repairs required to restore water tightness and appearance

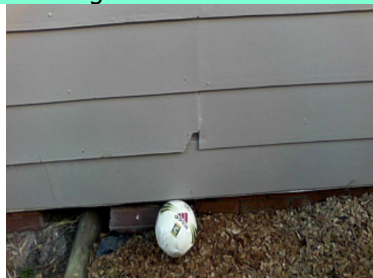
Split/loose cladding will need repair and re-finish to ensure water tightness and integrity of the cladding

CLADDING - Split/loose cladding will need repair and re-finish to ensure water tightness and integrity of the cladding

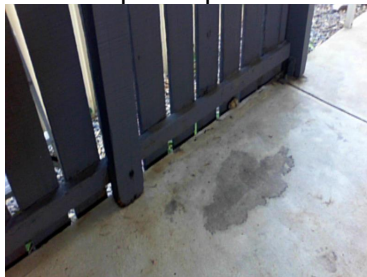
Damp Damage

Water/damp damaged area/s will need repair to prevent further damage

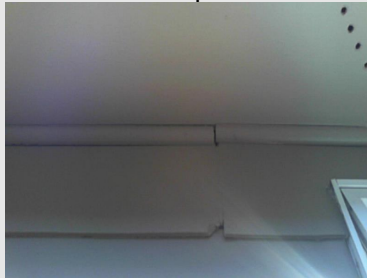
Mouldings

Moulding/s need/s minor typical maintenance repairs to restore appearance

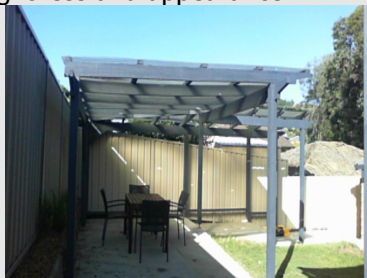
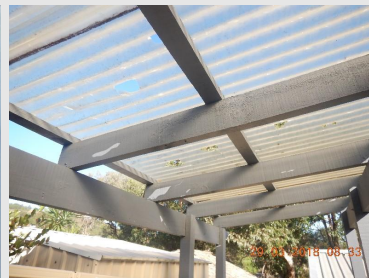
Verandah/s, Pergola/s

Substandard framing will need repair/improving to restore integrity, damage roof sheeting needs repair to restore water tightness and appearance

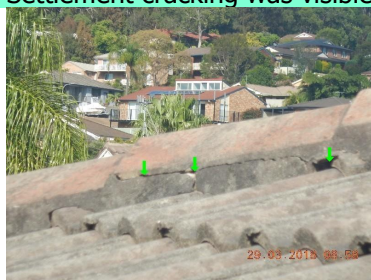
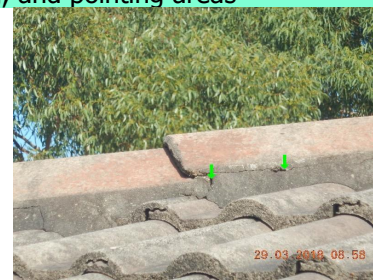
ROOF EXTERIOR Settlement cracking was visible to the roof tile ridging, bedding, and pointing areas

ROOF EXTERIOR - Settlement cracking was visible to the roof tile ridging, bedding, and pointing areas

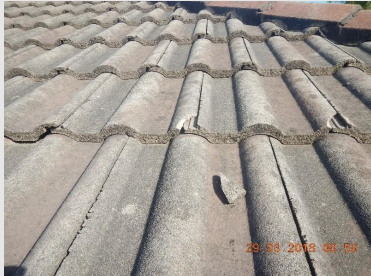
Cladding	Some cracked or broken tiles noted, and will need repair or replacing to prevent leaks and water damage

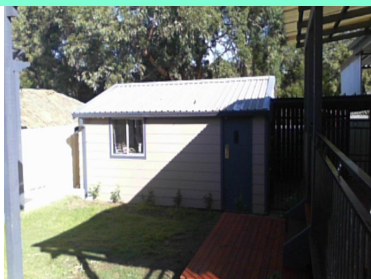
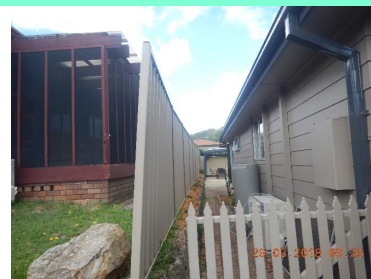
SITE

Garden shed/s	OK, The item described is performing the function it was designed for and its condition is very typical for it's age	
Paths / Driveways	Some paved areas have subsided and will need repair to restore appearance and/or remove trip hazard	   
Off street parking	Adequate areas for parking have been provided	
Retaining walls	OK, The item described is performing the function it was designed for and its condition is very typical for it's age	
Clothes Line	NIL, The item described is not present at the time of the inspection	
Boundary Fences / Gates	Metal fences were in fair yet wavy condition.	
Other	Hot water service overflow should be redirected away from dwelling via clear hose to minimise conducive conditions of termite attack Hot water cylinder is rusty and will need to be monitored for leaks

SITE/Paths / Driveways - Some paved areas have subsided and will need repair to restore appearance and/or remove trip hazard

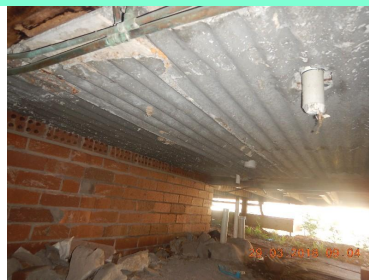
Condition of concrete	Minor cracking was noted, not considered significant, however this should be monitored annually and a structural engineer consulted if deterioration is noted
Dampness	Significant dampness was noted in areas, I recommend the site drainage be improved to help minimise dampness in this area
Drainage	Inadequate, I recommend the subfloor drainage is improved, improving the site drainage may also help limit the dampness in this area

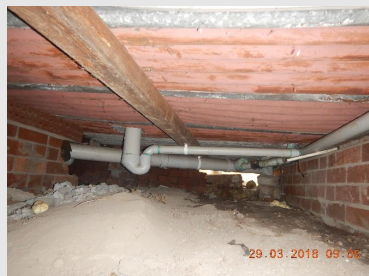
Debris	Debris was noted in this area and should be removed
Other

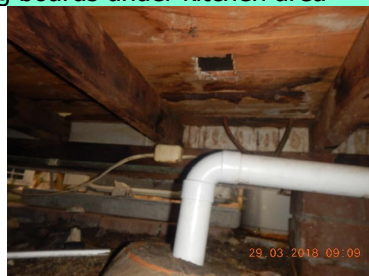
UNDERFLOOR SPACE Water damaged/stained flooring boards under kitchen area

UNDERFLOOR SPACE - Water damaged/stained flooring boards under kitchen area

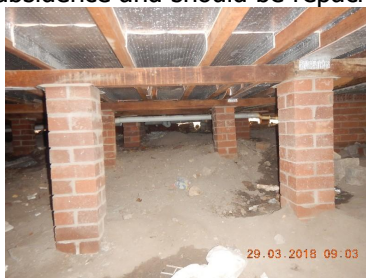
Piers/Stumps

Some evidence of typical pier subsidence and should be repacked to ensure stability

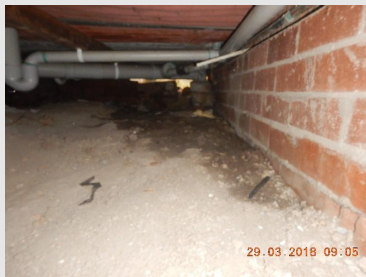
Dampness

Significant dampness was noted in areas, I recommend this is monitored during and after wet periods

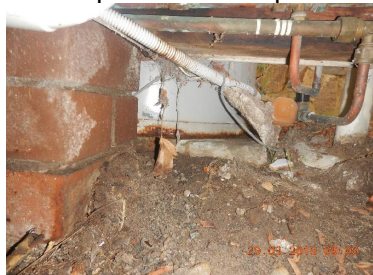
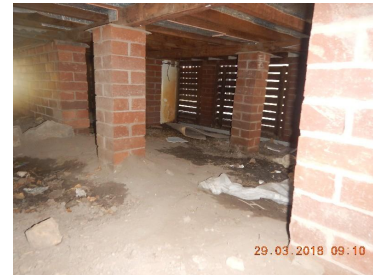
Drainage

Inadequate, I recommend the subfloor drainage is improved, improving the site drainage may also help limit the dampness in this area
