Pre-Sale Inspection Standard Timber Pest Detection Report

Date: 6th July 2021

Re property: 39 Ida Street, Mayfield NSW 2304

Inspection number: PSBPA 0607/191

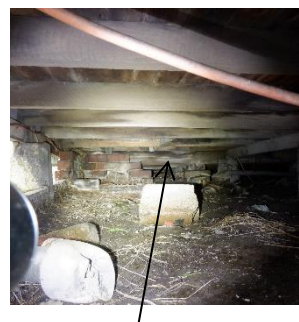
6.4 Termite Shielding: Missing and corroded in visible sections of the subfloor

Missing termite shielding

Where termite shielding is faulty you are advised to contact a Pest Management Company for an alternative barrier or where possible a repair of the shielding system.
