Pre-Sale Inspection Standard Timber Pest Detection Report

Date: 29th July 2021

Re property: 31 Invermore CI Wallsend NSW 2287

Inspection number: PSBPA 2907/112

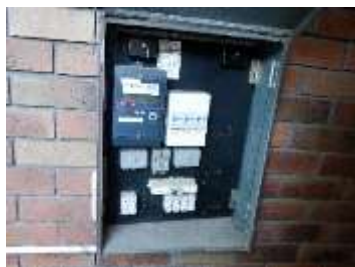
The following details were found suggesting a termite barrier or treatment has been carried out to this property: No barrier notice was found in the meterbox.

No barrier notice in meterbox
