Pre-Sale Inspection Standard Timber Pest Detection Report

Date: 30th September 2021

Re property: 26 Floralia Close, New Lambton Hts NSW 2305

Inspection number: BPA 2909/280

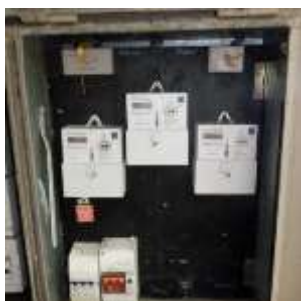
Was a durable notice found in the meterbox: No termite barrier notice was found in the meter box this does suggest no recent termite barrier work has been recently carried out.

No termite barrier notice

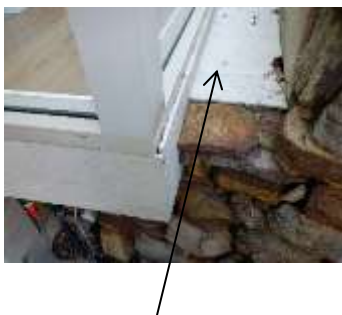
Drill holes were found to the north side of the Stairwell to upper level and adjacent the Family Room.

Drill hole from termite barrier application

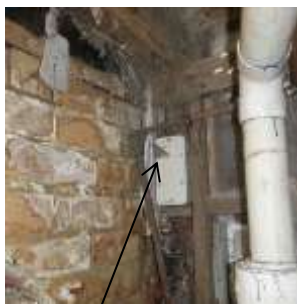
Old termite baiting station /workings

RECOMMENDATION Where evidence of damage to building timbers exists, competent advice (e.g. from a licensed or registered building contractor) should be obtained to determine the extent of any structural damage and as to the need or otherwise for rectification or repair work. See also Item 3.5 'Frequency of Future Inspections' recommendation.

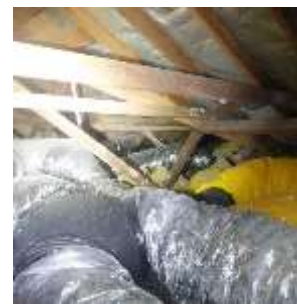
Insulation obscured timbers

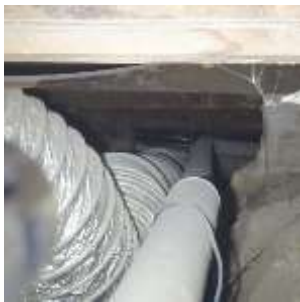
Was evidence of other damp related conditions found which may affect the dwelling on a seasonal or prevailing weather basis? Damp Subfloor areas were found which is common where the subfloor venation is reduced a venation fan/duct system is installed as a management system.

Limited clearances/Ventilation fan duct
