# **STANDARD RESIDENTIAL BUILDING INSPECTION REPORT**

**43 DELAWARE DRIVE, MACQUARIE HILLS**

**Property Address:** 43 DELAWARE DRIVE  
MACQUARIE HILLS NSW 2285

**Inspection Date/Time:** 23/03/2020 1:48 PM

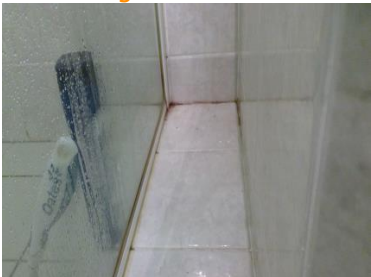
As tested, there was high moisture readings recorded on sections of the internal walls

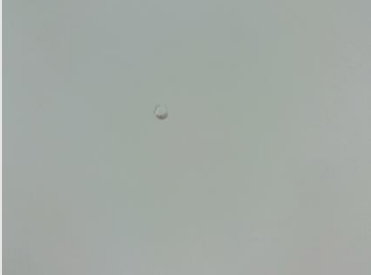
Popped nails need repair and re-finish to restore appearance

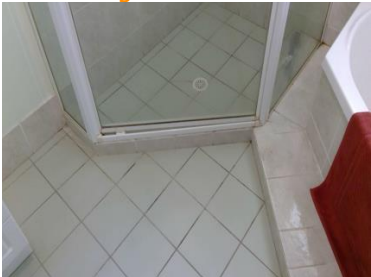
As tested, there was high moisture readings recorded in areas flooring

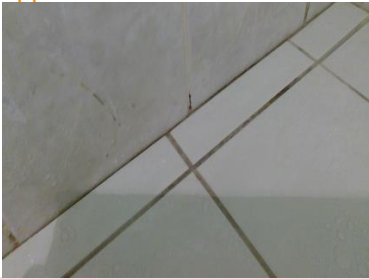
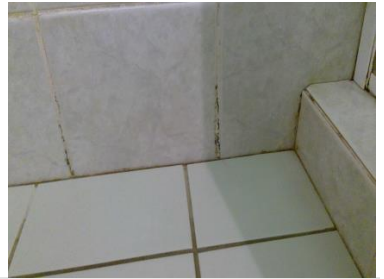
Shower	Tile grouting is cracked and or missing and will need repair to ensure water tightness and appearance

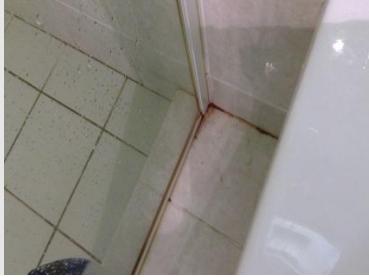
Screen/Curtain	The screen is leaking and will need repair to prevent water damage

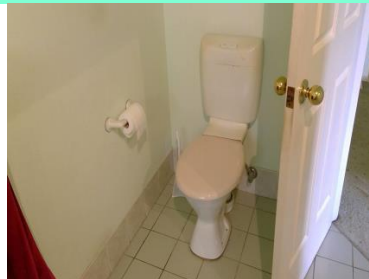
## BATHROOM TOILET

Cistern	OK, The item described is performing the function it was designed for and its condition is very typical for it's age
Pan	Loose pan needs securing to the floor for stability

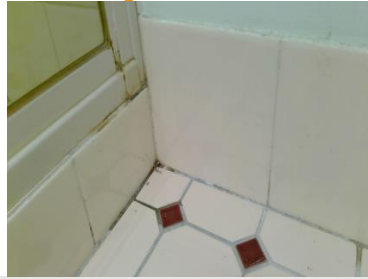
As tested, there was high moisture readings recorded on sections of the internal walls

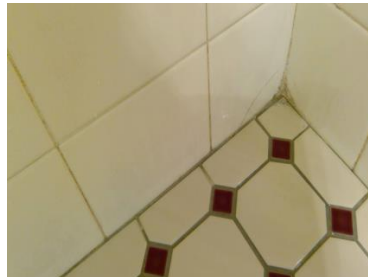
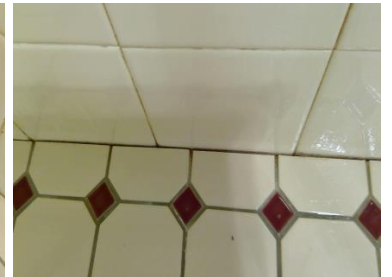
Tile grouting is cracked and or missing and will need repair to ensure water tightness and appearance, some cracked tiles noted

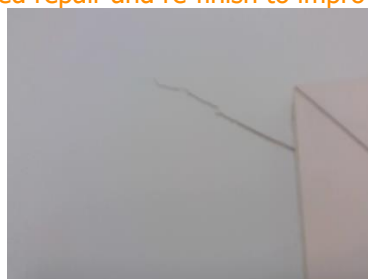
Door	OK, The item described is performing the function it was designed for and its condition is very typical for it's age
Walls	Typical plaster cracking, will need repair and re-finish to improve appearance

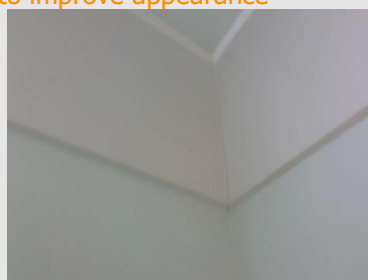
Ceiling	Cornice cracking needs repairs to improve appearance
---------	--

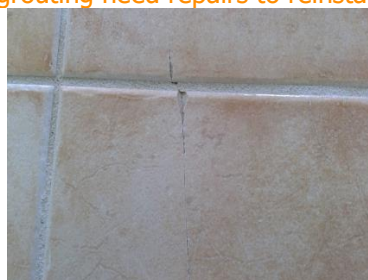
Floors	Cracked or broken tiles and/or grouting need repairs to reinstate integrity and appearance
--------	--

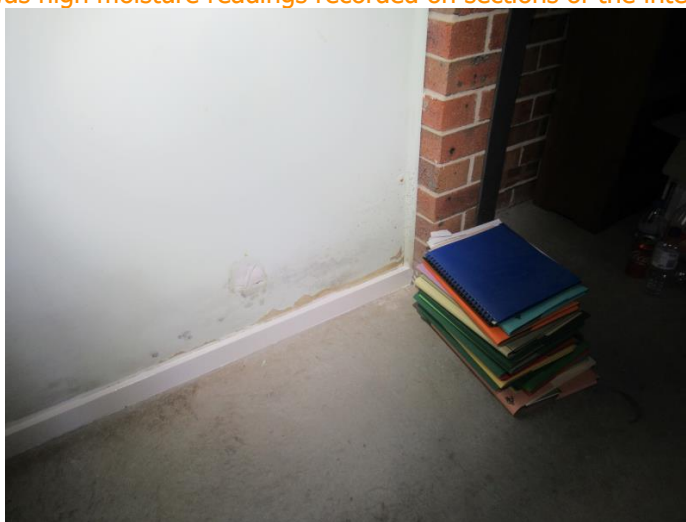
**Walls** As tested, there was high moisture readings recorded on sections of the internal walls

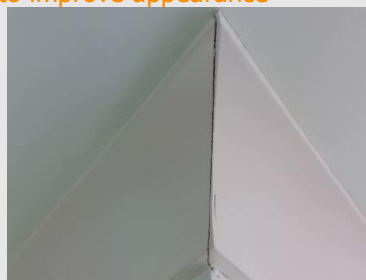
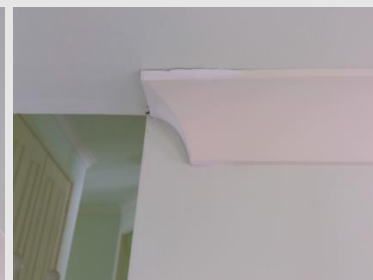
Door	OK, The item described is performing the function it was designed for and its condition is very typical for it's age
Walls	Minor joint cracking or deflection needs repair and re-finish to restore appearance
Ceiling	Cornice cracking needs repairs to improve appearance

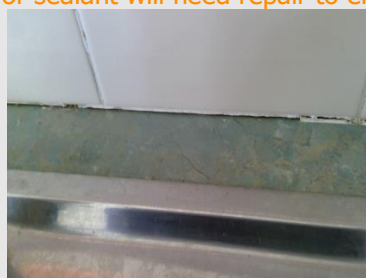
Splashbacks	Loose or missing tile grout and or sealant will need repair to ensure water tightness
-------------	---

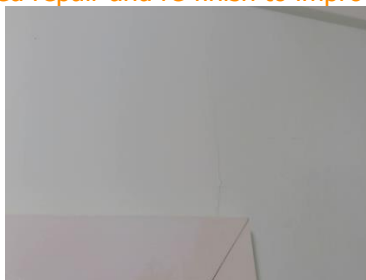
Typical plaster cracking, will need repair and re-finish to improve appearance

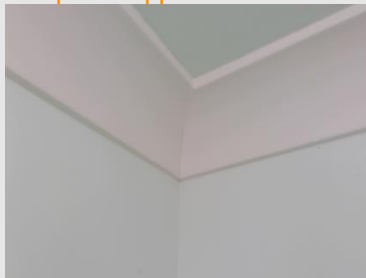
Cornice cracking needs repairs to improve appearance

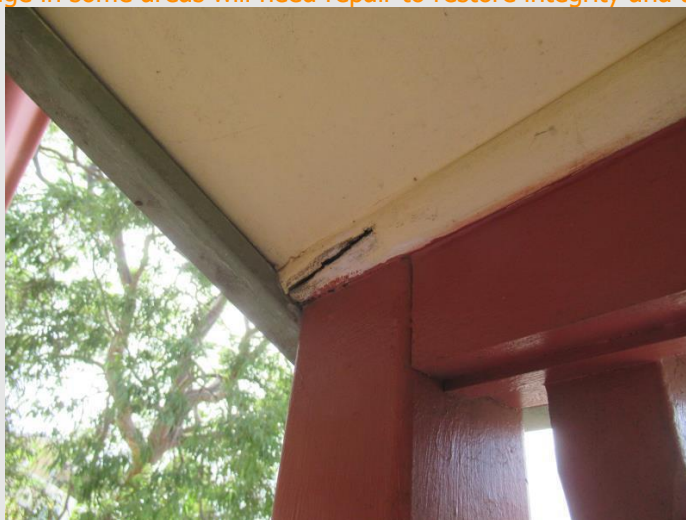
Minor water damage in some areas will need repair to restore integrity and appearance

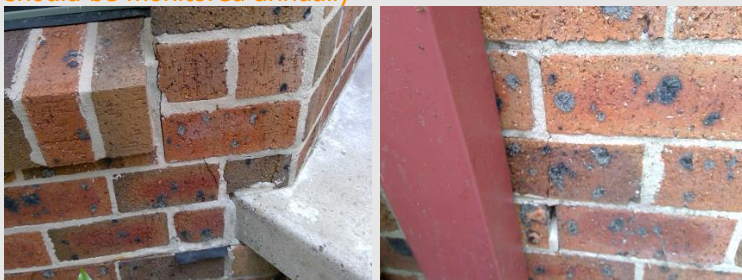
Minor typical settlement cracking only category 1, not considered significant, however this should be monitored annually

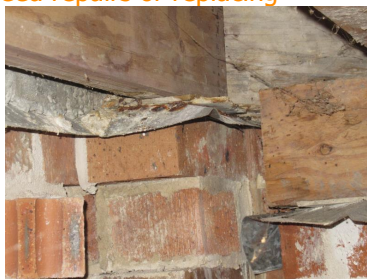
Rusting or damaged flashings need repairs or replacing

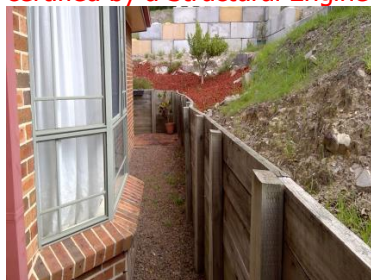
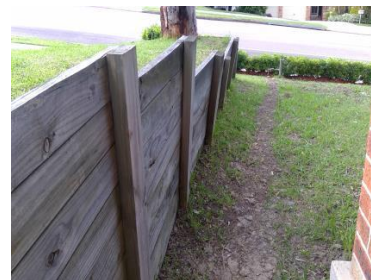
Timber retaining walls are leaning and need repairs. Any retaining wall over 700mm must be certified by a Structural Engineer

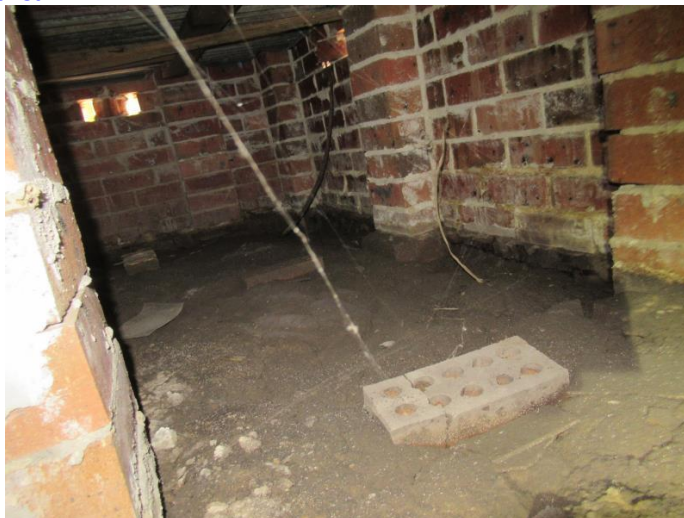
Dampness Significant dampness was noted, I recommend the site drainage be improved to help minimise dampness in this area

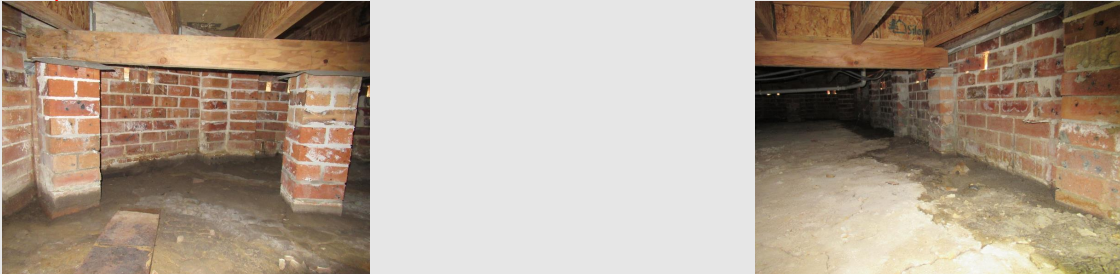
<b>Dampness</b>	Significant dampness was noted, I recommend the site drainage be improved to help minimise dampness in this area

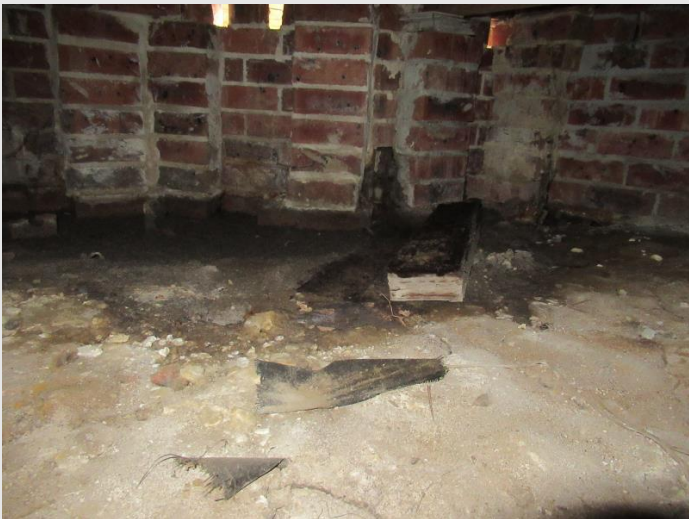
<b>Drainage</b>	Inadequate, I recommend the subfloor drainage is improved, improving the site drainage may also help limit the dampness in this area	
<b>Ventilation</b>	Limited in areas of the subfloor, ventilation should be improved	
<b>Cracked or leaking pipes</b>	NIL, No cracked or leaking pipes were noted at the time of the inspection, however this should be monitored periodically	
<b>Debris</b>	Timber debris within a subfloor area will form a conducive condition to potential termite attack and must be removed
