# Inspection Report

**Millerd Pest Control Pty Limited**

**43 Delaware Drive , Macquarie Hills, NSW, 2285**

Inspection Date: 23 Mar 2020

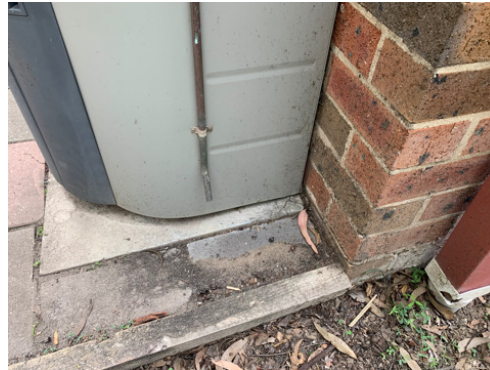
No - Divert hot water overflow away from the building perimeter

Hot water unit overflow not connected to drain. This provides conducive conditions for termite infestation. The degree of risk is moderate to high. Engage plumber to rectify.

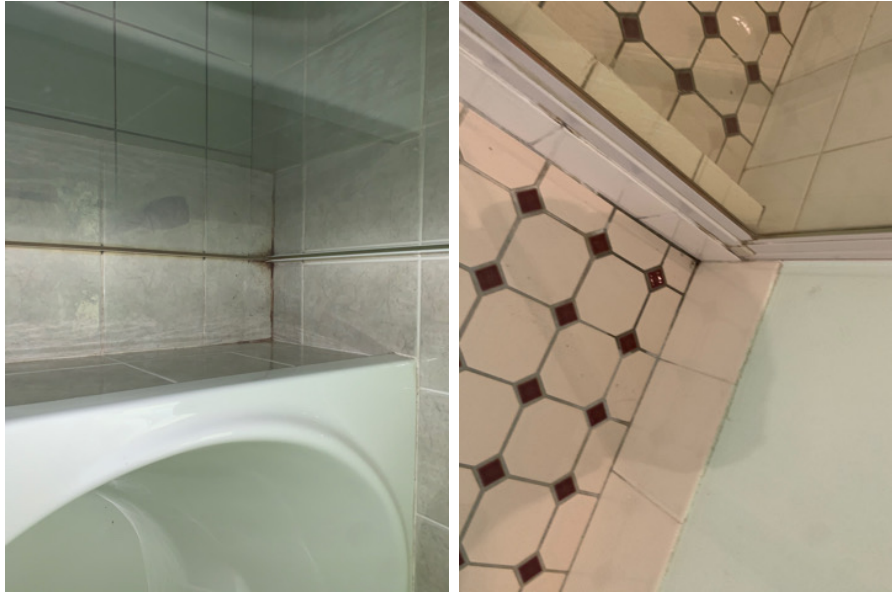
At the time of the inspection moisture readings were high

If high moisture was reported then you must have a building expert investigate the moisture and its cause and determine the full extent of damage and the estimated cost of repairs.

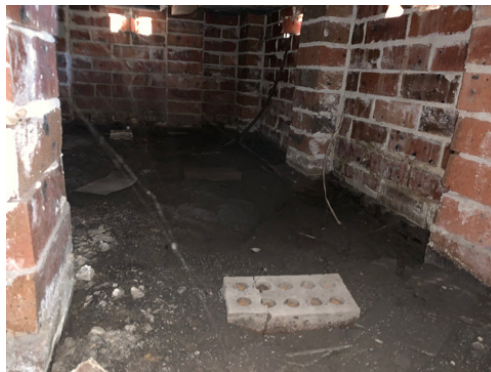
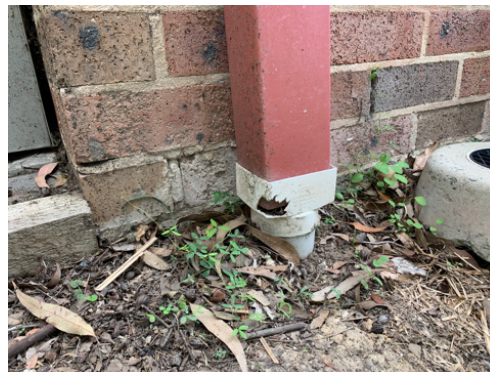
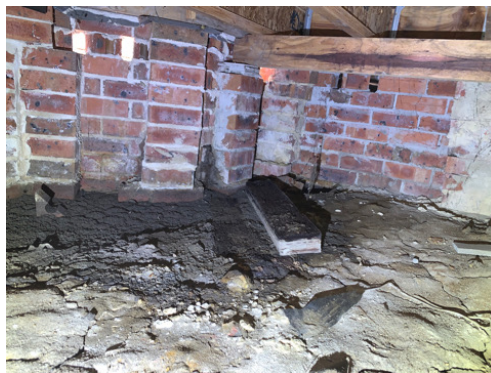
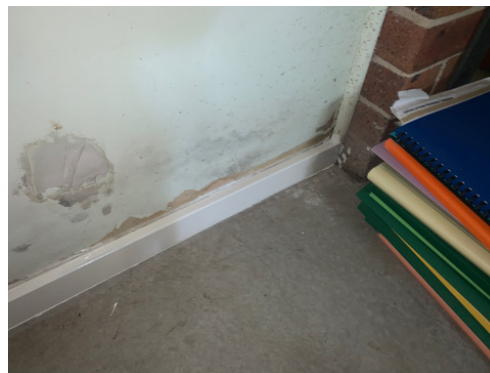
Down pipes not connected to storm water. This causes moisture and excess moisture is conducive to termite infestation. The degree of risk is high. You need to engage a plumber to rectify.

Damp sub floor soil. This provides conducive conditions for termite infestation. The degree of risk is high. Engage plumber to assess and rectify.

Timber debris in contact with ground in sub floor. This provides conducive and concealed conditions for termite infestation. The degree of risk is high. Remove.

External cladding is in contact with ground due finished ground levels high and being built close to ground. This provides conducive and concealed conditions and concealed entry for termite infestation. The degree of risk is high. Ground levels require lowering.
