Pre-Purchase Inspection - Residential Building Report

9 First Avenue North Lambton (Northern Elevation)

Inspector Details	
Name Of Inspection Firm:	CTP Pest and Building Inspections
Contact Phone:	0402 679 087
Inspector Name:	Craig Pearce
Report Prepared Date:	14/07/2020

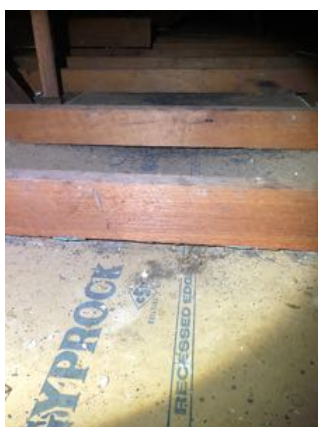
Defect 1. - Roof Void	
Defect Location:	South Side
Defect Summary:	Ceiling linings
Type of Defect:	Distortion, warping, twisting
Description:	Sagging ceiling linings
Ongoing Consequence:	Additional fixings recommend
Opinion of Cracking:	Not Applicable
Building Professional:	<p>Note: This defect should be referred to a qualified building professional for further advice on the cost and scope of the repairs/work required.</p> <p>Building Professional Required: Builder</p>

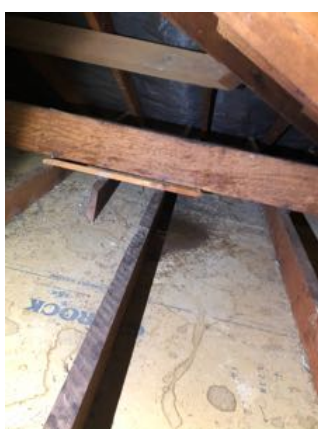
Defect 3. - Roof Void	
Defect Location:	West Side, East Side
Defect Summary:	Leaking roof
Type of Defect:	Water penetration, dampness
Description:	Damage Roof coverings
Ongoing Consequence:	Damage to surrounding elements
Opinion of Cracking:	Not Applicable
Building Professional:	<p>Note: This defect should be referred to a qualified building professional for further advice on the cost and scope of the repairs/work required.</p> <p>Building Professional Required: Roof Tiler</p>

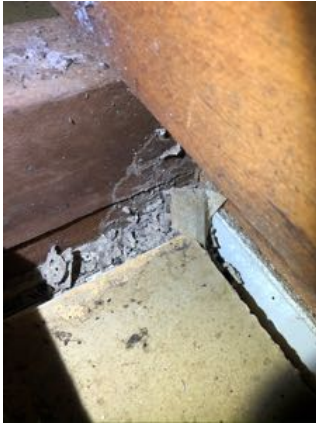
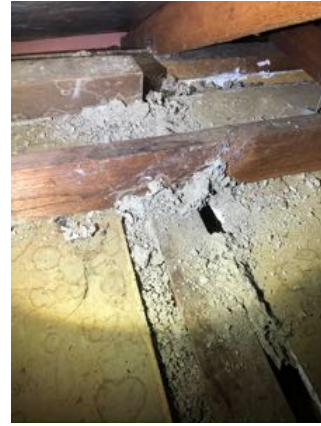
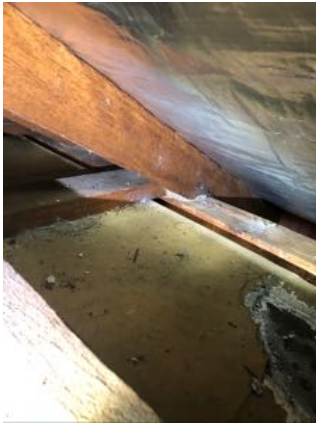
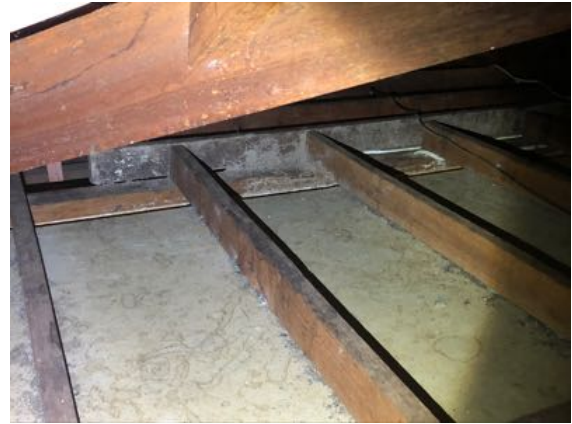
Defect 4. - Roof Void	
Defect Location:	South Side
Defect Summary:	Roof Framing
Type of Defect:	Damage
Description:	Evidence of timber pest damage
Ongoing Consequence:	Possible ongoing damage from timber pest infestation
Opinion of Cracking:	
Building Professional:	<p>Note: This defect should be referred to a qualified building professional for further advice on the cost and scope of the repairs/work required.</p> <p>Building Professional Required: Builder</p>

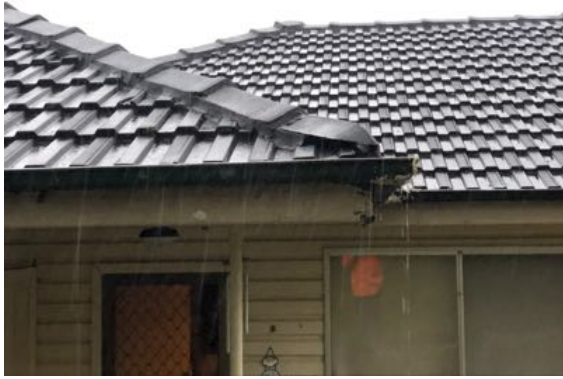
Defect 5. - Roof Exterior	
Defect Location:	North Side, West Side, South Side, East Side
Defect Summary:	Roof Coverings
Type of Defect:	Distortion, warping, twisting, Material deterioration
Description:	Repointing to ridge and/or hips required Concrete roof tiles weathered tiles have a life expectancy of 30yrs
Ongoing Consequence:	Water ingress to Roof Void Anticipate extensive roof restoration
Opinion of Cracking:	
Building Professional:	<p>Note: This defect should be referred to a qualified building professional for further advice on the cost and scope of the repairs/work required.</p> <p>Building Professional Required: Roof Tiler</p>

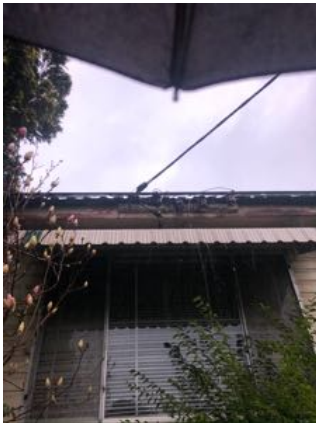
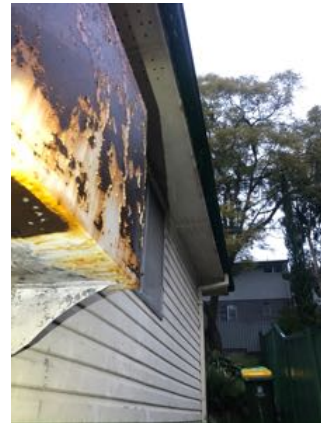
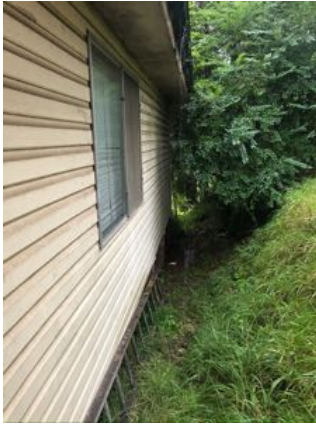
Defect 6. - Roof Exterior

Defect Location:	North Side, West Side, South Side, East Side
Defect Summary:	Guttering
Type of Defect:	Material deterioration
Description:	Guttering is rusted
Ongoing Consequence:	Damage to surrounding elements
Opinion of Cracking:	
Building Professional:	<p>Note: This defect should be referred to a qualified building professional for further advice on the cost and scope of the repairs/work required.</p> <p>Building Professional Required: Plumber</p>

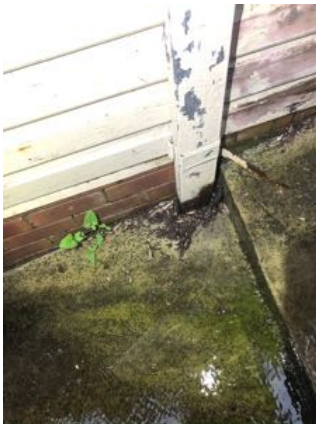
Defect 7. - Roof Exterior	
Defect Location:	West Side
Defect Summary:	Downpipes
Type of Defect:	Material deterioration
Description:	Downpipes are rusted
Ongoing Consequence:	Damage to surrounding elements
Opinion of Cracking:	
Building Professional:	<p>Note: This defect should be referred to a qualified building professional for further advice on the cost and scope of the repairs/work required.</p> <p>Building Professional Required: Plumber</p>

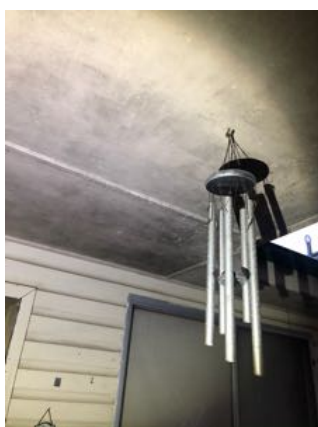
Defect 8. - Roof Exterior	
Defect Location:	North Side, West Side, South Side, East Side
Defect Summary:	Eaves, Fascia and Barges
Type of Defect:	Operational
Description:	Evidence of possible mould growth
Ongoing Consequence:	Unhealthy allergens may develop
Opinion of Cracking:	
Building Professional:	<p>Note: This defect should be referred to a qualified building professional for further advice on the cost and scope of the repairs/work required.</p> <p>Building Professional Required: Builder</p>

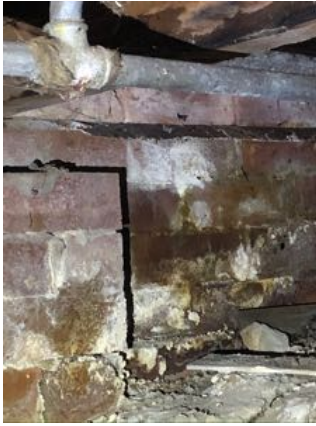
Defect 9. - Subfloor	
Defect Location:	Not Applicable
Defect Summary:	Ant Shielding
Type of Defect:	Material deterioration, Operational
Description:	Inadequate Rusted and concealed
Ongoing Consequence:	Increase risk of undetected termite entry
Opinion of Cracking:	
Building Professional:	<p>Note: This defect should be referred to a qualified building professional for further advice on the cost and scope of the repairs/work required.</p> <p>Building Professional Required: Builder</p>

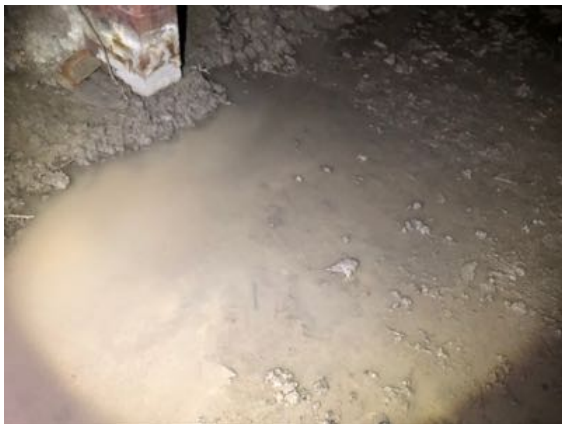
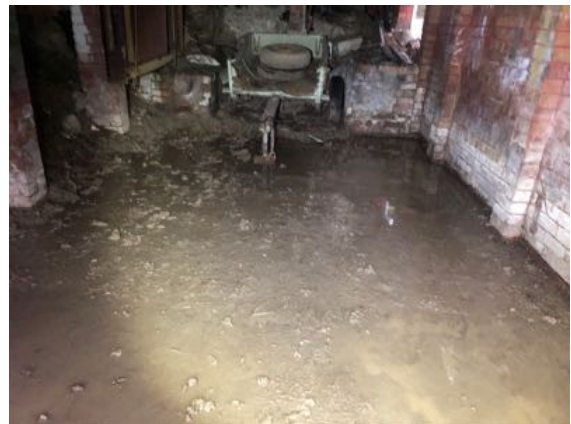
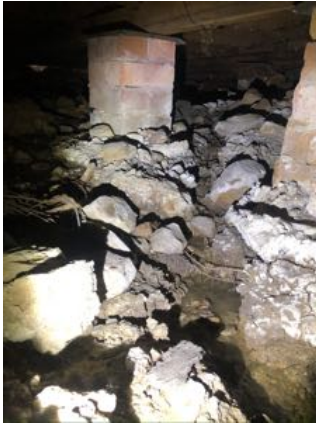
Defect 10. - Subfloor	
Defect Location:	Not Applicable
Defect Summary:	Ventilation (Subfloor)
Type of Defect:	Water penetration, dampness, Operational, Installation
Description:	The drainage appears to be inadequate, Water is pooling
Ongoing Consequence:	Pooling water may cause damage to the footings, Damage to surrounding elements, Unhealthy allergens may develop, Creates an environment that encourages the entry of timber pests
Opinion of Cracking:	
Building Professional:	<p>Note: This defect should be referred to a qualified building professional for further advice on the cost and scope of the repairs/work required.</p> <p>Building Professional Required: Plumber</p>

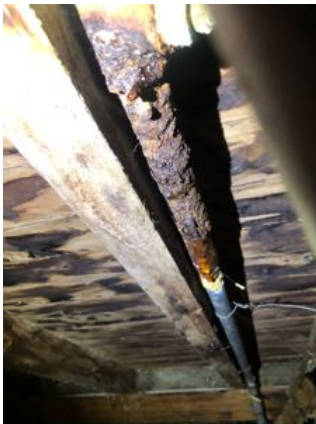
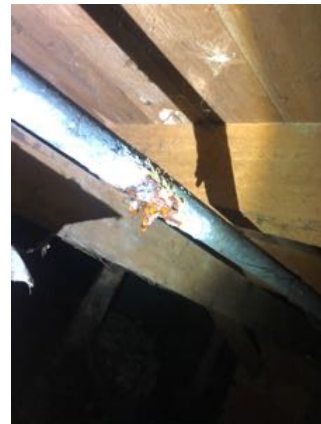
Defect 11. - Subfloor	
Defect Location:	Not Applicable
Defect Summary:	Water supply
Type of Defect:	Material deterioration
Description:	Corrosion and leaking galvanised water supply
Ongoing Consequence:	Increased water bills
Opinion of Cracking:	Not Applicable
Building Professional:	<p>Note: This defect should be referred to a qualified building professional for further advice on the cost and scope of the repairs/work required.</p> <p>Building Professional Required: Plumber</p>

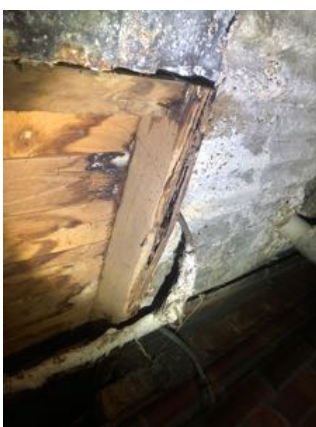
Defect 12. - Subfloor	
Defect Location:	Not Applicable
Defect Summary:	Flooring and floor frame around bathroom area
Type of Defect:	Material deterioration
Description:	Moderate decay
Ongoing Consequence:	Further decay
Opinion of Cracking:	Not Applicable
Building Professional:	<p>Note: This defect should be referred to a qualified building professional for further advice on the cost and scope of the repairs/work required.</p> <p>Building Professional Required: Builder</p>

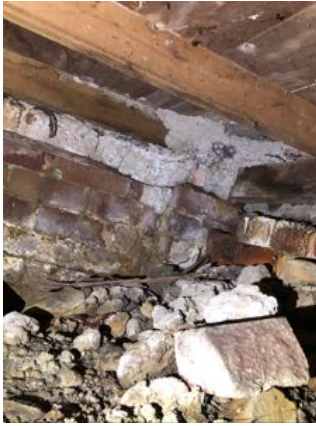
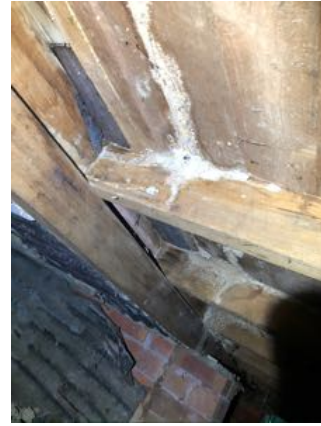
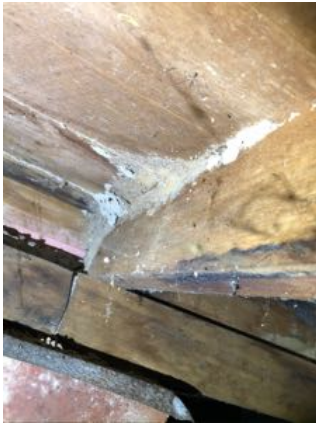
Defect 13. - Subfloor	
Defect Location:	Not Applicable
Defect Summary:	Flooring and floor frame throughout subfloor
Type of Defect:	Damage
Description:	Termite damage
Ongoing Consequence:	Possible further termite damage
Opinion of Cracking:	Not Applicable
Building Professional:	<p>Note: This defect should be referred to a qualified building professional for further advice on the cost and scope of the repairs/work required.</p> <p>Building Professional Required: Builder</p>

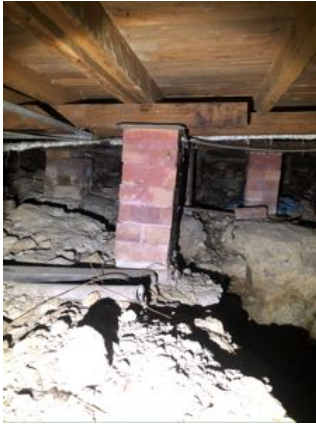
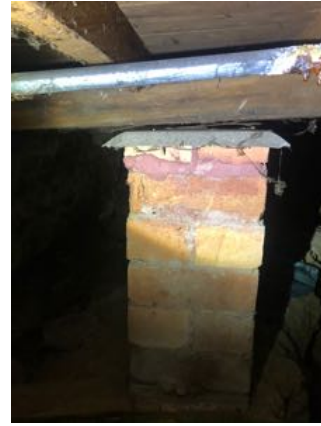
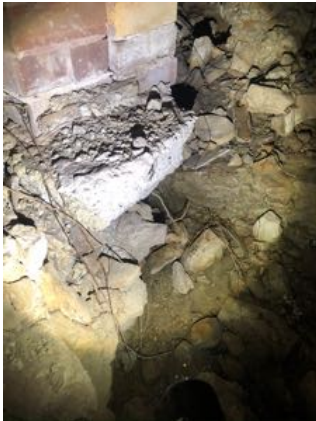
Defect 14. - Subfloor	
Defect Location:	Not Applicable
Defect Summary:	Piers and Foundation Walls
Type of Defect:	Distortion, warping, twisting, Structural
Description:	Piers appear to have settled, Piers appear to be rotating Footings undermined due to inadequate drainage
Ongoing Consequence:	Floor may begin excessive bounce
Opinion of Cracking:	Not Applicable
Building Professional:	<p>Note: This defect should be referred to a qualified building professional for further advice on the cost and scope of the repairs/work required.</p> <p>Building Professional Required: Builder</p>

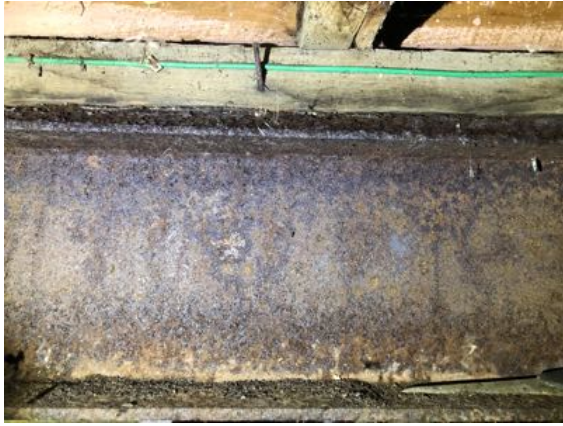
Defect 15. - Subfloor	
Defect Location:	Not Applicable
Defect Summary:	Steel bearer
Type of Defect:	Material deterioration, Structural
Description:	Extensive corrosion beam
Ongoing Consequence:	Loss of serviceability, damage to surrounding elements
Opinion of Cracking:	Not Applicable
Building Professional:	<p>Note: This defect should be referred to a qualified building professional for further advice on the cost and scope of the repairs/work required.</p> <p>Building Professional Required: Builder</p>

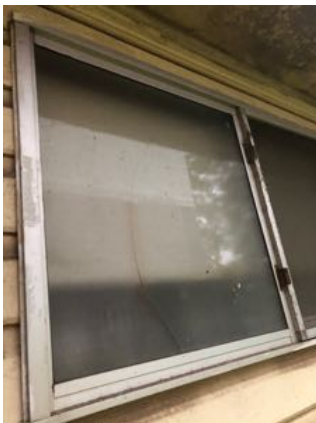
Defect 16. - Exterior	
Defect Location:	East Side
Defect Summary:	Walls - Timber Frame - Windows
Type of Defect:	Damage
Description:	Cracked glass
Ongoing Consequence:	Water entry into building
Opinion of Cracking:	
Building Professional:	<p>Note: This defect should be referred to a qualified building professional for further advice on the cost and scope of the repairs/work required.</p> <p>Building Professional Required: Glazier</p>

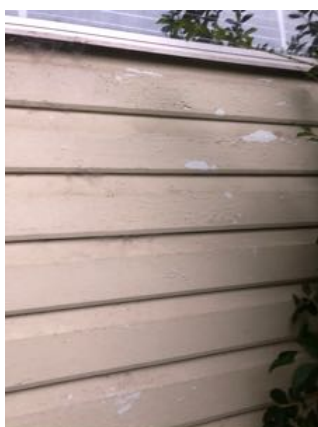
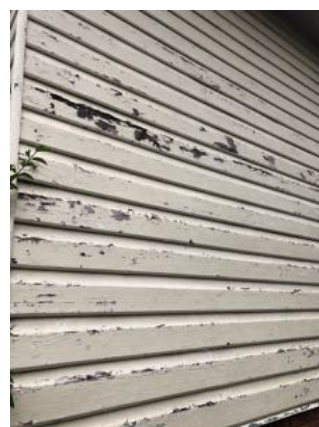
Defect 17. - Exterior	
Defect Location:	North Side, West Side, South Side, East Side
Defect Summary:	Walls - Timber Frame
Type of Defect:	Material deterioration
Description:	Paint has deteriorated significantly
Ongoing Consequence:	Damage to surrounding elements
Opinion of Cracking:	
Building Professional:	<p>Note: This defect should be referred to a qualified building professional for further advice on the cost and scope of the repairs/work required.</p> <p>Building Professional Required: Builder</p>

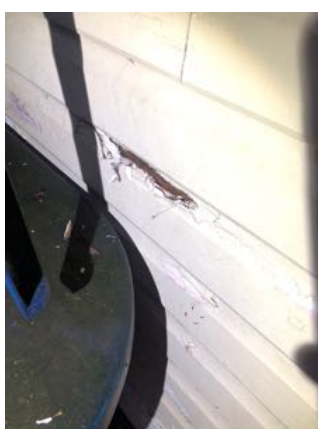
Defect 19. - Exterior	
Defect Location:	South Side
Defect Summary:	Walls - Timber Frame
Type of Defect:	Material deterioration
Description:	Decay cladding
Ongoing Consequence:	Further decay
Opinion of Cracking:	
Building Professional:	<p>Note: This defect should be referred to a qualified building professional for further advice on the cost and scope of the repairs/work required.</p> <p>Building Professional Required: Builder</p>

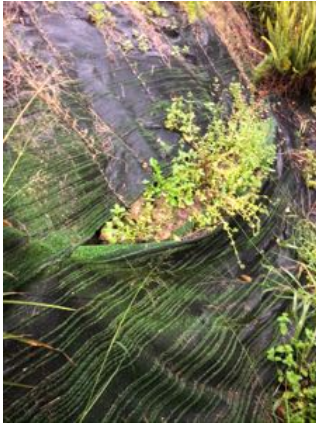
Defect 20. - Exterior	
Defect Location:	East Side
Defect Summary:	Erosion and sediment control cut bank
Type of Defect:	Distortion, warping, twisting, Installation
Description:	General erosion to cut bank
Ongoing Consequence:	Further erosion and subsidence
Opinion of Cracking:	Not Applicable
Building Professional:	<p>Note: This defect should be referred to a qualified building professional for further advice on the cost and scope of the repairs/work required.</p> <p>Building Professional Required: Builder</p>

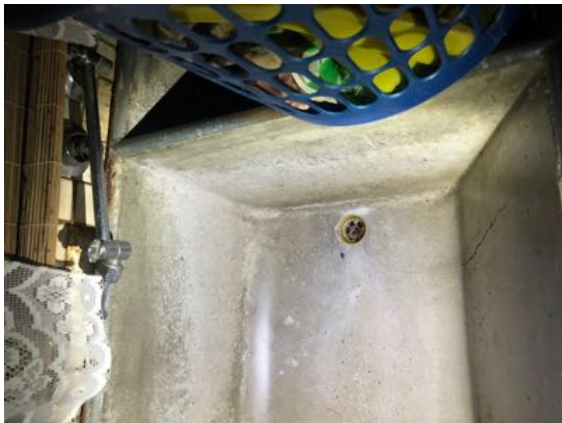
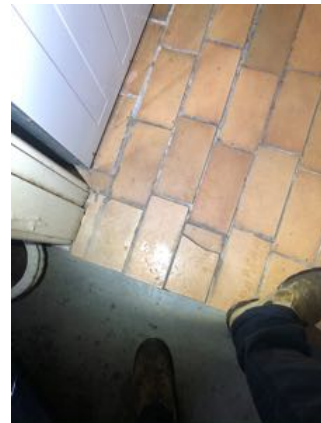
Defect 23. - Interior

Defect Location:	Laundry
Defect Summary:	Floor tiles and laundry tub and taps
Type of Defect:	Distortion, warping, twisting, Operational
Description:	Drummy floor tiles, missing taps and cracking concrete tub
Ongoing Consequence:	Tiles may come loose, may not function as expected
Opinion of Cracking:	Not Applicable
Building Professional:	Note: This defect should be referred to a qualified building professional for further advice on the cost and scope of the repairs/work required. Building Professional Required: Builder, Plumber

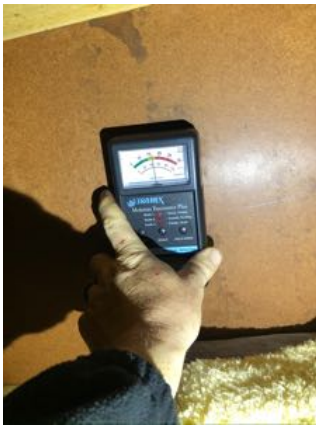
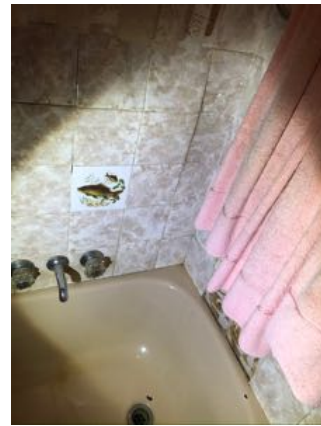
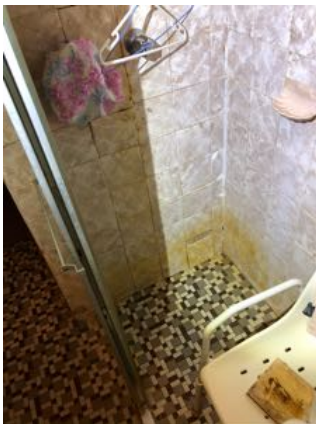
Defect 25. - Interior

Defect Location:	Bathroom
Defect Summary:	High moisture shower, wall tiles shower screen, ventilation,
Type of Defect:	Distortion, warping, twisting, Water penetration, dampness, Operational
Description:	Leaking shower recess, loose wall tiles, cracked shower screen, no ventilation,
Ongoing Consequence:	Original bathroom losing serviceability
Opinion of Cracking:	Not Applicable
Building Professional:	Note: This defect should be referred to a qualified building professional for further advice on the cost and scope of the repairs/work required. Building Professional Required: Builder, Electrician, Plumber

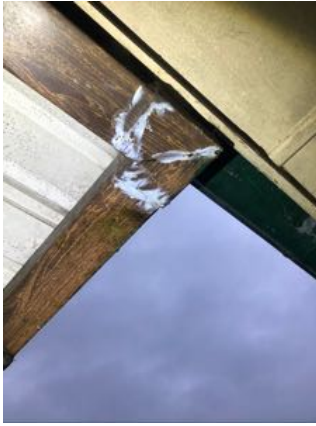
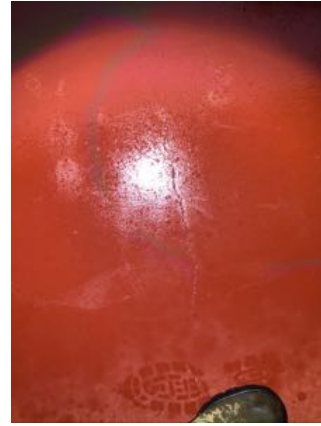
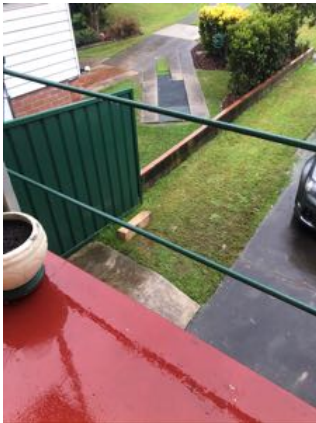
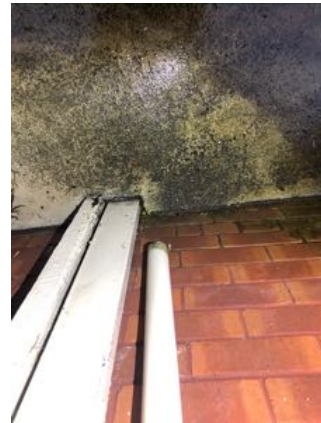
Site Defect 1. - Patio

Type of Defect:	Distortion, warping, twisting, Operational, Safety hazard
Direction (North being front of Structure):	North
Description:	Cracking slab, leaking guttering, downpipe not connected to stormwater, gaps balustrade too big, handrail is low
Ongoing Consequence:	Personal injury Possible further cracking to slab overflow may cause damage to surrounding elements
Opinion of Cracking:	Appearance cracking
Building Professional:	Note: This defect should be referred to a qualified building professional for further advice on the cost and scope of the repairs/work required. Building Professional Required: Builder, Plumber

Cracking of Masonry and/or Concrete			
Type	Area	Description	Opinion of Cracking
Patio	Distortion, warping, twisting, Operational, Safety hazard		Appearance cracking
Retaining Walls	Distortion, warping, twisting	Cracking, Wall appears to be out of align and losing serviceability	Serviceability cracking

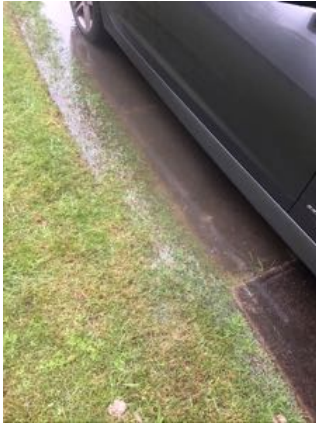
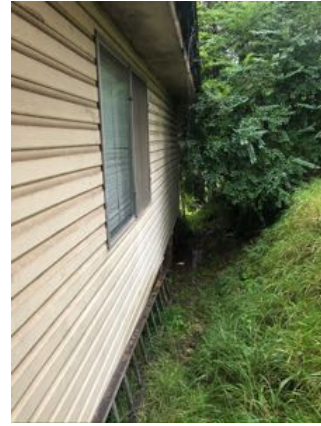
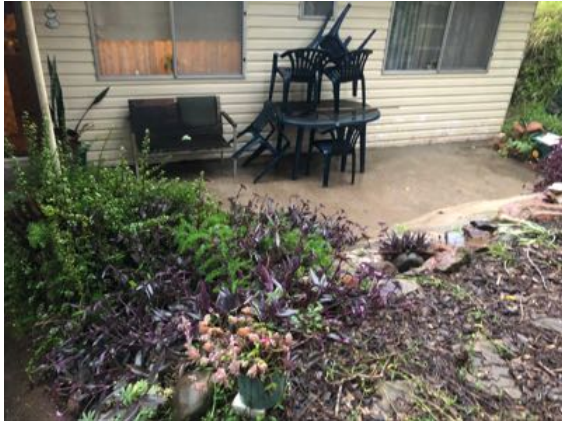
Site Defect 2. - Site Drainage	
Type of Defect:	Operational, Installation
Direction (North being front of Structure):	North, South, East
Description:	Water is ponding against the building, Water is ponding on the property
Ongoing Consequence:	Damage to the footings, Deterioration/damage to the surrounding elements
Opinion of Cracking:	
Building Professional:	<p>Note: This defect should be referred to a qualified building professional for further advice on the cost and scope of the repairs/work required.</p> <p>Building Professional Required: Plumber</p>

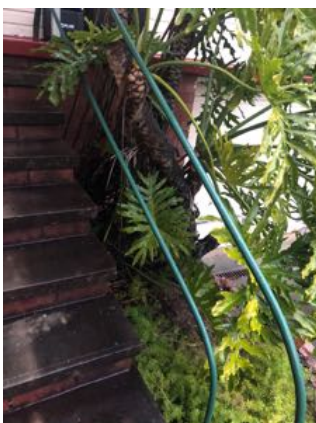
Site Defect 3. - Steps	
Type of Defect:	Safety hazard
Direction (North being front of Structure):	North
Description:	Gap between balustrades appears to be too large
Ongoing Consequence:	Personal injury
Opinion of Cracking:	Not Applicable
Building Professional:	<p>Note: This defect should be referred to a qualified building professional for further advice on the cost and scope of the repairs/work required.</p> <p>Building Professional Required: Builder</p>

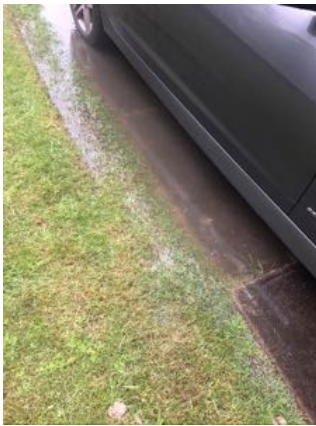
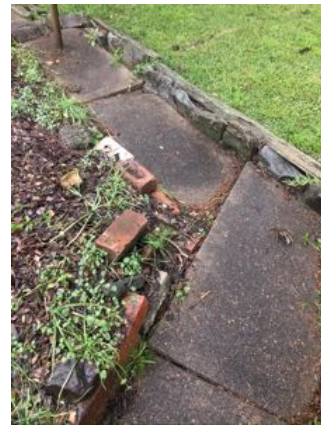
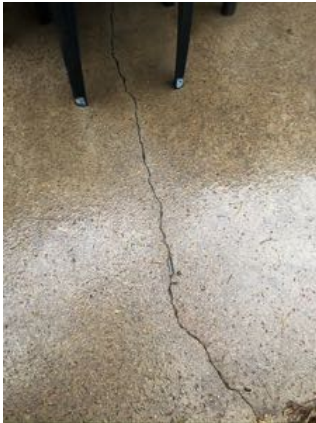
Site Defect 4. - Paths and Driveways

Type of Defect:	The path has subsided, The path is beginning to break up, The driveway has subsided
Direction (North being front of Structure):	North, South
Description:	Distortion, warping, twisting
Ongoing Consequence:	Personal injury
Opinion of Cracking:	Not Applicable
Building Professional:	Note: This defect should be referred to a qualified building professional for further advice on the cost and scope of the repairs/work required. Building Professional Required: Builder

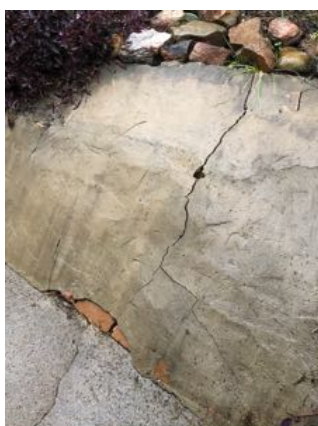
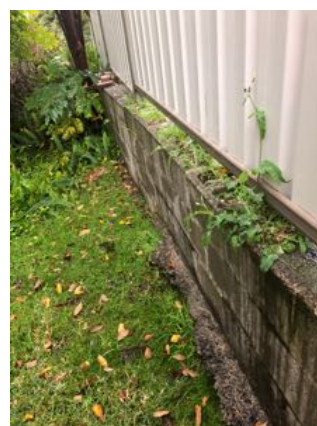
Site Defect 5. - Retaining Walls

Type of Defect:	Distortion, warping, twisting
Direction (North being front of Structure):	South, East
Description:	Cracking, Wall appears to be out of align and losing serviceability
Ongoing Consequence:	Possible collapse
Opinion of Cracking:	Serviceability cracking
Building Professional:	Note: This defect should be referred to a qualified building professional for further advice on the cost and scope of the repairs/work required. Building Professional Required: Builder
