## Pre-Sale Inspection Standard Timber Pest Detection Report

**Re property:** 23 Neridah Road, Belmont North NSW 2280

**Inspection number:** PSBPA 2710/309

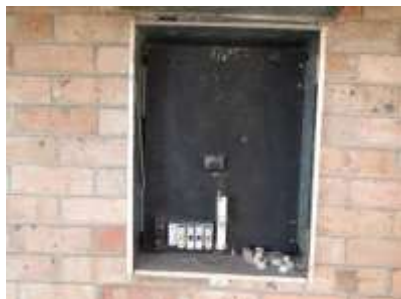
**Was a durable notice found in the meterbox:** No termite barrier notice was found in the meter box this does suggest no termite barrier work has been recently carried out.

No termite barrier notice

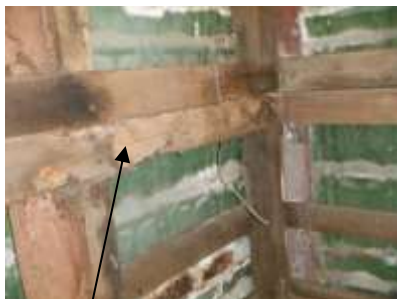
Termite workings in shed

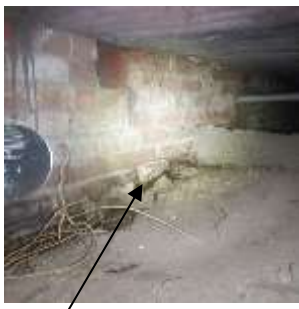
Loose timbers were found in ground contact in the subfloor and yard.

Remove timber from ground

Remove all loose timbers from ground contact in subfloor and yard.

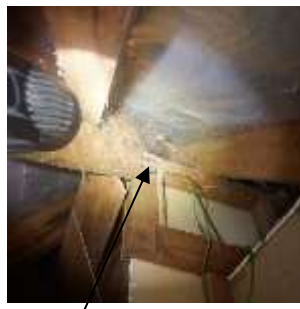
**Termite workings were found in the rear of the dwelling to the Kitchen/Family Room and to the wall and roof frames in the northeast corner**

Termite working in roof frame

**RECOMMENDATION** Where evidence of damage to building timbers exists, competent advice (e.g. from a licensed or registered building contractor) should be obtained to determine the extent of any structural damage and as to the need or otherwise for rectification or repair work. See also Item 3.5 ‘Frequency of Future Inspections’ recommendation.

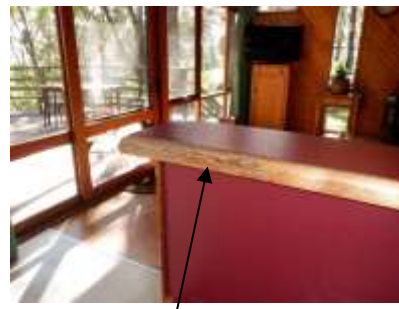
Termite working to Kitchen top

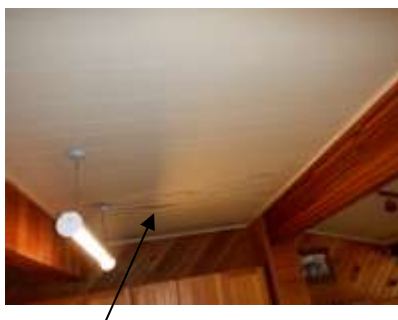
There have been previous leaks to the Dormer windows

Previous roof leaks
