Inspection Report

Reliant Pest, Pool And Building

3 Knebworth Grove, Rathmines, NSW, 2283

Pest And Building Inspection

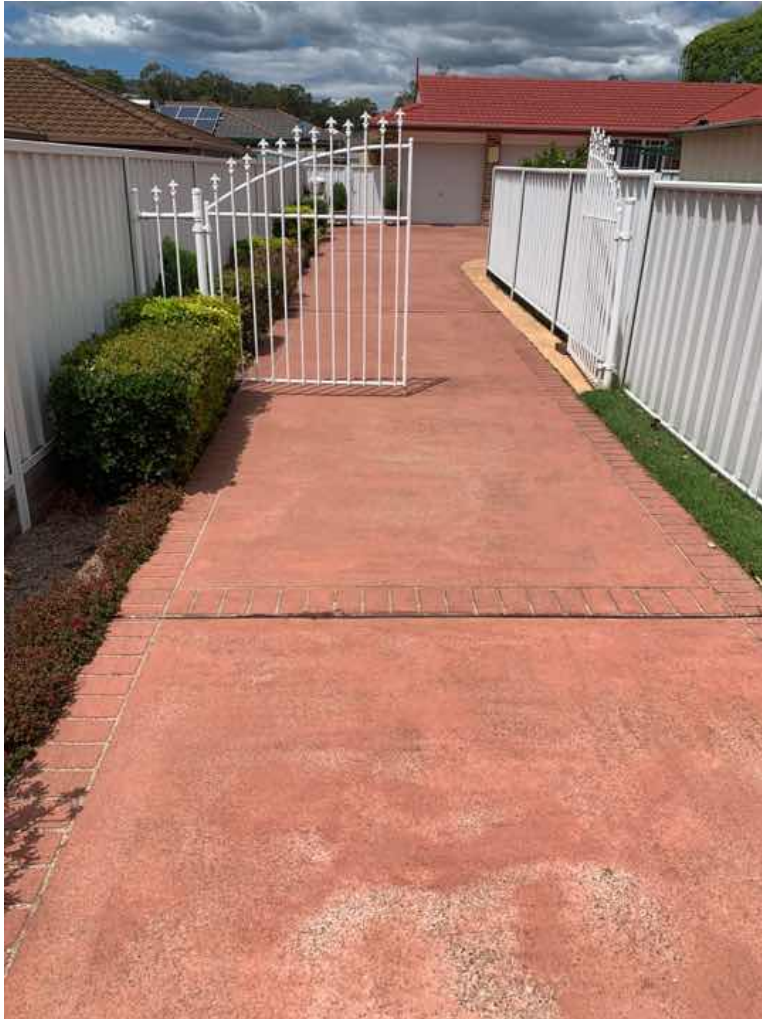
Driveway Condition

Common cracks were observed on the driveway. Whilst these cracks appeared to be typical at the time of inspection, we strongly recommend you monitor these cracks and if worsening occurs contact a concreter for further advice.

Surface raised and settled in some areas. This can cause water ponding. Relaying recommended.

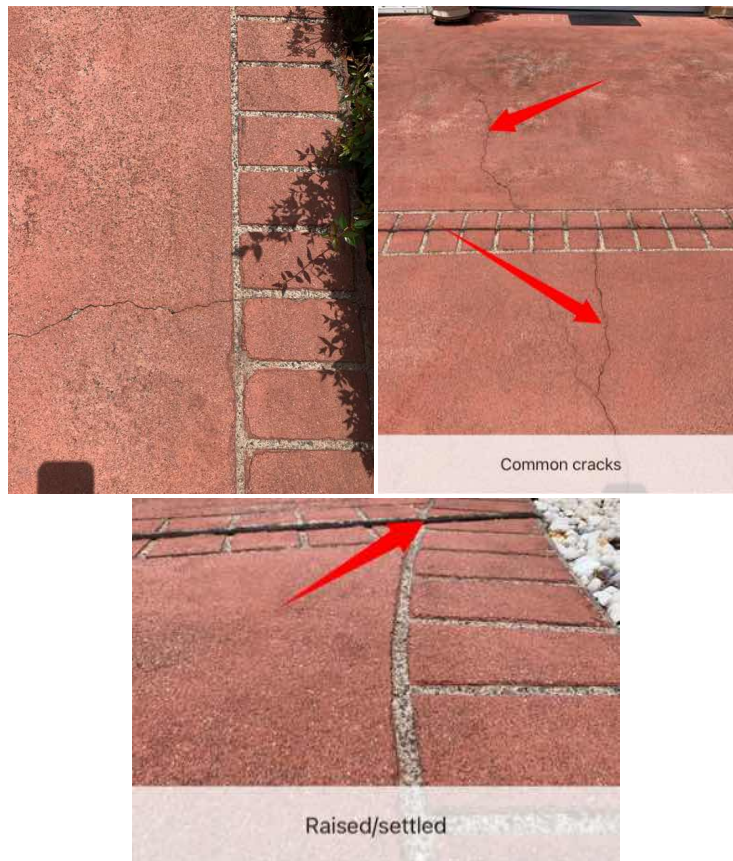
Pathways Condition

Common cracks and settlement were observed on paths. Whilst these cracks appeared to be typical at the time of inspection, we strongly recommend you monitor these cracks and if worsening occurs contact a concreter for further advice.

Surface raised and settled in some areas. This can cause water ponding. Relaying recommended.

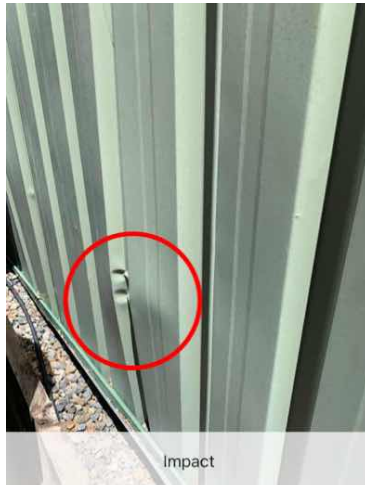
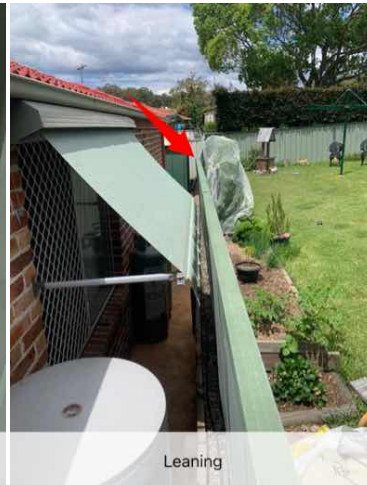
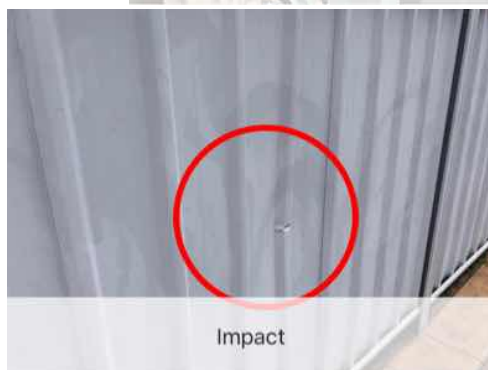
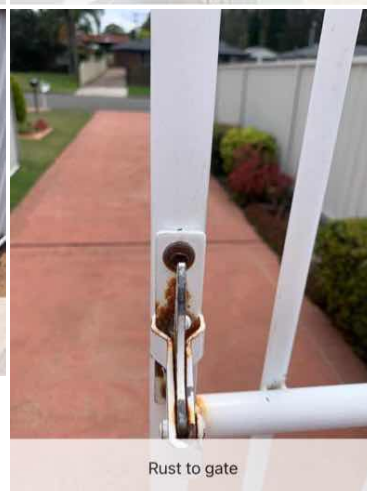
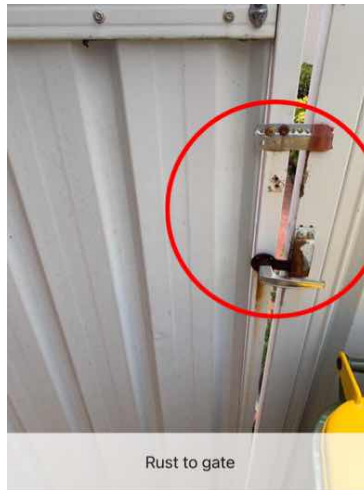
Fences & Gates

Impact damage noted to some fence panels.

Fence leaning. Repairs are required by fencing contractor to avoid unsafe conditions.

Rust noted to fence. Replacement recommended.

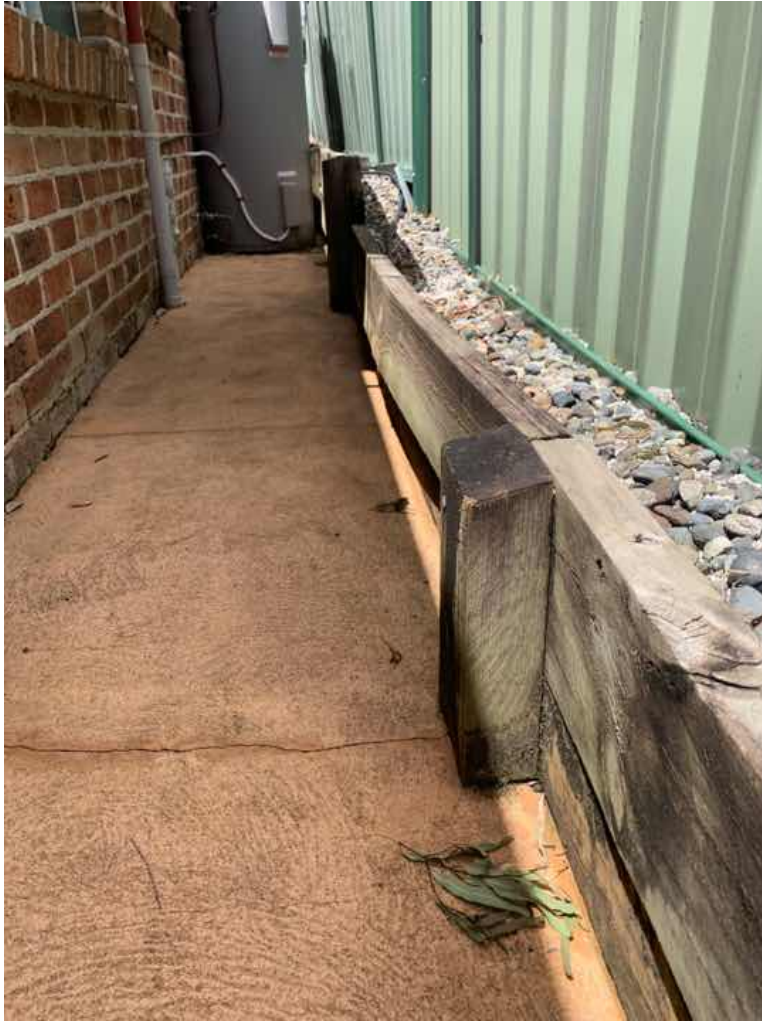
Retaining Walls

Retaining wall leaning due to deterioration and age. A qualified brick layer should be engaged for advice and recommendations.

Timber fungal decay evident. Recommendations: A qualified landscaping contractor should be engaged for repairs and recommendations.

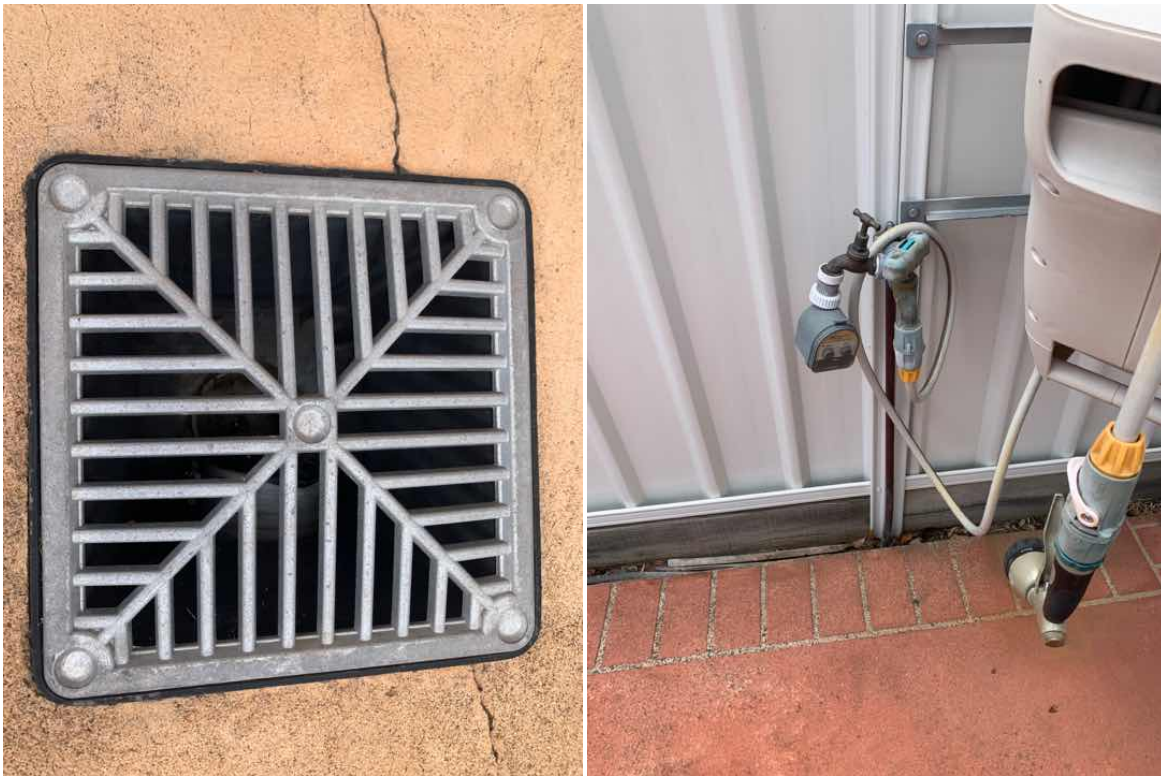
Drains

No evidence of slow or blocked drains at the time of inspections.
Recommend installing a drainage point under the tap to assist with drainage.

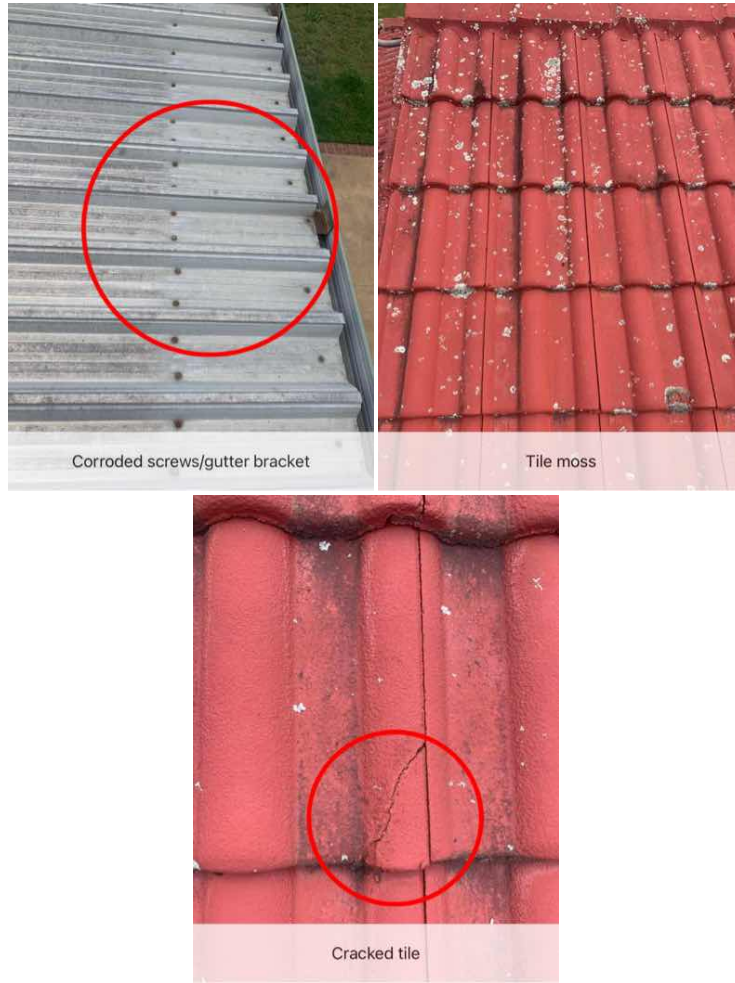
Roof Clad Condition

Cracked tiles visible. Contact a roof tiler for repairs. This has potential to become a serious issue if repairs aren't carried out due to water ingress into the roof cavity.

Corrosion noted to the screw fixings of the metal roof. Have these checked and replaced by qualified roofing contractor.

Moss has built up on the tiles over time. It is preferable to have removed / cleaned to prevent deterioration.

Recommendations: A qualified roof restoration contractor should be engaged for advice and recommendations.

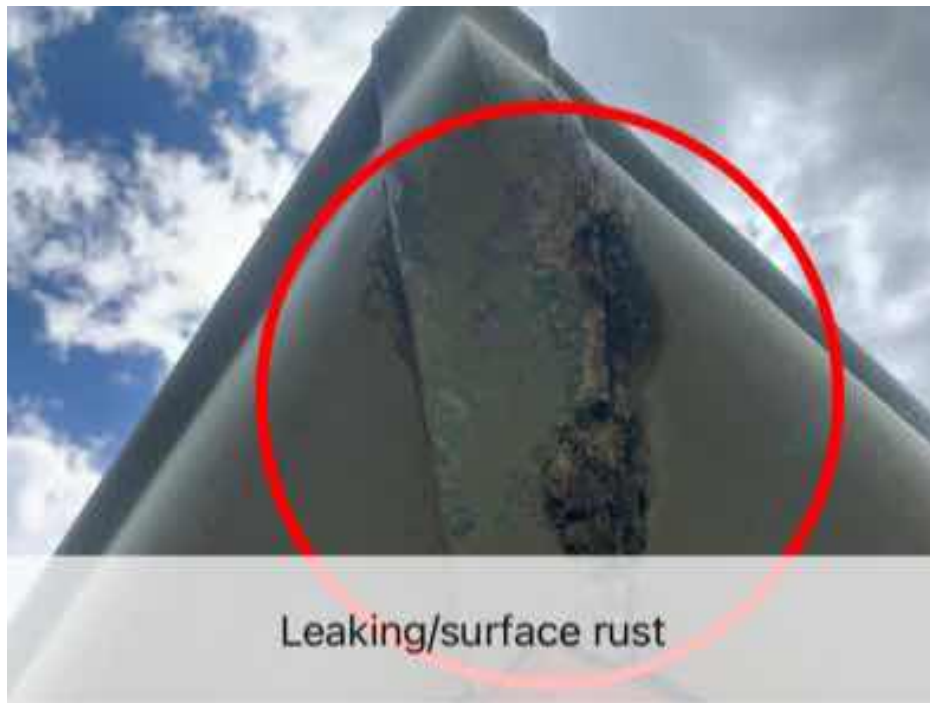
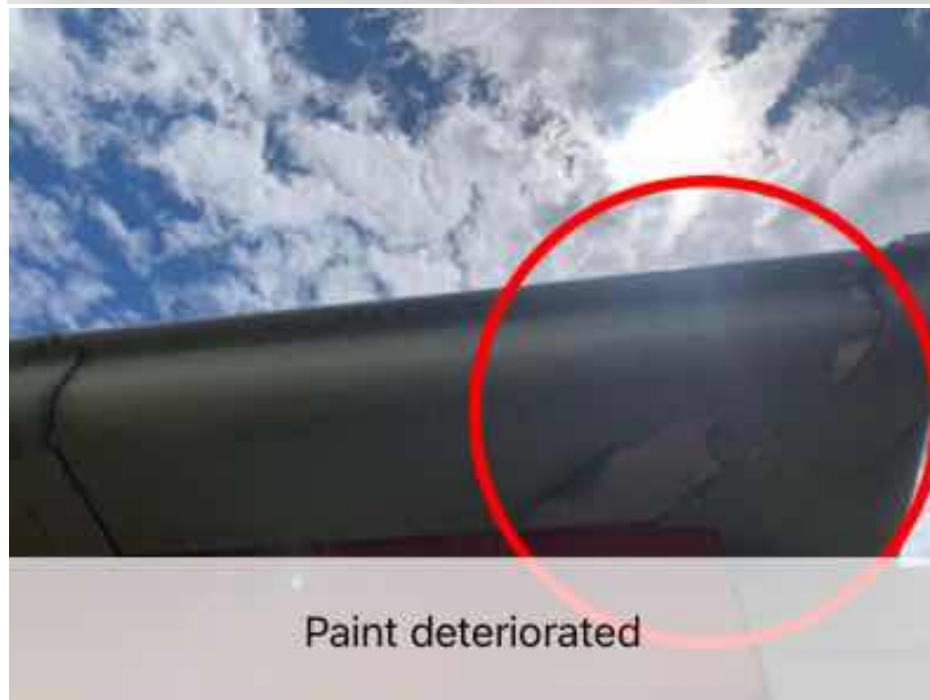
The gutter join/s have separated and will leak in rainy periods. A qualified roof plumber should be engaged for advice and recommendations.

Gutter surface rust in sections- the rust is yet to penetrate and repairs/sealing may be an option. A qualified roof plumber should be engaged for advice and recommendations.

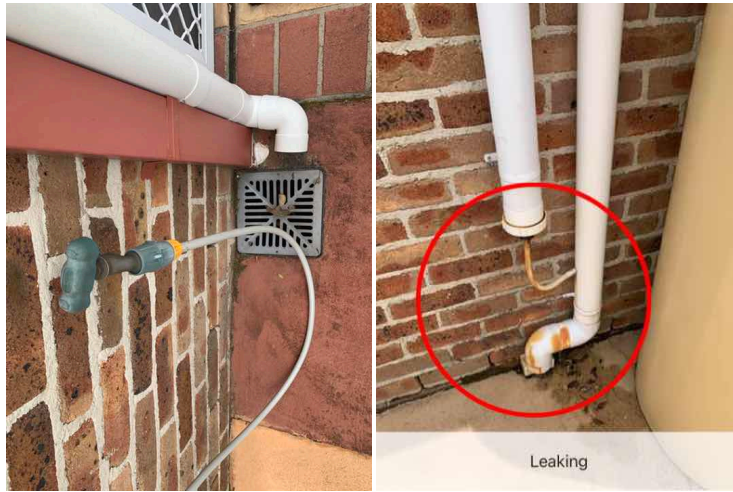
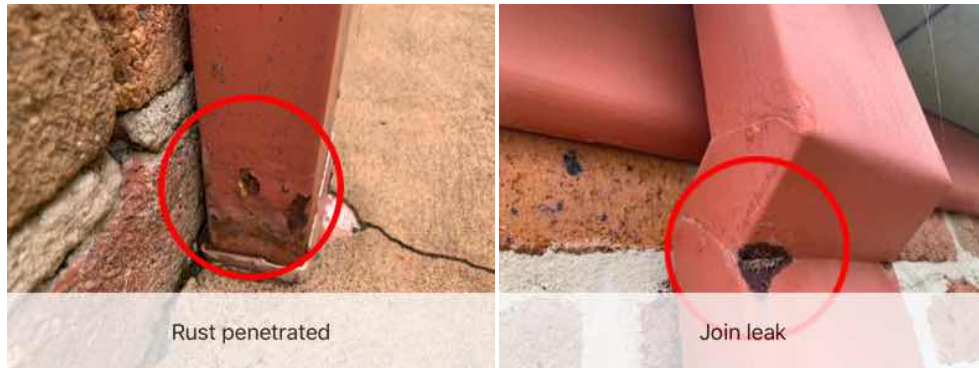
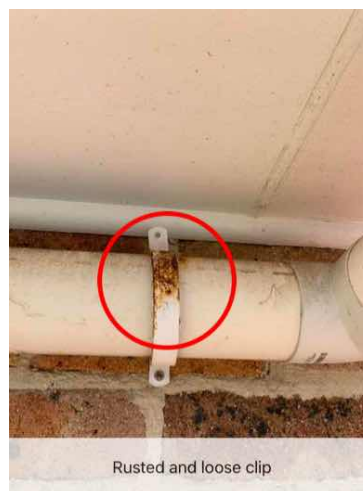
The downpipe/s wall clips is detached or missing. Although minor and easily rectifiable, we recommend a licensed roof plumber be engaged for repairs.

Leaking downpipe joints visible. This can be conducive to termite infestation and cause water damage to cladding over time. A qualified roof plumber should be engaged to repair.

Downpipe/s not connected to storm water discharge - Downpipes not connected to storm water have the potential to cause differential settlement to the footings, cause rising damp and is also conducive to termite infestation. A qualified roof plumber should be engaged for advice and recommendations.

Rust penetrations observed to downpipe. Over time this has potential to cause differential settlement to the footings, cause rising damp and is also conducive to termite infestation. A qualified plumber should be engaged for advice and recommendations.

Minor downpipe rust visible. A qualified plumber should be engaged for advice and recommendations.

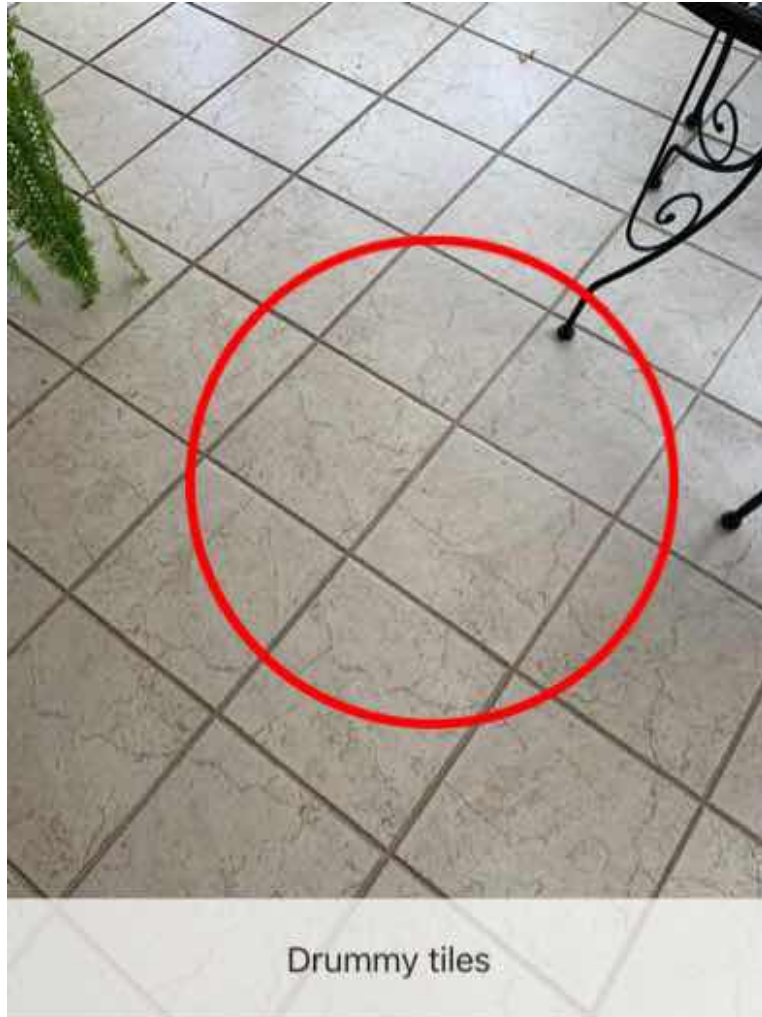
Base or Flooring Condition

Drummy tiles noted. This needs to be repaired at the earliest as this has the potential to lead to many related issues such as damp, water ingress to other areas and cracked tiles. Contact a qualified tiler for repairs and recommendation

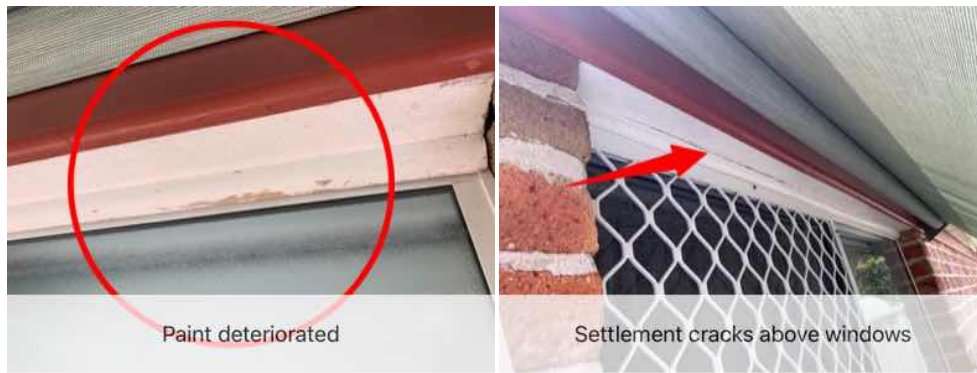
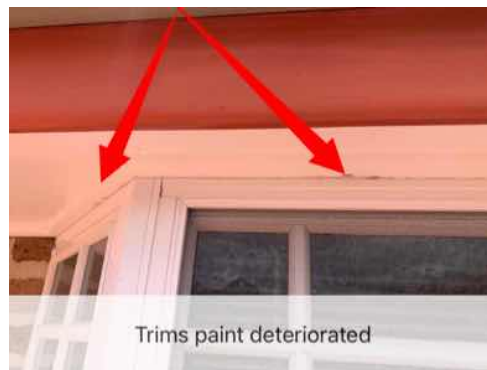
Eave Condition

Paint flake/deterioration is evident. Recommendations: General maintenance / painting as required.

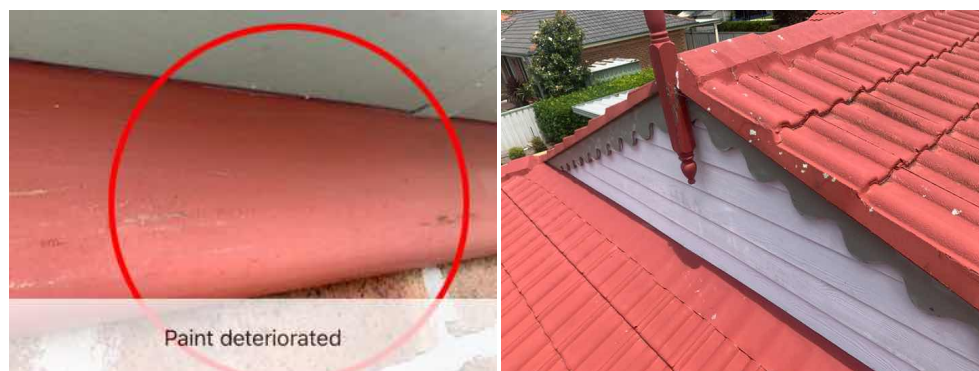
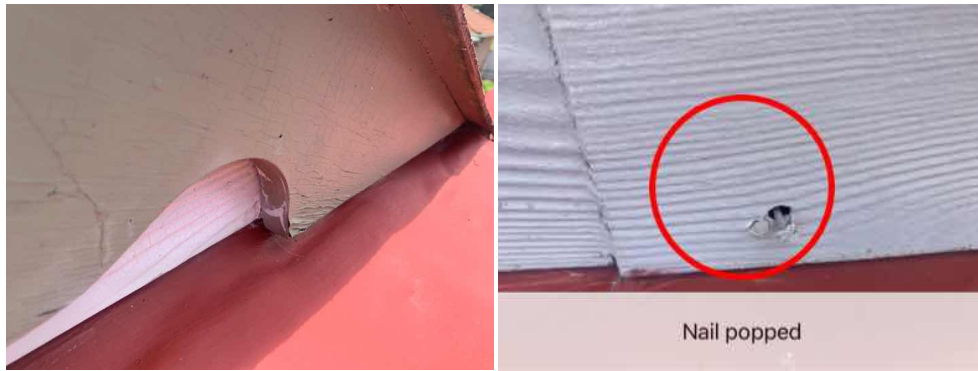
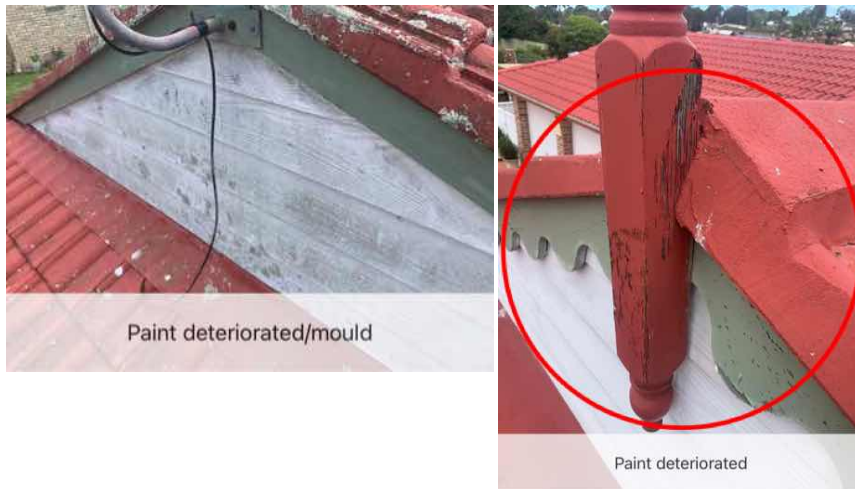
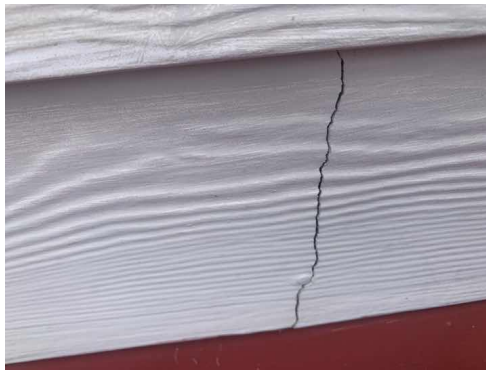
Fascia and Barge Boards

Paint / finish was deteriorated in areas and is in need of maintenance - Sanding back affected areas and painting required.

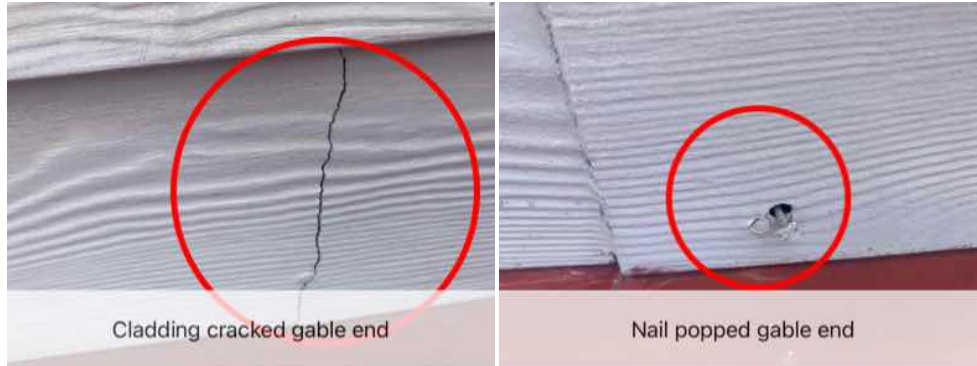
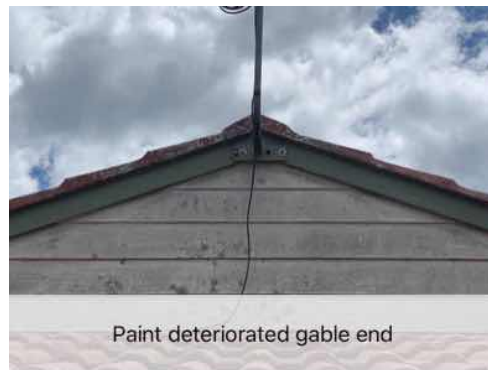
Paneling/cladding damaged. Have a suitably qualified tradesman assess and repair.

The external paint has deteriorated . External wall paint preserves and protects the building elements. Contact a qualified painter for repairs.

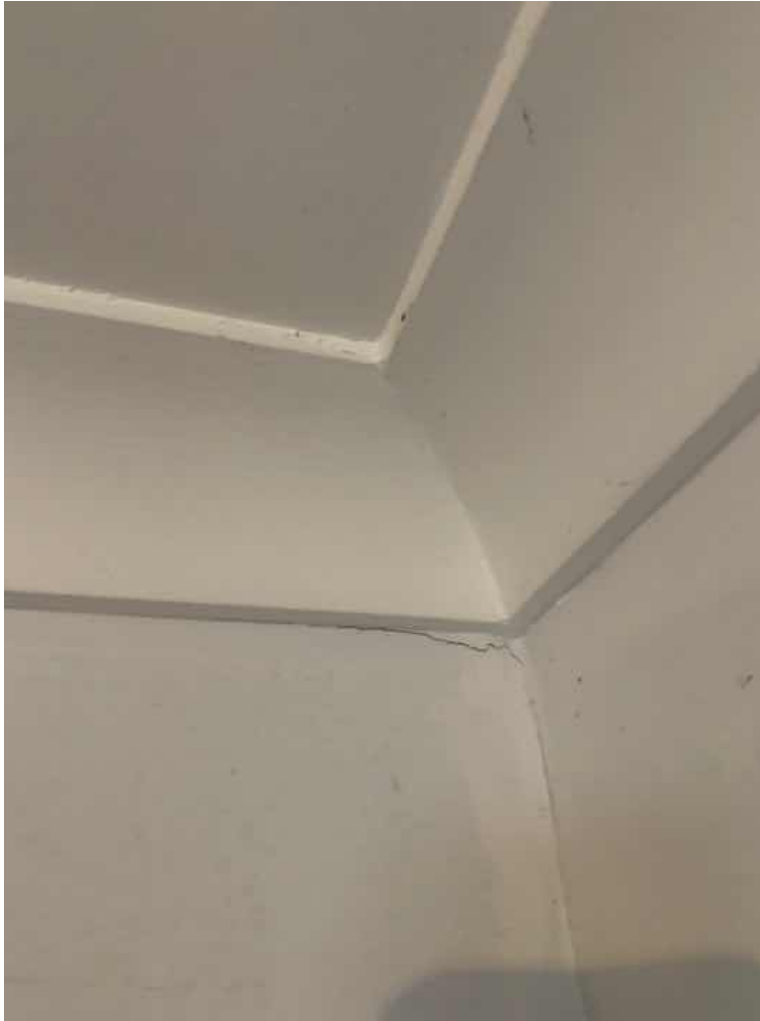
Ceiling Findings

Settlement Cracks Noted . These are typical and generally patch and paint will suffice, however Monitoring these cracks advised for 12 months and if become wider or longer, you will need to contact a structural engineers to assess.

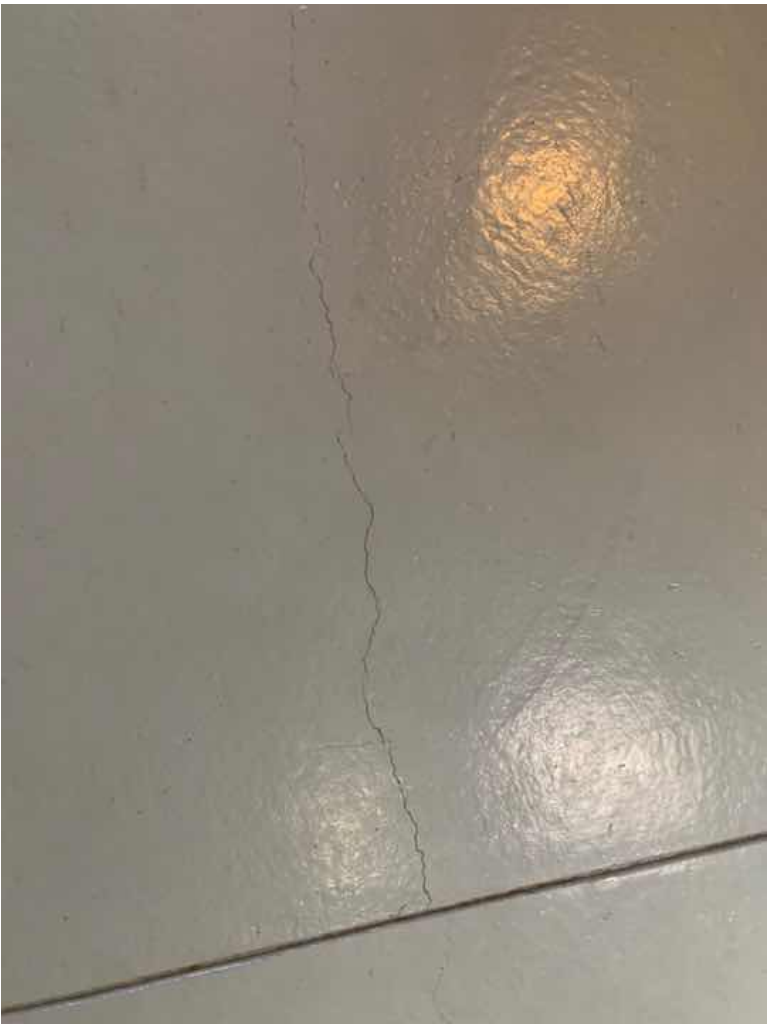
Floor Findings

Minor hairline slab cracks - Note. Whilst these cracks appeared to be minor at the time of inspection, we strongly recommend you monitor these cracks and if worsening occurs contact a qualified concreter for further advice.

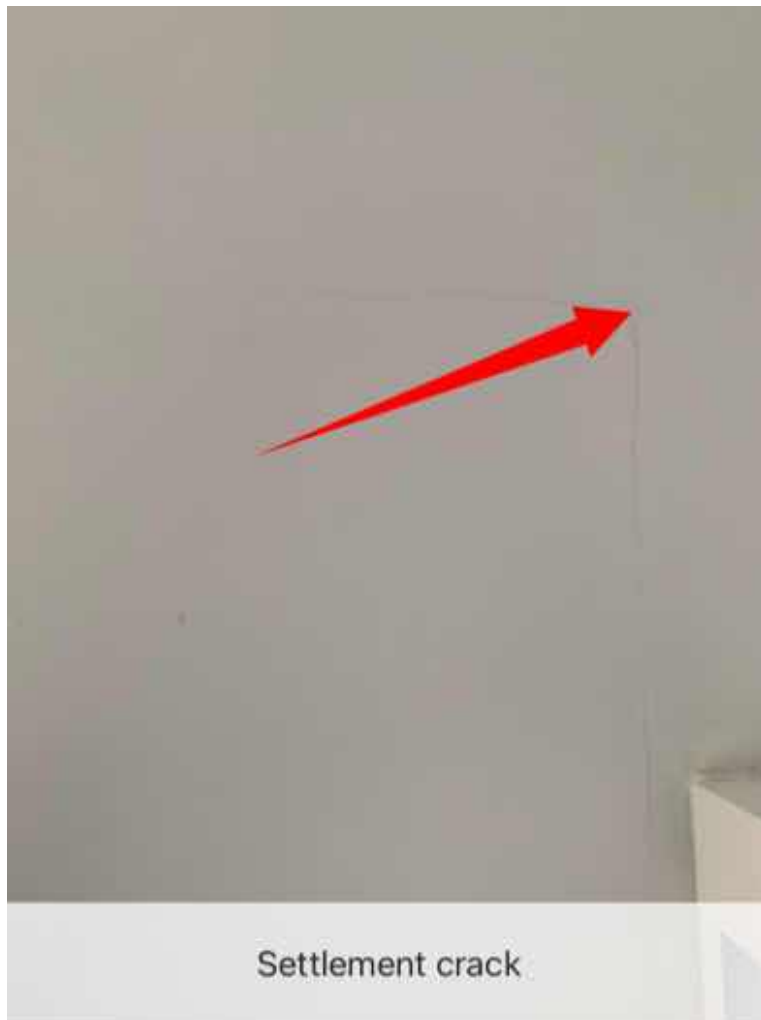
Walls

Settlement Cracks Noted . These are typical and generally patch and paint will suffice, however Monitoring these cracks advised for 12 months and if become wider or longer, you will need to contact a structural engineers to assess.

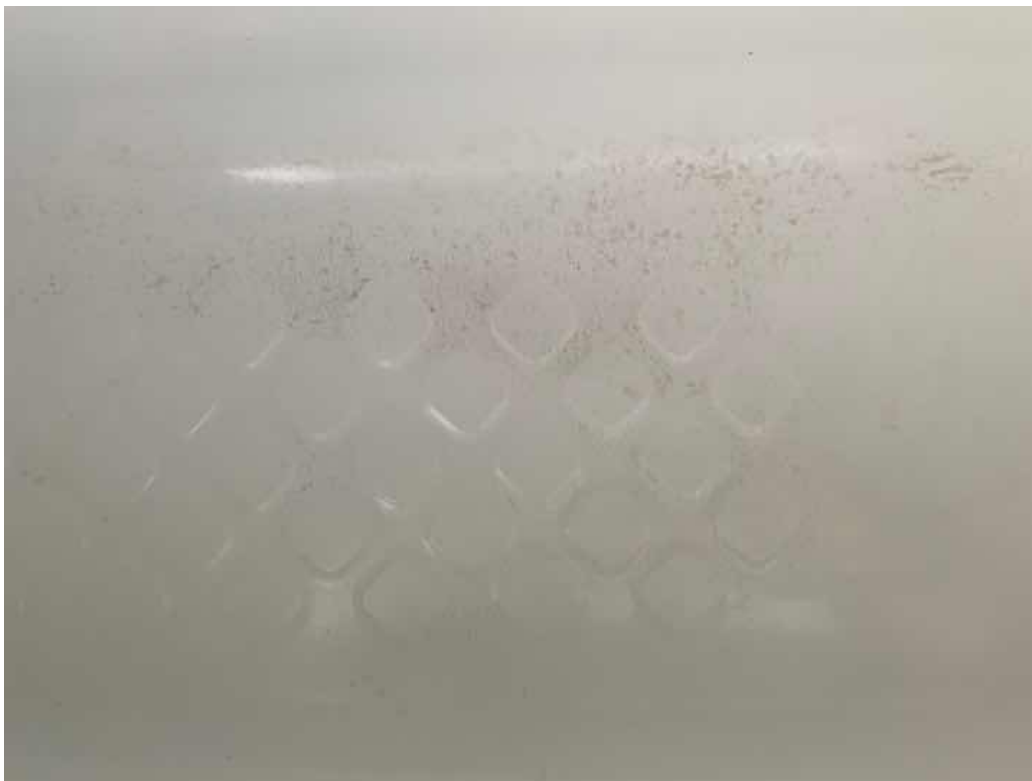
Shower And Bath

The bath tub is deteriorate. Refinish or replace. Contact a qualified plumber for recommendations and repairs

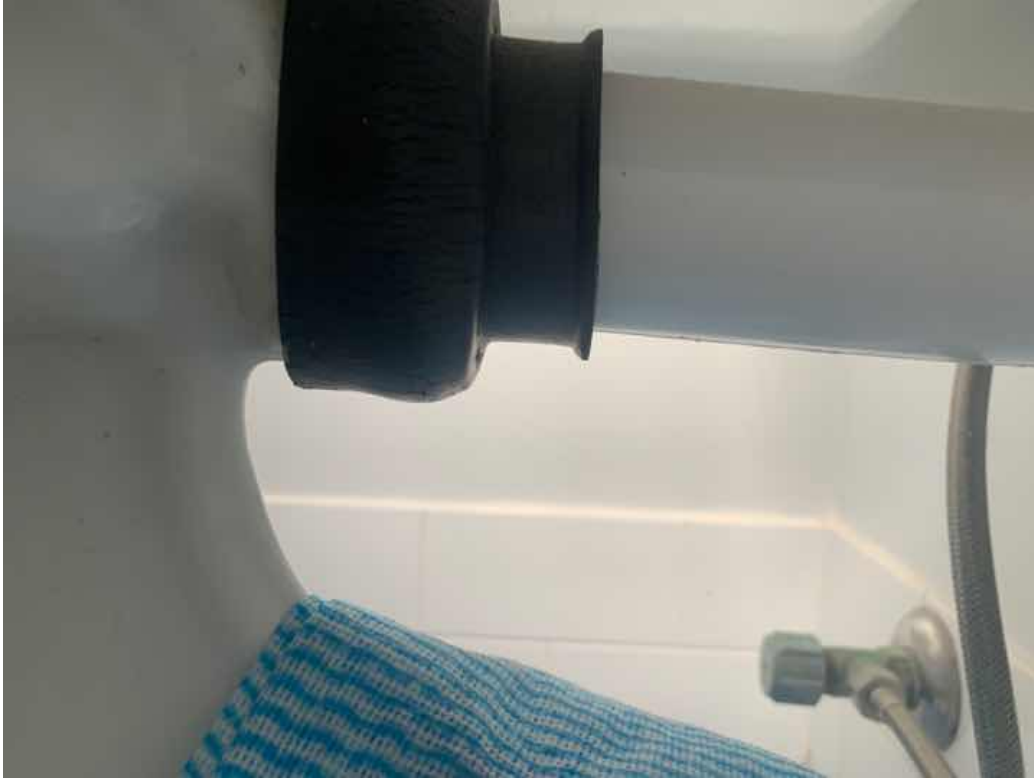
Toilet

The seal is deteriorated causing water to continuously run. Though a maintenance issue I recommend you contact a qualified plumber for repairs.

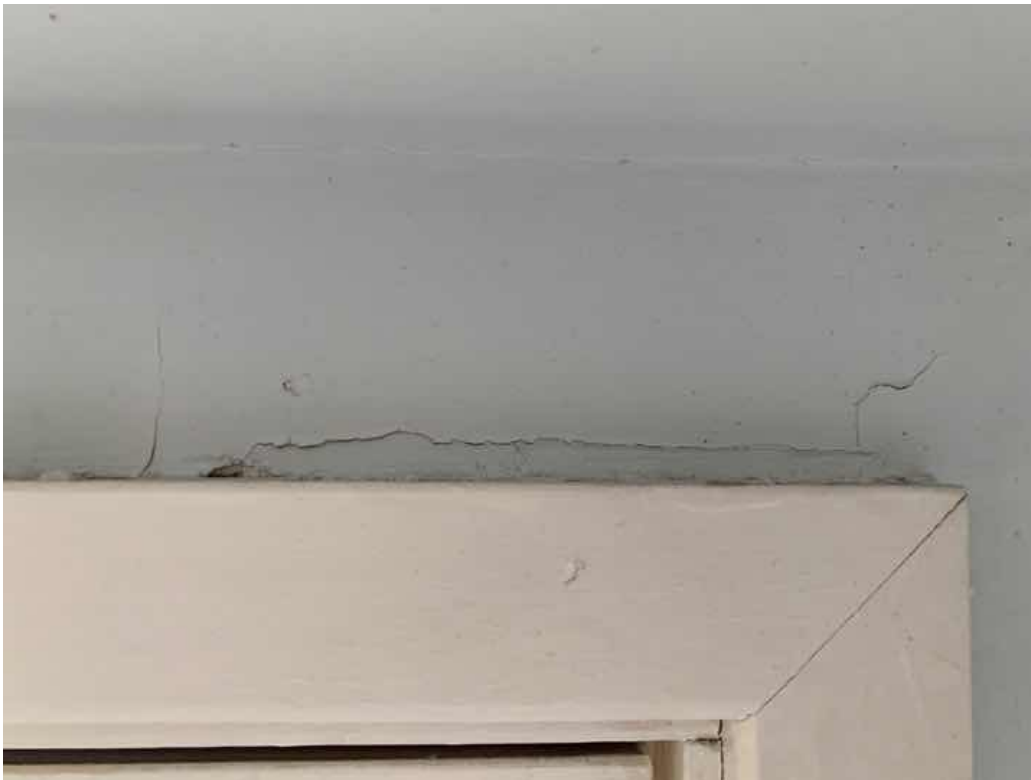
Walls

Settlement Cracks Noted . These are typical and generally patch and paint will suffice, however Monitoring these cracks advised for 12 months and if become wider or longer, you will need to contact a structural engineers to assess.

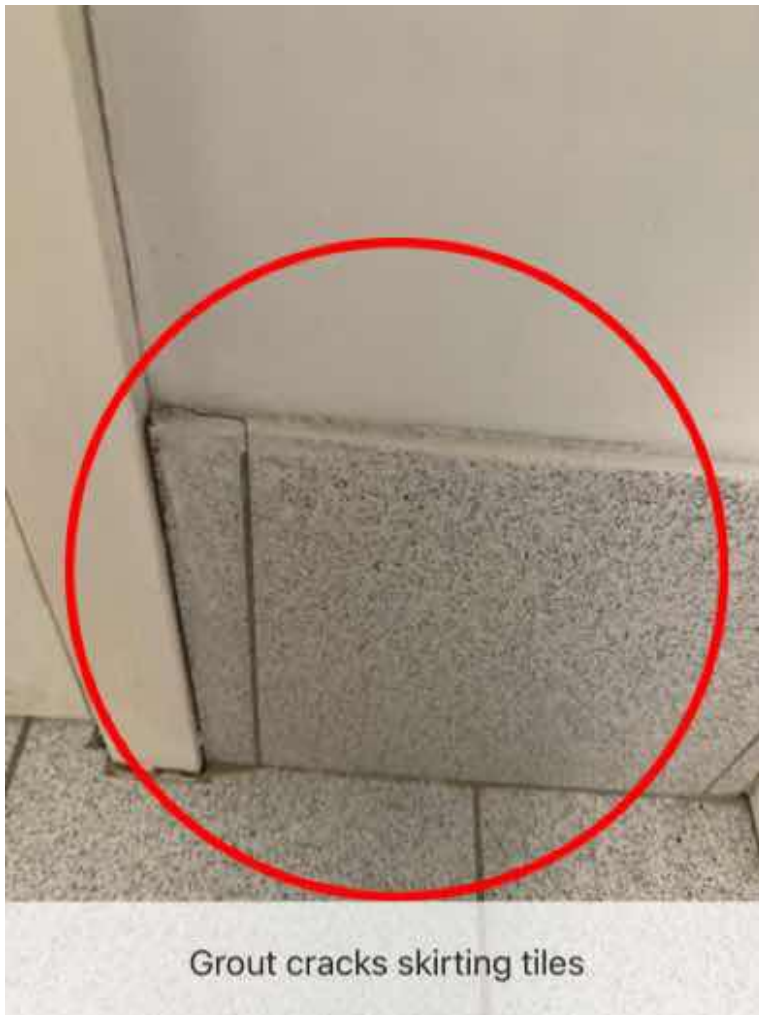
Deteriorated grout noted. This should be repaired as this will lead to water ingress under the tiles causing uplifting and possible water penetration.

Grout cracks skirting tiles

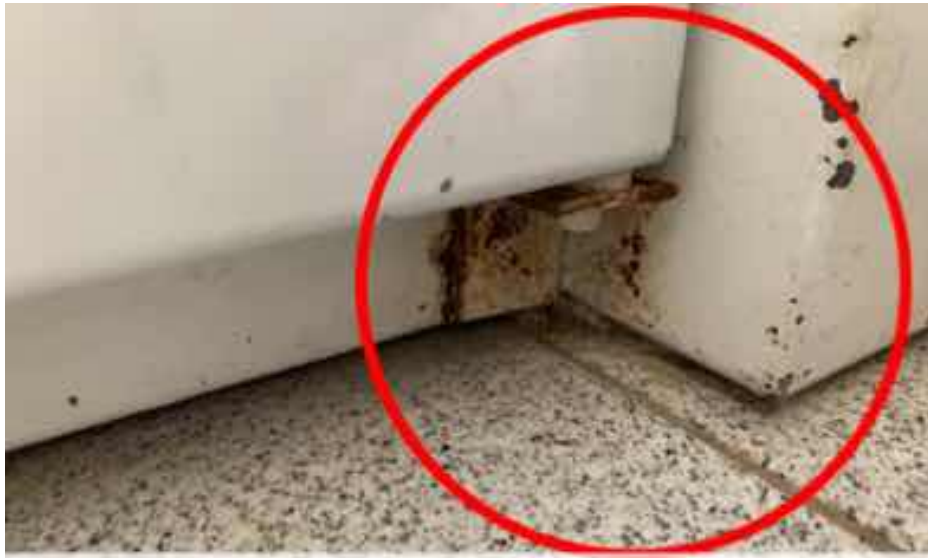
Tub is corroded. Replacement recommended.

Rust to tub

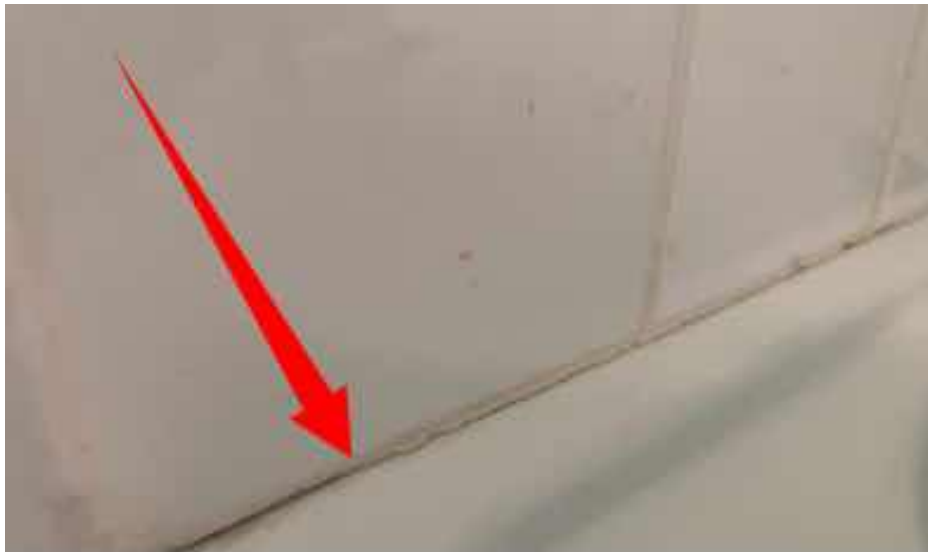
Bench top and splash back junction sealing deteriorated. Re-sealing by a plumber or general maintenance contractor is recommended to prevent water access behind the bench.

Splash back junction sealant

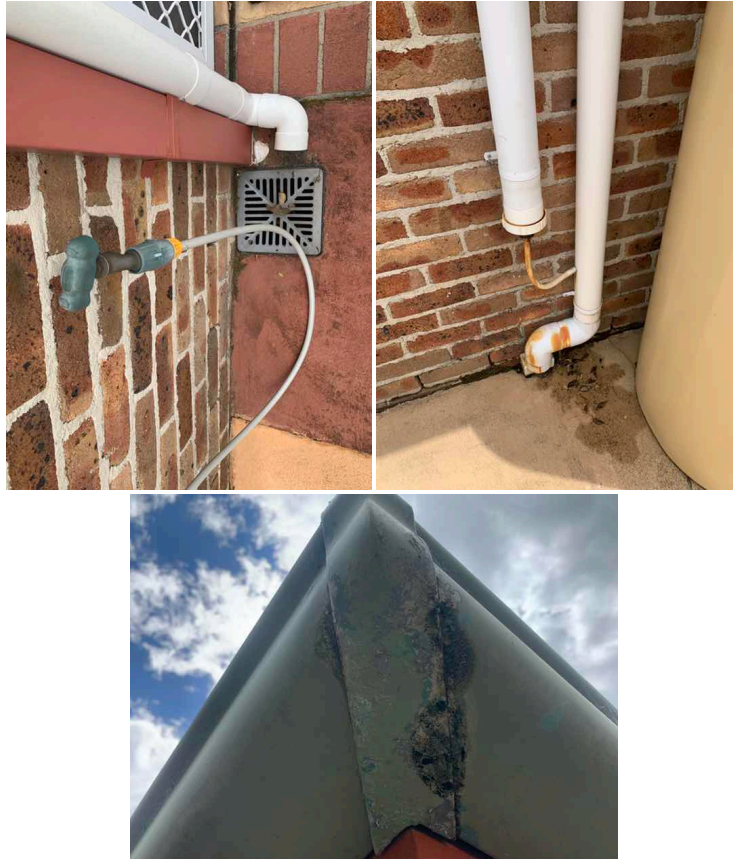
There was water leakage detected during the inspection from the water tank pipe joins. Consult a qualified plumber for a scope of works and cost of repairs for the issue prior to contracts becoming binding.
