# STANDARD RESIDENTIAL BUILDING INSPECTION REPORT

**70 BOUSFIELD STREET, WALLSEND**

**Property Address:** 70 BOUSFIELD STREET  
WALLSEND NSW 2287

**Inspection Date/Time:** 4/06/2018 1:17 PM

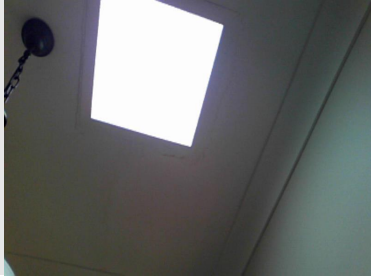
Walls	OK, The item described is performing the function it was designed for and its condition is very typical for it's age
Ceiling	Water damage needs repair and re-finish to restore appearance

BATHROOM/Ceiling - Water damage needs repair and re-finish to restore appearance

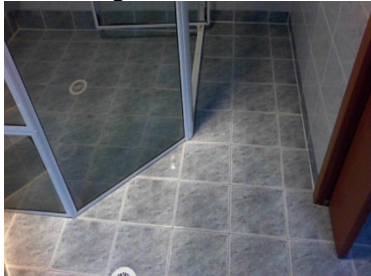
Floors	As tested there was high moisture readings found in areas of bathroom floor

BATHROOM/Floors - As tested there was high moisture readings found in areas of bathroom floor

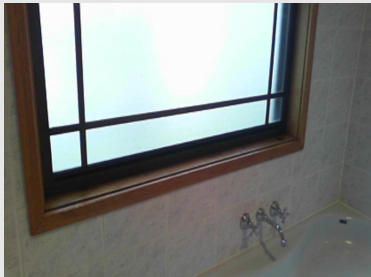
Window/s	Window unable to be opened or tested

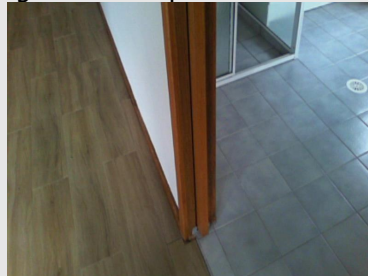
Door Cavity door frame is water damaged needs repairs to ensure integrity

BATHROOM 2/Door - Cavity door frame is water damaged needs repairs to ensure integrity

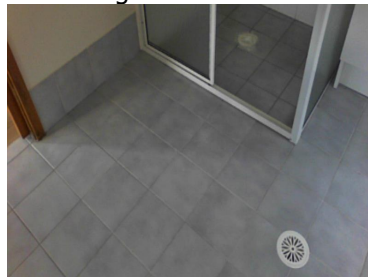
Floors As tested there was high moisture readings found in areas of bathroom floor

BATHROOM 2/Floors - As tested there was high moisture readings found in areas of bathroom floor

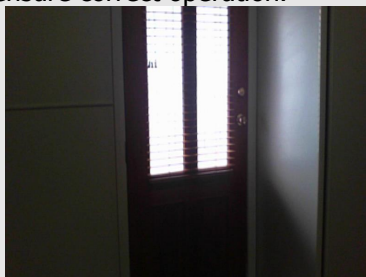
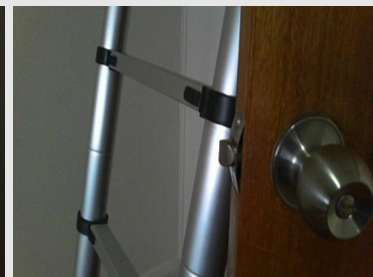
Door	Binding, will need adjusting to ensure correct operation.
------	-----------------------------------------------------------

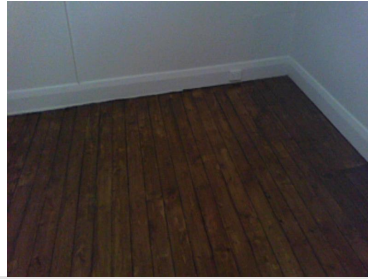
Borer damage was evident to flooring boards refer to a pest inspection report for further details

BEDROOM 4/Floors - Borer damage was evident to flooring boards refer to a pest inspection report for further details

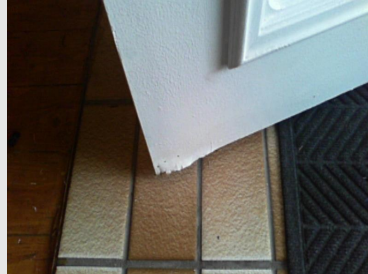
Damaged outside face will need repair to improve appearance, binding noted

ENTRY/Door - Damaged outside face will need repair to improve appearance, binding noted

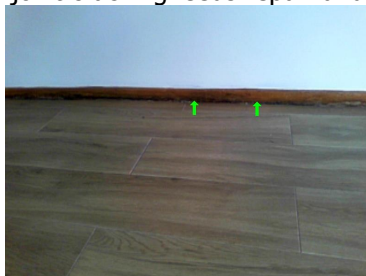
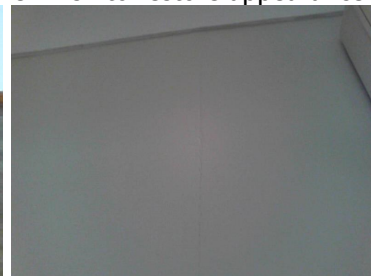
Wood decay damage and minor joint cracking needs repair and re-finish to restore appearance

KITCHEN/Walls - Wood decay damage and minor joint cracking needs repair and re-finish to restore appearance

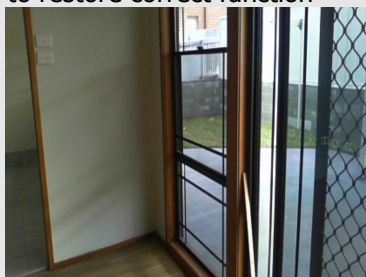
Binding sashes will need easing to restore correct function

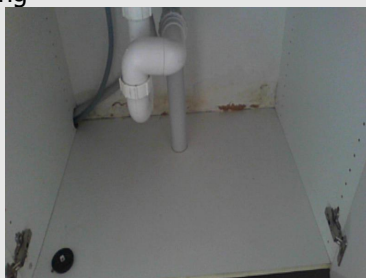
Binding doors and or drawers will need adjusting to restore correct operation, water damaged cabinets need repairs or replacing

KITCHEN/Doors, Drawers & Cabinets - Binding doors and or drawers will need adjusting to restore correct operation, water damaged cabinets need repairs or replacing

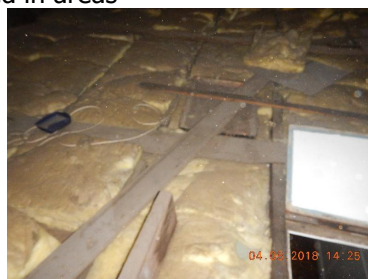
Springy roof framing joists noted in areas

ROOF SPACE/Other - Springy roof framing joists noted in areas

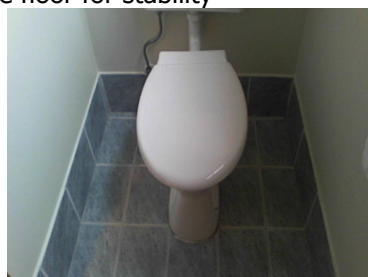
Loose pan needs securing to the floor for stability

WC / TOILET 1/Pan - Loose pan needs securing to the floor for stability

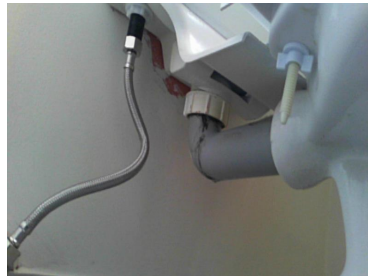
Pan	Loose pan needs securing to the floor for stability
-----	-----------------------------------------------------

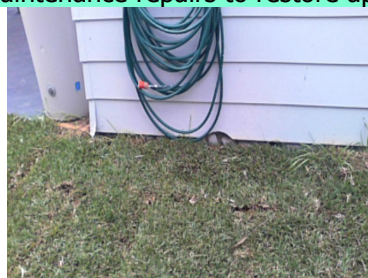
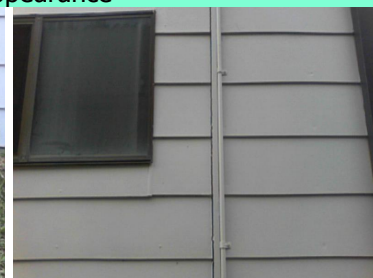
Cladding needs minor typical maintenance repairs to restore appearance

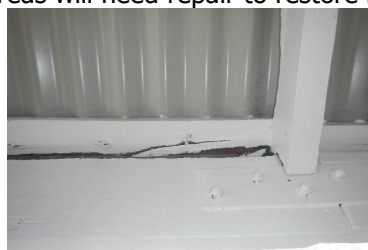
Damp Damage Minor water damage in some areas will need repair to restore integrity and appearance

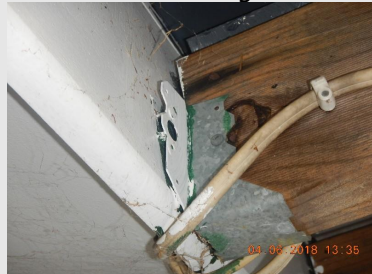
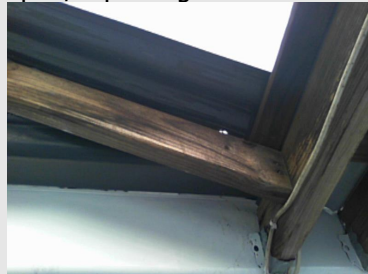
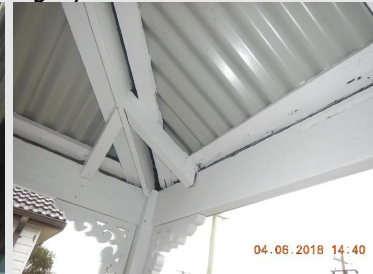
Substandard framing will need repair/improving to ensure it's integrity

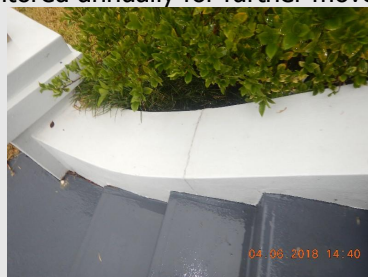
Steps & Stairs Minor cracking and/or separation in the concrete steps, whilst not considered significant we recommend this should be monitored annually for further movement

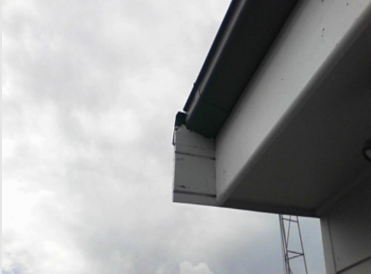
Fascia/Barge boards Timber fascia/barge boards need repair and paint to prevent further damage

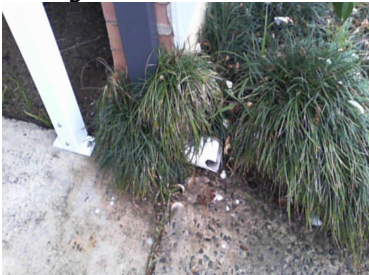
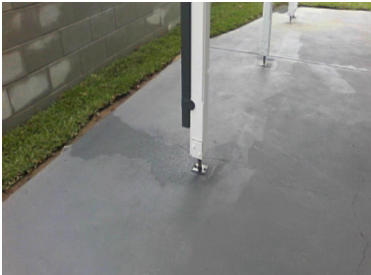
Gutters/Downpipes Downpipes discharge onto ground and will need connecting to stormwater drain to avoid water damage areas

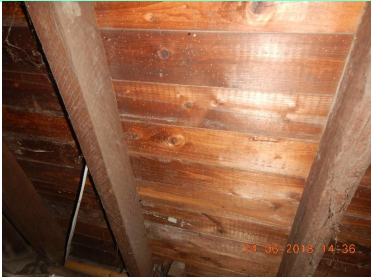
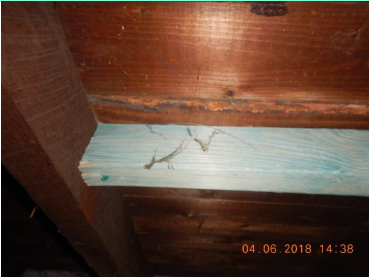
Borer damage noted to flooring boards and/or framing elements refer to a pest report for further details

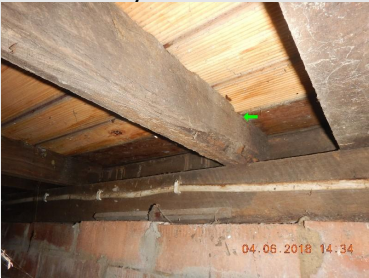
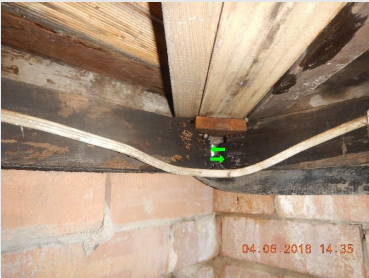
Bearers/Joists	Wood decay to bearers was observed

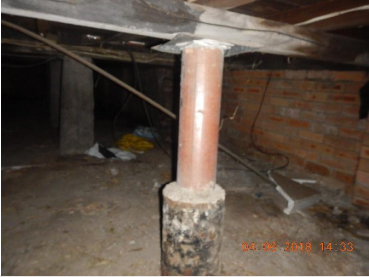
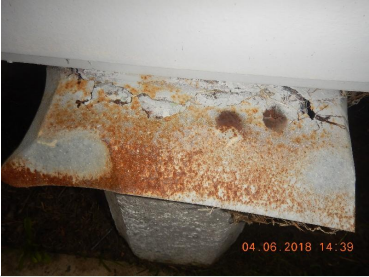
Piers/Stumps	Whilst unconventional compared to modern construction, this is typical for its age and the whole floor framing system will need constant monitoring for decay and movement, ant cappings were rusting and inadequate, fretting noted to some masonry piers
