# Inspection Report

**Millerd Pest Control Pty Limited**

**70 Bousfield Street, Wallsend, NSW, 2287**

Inspection Date:        04 Jun 2018

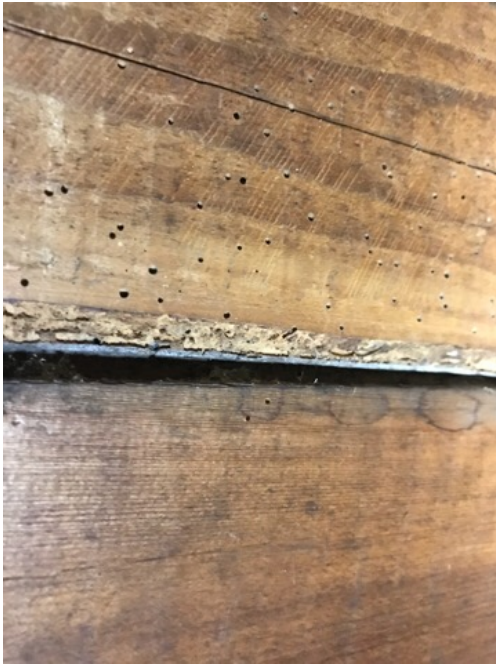
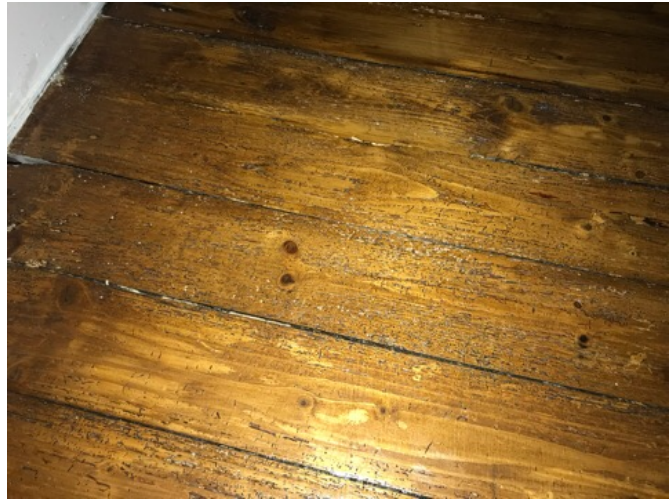
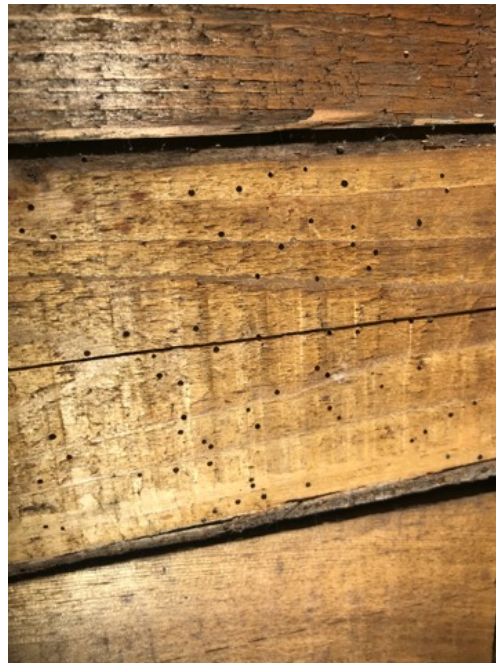
Yes, anobium punctatum was found- commonly known as the furniture beetle.

## **Moderate Damage was Found in -**

Floor boards

Replacement of all susceptible timbers is always preferred since, in the event of selling the property in the future it is probable that an inspector will report the borers as active (see above). A chemical treatment to control and/or protect against furniture beetle and/or queensland pine beetle can be considered as a less effective, lower cost option. Before considering this option you should consult with a builder (see terms & limitations) to determine if the timbers are structurally sound. Following the initial treatment a further inspection is essential in twelve months' time to determine if further treatment is needed. Treatments over a number of consecutive years may be required.

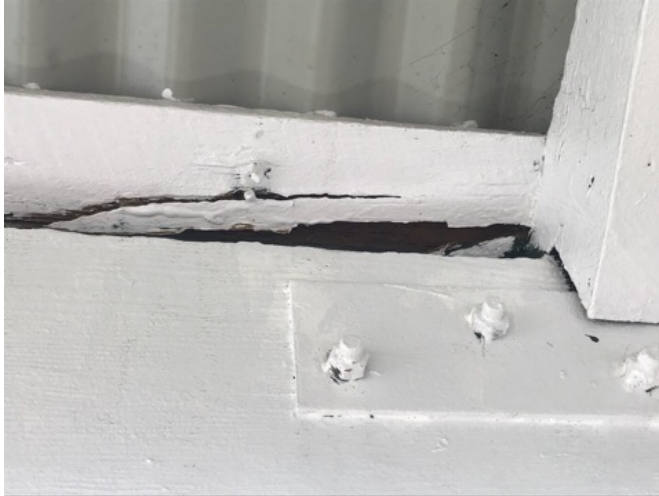
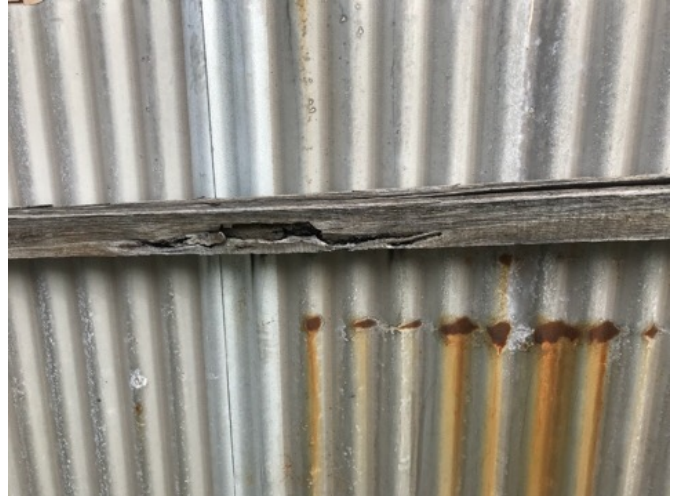
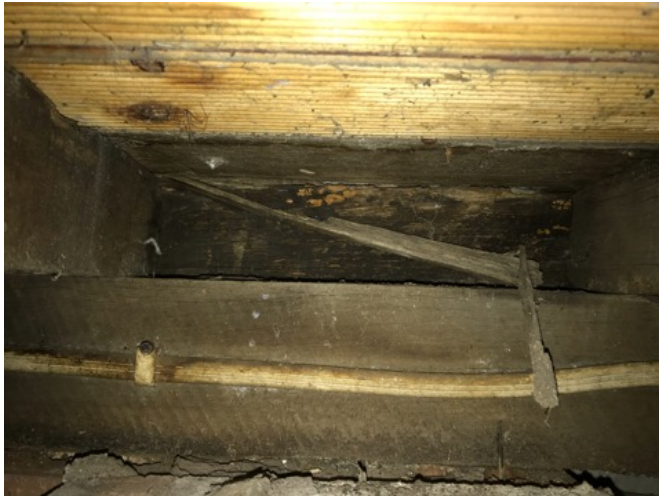
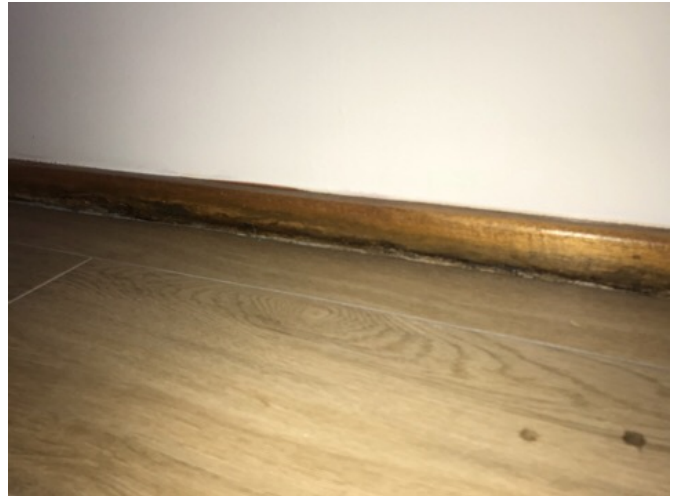
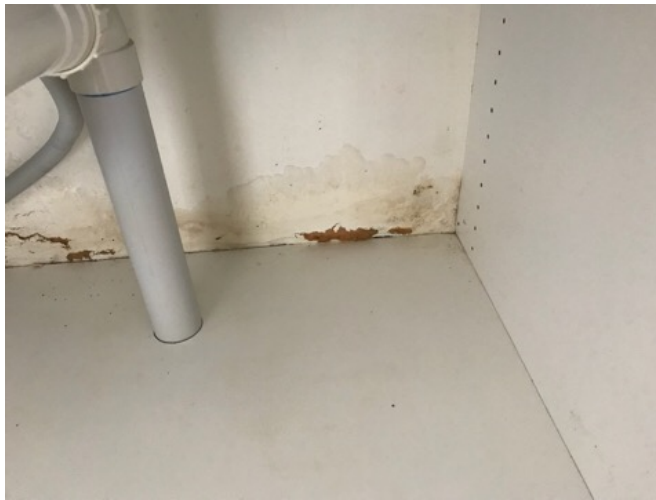
Yes, in the following areas ,  
Fascia and / or Barge board ,  
Timber Fence ,  
Subfloor Timbers ,  
Exterior Wall Clad ,  
Internal timbers  
Verandah timbers

Moderate Damage

If any evidence of fungal decay or damage is reported you should consult a building expert determine the full extent of damage and the estimated cost of repairs or timber replacement (see terms & limitations).

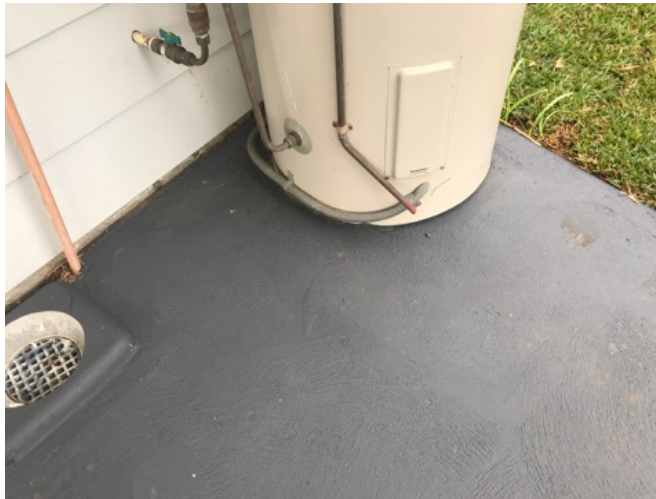
No - Divert hot water overflow away from the building perimeter

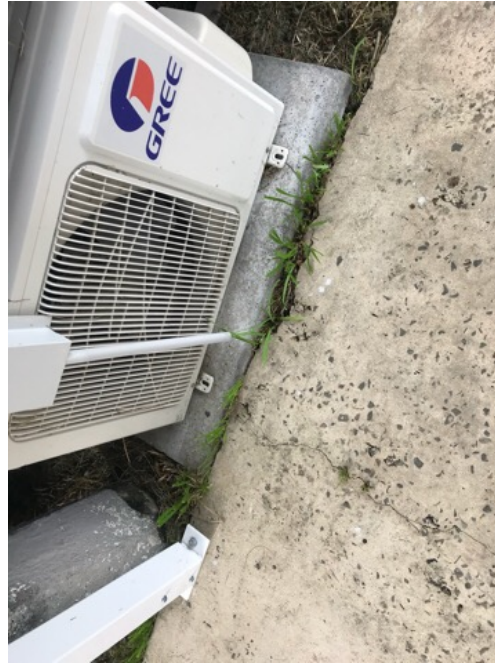
No - Divert A/C overflow away from the building perimeter

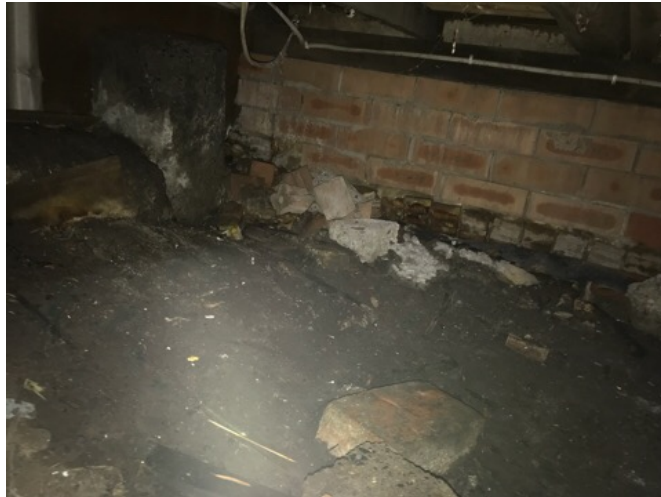
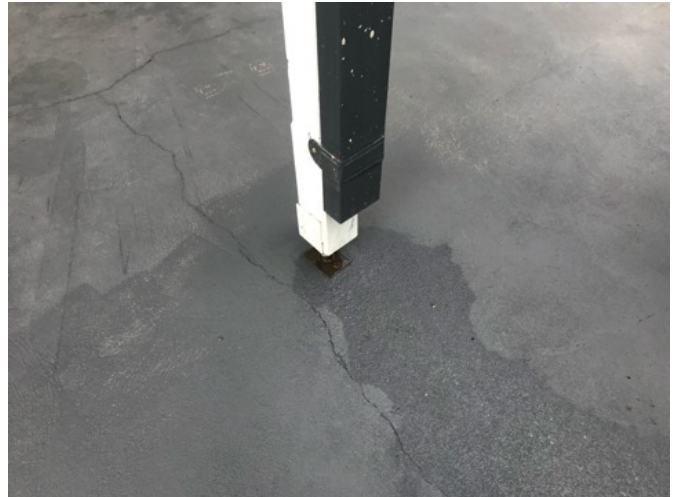
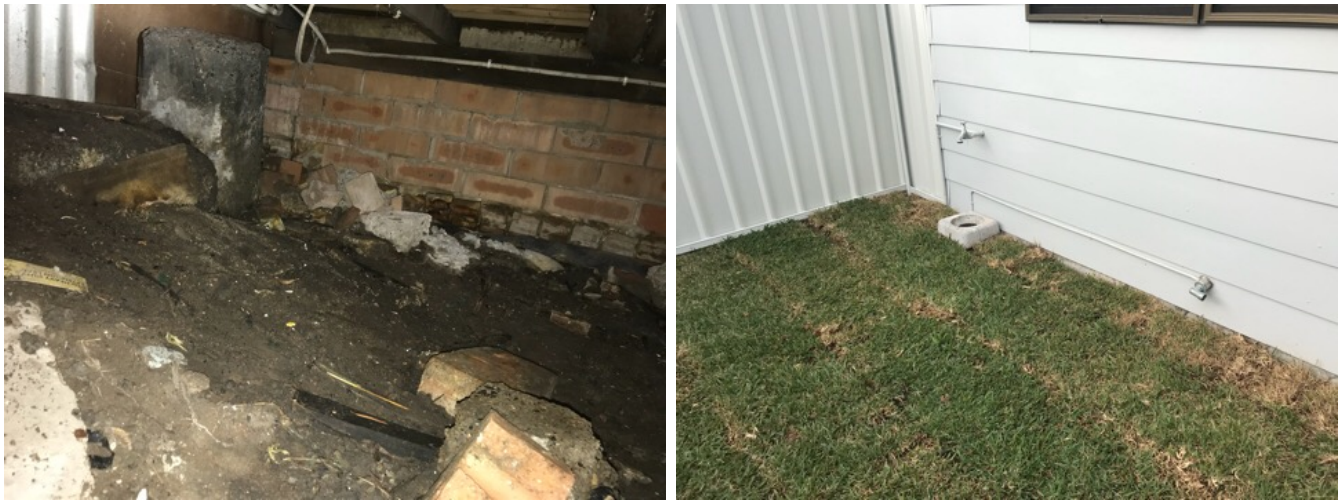
Down pipes not connected to storm water. This causes moisture and excess moisture is conducive to termite infestation. The degree of risk is high. You need to engage a plumber to rectify.

Damp sub floor soil. This provides conducive conditions for termite infestation. The degree of risk is high. Engage plumber to assess and rectify.

Gutter leaking due to rust. This causes moisture and excess moisture is conducive to termite infestation. The degree of risk is moderate to high. You need to engage a plumber to rectify.

Poor drainage - There is water ponding against walls. This provides conducive conditions for termite infestation. The degree of risk is high. Engage plumber to rectify.

External cladding is in contact with ground due finished ground levels high and being built close to ground. This provides conducive and concealed conditions and concealed entry for termite infestation. The degree of risk is high. Ground levels require lowering.
