BPI BUILDING & PEST INSPECTIONS

BPI - INSPECTION REPORT

11 Heron Place, Shellharbour NSW 2529.

BUILDING & TIMBER PEST INSPECTION REPORT TO AS4349.1-2007 & AS4349.3-2010.

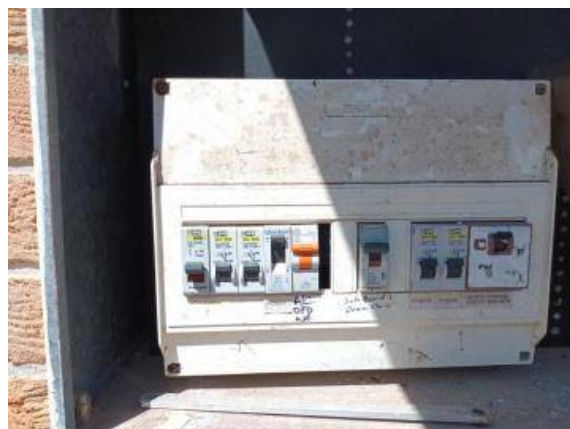
Test button not present to all circuits - Installation is recommended.

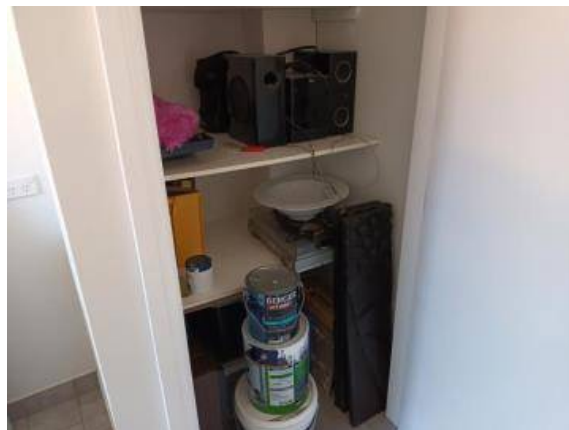
The inspection was restricted due to stored goods being present.
The stored items may be concealing damage. The following area(s) were restricted:-

Various internal areas.

Further inspection of these areas is strongly recommended once access has been obtained and prior to a purchase decision.

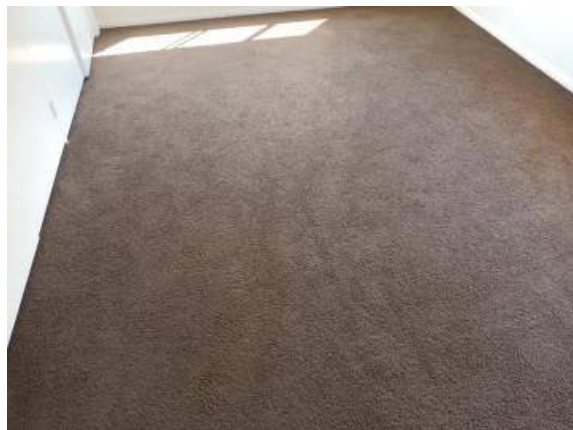
Squeaky flooring to some areas.

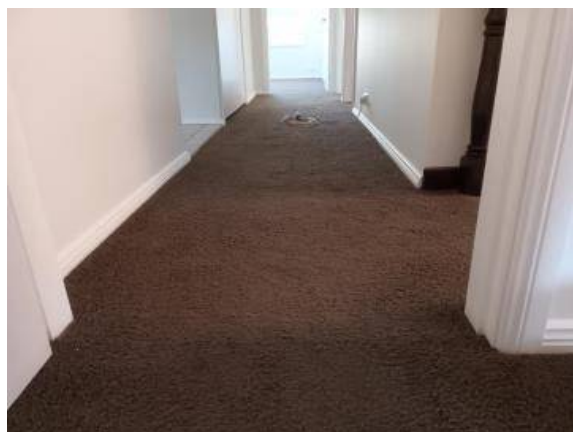
There is evidence of undulations to some flooring consistent with a house of its age & construction.

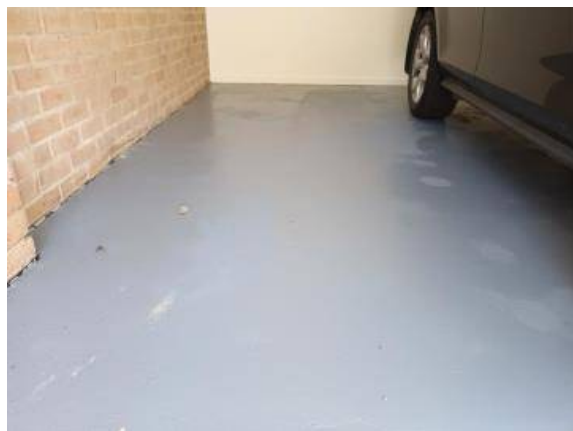
Some minor surface cracks to the garage slab.

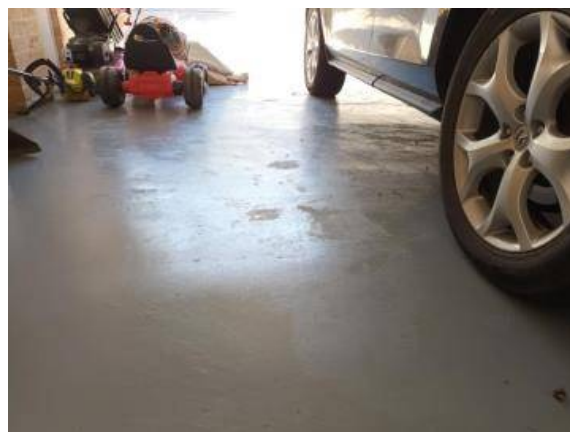
Slight undulations to some slabs.

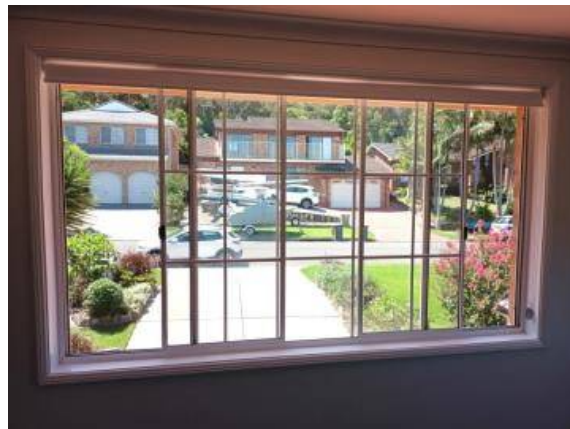
We recommend that all openable Bedroom windows over 2m above the external ground level have safety devices fitted that limit the window opening to a maximum of 125mm or have security grills installed. This is a safety hazard.

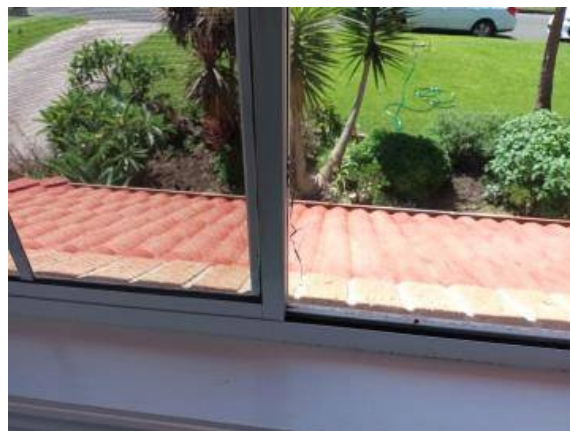
Broken glass to window to bed 3.

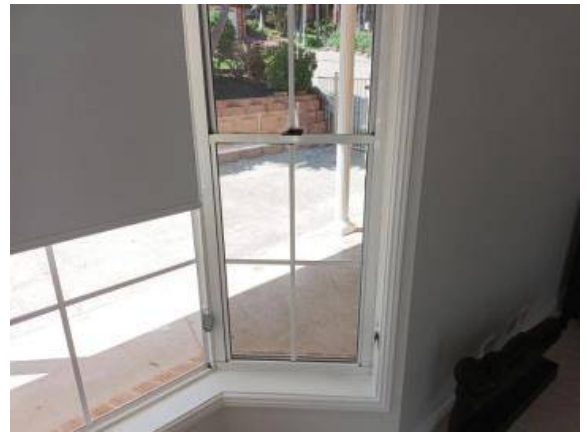
Spiral balances to double hung window to lounge requires repair / replacement.

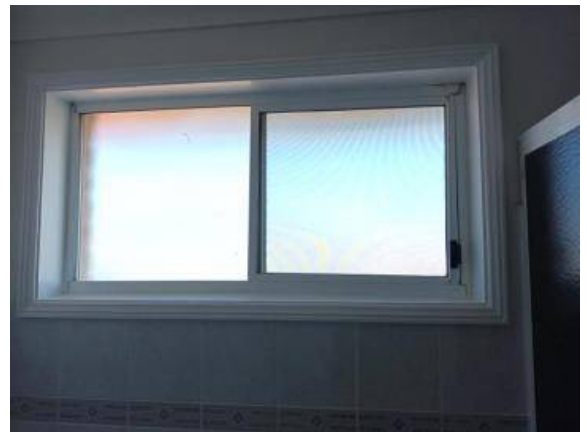
Some hardware requires adjustment / lubrication.

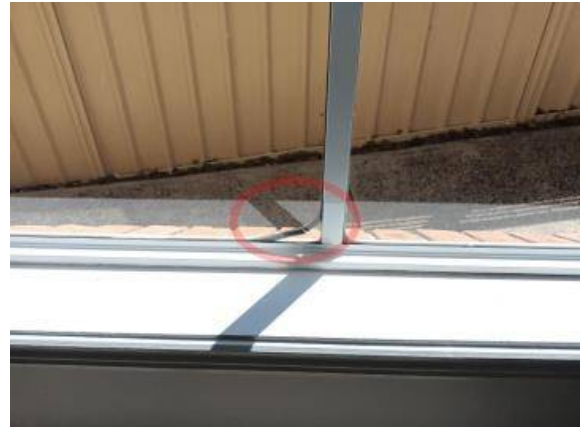
Some window glazing seals have hardened / perished / shrunk and require repair / replacement.

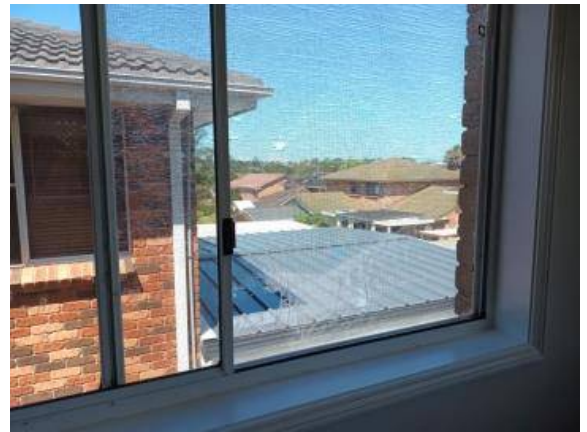
Screen to family room requires repair.

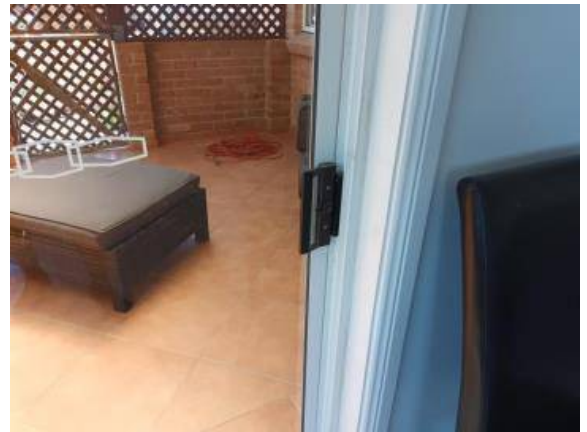
Some door hardware to external sliders requires adjustment / refixing.

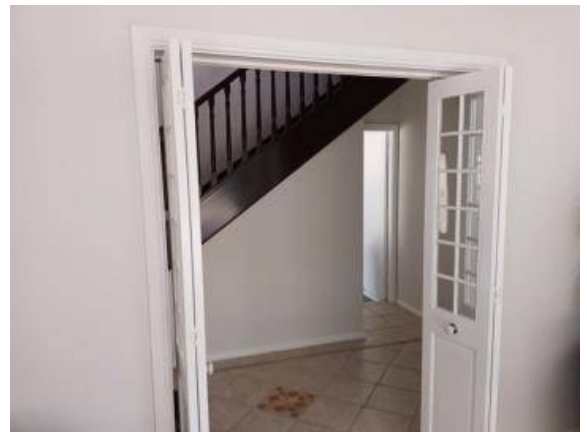
Bi fold door hardware requires adjustment.

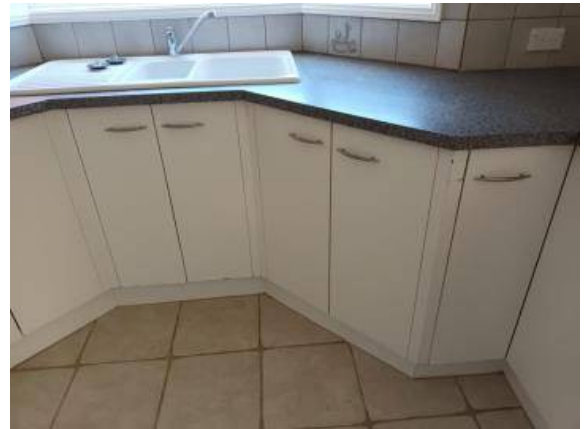
The Kitchen cabinetry / bench tops / laminate show evidence of general wear / surface damage & scratches.

Some edge stripping laminate is damaged / peeling.

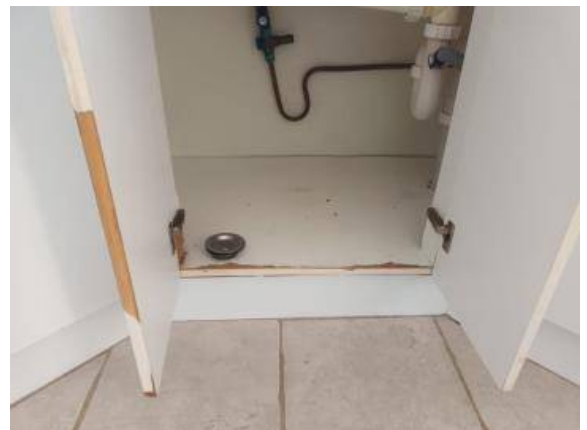
Evidence of past water penetration to sink cupboard.

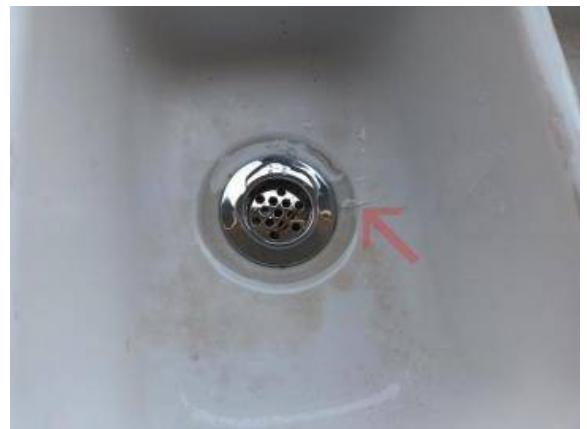
Small crack to kitchen sink.

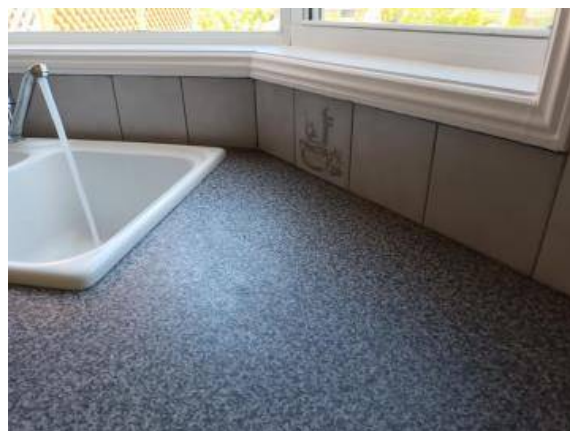
Junctions of bench tops and splashback tiles require resealing with silicone.

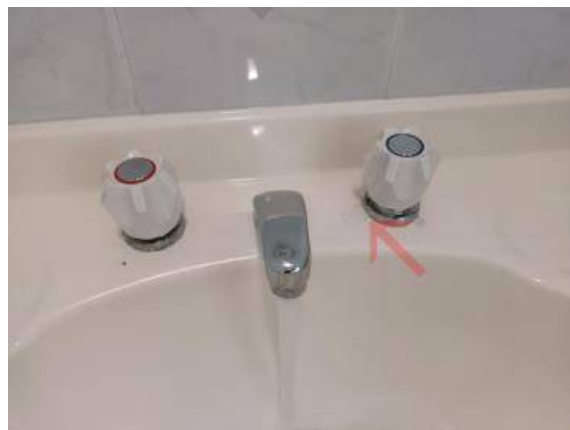
Bathroom vanity cold tap requires maintenance / a new washer.

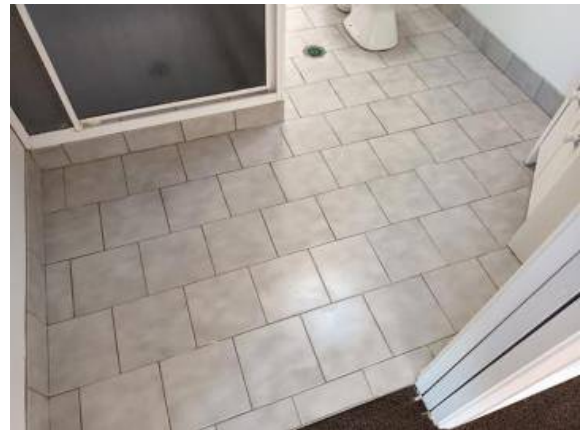
Drummy floor tiles present to various areas. Floor tiles become drummy due to the loss of adhesion to the underside of the tiles and may become loose or cracked. I recommend that a qualified tiler be engaged for further inspection / advice.

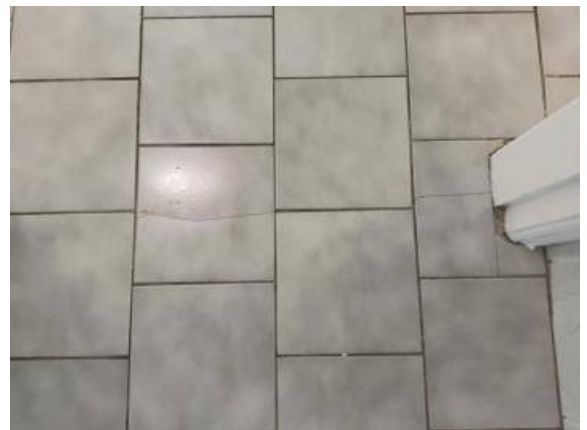
Hairline cracks to some floor tiles.

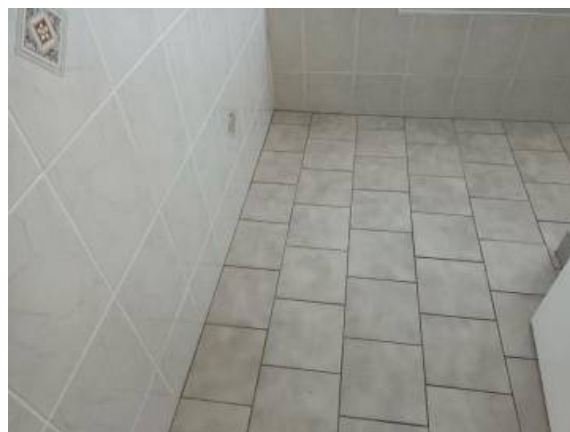
I recommend all wet area floor tile / skirting tile / wall tile joins be sealed with silicone.

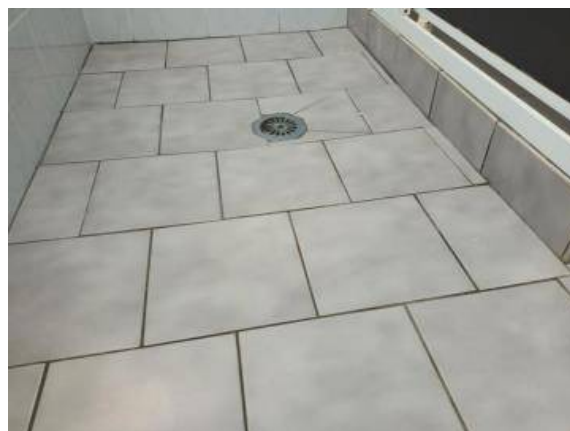
There was no evident grade / fall noted to the Wet Area flooring towards the floor waste(s). This is compliant with the NCC standards.

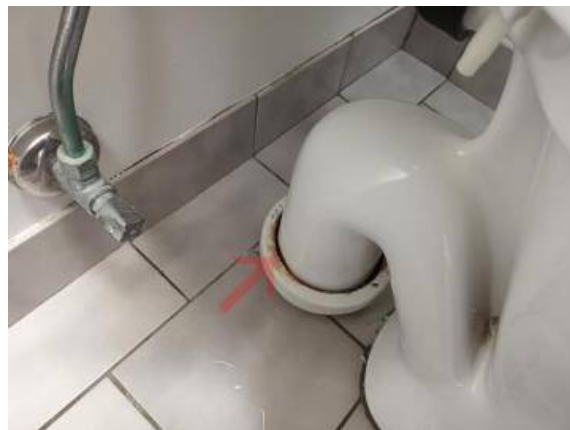
Flushpipe rubber is leaking and requires repair / refixing.

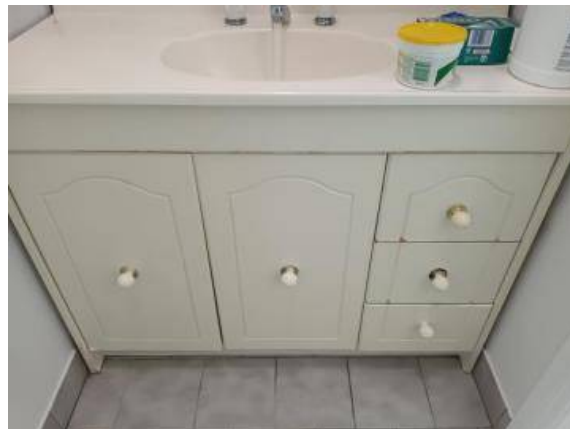
Surface wear, small chips & scratches to some laminate to Bathroom & Ensuite vanities.

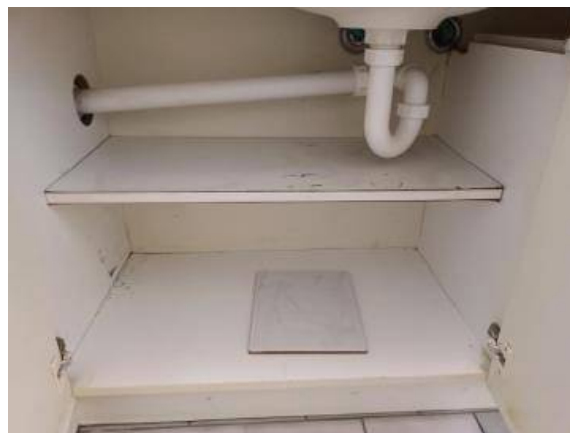
Signs of past water damage to Bathroom vanity cabinet.

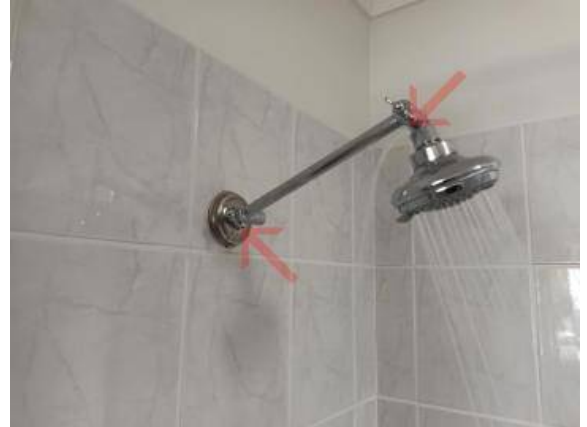
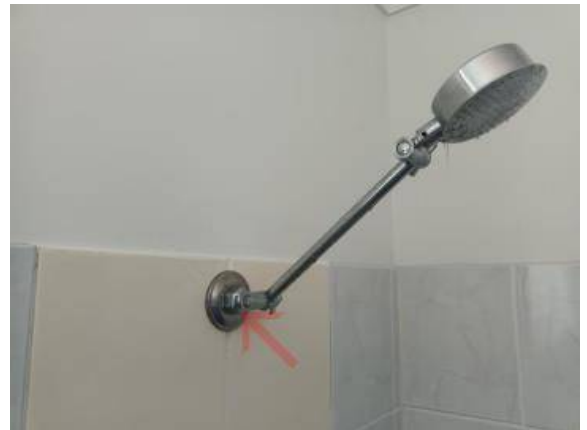
There is evidence of a water leaks to the Ensuite & bathroom shower rose & head. I recommend that a plumber be engaged to inspect the taps / washers, conduct a compression check on the combination / pipes and inspect the wetseal and sealant.

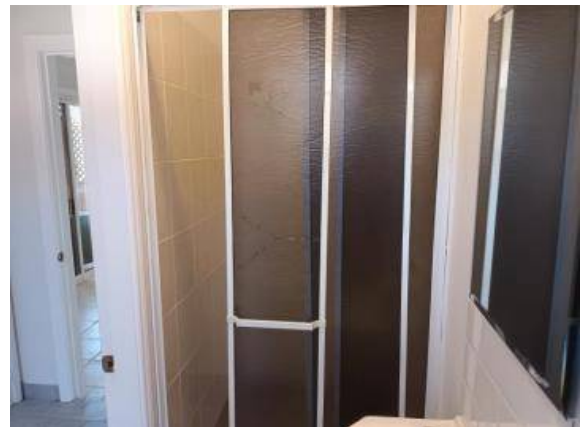
Bathroom / laundry shower screen door is binding on the frame and requires adjustment / refixing.

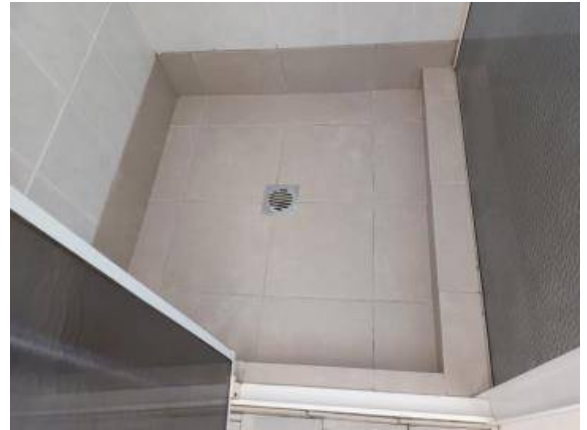
Junctions of Ensuite & Bathroom shower floor / wall tile joins
require resealing with silicone.

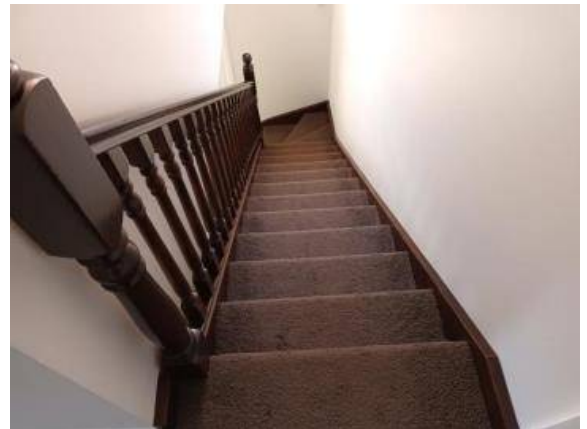
Tread and Risers - Size & Condition
Some stair treads squeak / creak.

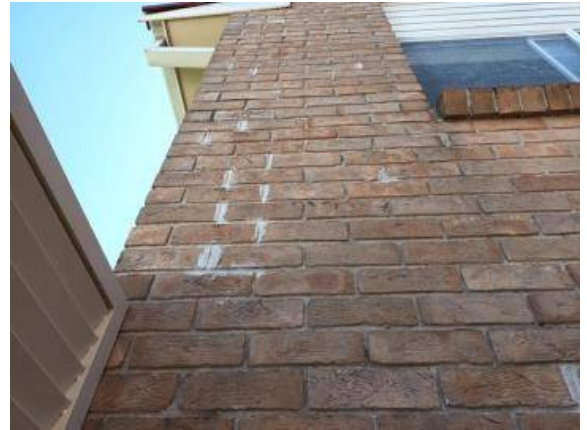
Some mortar joints have been filled / repaired.

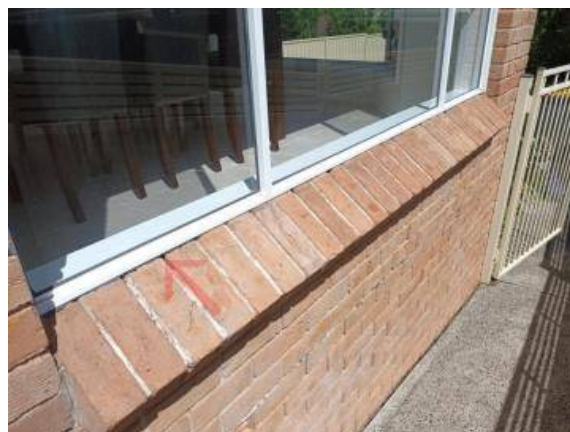
Some window frame / brickwork joins require resealing with a suitable sealant.

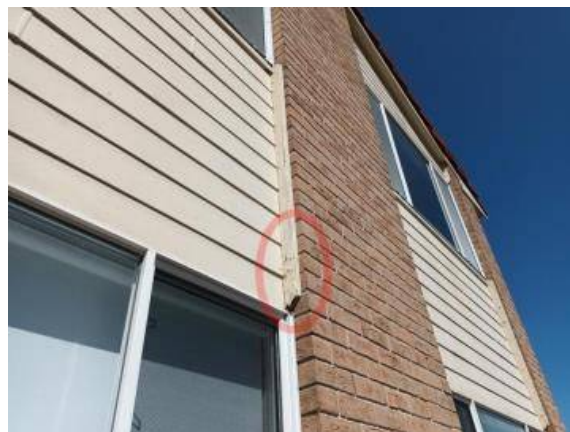
Some timber cover strips show signs of weather damage and require repair / sealing.

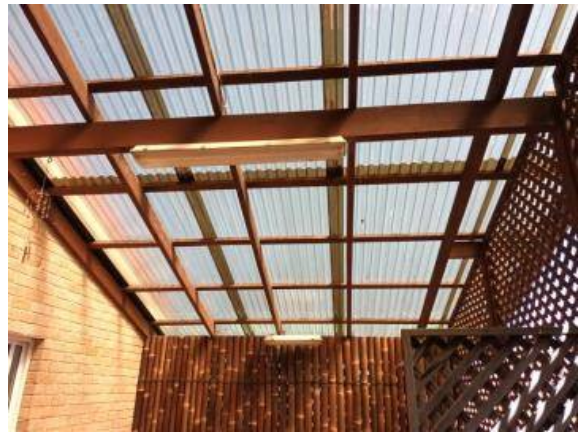
Some verandah framing timbers show signs of weather damage / decay and require repair / resealing.

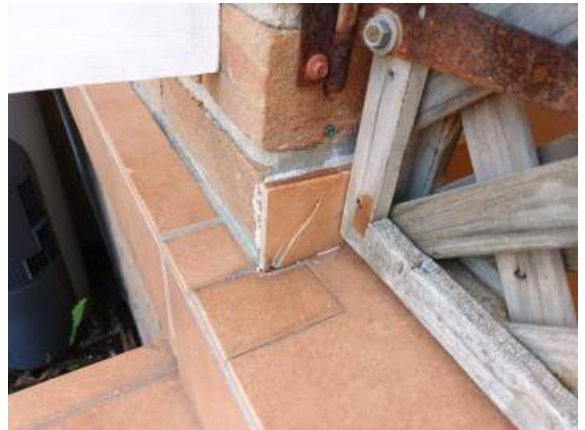
Cracks to some patio / stair tiles.

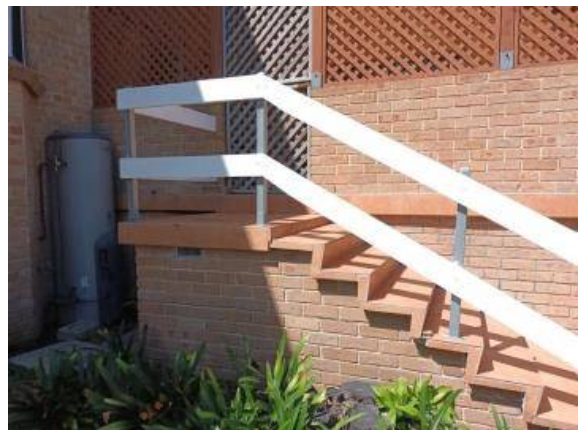
The handrail & balustrades do not comply with current BCA standards however, they may comply with the date of construction. Although this report does not generally comment on items of compliance, this issue may become a safety issue / fall hazard and therefore was included in this report. We recommend you further investigate this matter and upgrade if / where necessary.

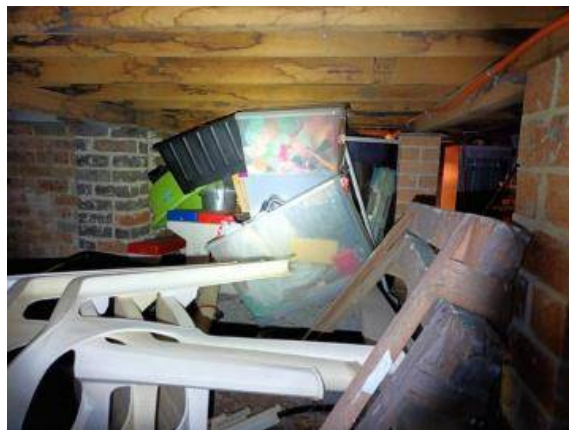
Stored goods are present in this area and restricted inspection.

Further inspection of these areas is strongly recommended once access has been obtained.

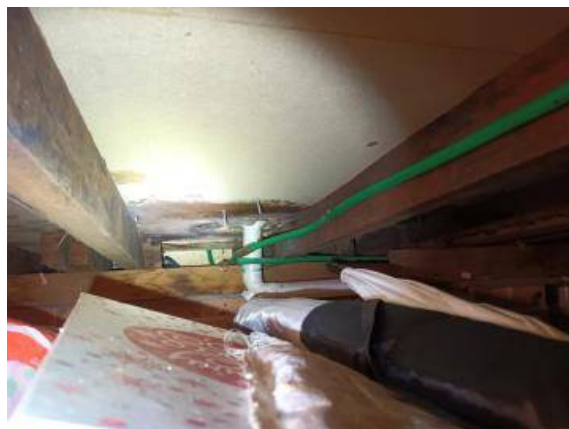
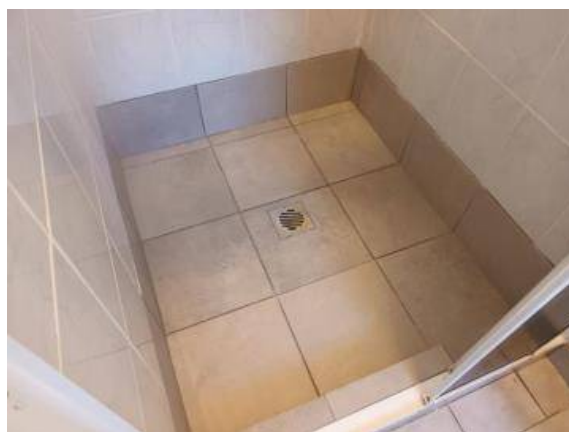
Some flooring shows signs of past water damage to Laundry bathroom shower.

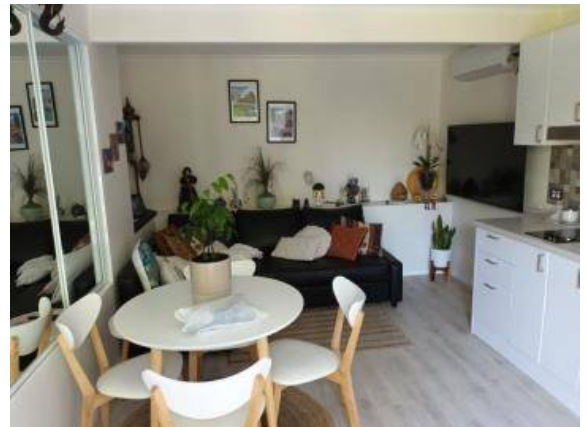
The inspection was restricted due to stored goods being present. The stored items may be concealing damage.

The inspection of the interior was restricted by furnishings that were not moved. The furnishings may be concealing damage.

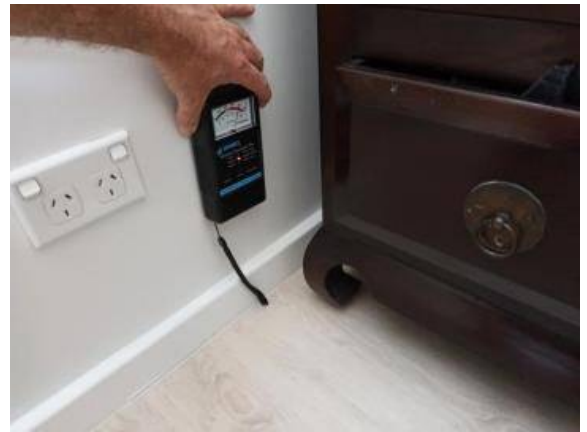
Signs of high moisture levels in wall at rear of shower and in walls to exterior.

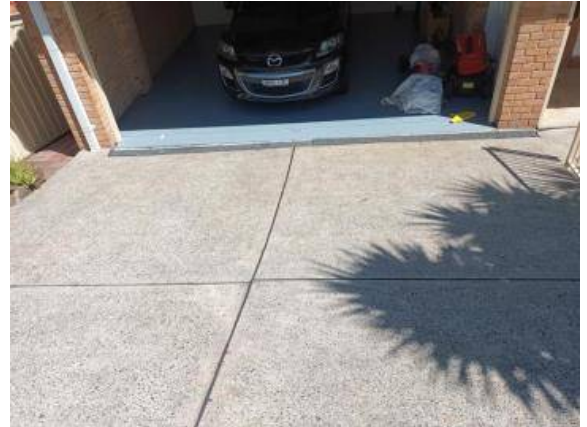
The garage is at the base of a sloping driveway. This may allow water to penetrate the Garage during wet weather conditions. I recommend a qualified plumber / drainer be engaged for further inspection.

The property is constructed on a sloping site and may / will be subject to surface water runoff. It is recommended you engage a qualified plumber / drainer for further inspection to inspect the surface water runoff / drainage & any drainage systems to ensure that they are functional and adequate for the situation. The installation of drains / additional drains may be required.

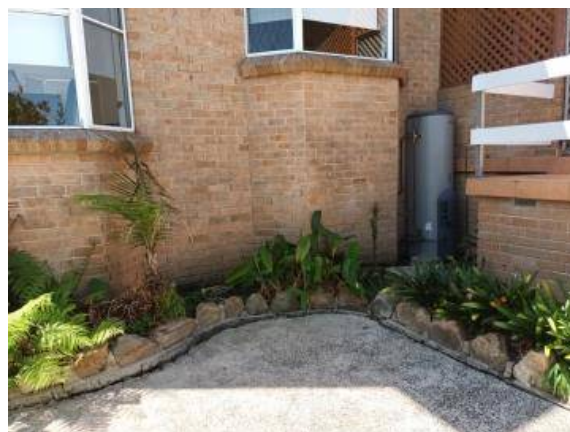
- Some taps adjacent to the building(s) were not located above a drain or concrete pad. Water discharging on to the soil adjacent to the structure is highly conducive to termite attack. You should have a plumber install drains to all such taps or place a concrete pad beneath the tap so that water is dispersed.

- Some fencing is fixed to the external walls may allow concealed termite entry / activity. I recommend the connected fence be modified so that a visual barrier is present or have a chemical barrier installed to prevent concealed entry.

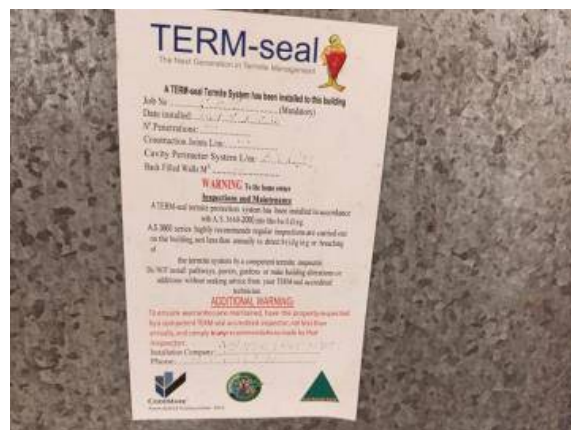
A termite barrier / treatment notice in the Meter Box / Kitchen Cupboard indicates that the perimeters are protected from termite activity by Termseal barriers. We strongly recommend you obtain all barrier paperwork & warranty information. These barriers were installed in August 2016.
