Pre-Purchase Inspection - Residential Building Report

1185 Packham Dr Molong

Re: 1185 Packham Dr Molong NSW 2866

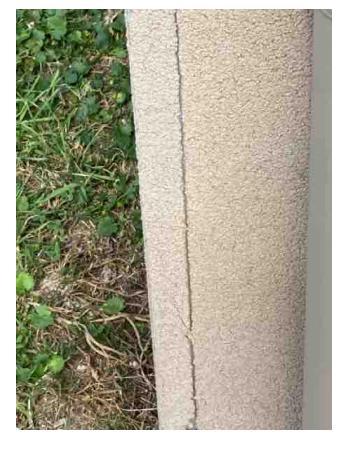
The cracking cladding on the external corner.

The cladding on the exterior of the property is cracking on the joins.

Further deterioration.

Building Professional Required: Renderer.

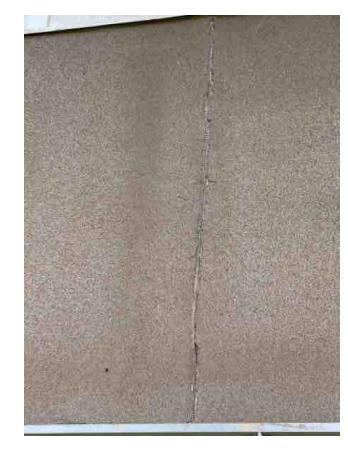
Vertical cracking on the sheet join.

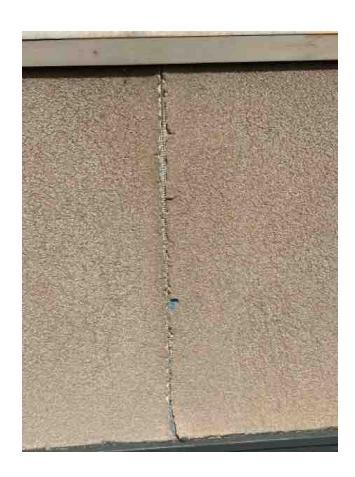
Vertical cracking on the sheet join

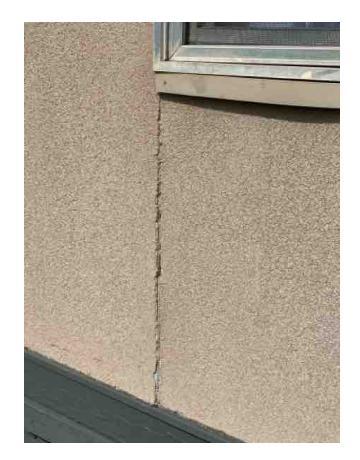
Vertical cracking on the sheet join.

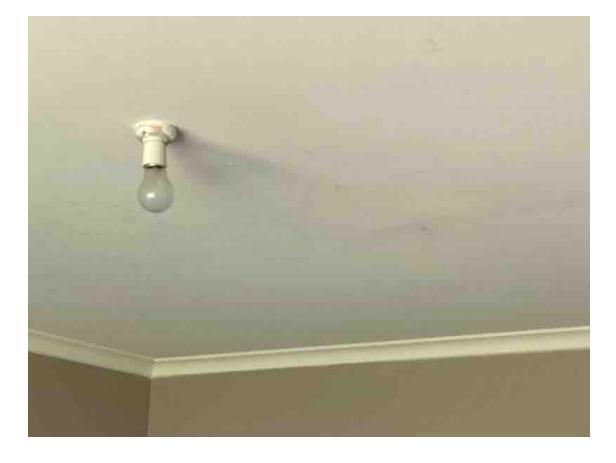
Bedroom 4

The nails are popping in the ceiling sheets.

Further deterioration and popping.

There are popping nails that need to be repaired.

Building Professional Required: Plasterer, Painter

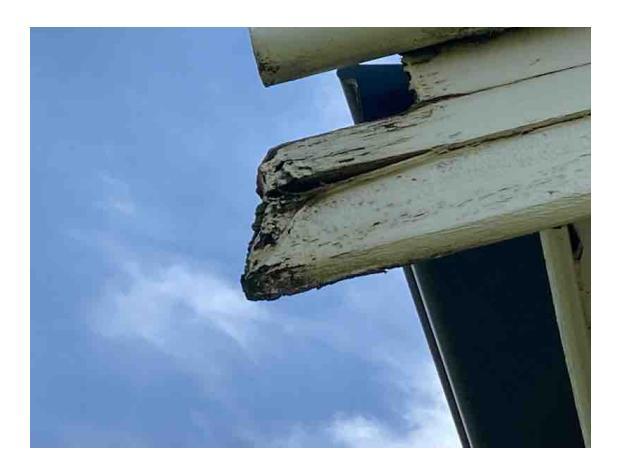
| Defect Location: | Various Areas |
|---|--|
| Description: | Barge boards has decayed The eave sheeting has dislodged from the fascia and the paintwork has deteriorated. |

The damaged barge board.

| Defect Location: | Various Areas |
|---|--|
| | Building Professional Required: Carpenter, Painter |

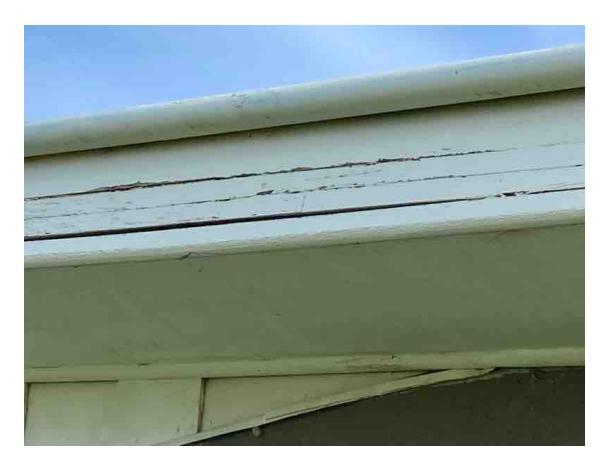
The barge board has deteriorated

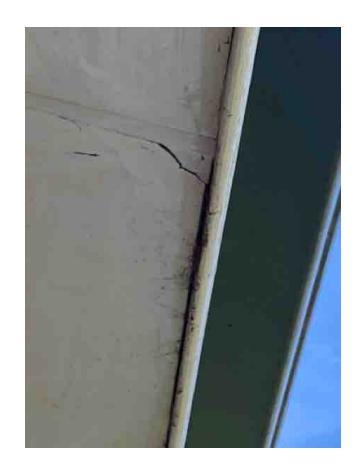
The fibro eave lining has dislodged from the fascia.

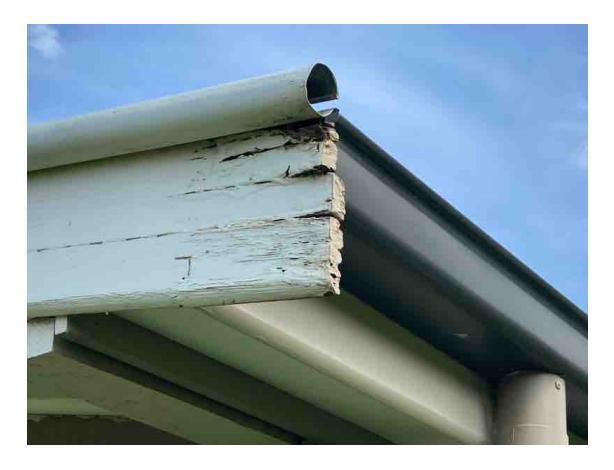
The damaged barge board.

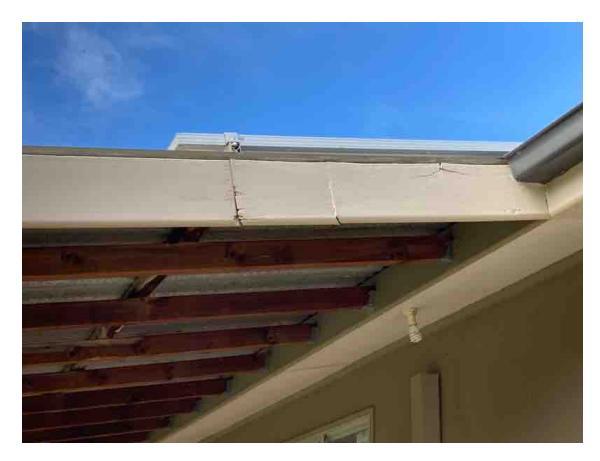
The barge board has deteriorated and there is no barge roof capping installed.

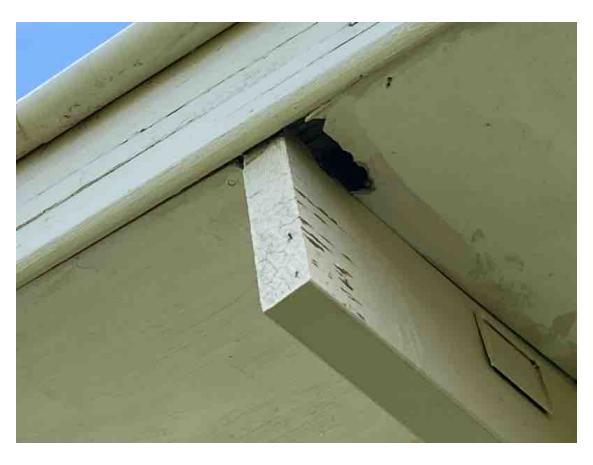
The eave lining is damaged and the timber support beam paintwork has deteriorated.

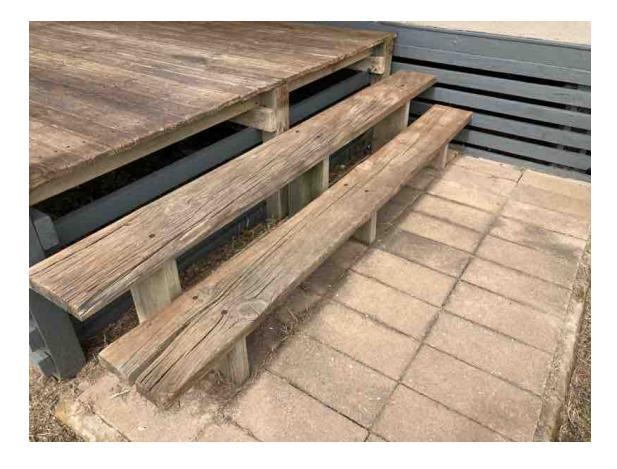
The stairs on the front deck do not comply.

Personal injury, Tripping hazard

The steps do not comply to the current Australian Standards.

Building Professional Required: Carpenter

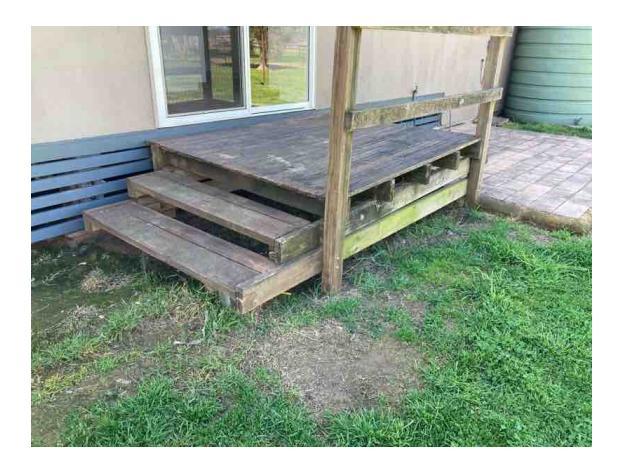
The rear steps do not comply and the deck has deteriorated and needs maintenance.

The rear deck needs maintenance.

Building Professional Required: Carpenter

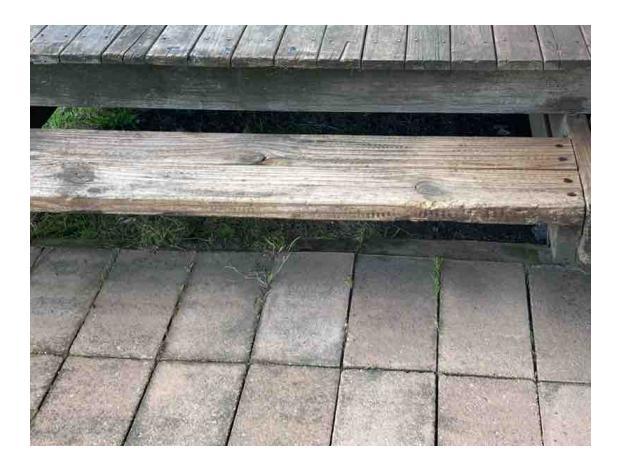
The steps do not comply to current Australian Standards and are a safety issue.

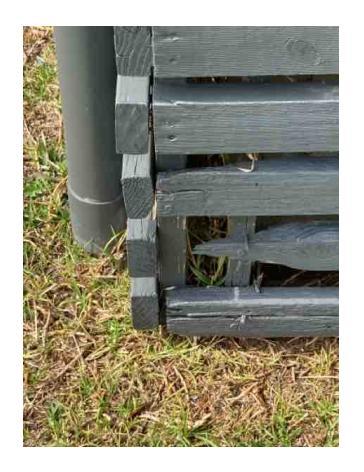
The timber has deteriorated.

The damaged timber railing.

Building Professional Required: Carpenter, Painter

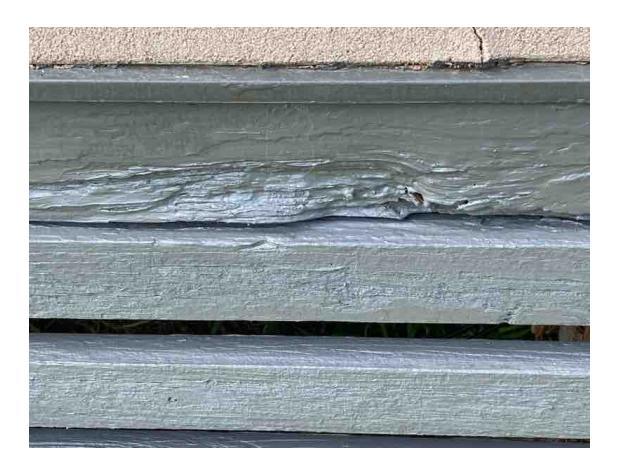
Water damaged timber trimming above the railing.

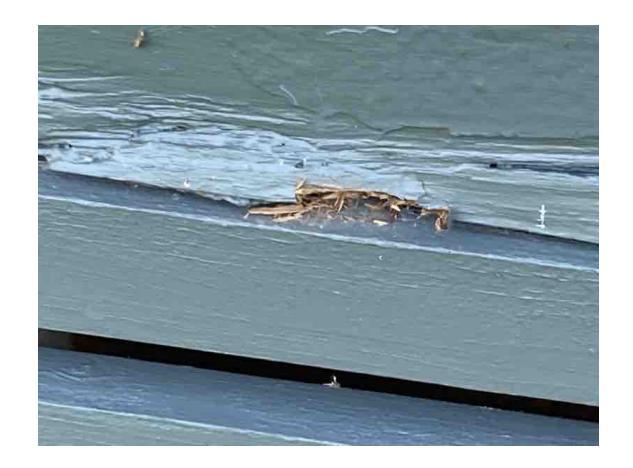
Water damaged timber trimming above the railing.

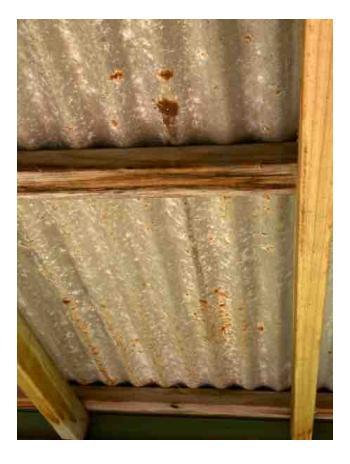
Metal roofing has rusted

Water ingress to Roof Void

The roof sheeting on the front verandah is showing rust deterioration.

Building Professional Required: Roof Plumber

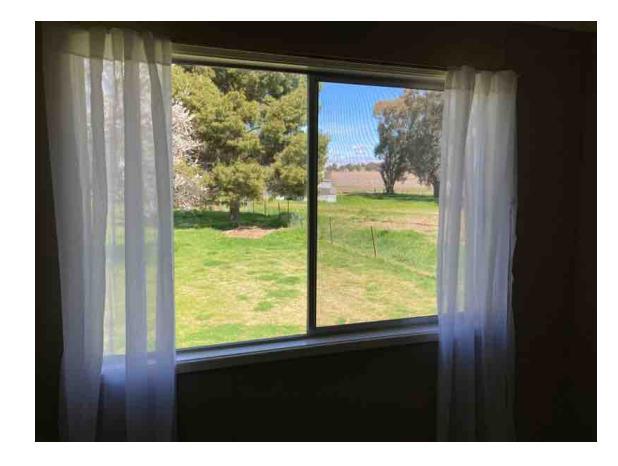
Defect Location: Bedroom 4 Metal Windows and Doors - Sash/Door Defect Summary: Operation Type of Defect: Operational Description: The rollers are damaged Ongoing Consequence: damage to the sash/door Opinion of Cracking: Not Applicable **Building Professional:** Note: This defect should be referred to a qualified building professional for the

The window running wheels have deteriorated and need replacing/adjusting.

Building Professional Required: Glazier

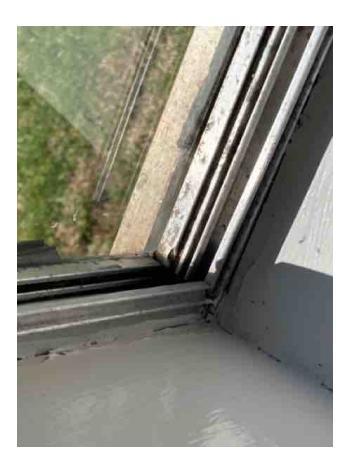
The glazing seals have perished

The glazing seals in various areas of the property need replacing as they are perished.

Building Professional Required: Glazier

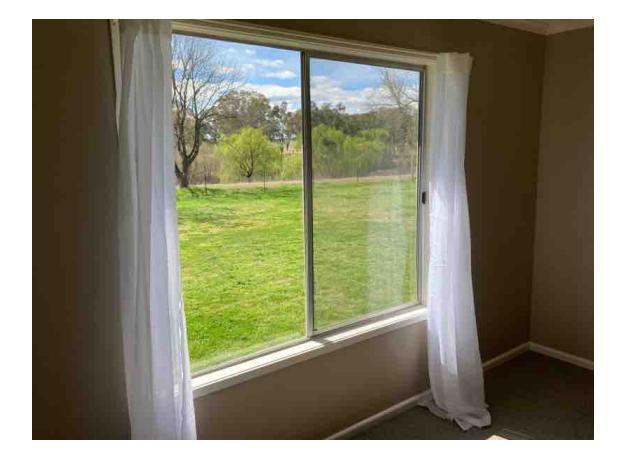
| Defect Location: | Bedroom 3 |

| Defect Location: | Bedroom 3 |
|---|---|
| Description: | The rollers are damaged |

The running wheels need replacing/adjusting.

| Defect Location: | Bedroom 3 |
|---|---|
| | Building Professional Required: Glazier |

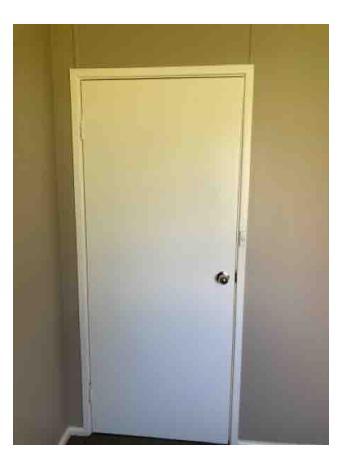
The door is binding.

The door needs easing.

Building Professional Required: Carpenter

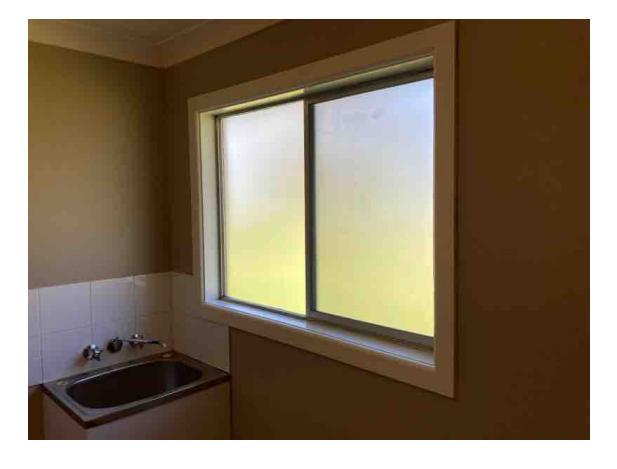
Laundry

The door lock/s have broken or are missing

The window locking system is missing.

Building Professional Required: Glazier

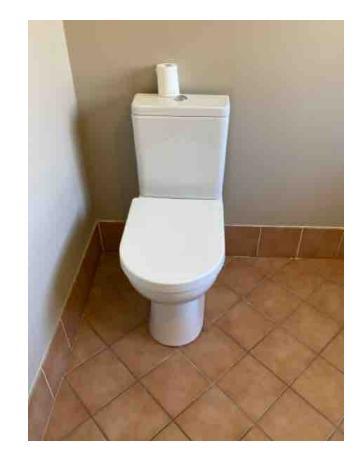
Laundry

The pan is not secured adequately to the floor

The toilet cistern needs to be re-attached to the floor.

Building Professional Required: Plumber

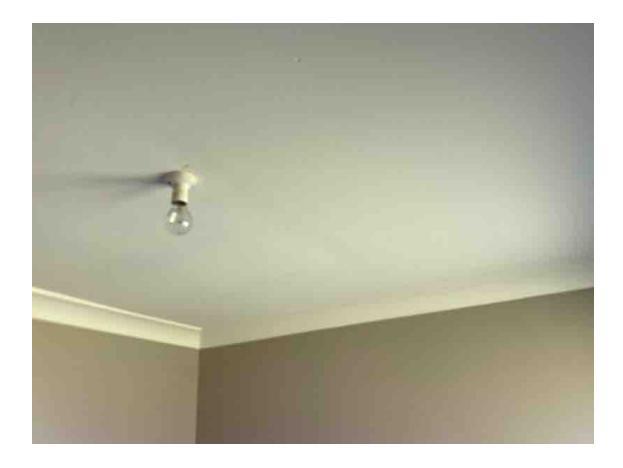
| Defect Location: | Laundry |

| Defect Location: | Laundry |
|---|---|
| Description: | There are popping nails in the ceiling. |

The ceiling nail popping needs repair.

Building Professional Required: Plasterer, Painter

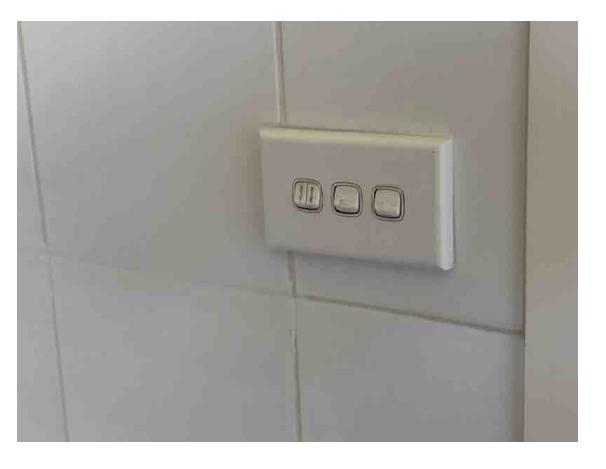
The fan and light switch need tightening.

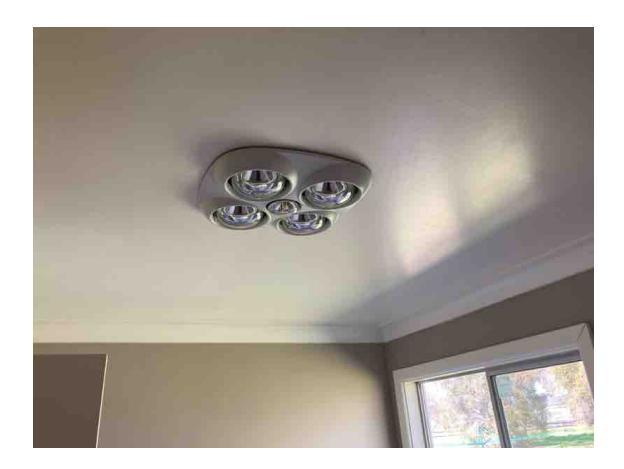
Bathroom 1

The exhaust fan is not operating and the fan switch is loose and needs tightening.

The exhaust fan is not operating.

Building Professional Required: Electrician

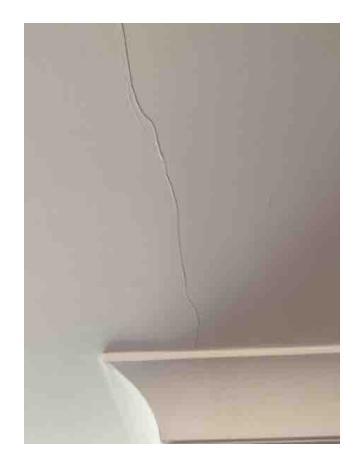
Hallway

Cracking

The cracked ceiling sheet.

Building Professional Required: Plasterer, Painter

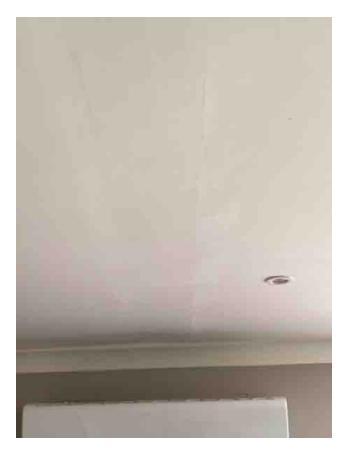
The ceiling plaster joint is cracking and there are popping nails.

The damaged plaster joint needs re-setting and the popped nails need repairing.

Building Professional Required: Plasterer, Painter

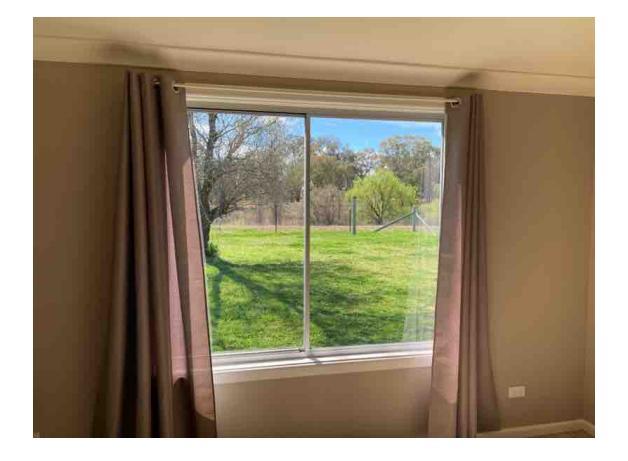
The door lock/s have broken or are missing

The window has no locking system.

Building Professional Required: Glazier

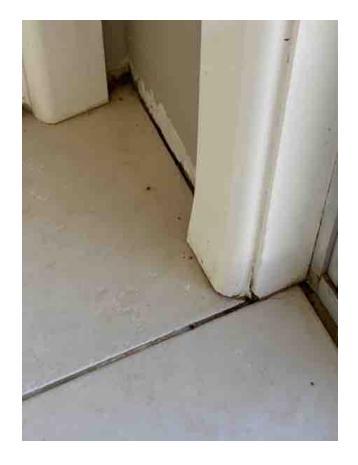
The skirting is missing and the timber architrave is swollen from water penetration.

The swollen architrave and missing skirting.

Building Professional Required: Carpenter

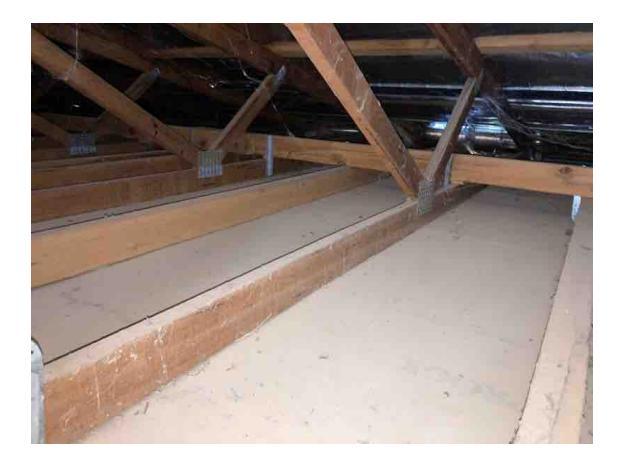
The roof void area has no insulation installed.

Building Professional Required: Plasterer

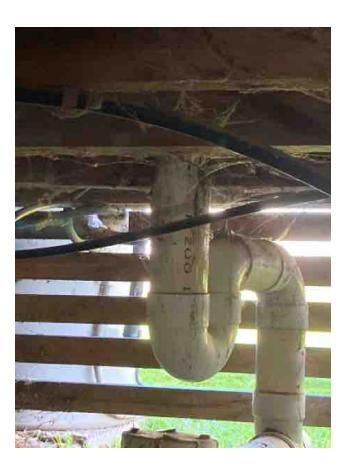
The shower waste connection is leaking.

There is a leak under the shower in the subfloor.

The shower is leaking around the waste point.

Building Professional Required: Plumber, Tiler

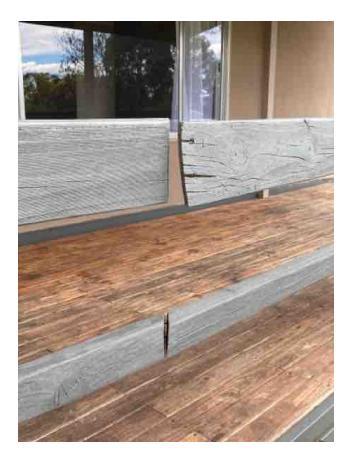
| Defect Location: | North Side |
|---|---|
| Defect Summary: | The timber hand rails are unstable and are a safety issue. |

The damaged handrail is unstable and is a safety issue.

| Defect Location: | North Side |
|---|---|
| | Building Professional Required: Carpenter |
