Accredited Thermographers

2015  
Thermographic Inspection  
**(Project Name & Location)**

**Inspected Equipment**  
**Mechanical Services Switchboard**  
**Located Level 4 Plant Room**

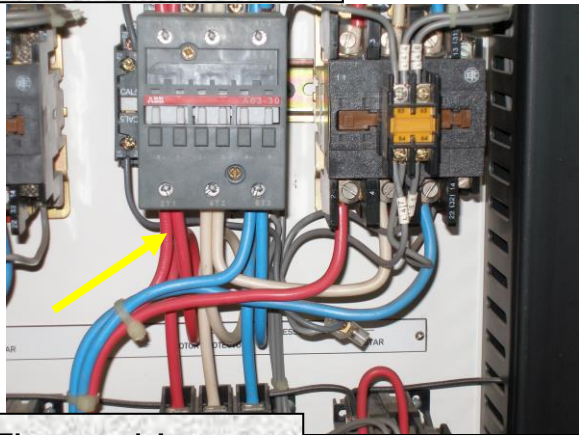
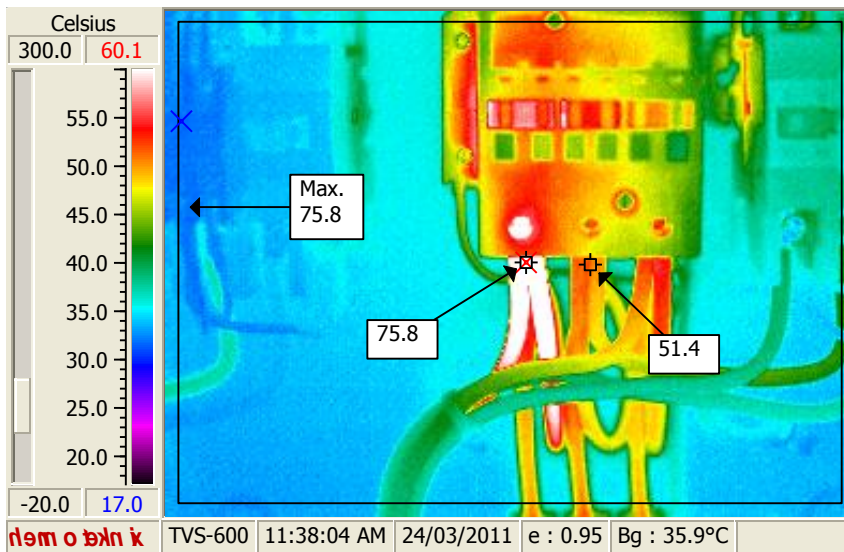
Equipment	Compressor 3 Motor Starter
Equipment Type	ABB A-63
Additional Information	
Date	14/03/2011
Time	11:38 AM
Working conditions:	
Located within a non ventilated environment

IR Image Details	
Image No.	
Emissivity	0.95
Spot 1	51.4°C
Spot 2	75.8°C
Area 1 Max.	75.8°C
Area 2 Max.	<unknown>
Background	36.0°C

<b>Description of Fault</b>	High resistance A phase load side termination.
<b>Priority Rating</b>	<b>2</b>
<b>Recommendation</b>	Re-scan within 12 months.

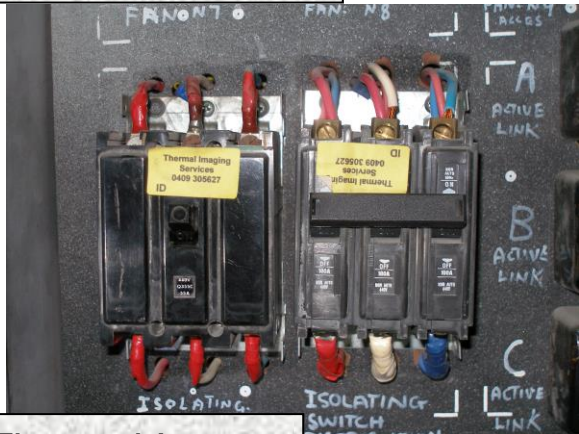
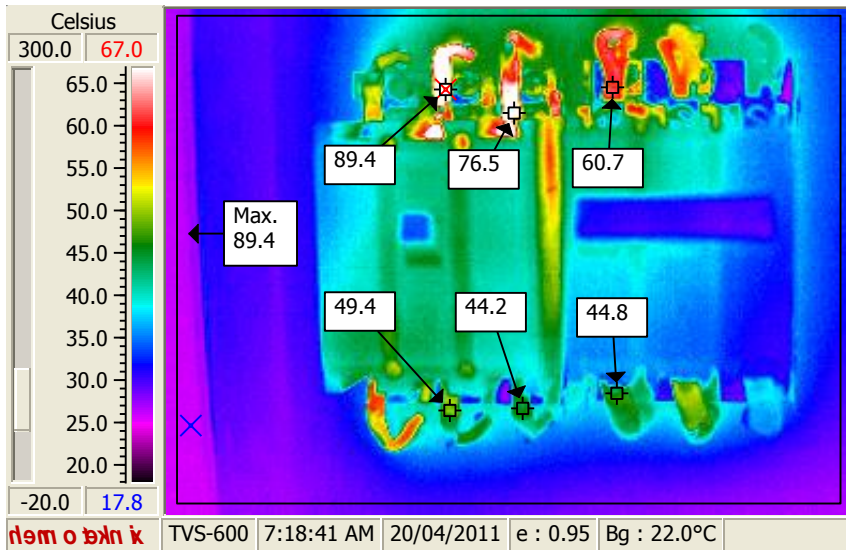
<b>Inspected Equipment</b>	<b>Operator:</b>
	House Services Panel Located Level 3 Riser	Malcolm Rhind

Equipment	Fan Isolating Switch & DB-2 Isolating Switch
Equipment Type	Quicklag Q355C & Q3100CN
Additional Information	
Date	20/04/2011
Time	07:18 AM
Working conditions:	Located within a non ventilated environment

IR Image Details	
Image No.	
Emissivity	0.95
Spot 1	49.4°C
Spot 2	89.4°C
Area 1 Max.	89.4°C
Area 2 Max.	<unknown>
Background	22.0°C

<b>Description of Fault</b>	High resistance terminations. Variation in line and load side temperatures
<b>Priority Rating</b>	<b>2</b>
<b>Recommendation</b>	Inspect contact surfaces and re-terminate. Ensure tunnel terminals are securely fitted to circuit breaker housings

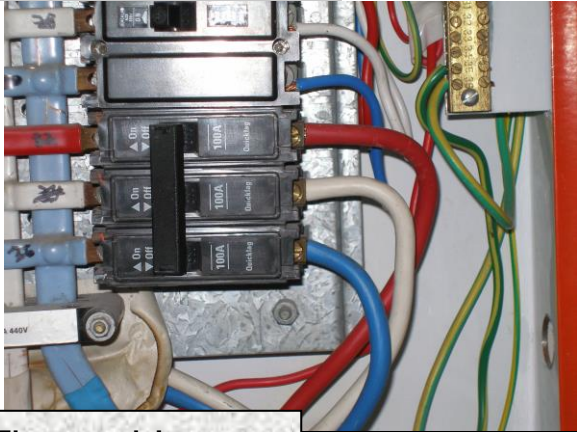
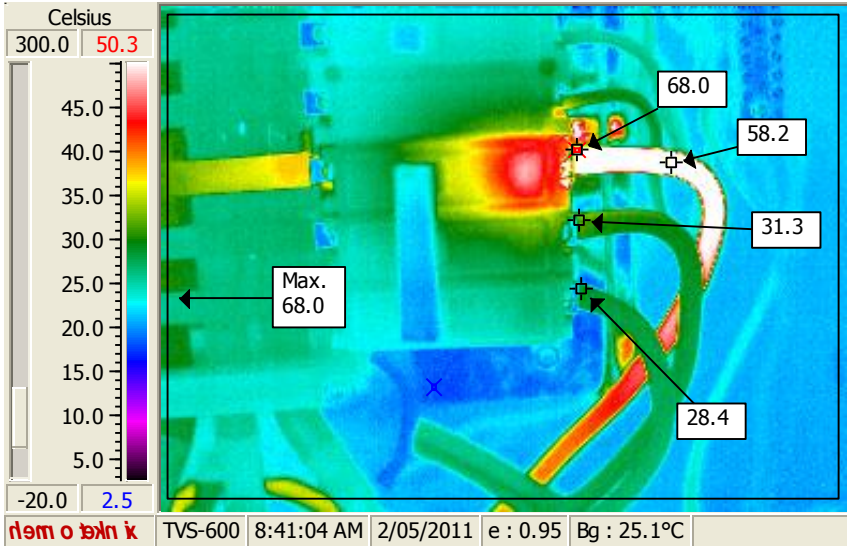
<b>Inspected Equipment</b>	<b>Operator:</b>
	DB-8A Located Level 4 Riser	Malcolm Rhind

Equipment	Main Switch
Equipment Type	Quicklag Q3100C
Additional Information	Loading A Phase – 89 Amperes B Phase – 32 Amperes C Phase – 38 Amperes
Date	2/05/2011
Time	08:41 AM
Working conditions:	
Located within a ventilated environment

IR Image Details	
Image No.	
Emissivity	0.95
Spot 1	31.3°C
Spot 2	68.0°C
Area 1 Max.	68.0°C
Area 2 Max.	<unknown>
Background	25.0°C

<b>Description of Fault</b>	High resistance A phase connection. Unbalanced load
<b>Priority Rating</b>	<b>2</b>
<b>Recommendation</b>	Ensure runnel terminal is securely fitted to circuit breaker housing. Re-tension termination. Re-distribute load over adjacent phases.

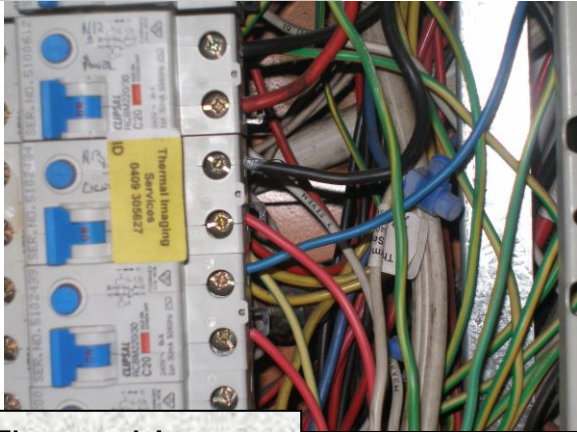
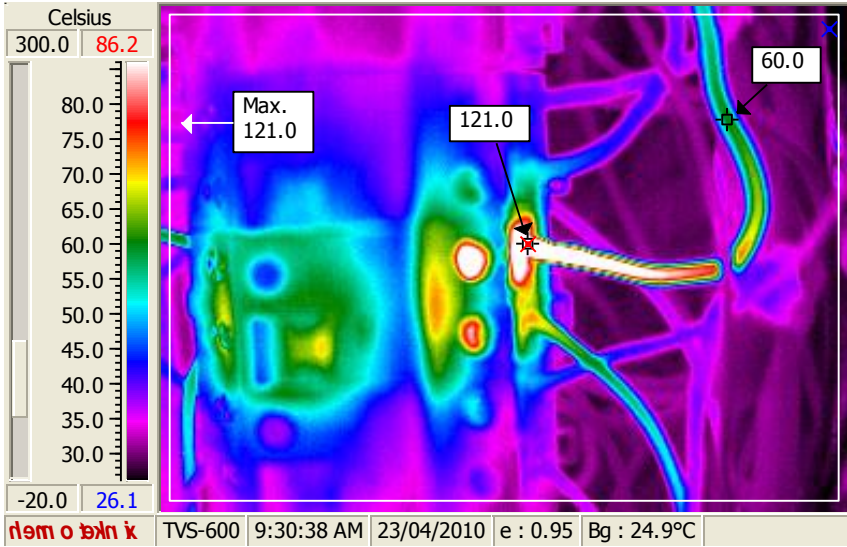
<b>Inspected Equipment</b>	<b>Operator:</b>
	DB-3 Located Warehouse Ramp	Malcolm Rhind

Equipment	Circuit Breaker 89-90
Equipment Type	Hager
Additional Information	Neutral Conductor
Date	23/04/2010
Time	09:30 AM
Working conditions:	
Located within a ventilated environment

IR Image Details	
Image No.	
Emissivity	0.95
Spot 1	121.0°C
Spot 2	60.0°C
Area 1 Max.	121.0°C
Area 2 Max.	<unknown>
Background	25.0°C

<b>Description of Fault</b>	High resistance termination.
<b>Priority Rating</b>	<b>1</b>
<b>Recommendation</b>	Make good cable end and re-terminate

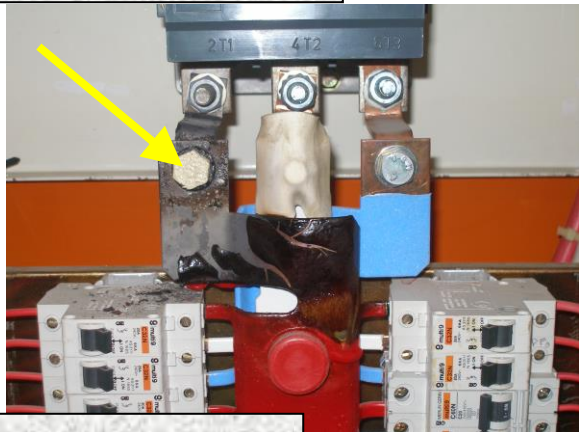
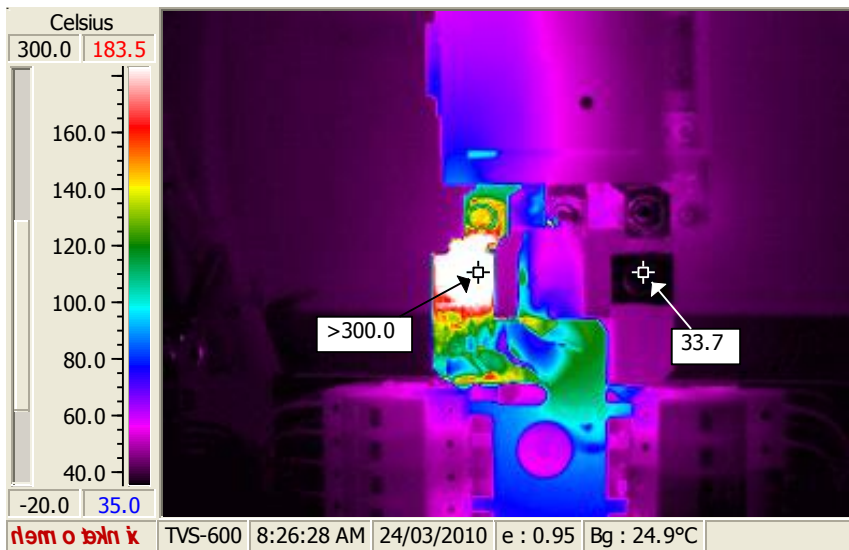
<b>Inspected Equipment</b>	<b>Operator:</b>
	DB-4.4 Located Level 1 Riser	Malcolm Rhind

Equipment	A phase circuit breaker chassis
Equipment Type	Merlin Gerin
Additional Information	
Date	24/03/2010
Time	08:26 AM
Working conditions:	Located within a non ventilated environment.

IR Image Details	
Image No.	
Emissivity	0.95
Spot 1	300.0°C
Spot 2	33.7°C
Area 1 Max.	300.0°C
Area 2 Max.	<unknown>
Background	25.0°C

<b>Description of Fault</b>	High resistance A phase connection to circuit breaker chassis
<b>Priority Rating</b>	<b>1</b>
<b>Recommendation</b>	Replace circuit breaker chassis and make good connection hardware and conductor.
