Accredited Thermographers

**2015**  
**Thermographic Inspection**  
**(Project Name & Location)**

Location: XXXXXXXXXXXXXXXX

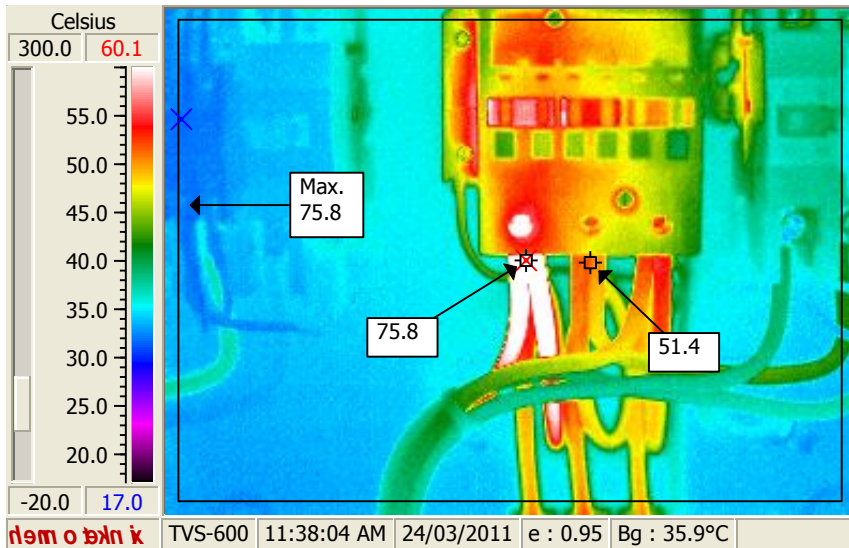
Equipment	Compressor 3 Motor Starter
Equipment Type	ABB A-63
Additional Information	
Date	14/03/2011
Time	11:38 AM
Working conditions:	
Located within a non ventilated environment

IR Image Details	
Image No.	
Emissivity	0.95
Spot 1	51.4°C
Spot 2	75.8°C
Area 1 Max.	75.8°C
Area 2 Max.	<unknown>
Background	36.0°C

<b>Description of Fault</b>	High resistance A phase load side termination.
<b>Priority Rating</b>	<b>2</b>
<b>Recommendation</b>	Re-scan within 12 months.

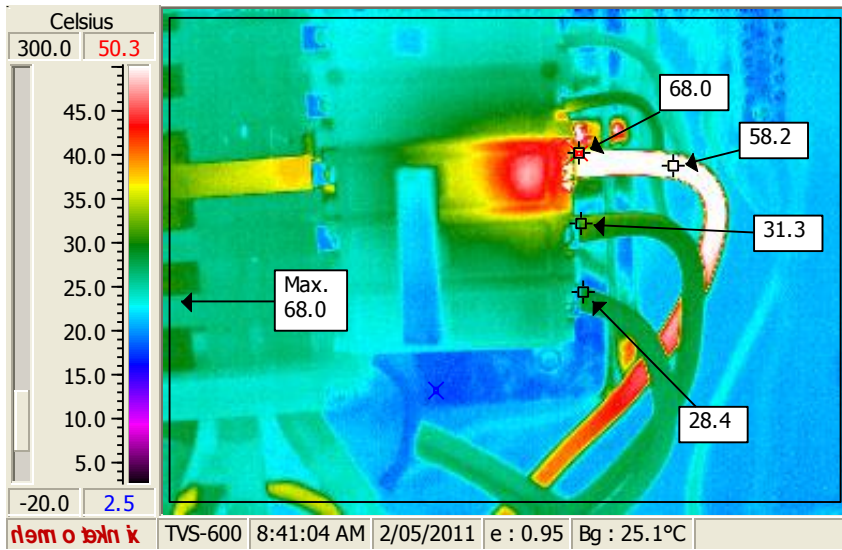
<b>Inspected Equipment</b>	<b>Operator:</b>
	DB-8A Located Level 4 Riser	Malcolm Rhind

Equipment	Main Switch
Equipment Type	Quicklag Q3100C
Additional Information	Loading A Phase – 89 Amperes B Phase – 32 Amperes C Phase – 38 Amperes
Date	2/05/2011
Time	08:41 AM
Working conditions:	
Located within a ventilated environment

IR Image Details	
Image No.	
Emissivity	0.95
Spot 1	31.3°C
Spot 2	68.0°C
Area 1 Max.	68.0°C
Area 2 Max.	<unknown>
Background	25.0°C

<b>Description of Fault</b>	High resistance A phase connection. Unbalanced load
<b>Priority Rating</b>	<b>2</b>
<b>Recommendation</b>	Ensure runnel terminal is securely fitted to circuit breaker housing. Re-tension termination. Re-distribute load over adjacent phases.
