PARMELIA HOUSE STRUCTURAL STRENGTHENING

PERTH, WA

MAINTENANCE - STRUCTURAL STRENGTHENING

Parmelia House Sun Hood Structural Strengthening

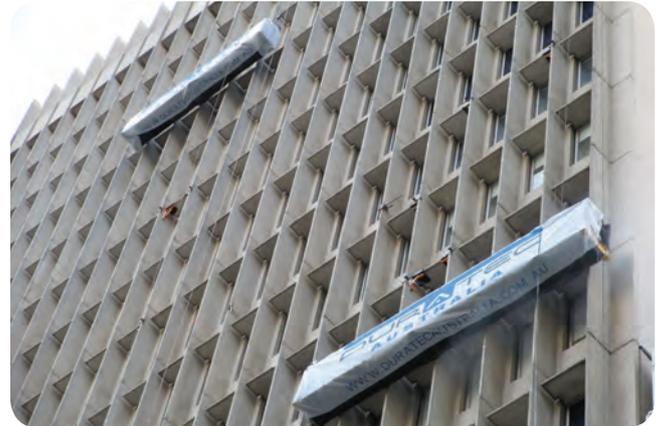
- ▶ The southern facade was accessed by swing stage.
- ▶ Rope access provided a very safe, fast and efficient method of repairing the sun awnings.
- ▶ Example of broken of edge of sun hood.

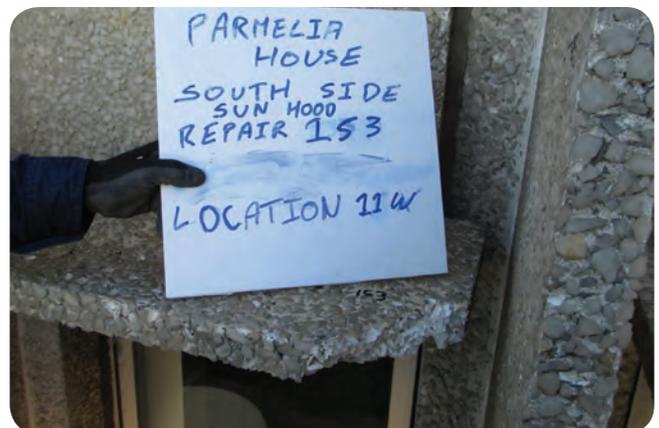
Corners of the sun hoods had broken off due to the reinforcement being well back from the edge. This had occurred over a number of years particularly when the building was accessed by rope access for window cleaning.

Some of the edges of the sun hoods and shades were also cracked and at risk of breaking causing safety concerns. The edges of the pre-cast concrete panels were repaired using form and pour techniques and stainless steel pins. All sun hoods received a four-layer reinforced membrane coating system that will strengthen them and eliminate the risk of further spalls. This method of structural strengthening was unique to this project.

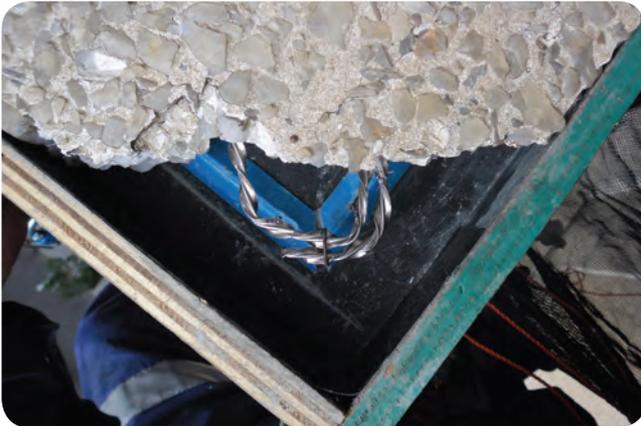
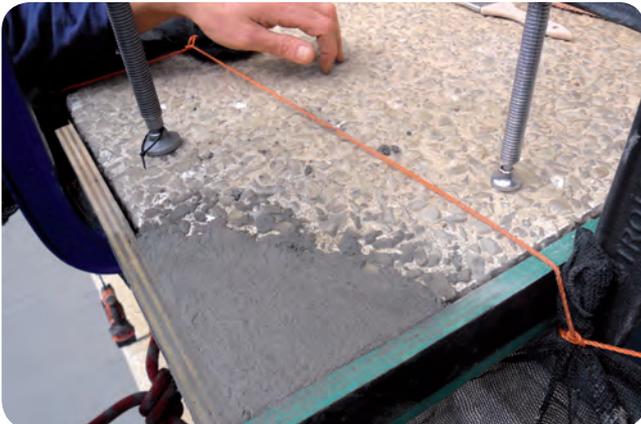
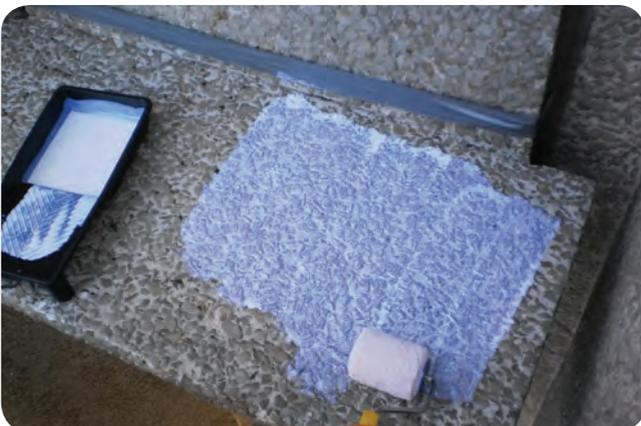
IMAGES (FROM TOP TO BOTTOM)

- ▶ Helifix ties were utilised to reinforce the edges of the sun hoods.
- ▶ The sun hood was formed and repaired with an epoxy mortar.
- ▶ Priming the concrete sun hoods.

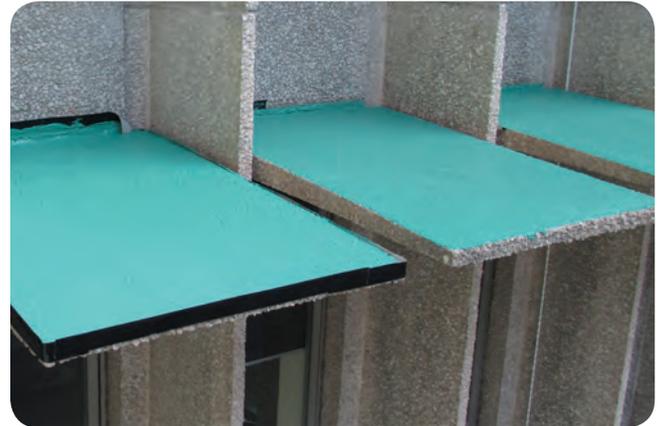
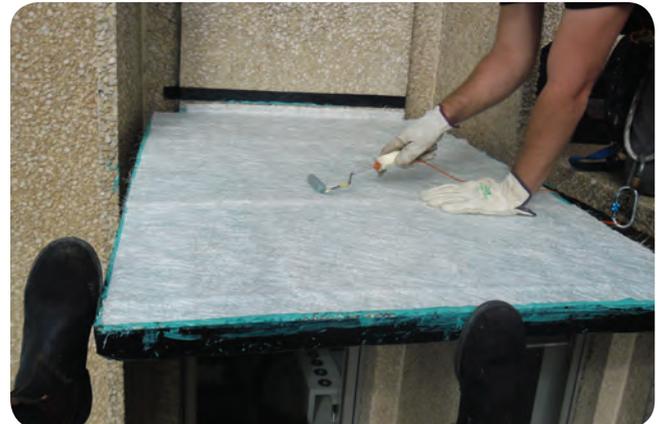
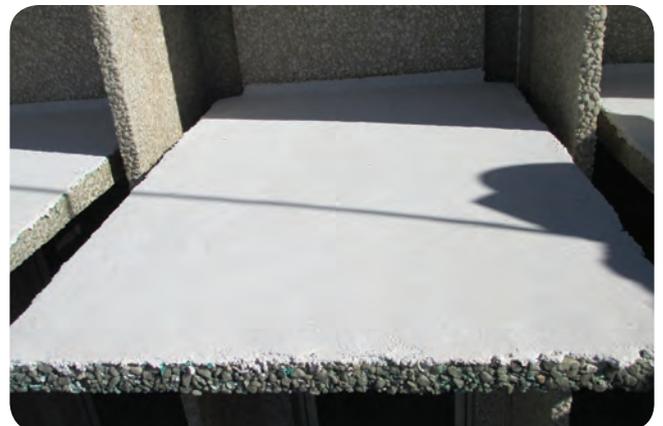
IMAGES (FROM TOP TO BOTTOM)

- ▶ First coat of the epoxy membrane.
- ▶ Duratec specialist embedding the glass fibre reinforcing into the wet membrane.
- ▶ Final Gemstone texture finishing coat.
