CAPSTANS COATING REPAIRS

MAINTENANCE - PROTECTIVE COATINGS

Pilbara Ports Dampier Bulk Liquid Berth Capstans Coating Repairs

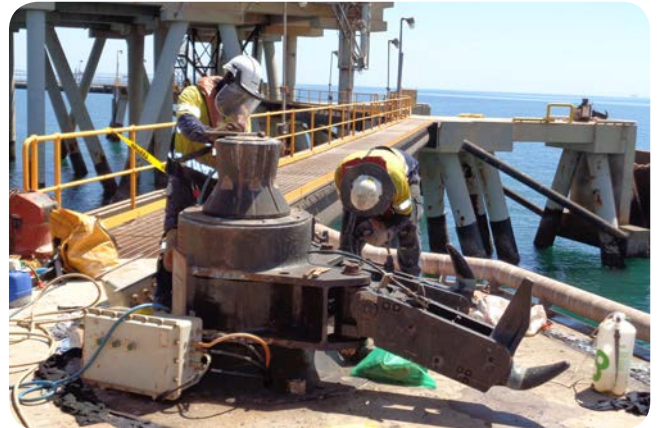
- ▶ Surface preparation of the capstan.
- ▶ Application of light coloured epoxy barrier coat.
- ▶ Completed capstan.

- ▶ High pressure wash to remove residual contaminants.
- ▶ Hand preparation of corroded locations to a minimum class St3 using a pneumatic surface preparation tool.
- ▶ Preparation of remaining existing coatings by abrasive paper.
- ▶ Application of a light coloured epoxy barrier coat to the bare steel locations.
- ▶ Application of a coat of black acrylic polyurethane finish.
