FACADE PANEL TESTING & REMEDIATION

PERTH, WA

Australia Place Façade Panel Testing & Remediation

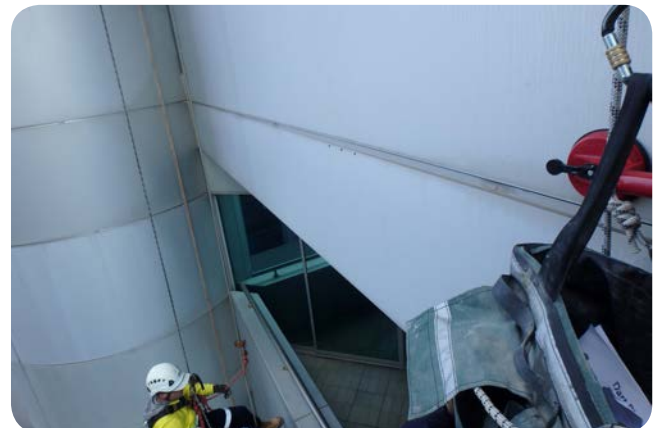
- ▶ Overview of Australia Place facade.
- ▶ Works in progress.
- ▶ Completed screw fixings.

Failed welds were rectified at the time they were identified by pull testing by fitting screws to the defective weld locations. Fixings were installed at the specific failure point and immediately either side only, not around the perimeter of the entire panel.
