# WESTFIELD MARION EXPANSION JOINT REPLACEMENT

ADELAIDE, SA

MAINTENANCE - JOINT SEALING

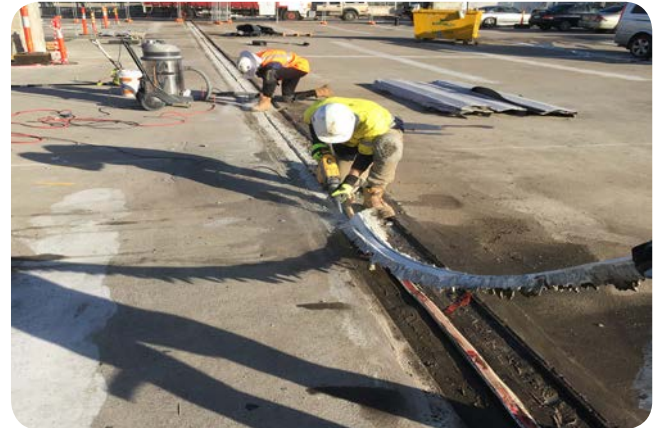
- ▶ Removal of existng joint system.
- ▶ Completed joint replacement.
- ▶ Completed joint with steel cover plate.

Duratec selected the Sikadur Combiflex system for the install based upon the large movement criteria of the expansion joints. Following removal of the defunct steel cover plates, Duratec removed the failed joint system, prepared the substrate through diamond grinding and installed the new Combiflex system.
