ADMIRALTY TOWERS ONE BALCONY REPAIRS

BRISBANE, QLD

MAINTENANCE - FACADE REPAIRS

Admiralty Towers One Balcony Hobs Concrete Repairs

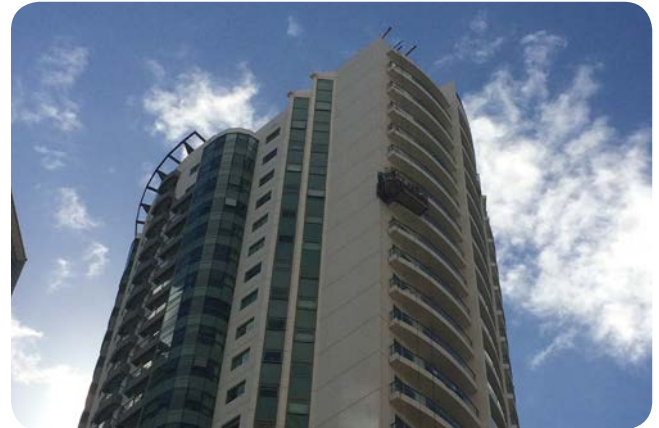
- ▶ Swing stage on the facade of the building.
- ▶ Typical defect.
- ▶ Repair to defect.

- ▶ Duratec chose an access system of two concurrent swing stages to complete the works which were considered safer than rope access in capturing falling debris, for jack hammering and saw cutting concrete and dust mitigation control.
- ▶ Duratec chose the painting works to the hobs to be performed by rope access as the entire length and height of the hob required repainting, this was a cost effective solution as it reduced the number of moves and hire period of the swing stages.

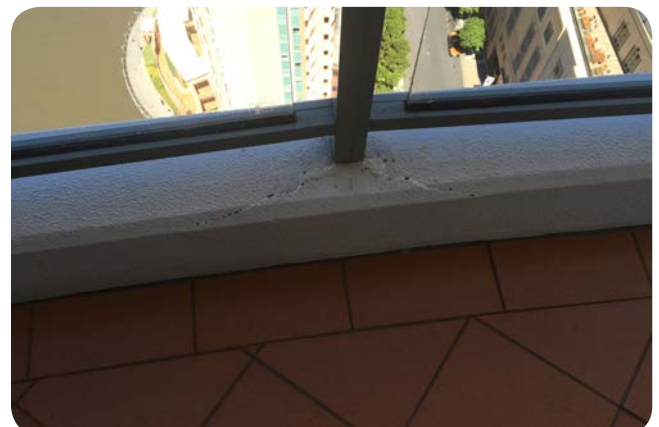
Concrete cracking and connection failure at the base of balustrade posts to the precast concrete hob at the edge of the balconies was presenting a public safety issue.

Duratec was engaged to apply structural repair epoxy and install carbon fibre wrap and carbon fibre laminate to repair the concrete, recessing a minimum of 5 to 10mm so that once the wrap and laminate are installed the repair will finish flush with the existing hob surface.
