COWAL GOLD CIL TANK REFURBISHMENT

COWAL, NSW

MAINTENANCE - TANK REFURBISHMENT

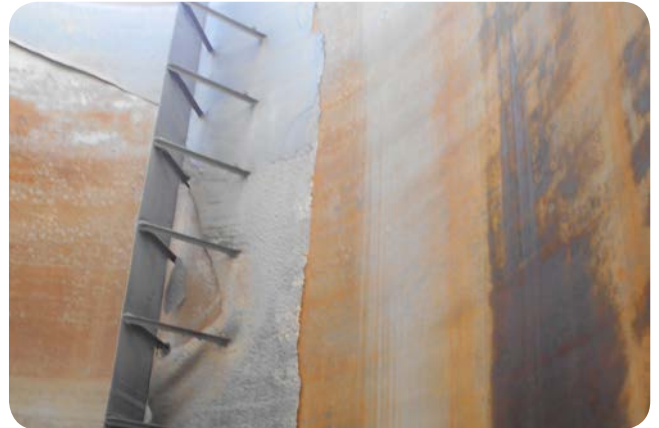
During a routine maintenance inspection Evolution discovered that sections of the CIL tank's internal lining had delaminated from the substrate and wrapped themselves around the tank's agitator shaft. The tank was then taken off-line for refurbishment.

- Condition of tank internal prior to remediation.
- Application of protective coating.
- Progression of coating works.
