COURTYARD DECK WATERPROOFING

SHENTON PARK, WA

MAINTENANCE - WATERPROOFING

Shenton Village Courtyard Deck Waterproofing

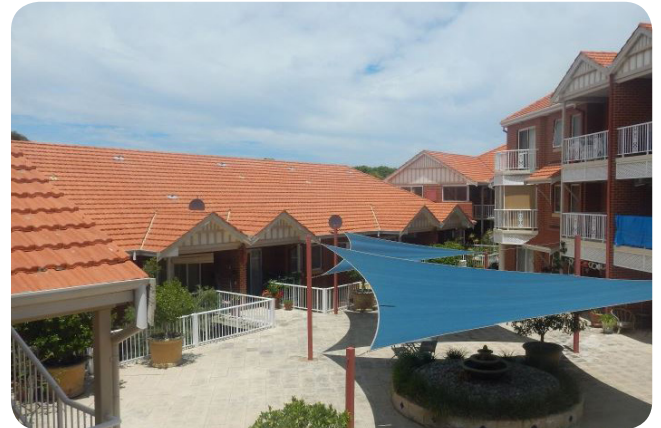
Shenton Village is a 66 unit retirement complex in the western suburbs of Perth. The existing courtyard flooring system was showing signs of water damage, with leakage into the basement car park below and flooding in some areas.

- ▶ The old courtyard.
- ▶ Removal of trees and beginning of paver demolition.
- ▶ Final tooling off of joint sealant.

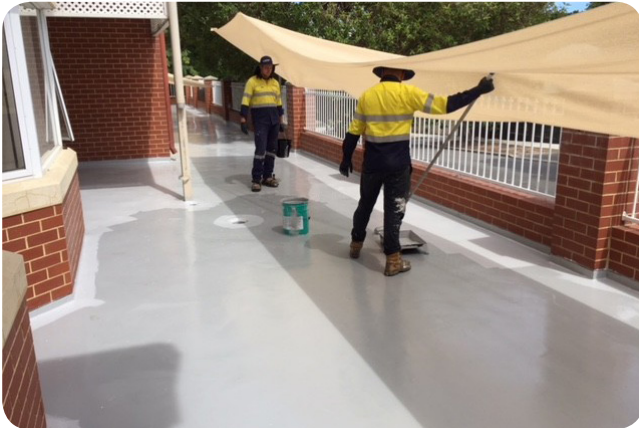
- ▶ Rolled application and sand seed of waterproof membrane.
- ▶ Reinstallation of pavers.
- ▶ Completion of fencing (balustrade).

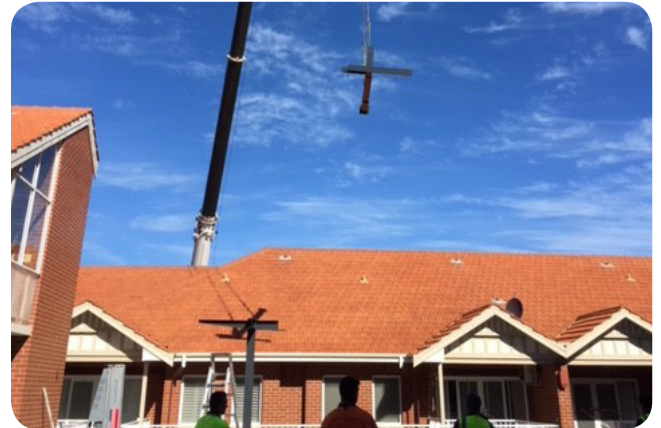
- ▶ Craning in pergola frame columns.
- ▶ Southern garden bed planted and mulched.
- ▶ The new courtyard.
