# NORTH METRO TAFE ROOF REDEVELOPMENT

PERTH, WA

MAINTENANCE - WATERPROOFING

North Metro TAFE Roof Redevelopment

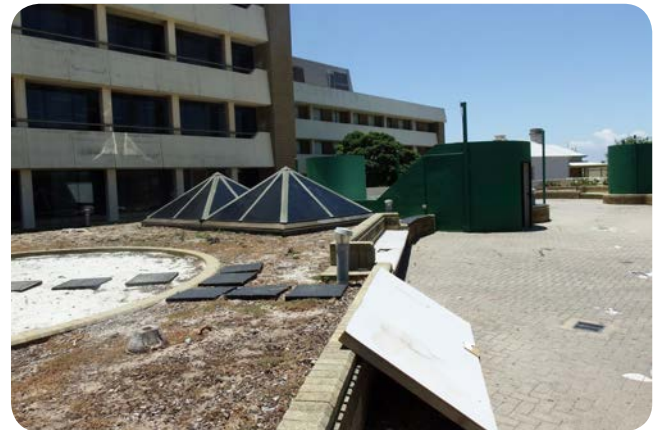
- ▶ The original rooftop podium.
- ▶ Demolition in progress.
- ▶ Wireless remote-controlled grinder.

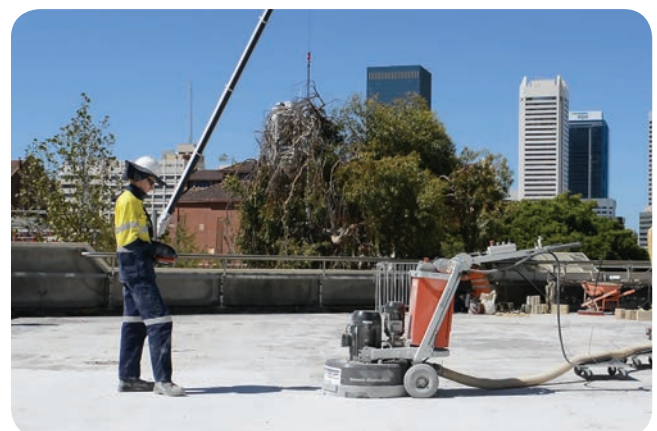
- ▶ A self-operating, wireless remote-controlled grinder which eliminates operator fatigue was utilised for the surface preparation. This multi-purpose unit is perfect for when an extremely powerful and tough grinder/polisher is required to re-surface large areas.
- ▶ Duratec delivered a remedial solution to improve the service life and serviceability of the building. This was achieved through the rectification of water ingress issues and removal and replacement of the rooftop waterproofing membrane and various other roof elements. This will prevent further deterioration of the building, preserve the integrity of the structure and eliminate potential public liability issues.

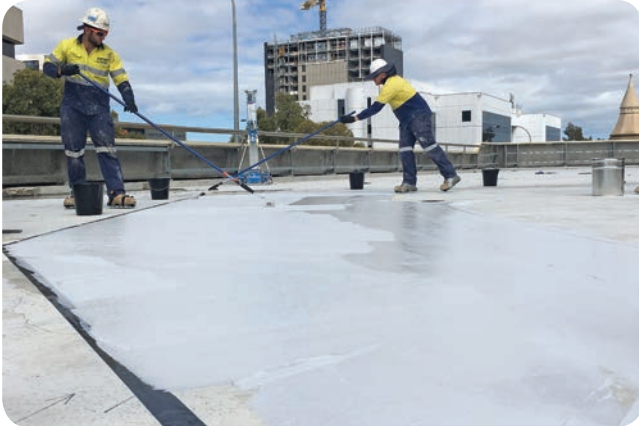
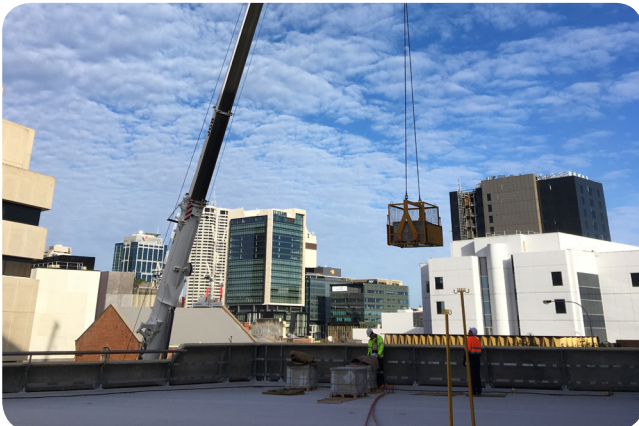
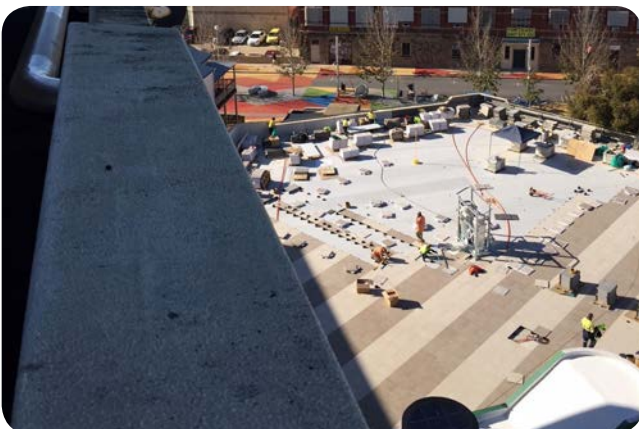
- ▶ Application of waterproof membrane.
- ▶ Craning in paving pallets.
- ▶ Overview of works in progress.

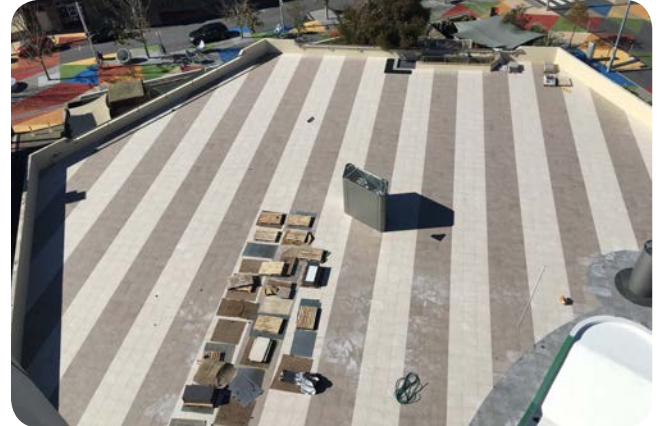
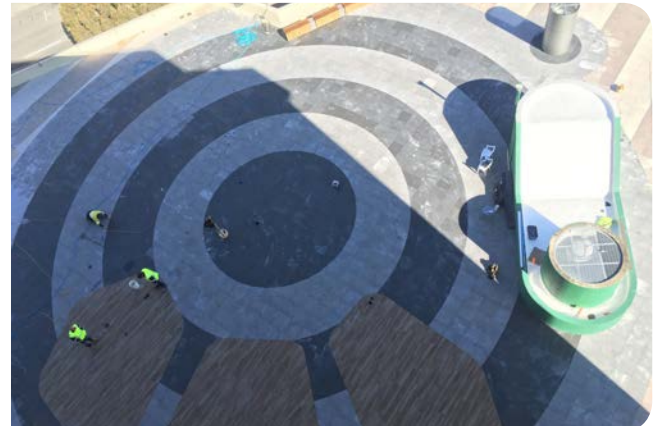
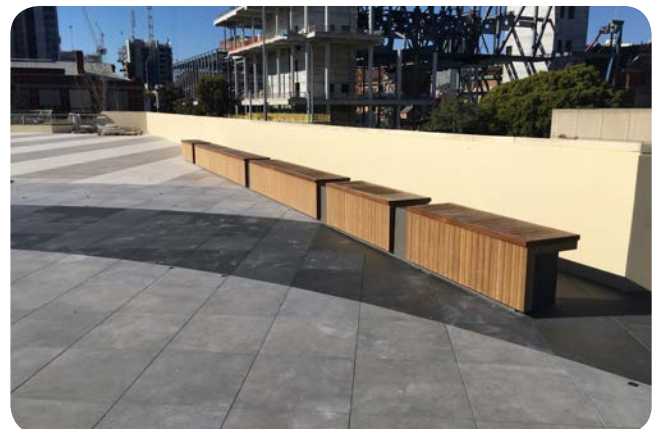
- ▶ Paving installation in progress.
- ▶ Paving installation in progress.
- ▶ Completed timber clad seating.
